**MORFA HAZARDOUS  
LANDFILL  
PORT TALBOT**

**PERMIT BW2692IM**

**2020 Annual Review of  
Environmental  
Monitoring Results**

*Report Number 2093r1v1d0221*

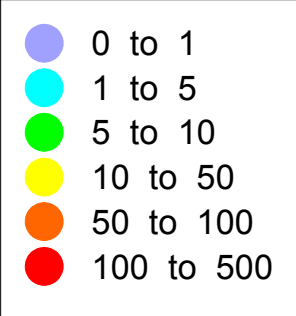
**Q4, 2020 - Shallow GW, Leachate, Ponds and Surface Water**

Chloride in Groundwater, Leachate and Surface Water (mg/l)
