## Compliance Assessment Report CAR\_NRW0037627

**Permit being assessed:** BB3299FN.

For: SL Recycling Ltd, held by SL Recycling LTD

**Type of assessment carried out:** Site Inspection, Reason: Routine.

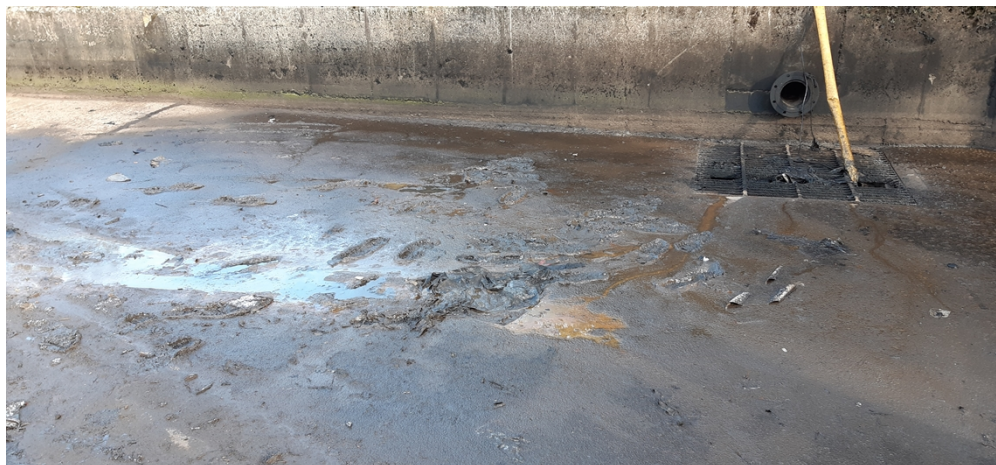
The general housekeeping on the site was in good condition with no major amounts of loose debris located on the floor. It was noted that one area of the site contained a pooling of excess residual sludge from a recent flood that had occurred in the area. Within this sludge there were some traces of oil which does drain to the sites interceptor drainage system (as seen in photo 1). Although this wasn't a major concern it was pointed out that the residual sludge will need to be cleaned up.

**Photo 1** - Residual sludge containing traces of oil from recent flooding event

| Criteria | Action needed | Complete by |
|---|---|---|
| B3 | Repair damaged areas of flooring on site and remove excess sludge from drainage area following recent flooding to prevent potential contamination to ground water | 19/03/2021 |

**ACTION:** Repair damaged areas of flooring on site and remove excess sludge from drainage area following recent flooding to prevent potential contamination to ground water

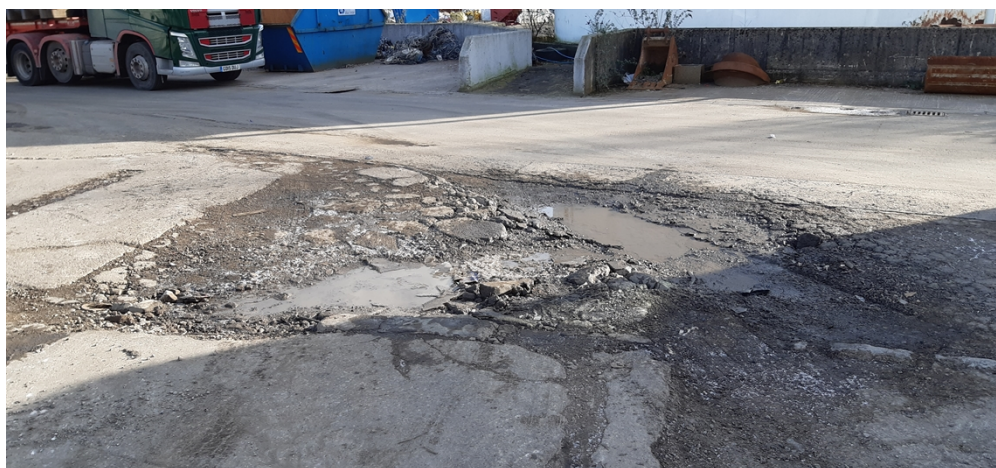
The site has an operational interceptor drainage system which was maintained and in good working order and maintained periodically with no concerns at the time of the site inspection. It was noted that although the concrete impermeable flooring was in good condition, there were some areas where they were damaged and needed repairing (as seen in photo 2). An action plan is in place to repair and maintain the damaged flooring areas in question soon.

**Photo 2** - Damaged flooring located on site

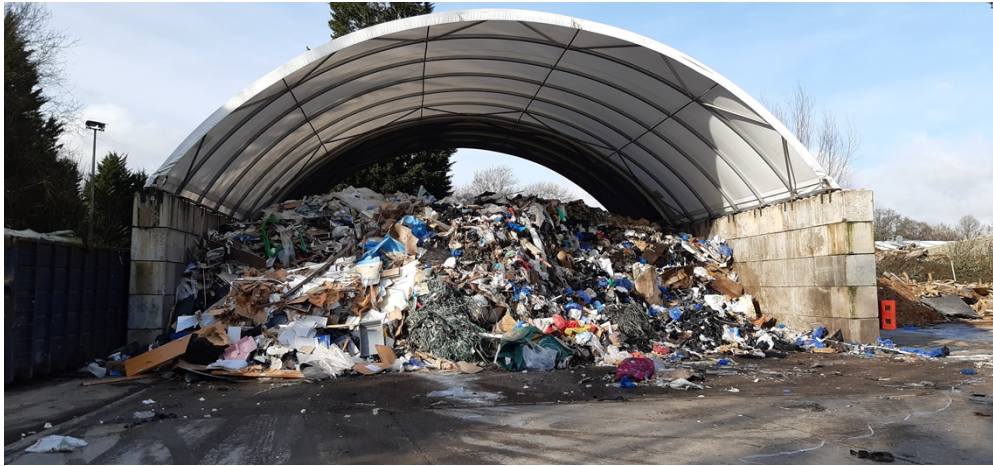
During the site visit there were various segregated stockpiles of different waste streams. The majority of the mixed stockpiled general waste was located underneath a 'zap' shelter. The general waste is removed and sent to various downstream waste companies such as Opez, Viridor and NCD. It was noted that the size of the waste stockpile was particularly large at the time of the site inspection (as seen in photo 3) and that it should be reduced in size to prevent any potential fires occurring. Officer BOWDER reiterated during the site visit the FPMP (Fire Prevention Mitigation Plan) to Ms. TUCKER that the height of the waste must be under 4 metres and clear separation distances exercised to prevent fire spread.

**Photo 3 - General waste located underneath 'Zap' Shelter**

| Criteria | Action needed | Complete by |
|---|---|---|
| C2 | Reduce size of waste stockpile to 4 metres or less and establish clear separation distances between deposited waste and site boundaries as per SL Recycling, Pontypool FPMP (Fire Prevention and Mitigation Plan) | 19/03/2021 |

**ACTION:** Reduce size and create designated separation distance of waste stockpile to prevent potential fire

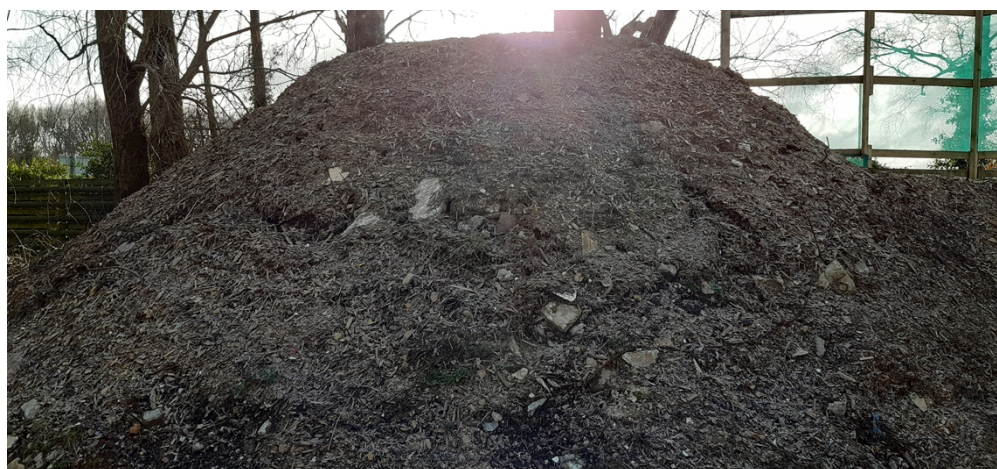
During the site visit there were a couple of stockpiles of waste wood / wood chip (as seen in photo 4) which is collected from the processing of general waste. Some of this wood chip was used to increase the size of the sites bund to help noise suppression which is dictated by Torfaen County Council. NRW would only regulate the material being used for the bund (as seen in photo 5).

The wood is to be stored inside however due to recent flood damage, the access route to the warehouse where the wood was to be stored was damaged and due for repair therefore as a temporary measure it was stored outside away from any possible ignition sources. It was noted the stockpile was relatively high however it was not a cause for concern. The waste wood is stored on site and then sent to South Wales Wood Products, Newport.

**Photo 4** - Stockpile of woodchip located on site

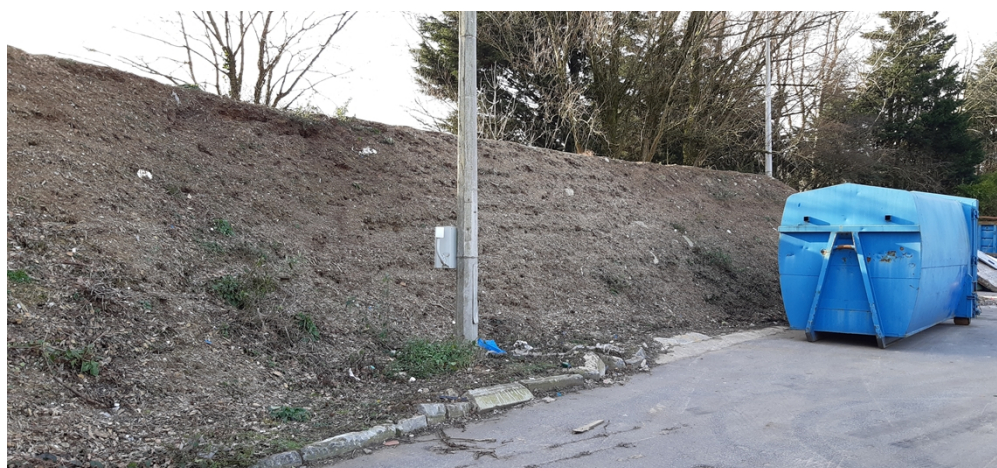
**Photo 5** - Increased size of bund to assist with noise suppression on site

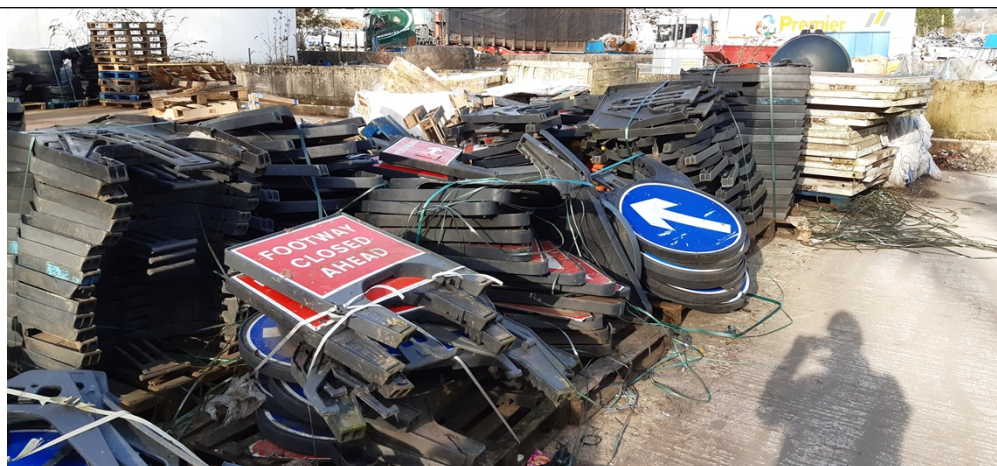
During the visit there was a segregated and secured stockpile of hard plastic waste (as seen in photo 6). This waste was to be processed on site and sent to AWD plastics, Port Talbot. Again, this was no cause of concern at the time of the site inspection.

**Photo 6** - Stockpile of hard plastic waste located on site

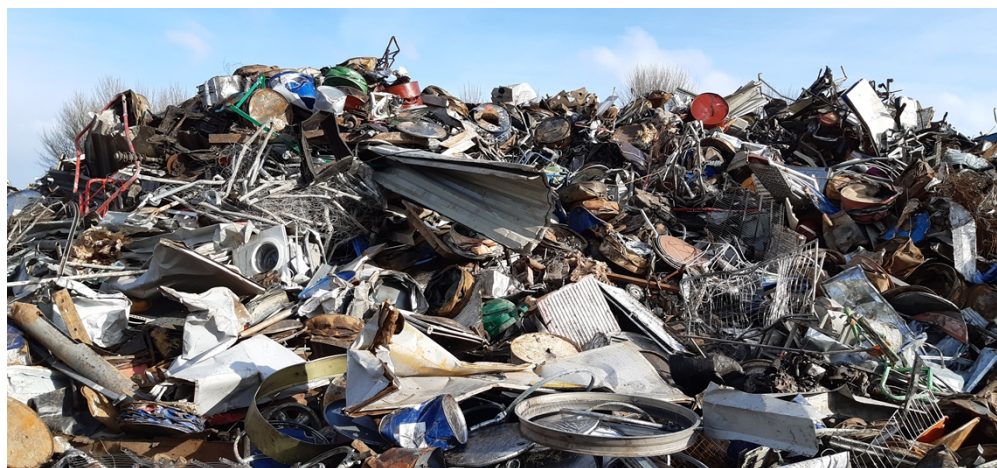
The site contained large quantities of scrap metal that would be baled and sent to the relevant downstream scrap metal dealers. It was noted that the size of the waste stockpile was particularly large at the time of the site inspection (as seen in photo 7) and that it should be reduced in size to prevent any potential fires occurring. NRW Officers reiterated to the operator that the height of the scrap metal stockpile must not exceed 4 metres at any time and clear separation distances exercised to prevent fire spread / accessibility.

**Photo 7** - Large stockpile of scrap metal waste located on site

**ACTION:** Ensure there is an established minimum separation distance across all waste streams on site to reduce fire risk and allow emergency service access if required.

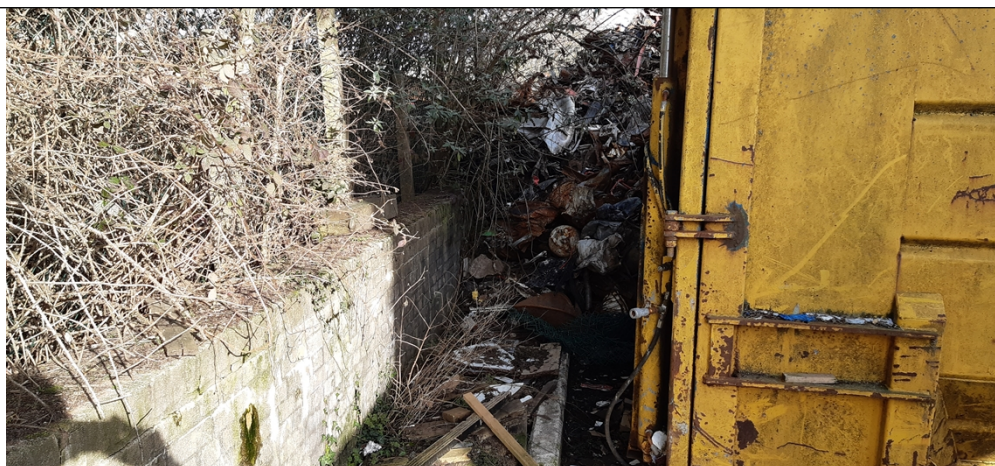
- Stockpile of waste without an established separation distance to site boundary.

There was also no clear separation between the metal waste and site boundary (as seen in photo 8). There should be a clear separation distance established at all times between building, boundaries and neighbouring stockpiles to allow access for fire and rescue services. This has scored the site a category 3 breach as a result.

**Photo 8** - No clear separation distance between waste and site boundary

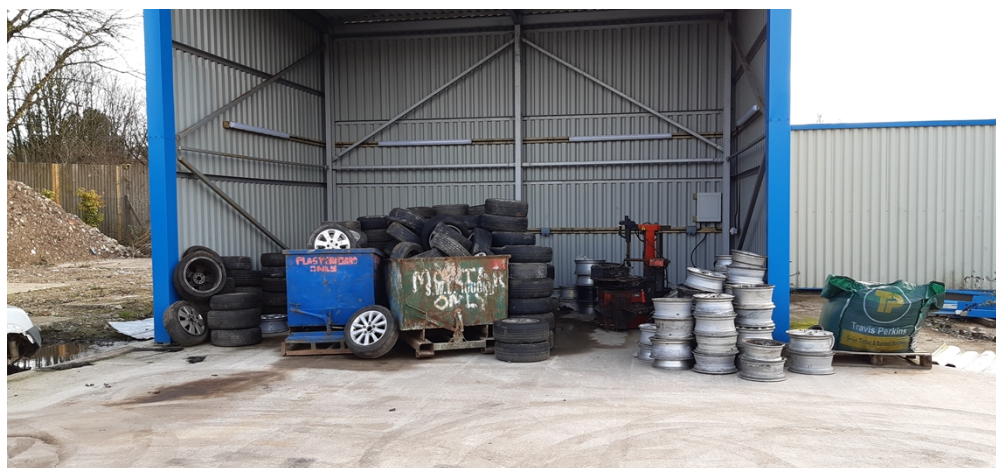
The site now has an erected and installed depollution bay on site (as seen in photo 9) with only a few other elements of equipment required to begin ELV operations. The flooring infrastructure was in excellent condition which is all linked to the sites interceptor drainage system. The scrap vehicles on site were stored securely and no more than 3 vehicles high at any one time (as seen in photo 10).

**Photo 9** - Newly erected de-pollution bay at SL Recycling, Pontypool

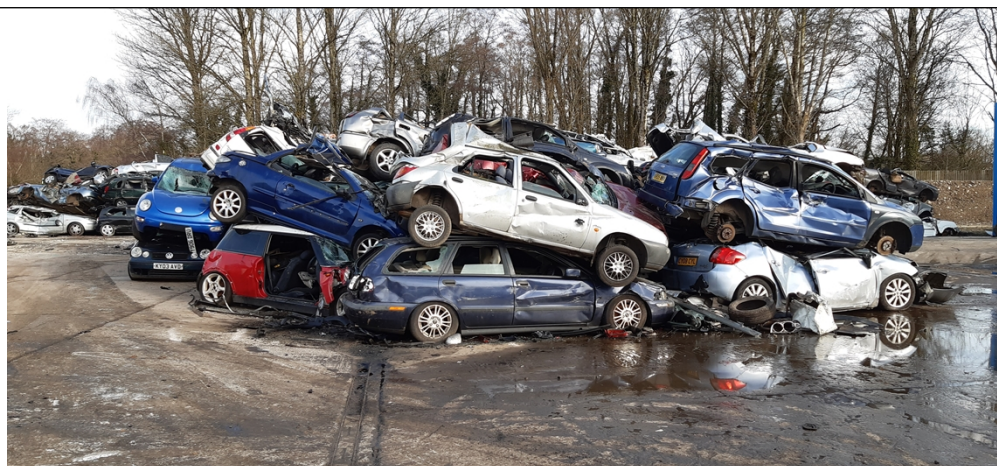
**Photo 10** - Storage of vehicles ready for the de-pollution process

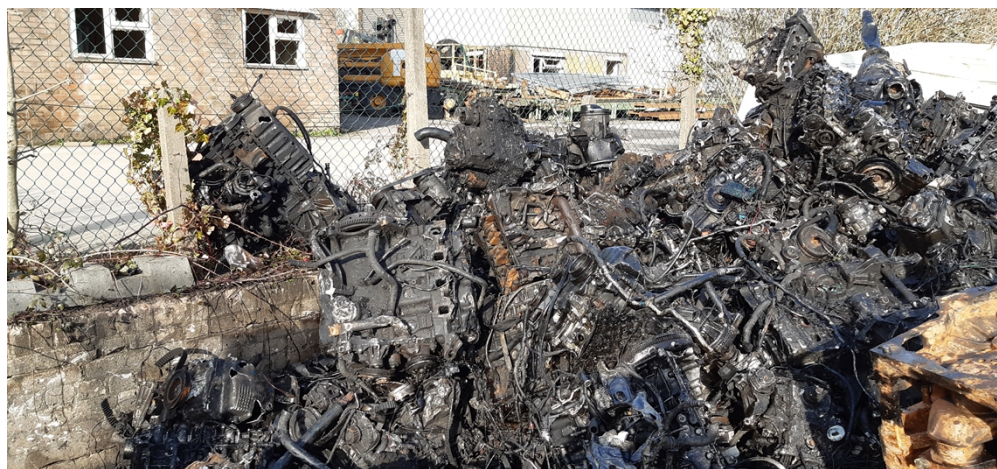
It was also noted, as per the metal waste above, that various ELV parts were 'propped' up against the site boundary fence (as seen in photo 11). As previously mentioned, there should be a clear and established separation distance at all times to allow access for fire and rescue services. It was noted that there was some residual oil that has leaked from ELV parts however as good practice, SL Recycling have used sawdust to absorb the residual oil as well as collect any excess via the sites interceptor drainage system. Officers questioned where the oil soaked sawdust was being removed to. The operator stated it was removed and transported by an authorised hazardous waste carrier.

**Photo 11** - ELV parts placed up against fence

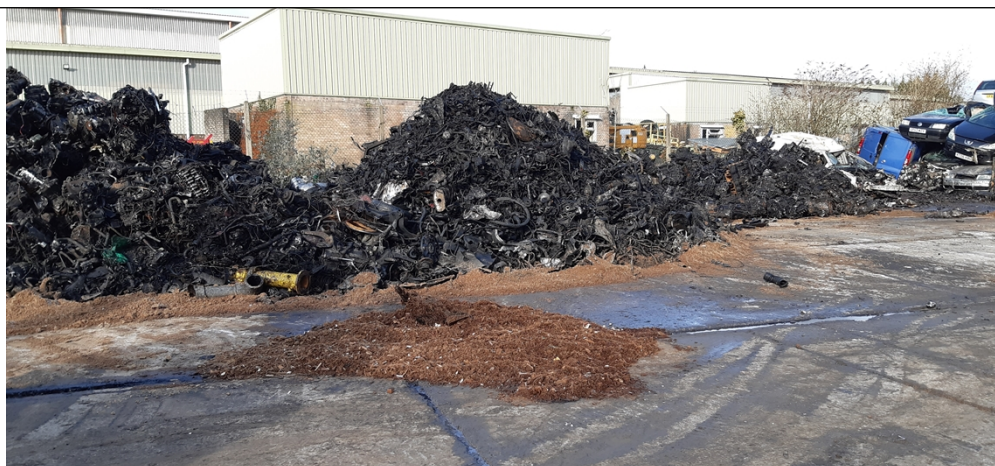
**Photo 12** - Use of sawdust to contain and absorb residual oil from ELV parts
