Compliance Assessment Report for: CAR_NRW0037040

Permit number	BW2692IM	Operator name	Tata Steel (UK) Ltd.
----------------------	----------	----------------------	----------------------

Site name	Morfa Hazardous Landfill
Site address	Morfa Landfill, Port Talbot Steelworks, Port Talbot, SA32 2NG
Type of assessment	Site inspection & check sampling

Date of assessment	8 th October 2020
---------------------------	------------------------------

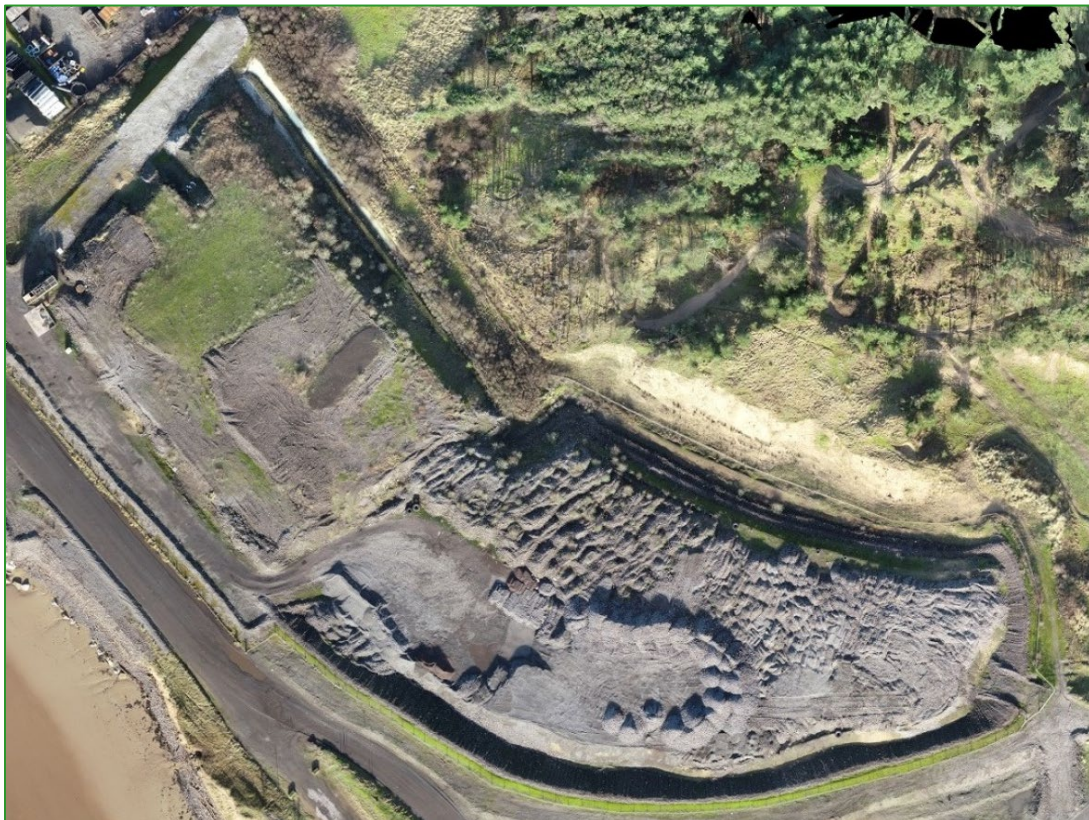
- I was escorted around the permitted installation by Rhys Lloyd and James Davies (Darlow Lloyd & Sons) and Ben Rees (Geotechnology).
- The purpose of the visit was a routine inspection of the Morfa Hazardous Landfill (see Figure 1).
- The facility is an operational hazardous waste landfill that receives wastes primarily from Tata's Port Talbot Steelworks installation and Tata's Llanwern facility.
- The landfill currently consists of two engineered sub cells with a shared leachate collection system draining to a leachate sump.
- In the last two years the volume of wastes deposited at the landfill has been very small and a reflection of TATA's successful and continuous programme of waste minimisation, treatment and recovery within the steelworks.
- The waste types that are currently deposited at the facility¹ are almost entirely limited to insulation type wastes (Chapter 17 wastes).

Figure 1.
Aerial
Photograph,
showing the
two operational
landfill cells.

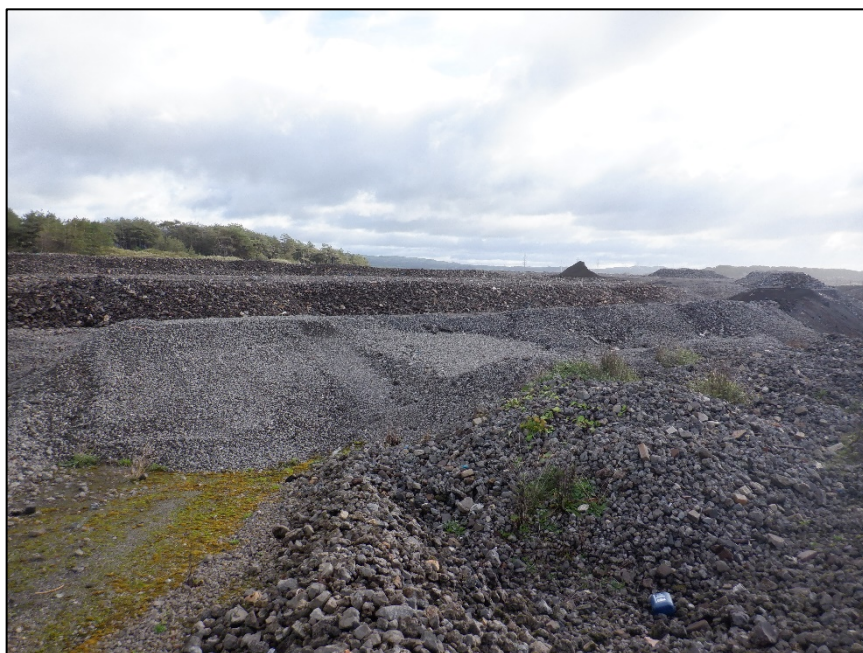
- No wastes were visible on any of the areas that I inspected, and the wastes appeared to be suitably covered with appropriate daily or intermediate cover (see figure 2).

Figure 2: photograph showing the waste deposits at the hazardous landfill, covered with appropriate intermediate cover.

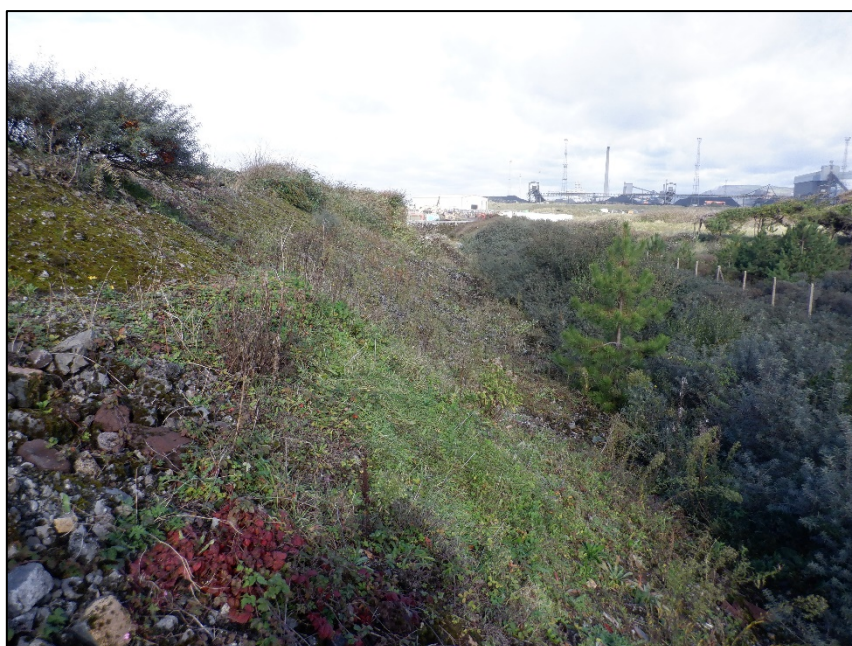
- Vegetation clearance needs to be undertaken along the northern flanks (see figure 3) of the landfill, especially the removal of trees growing on or near the landfill's containment bund.

Figure 3: Photograph showing vegetation along northern flank of landfill.

Criteria	Action needed	Complete by
B1	Ref: 0037040.1 <ul style="list-style-type: none"> Operator to clear vegetation from the landfill flanks and cells containment bund. The work shall be planned and undertaken to minimise the risk of any ecological impacts. 	31 st Dec 2020
B3	Ref: 0037040.2 <ul style="list-style-type: none"> Tata to monitor and remove surface water collecting along the northern ditch lying to the north of the containment bund serving cell 1. 	Ongoing
B3	Ref: 0037068.2* <ul style="list-style-type: none"> Tata to undertake a review into the performance of the current flow meters used in the site's leachate collection system. The review should also examine the accuracy of the flow meters for the purposes of leak detection. <p>*NOTE: This action has already been documented in a separate CAR report relating to the Non Hazardous Landfill (CAR ref: NRW0037068). To avoid confusion the same action reference (and deadline) from this report has been used.</p>	31 st Jan 2021

Please have regard to reducing any ecological impacts when undertaking any clearance works (check with TATA's ecologist before attempting any works). **Action**

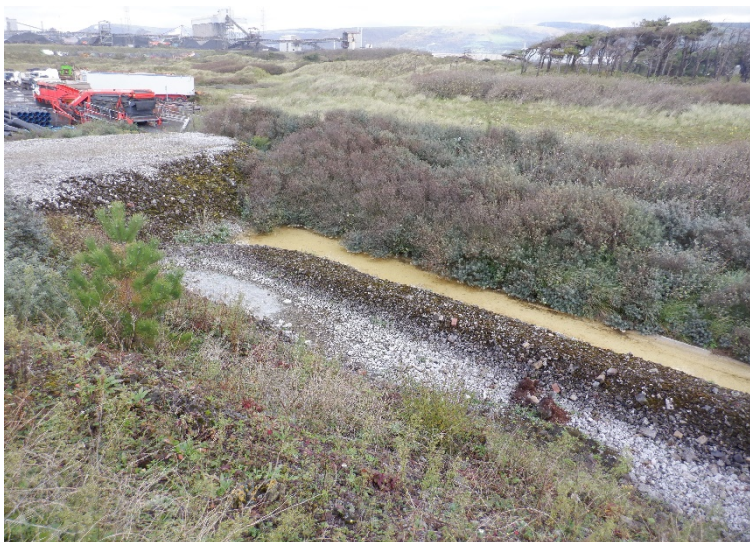
Figure 4:

- On the northern flank of sub cell 1, a low point (see figure 4), running along part of this flank is presently collecting surface water. In time this area will be developed to construct the third, and final cell however in the meantime water cannot easily drain from this point. As the surface water is resting against the site's containment bund it appears to be reacting with the slag aggregates forming the bund. This in turn appears to be affecting the pH of the surface water. Until the third cell is developed (and this low point removed) the operator needs to periodically remove this surface water and dispose of it appropriately.

Action
