## Compliance Assessment Report CAR\_NRW0037675

**Permit being assessed:** AB3690CP.

For: J M Envirofuels (Barry) Limited, held by JM ENVIROFUELS (BARRY) LIMITED

At: Berth 31 Wimbourne Rd, Barry Docks, Barry, CF63 3DH.

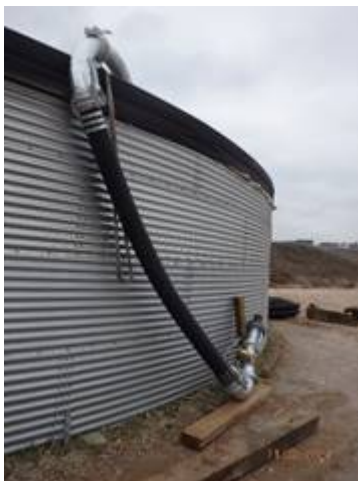
On our arrival, the Managing Director advised officers that the coupling facility (requirement of the Regulation 36 Notice), which would enable the Fire and Rescue Service FRS to access the water supply had arrived, and showed officers the connection for the FRS being the 4" BSP Male Thread, attached to the water tank, as photographed below.

The Managing Director advised the stand for the valve and pipe was subsequently fitted on the 22nd February 2021. The Managing Director explained that the water tank would solely be for use by the FRS in the event of a fire. The Managing Director advised that in the event of a fire, site operatives would use the four fire hydrants available, with three located on site and a fourth available on the access road. During the visit Officers were shown two fire hydrants, one located dockside and another closer to the adjacent Maltese Cross configuration.

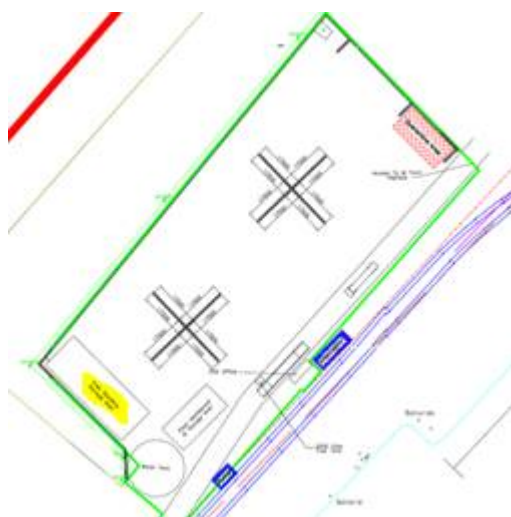
The Managing Director advised that the corner of the site adjacent/nearest to the water tank and opposite a Maltese Cross, is now to be used as a 'freestanding storage area' located on the western edge of the site, as shown below marked in yellow. During the visit, officers observed this area to be empty, with no indication/or markings on the ground as to how large the stockpile would be.

Officers asked what this new additional storage area would be used for and were advised for wood waste. The Managing Director pointed out that this area was included in v6 of the FPMP submitted to NRW December 2020. Whilst it is acknowledged that the above revised layout plan is an extract from FPMP v6 (only used to demonstrate the location), as v6 has not been agreed by NRW, the use of this area as a wood waste storage area, as this is not included in the agreed FPMP v5, in which compliance will continue to be assessed, this area cannot be used for the storage of wood waste until such time that a revised version of FPMP v5 has been amended by the operator, reviewed and agreed by NRW. **Until such time, any use of this area for the storage of waste would be considered a breach of permit condition of 3.4.1.**

**ACTION:** Please be advised, if you wish to use this area for the storage of waste, prior to site using this area to store wood waste, a revised version of the FPMP v5 must be submitted for review and agreed by NRW. In order to assist the operator in the revision of the FPMP, the operator has also previously been provided comments on both FPMP version 5 and 6.

**A & G:** In addition to the comments provided on this area in the FPMP review of v5 and v6, officers noted whilst on site that as a 'freestanding' storage area for

wood waste, if access is only available from one side of the freestanding stockpile, the maximum stack width is 10m and a calculation would be required based on the length of the stack to ensure the appropriate separation distances. For further guidance, please refer to the Fire Prevention Plan Guidance.

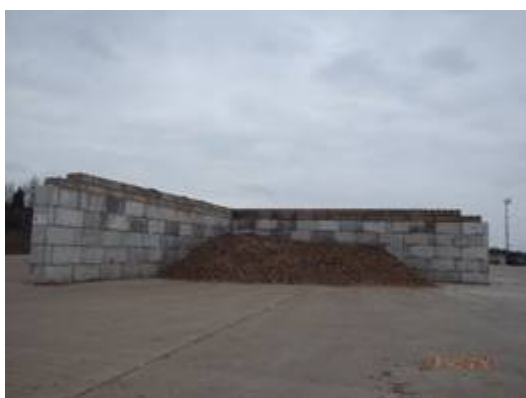
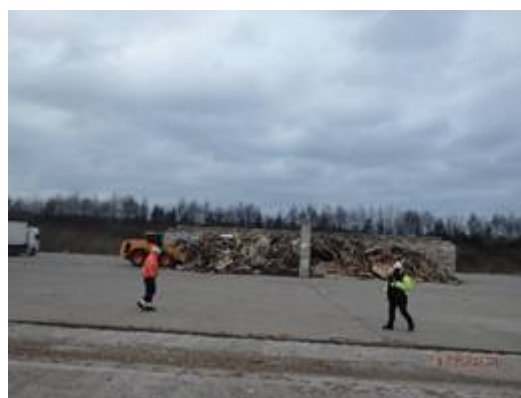
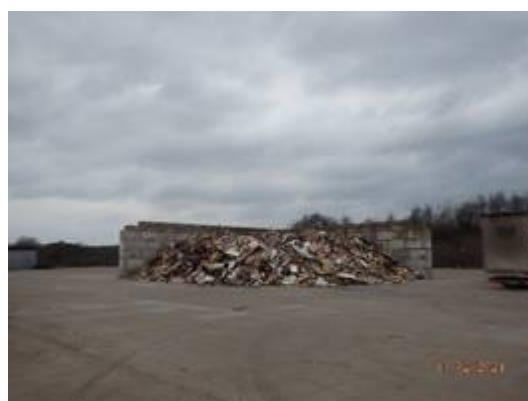
Officers then proceeded to walk around the perimeter of the site with the Managing Director and Site Manager in order to check the volumes of wood waste stored within each quadrant of both Maltese Cross configurations. The condition on site was photographed, as seen below.

The Notice issued required the removal of wood waste that had been stored onsite for more than 3 months. The Managing Director advised that the waste stored for more than 3 months had now been removed from site. Officers who had attended previously observed that the majority of the woodchip, as well as all of the unprocessed wood had been removed and confirmed that this requirement of the notice had been complied with.

Officers observed during the visit that there was material being stored within 4 out of the 8 Maltese cross quadrants, as seen above. As per the requirements of the notice, officers confirmed that the wood waste was being stored in line with current FPMP guidance, with stack heights no greater than 4m, with a minimum freeboard of 1m between the stockpile and top of the bay and at stack widths of no greater than 17.5m, as specified in FPMP v5. Officers took sample measurements of bay 6 and confirmed the length of the walls within the quadrant measure at a length of 17.5m and 18.1m. The Managing Director advised there may be some minor variation between bays due to how the blocks were constructed on site.

Each bay/quadrant segregated waste wood containing pallets, waste wood from a local Council, waste from various skip companies and woodchip which arrived in December. Please ensure that no wood waste is stored for more 3 months in accordance with your permit. V5 of the FPMP contains an 'Extended Storage Programme'. The Managing Director explained that the programme was introduced previously as part of an agreed action plan with NRW, as a temporary measure. **The Managing Director was advised before the site visit that use of this programme is no longer suitable and storage over 3 months would constitute a breach of the permit conditions.**

**ACTION:** If submitting a revised version of FPMP v5, please ensure that the 'Extended Storage Programme' is removed.

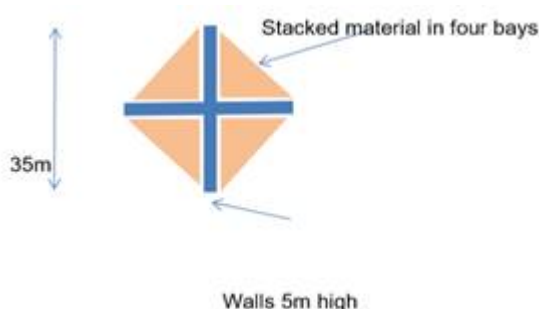
The Managing Director advised that each quadrant of the Maltese Cross, if at their full storage capacity would form areas square in shape of 17.5m x 17.5m x 4m. Officer Elysia Lovelock queried this due to the formation shown within the FPMP as shown below, which shows triangular quadrants.

This information is significant as an area square in shape could hold twice as much (in terms of volume) of an area triangular in shape. Therefore, clarification is required within a revised version of the FPMP, as this information on the volume of a stockpile informs information on/but not limited to the: firefighting water supply required, how much run-off a fire could create, radiant heat, the separation distances required, size of the quarantine area required etc.

**ACTION:** If submitting a revised FPMP of v5, please clarify the stack layout (incl. dimensions and shape), considering the comments previously provided to the operator on FPMP v5 and v6.

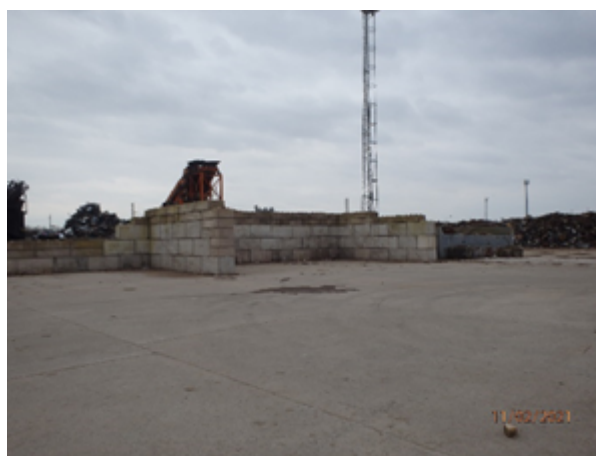
The notice also required the removal of waste stored in the quarantine area by the 15<sup>th</sup> February 2021. Officers observed during the visit that the quarantine area was now clear, as photographed below.

Officers were informed that the quarantine area was sometimes used to store delivered loads that were rejected and awaiting collection and that collection may take a few hours, or up to 1-2 days. Officers explained that in the event of a fire, a quarantine area, large enough to accommodate 50% of the volume of the largest stockpile, must be available at all times.

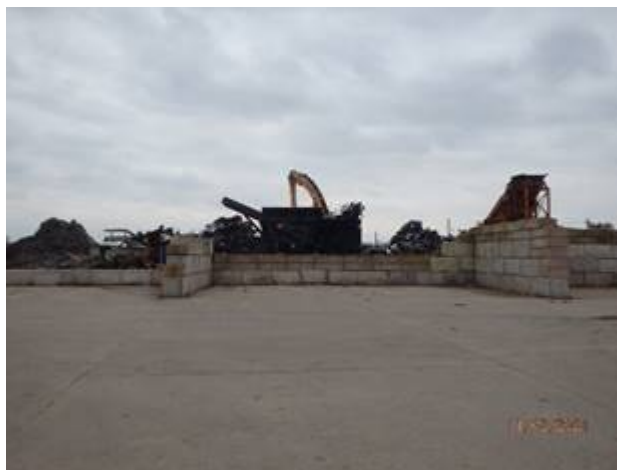
Officers noted an area next to the quarantine area which appeared to be constructed as a bay however, with a rear wall at a lower height of 2-3 blocks. At the time of the visit, this area was empty. It was unclear from discussions on site as to the use of this area. This area has been photographed as seen below:

Officers noted that there was plant machinery behind this area, which officers were advised form part of the regulated operations on the adjacent site to that of JMEL. Officers were advised that the adjacent site/operator had previously moved machinery due to the potential for sparks. We therefore require clarification on the use of this area.

**ACTION:** A revised FPMP of v5 must clearly explain the use of this area and ensure that it is appropriately identified on the site plan and that all potential ignition sources are appropriately identified within the FPMP.
