## Brookhill Landfill Site

Flintshire County Council Waste Management Services

## Surface Emissions Monitoring Survey

August 2020

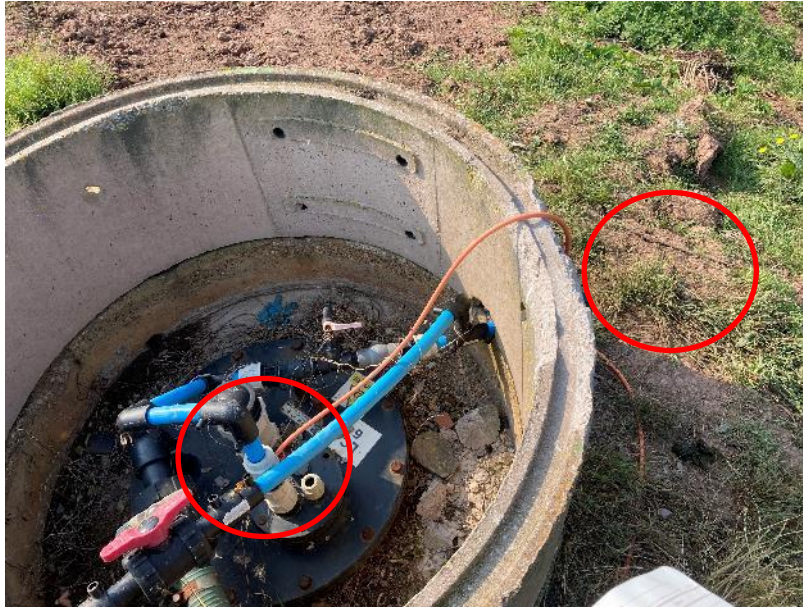
**Photo 1**

- 3.0.6 Two discreet features were identified at LC6 which were resulting in PSEs; the fittings were a source of relatively low concentrations (1000 ppm) while the clay around the well recorded a concentration of 5000 ppm. This higher concentration was potentially from the buried gas line, which may have been damaged by heavy machinery during the recent installation of nearby LW6.

| <b>Plate No.</b> | <b>PSE No</b> | <b>ID</b> | <b>Comments</b> |
|---|---|---|---|
| <b>1</b> | 3 | LC6 | PSE from top fittings and at ground level, outside chamber |

- 4.0.2 It is recommended that the well headworks be serviced at all PSEs identified at specific wells, or within the chambers these wells are housed in. Fixtures such as pump connections, monitoring points, clamps, valves and the main head works seal should be serviced to improve the seal on these wells.

- 4.0.3 As identified in the previous review, the rubber well head boot on LC4B was noted to be dry rotting and has now cracked. The flexible boots at R5 and LC6B are similarly dry rotting and should be replaced.

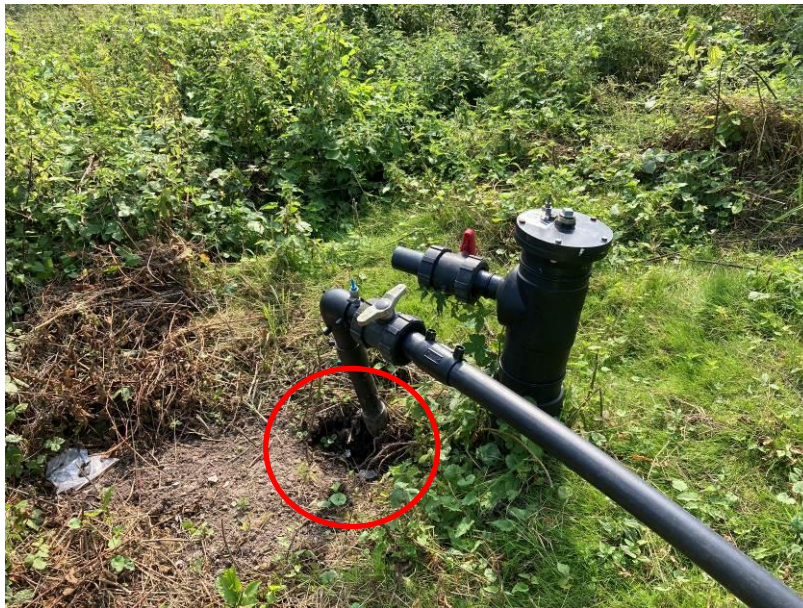
**Photo 2**

| PSE | ID/Location | Methane Concentration (ppm) | Source of Emission | Photo No. |
|---|---|---|---|---|
| 22 | GV10 | >10,000 | base of gas connection line from new LW1 | 2 |

| <b>Plate No.</b> | <b>PSE No</b> | <b>ID</b> | <b>Comments</b> |
|---|---|---|---|
| <b>2</b> | 22 | GV10 | Gas line connection from LW1 |

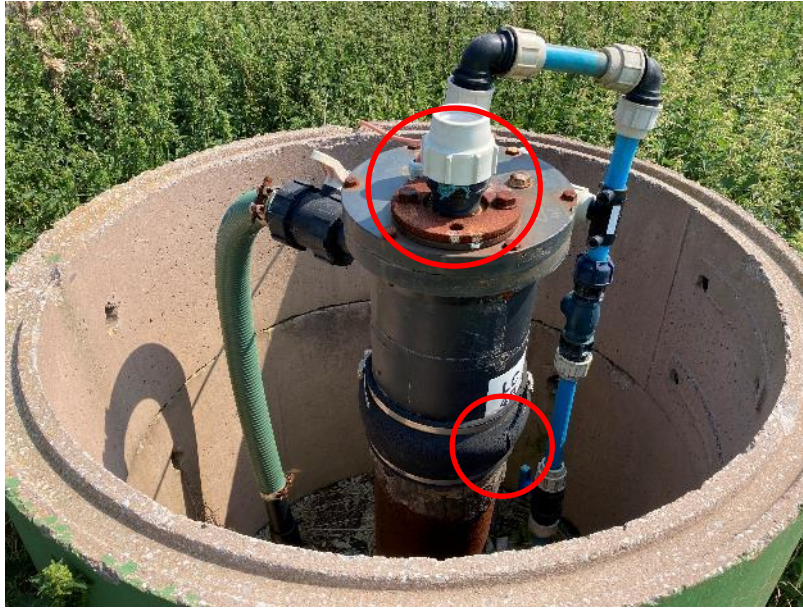
**Photo 3**

| PSE | ID/Location | Methane Concentration (ppm) | Source of Emission | Photo No. |
|---|---|---|---|---|
| 30 | LC4B | >10,000 | well head top plate, fittings and flexible boot (dry rotted & cracked) | 3 |

| <b>Plate No.</b> | <b>PSE No</b> | <b>ID</b> | <b>Comments</b> |
|---|---|---|---|
| <b>3</b> | 30 | LC4B | Well head flexi boot, top plate & fittings |

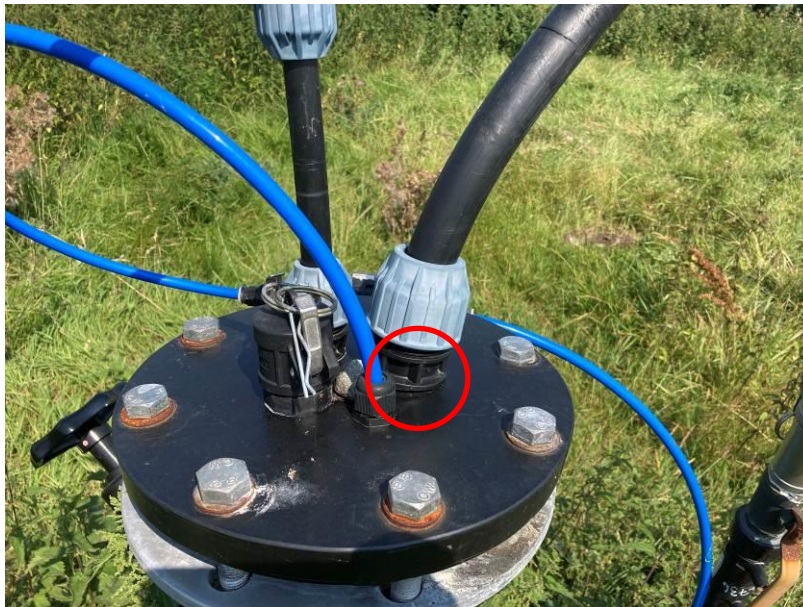
**Photo 4**

| PSE | ID/Location | Methane Concentration (ppm) | Source of Emission | Photo No. |
|---|---|---|---|---|
| 32 | GV46 | >10,000 | well head; LC extraction top fittings | 4 |

| <b>Plate No.</b> | <b>PSE No</b> | <b>ID</b> | <b>Comments</b> |
|---|---|---|---|
| <b>4</b> | 32 | GV46 | LC extraction fitting cross threaded |
