# **Old Colwyn Coastal Defence and Active Travel Scheme**

Bat Survey Report

July 2020

**Document reference:** 417437-MMD-00-XX-RP-N-1727

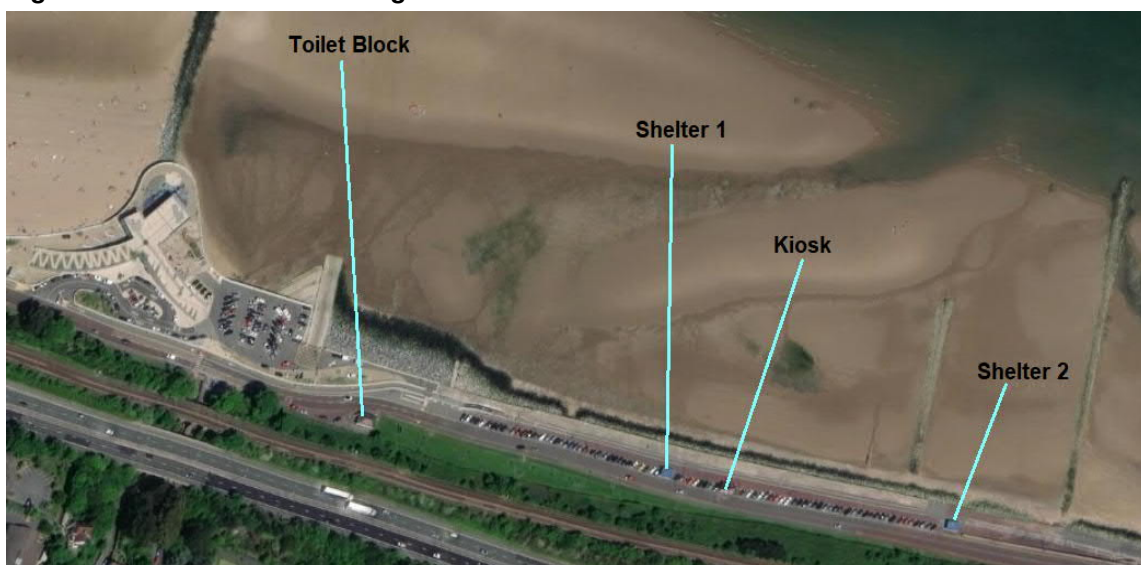
**Figure 4.1: Location of Buildings**

Four buildings were assessed within the site (buildings B1 to B4 in Figure 4.1 below).

During the emergence survey on 3 June 2020 no bats were recorded emerging from or re-entering either Shelter 1 or the toilet block. Emergence / re-entry surveyor locations are shown on Figures 4.1 and 4.2.

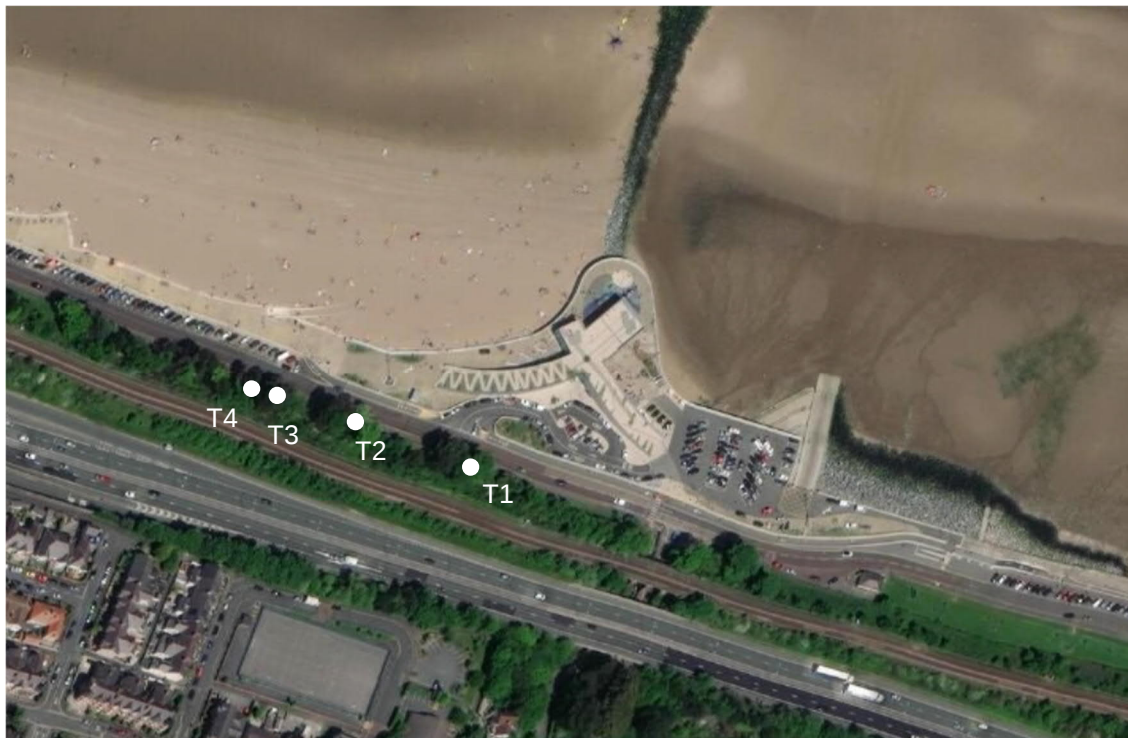
**Figure 4.2: Location of Trees with Bat Potential**

Trees within bat potential noted (trees T1-T4) are illustrated on Figure 4.2 and described below:

- Tree T1: Sycamore (*Acer pseudoplanatus*) tree with a callus roll;
- Tree T2: Sycamore tree with three callus rolls;
- Tree T3: Scot's Pine (*Pinus sylvestris*) with dense ivy covering; and
- Tree T4: Scot's Pine with dense ivy covering.

All of these trees were assessed as having low bat roosting potential.

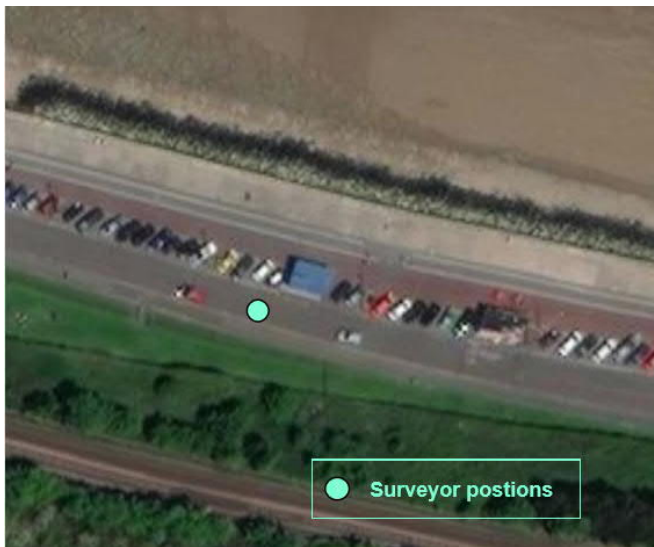
**Figure 4.3: Surveyor Positions- Shelter 1**

| Date | Survey Type | Building | Emergence Results | General Observations |
|---|---|---|---|---|
| 03/06/2020 | Emergence | Shelter 1 | None | No bat activity was identified during the survey. |

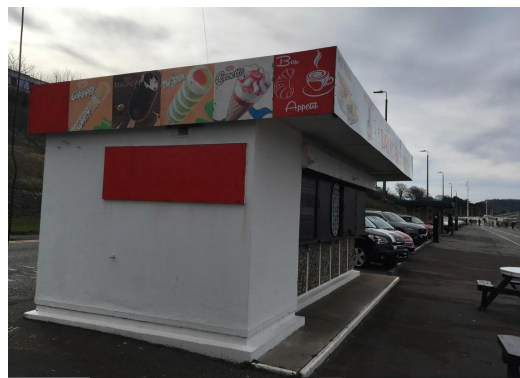
**Photo A.1: Kiosk**

| Building | Description of Building and Potential Roost Features | Assessment of Bat Potential and Evidence of Bats |
|---|---|---|
| Kiosk | Concrete structure clad in coated wood and metal/ composite panels. Flat roof supported by metal beams.<br>No potential roost features identified. | Negligible potential. No evidence. |

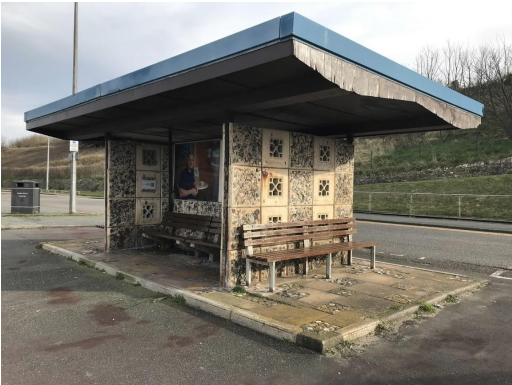
**Photo A.2: Shelter 1**

| Building | Description of Building and Potential Roost Features | Assessment of Bat Potential and Evidence of Bats |
|---|---|---|
| Shelter 1 | Concrete structure clad in pebbledash. Flat, hollow, wooden roof and fascia board with outer coating.<br>A gap is present under coated wooden fascia board on south west corner. This feature gives access into a hollow cavity large enough for a small number of bats. The building is in an open environment which is relatively exposed, limiting bat potential. | Low potential. No evidence. |

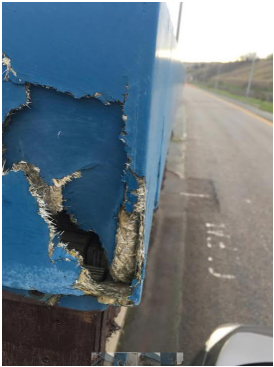
**Photo A.3: Shelter 1**

Gap under coated wooden fascia board on south west corner.

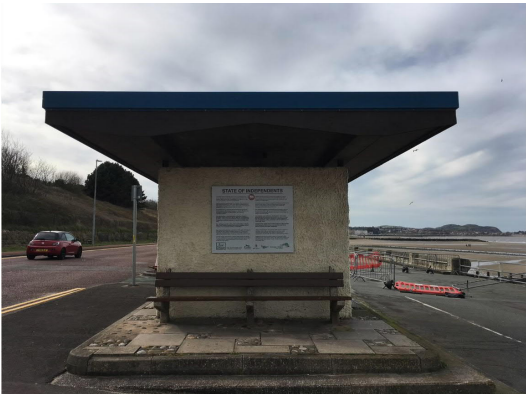
**Photo A.4: Shelter 2**

| Building | Description of Building and Potential Roost Features | Assessment of Bat Potential and Evidence of Bats |
|---|---|---|
| Shelter 2 | Concrete structure clad in painted pebbledash. Flat, wooden roof and wooden fascia board with outer coating.<br><br>No potential roost features identified | Negligible potential. No evidence. |

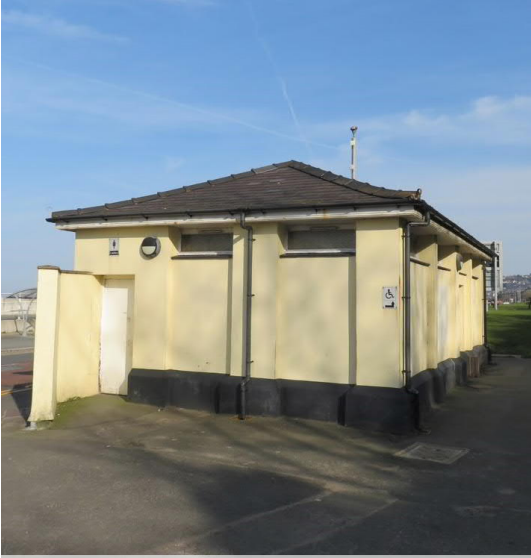
**Photo A.5: Toilet block**

| Building | Description of Building and Potential Roost Features | Assessment of Bat Potential and Evidence of Bats |
|---|---|---|
| Toilet Block | Single-storey building with concrete walls and a pitched, tiled roof with ridge tiles. Exterior lighting is present above doorways.<br>A composite material soffit box and fascia board present.<br><br>Gaps are visible under ridge tiles and other roof tiles offering some crevice dwelling opportunities. The surrounding environment is relatively exposed, limiting bat potential. | Low potential. No evidence. |

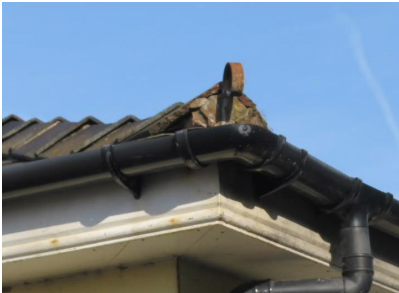
**Photo A.7: Toilet Block**

Gaps visible under ridge tiles and other roof tiles.
