# **Old Colwyn Coastal Defence and Active Travel Scheme**

Water Framework Directive Assessment

July 2020

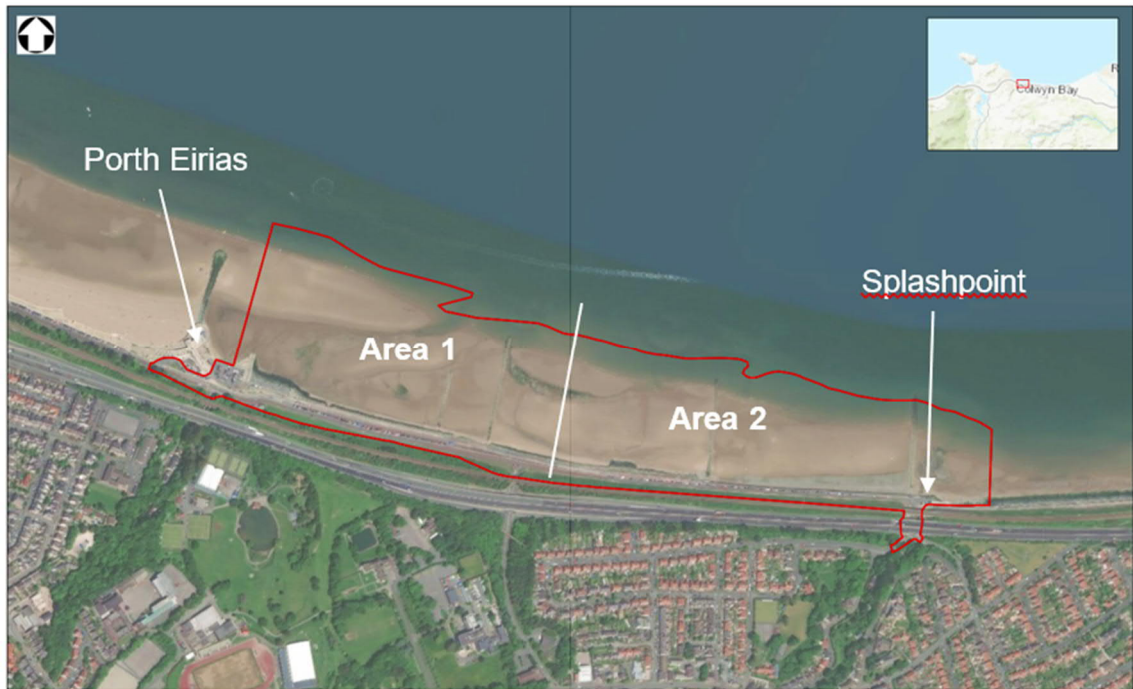
Figure 1.1: Location of the Scheme

The red line boundary has been extended beyond the footprint as shown in Figure 1.1 to allow for access during construction.

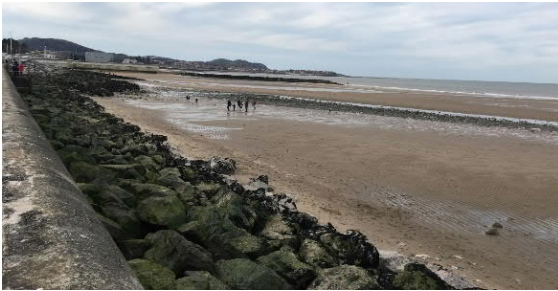
**Photo 1.1: Looking North-West from Area 1 Promenade Across Old Colwyn Beach**

The toe of the sea wall has been protected from erosion and undermining by a variety of defences. Across the first 750m west to east, rock armour has been placed directly in front of the wall (Photo 1.1, Photo 1.2), while over the remainder the toe has been protected either by reinforced concrete aprons or steel sheet piling (Photo 1.3).

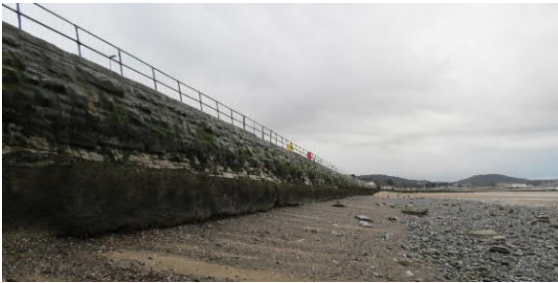
**Photo 1.3: Looking West Along Sea Wall in Area 2 with Toe Protection Visible**

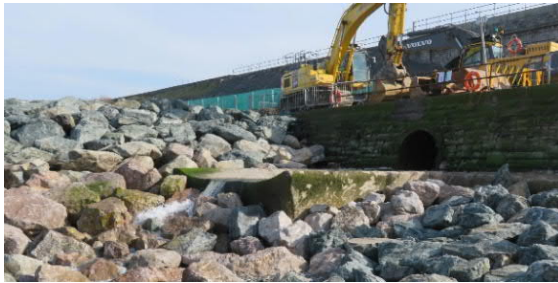
**Photo 1.4: Looking North-East At Splashpoint Nant y Fynnon Outfall During Revetment Construction**

There are slipways located at Porth Eirias to the immediate west of the Scheme footprint and Splashpoint in the far east for beach access along with four sets of pedestrian access steps in various states of disrepair with some currently deemed unsafe and blocked-off. Rock groynes are present at four locations, outfalls are culverted beneath two groynes while other outfalls currently discharge directly to the beach (Photo 1.4).

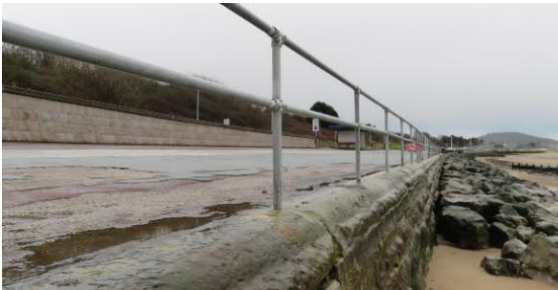
**Photo 1.5: Looking West along Promenade South of Rotary Way**

Immediately landward of the wall is a part paved/part tarmac surfaced dual usage (pedestrian and cycle path) promenade, which adjoins the Promenade highway (Photo 1.5 and Photo 1.6). Moving west to east through Area 1, the Promenade highway increases in height to meet the incoming link road from Old Colwyn (Rotary Way) which provides access to the A55 (Junction 22) before dropping down to the same level in Area 2 as the top of the sea wall over the remainder of the length.

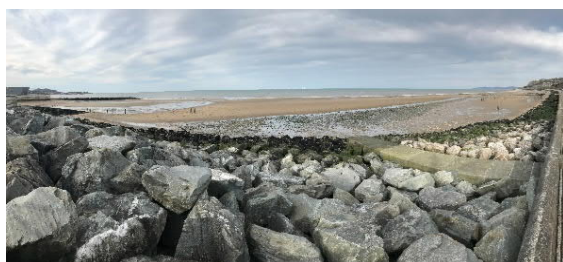
**Photo 1.7: Looking North-East Across the Transition between the Existing Porth Eirias Revetment and the Scheme Area 1**

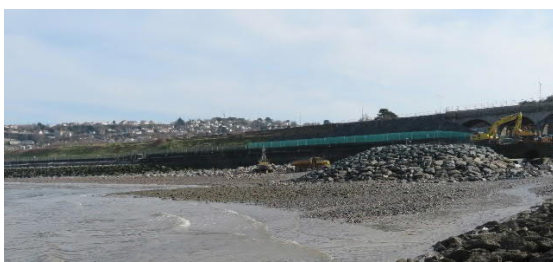
**Photo 1.8: Looking South-East Across the Transition between the Existing Splashpoint Revetment (Area 2) and the Area to the East of the Scheme**

In addition, at the far eastern end of the Scheme, as part of the Splashpoint Project a rock revetment section of similar width with a 1:2.5 slope was constructed earlier in 2020 (Photo 1.8 **Error! Reference source not found.**) to curve around the eastern corner of the promenade highway to the point at which it makes a right angle turn southwards beneath the A55 Expressway and NWC Railway Line towards Beach Road/Cliff Gardens.

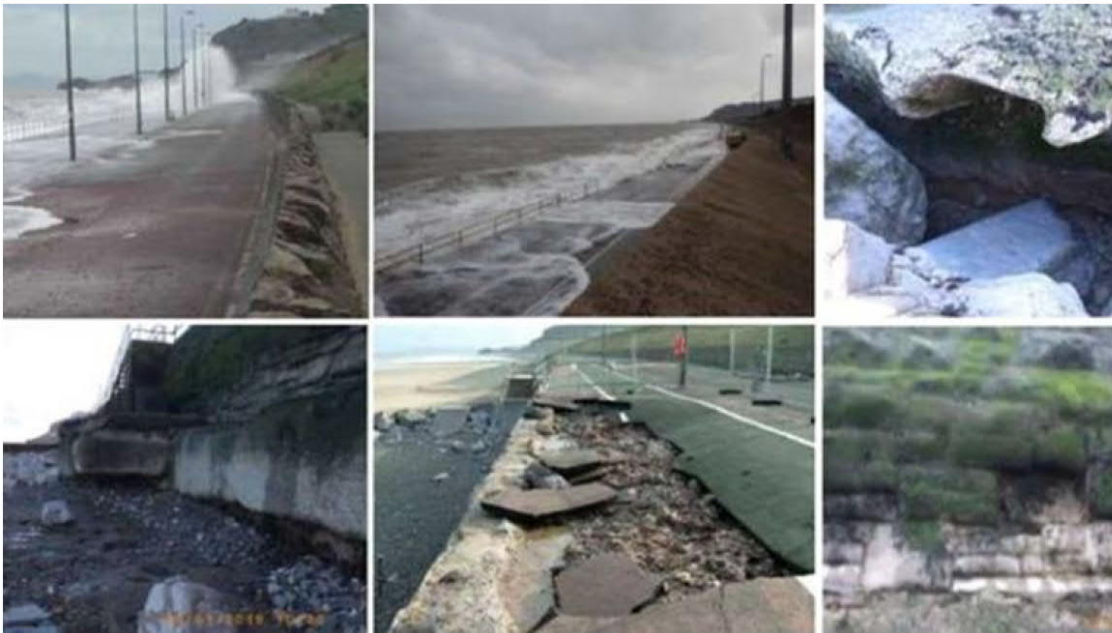
**Figure 1.2: Examples of Old Colwyn Promenade Storm Damage**

The impact of present day conditions is shown in visual and recorded evidence from more recent storm events (Figure 1.2), which confirms the overtopping behaviour and also identifies the following as taking place:

- Damage/Loss of Railings;
- Damage to promenade/highway surfacing and removal of fill behind the sea wall;
- Damage to boundary wall and erosion at toe of railway embankment;
- Lowering of beach levels in front of the sea wall;
- Undermining of the sea wall; and
- Removal of facing blocks to the sea wall.

Examples of this damage are provided in Figure 1.2.

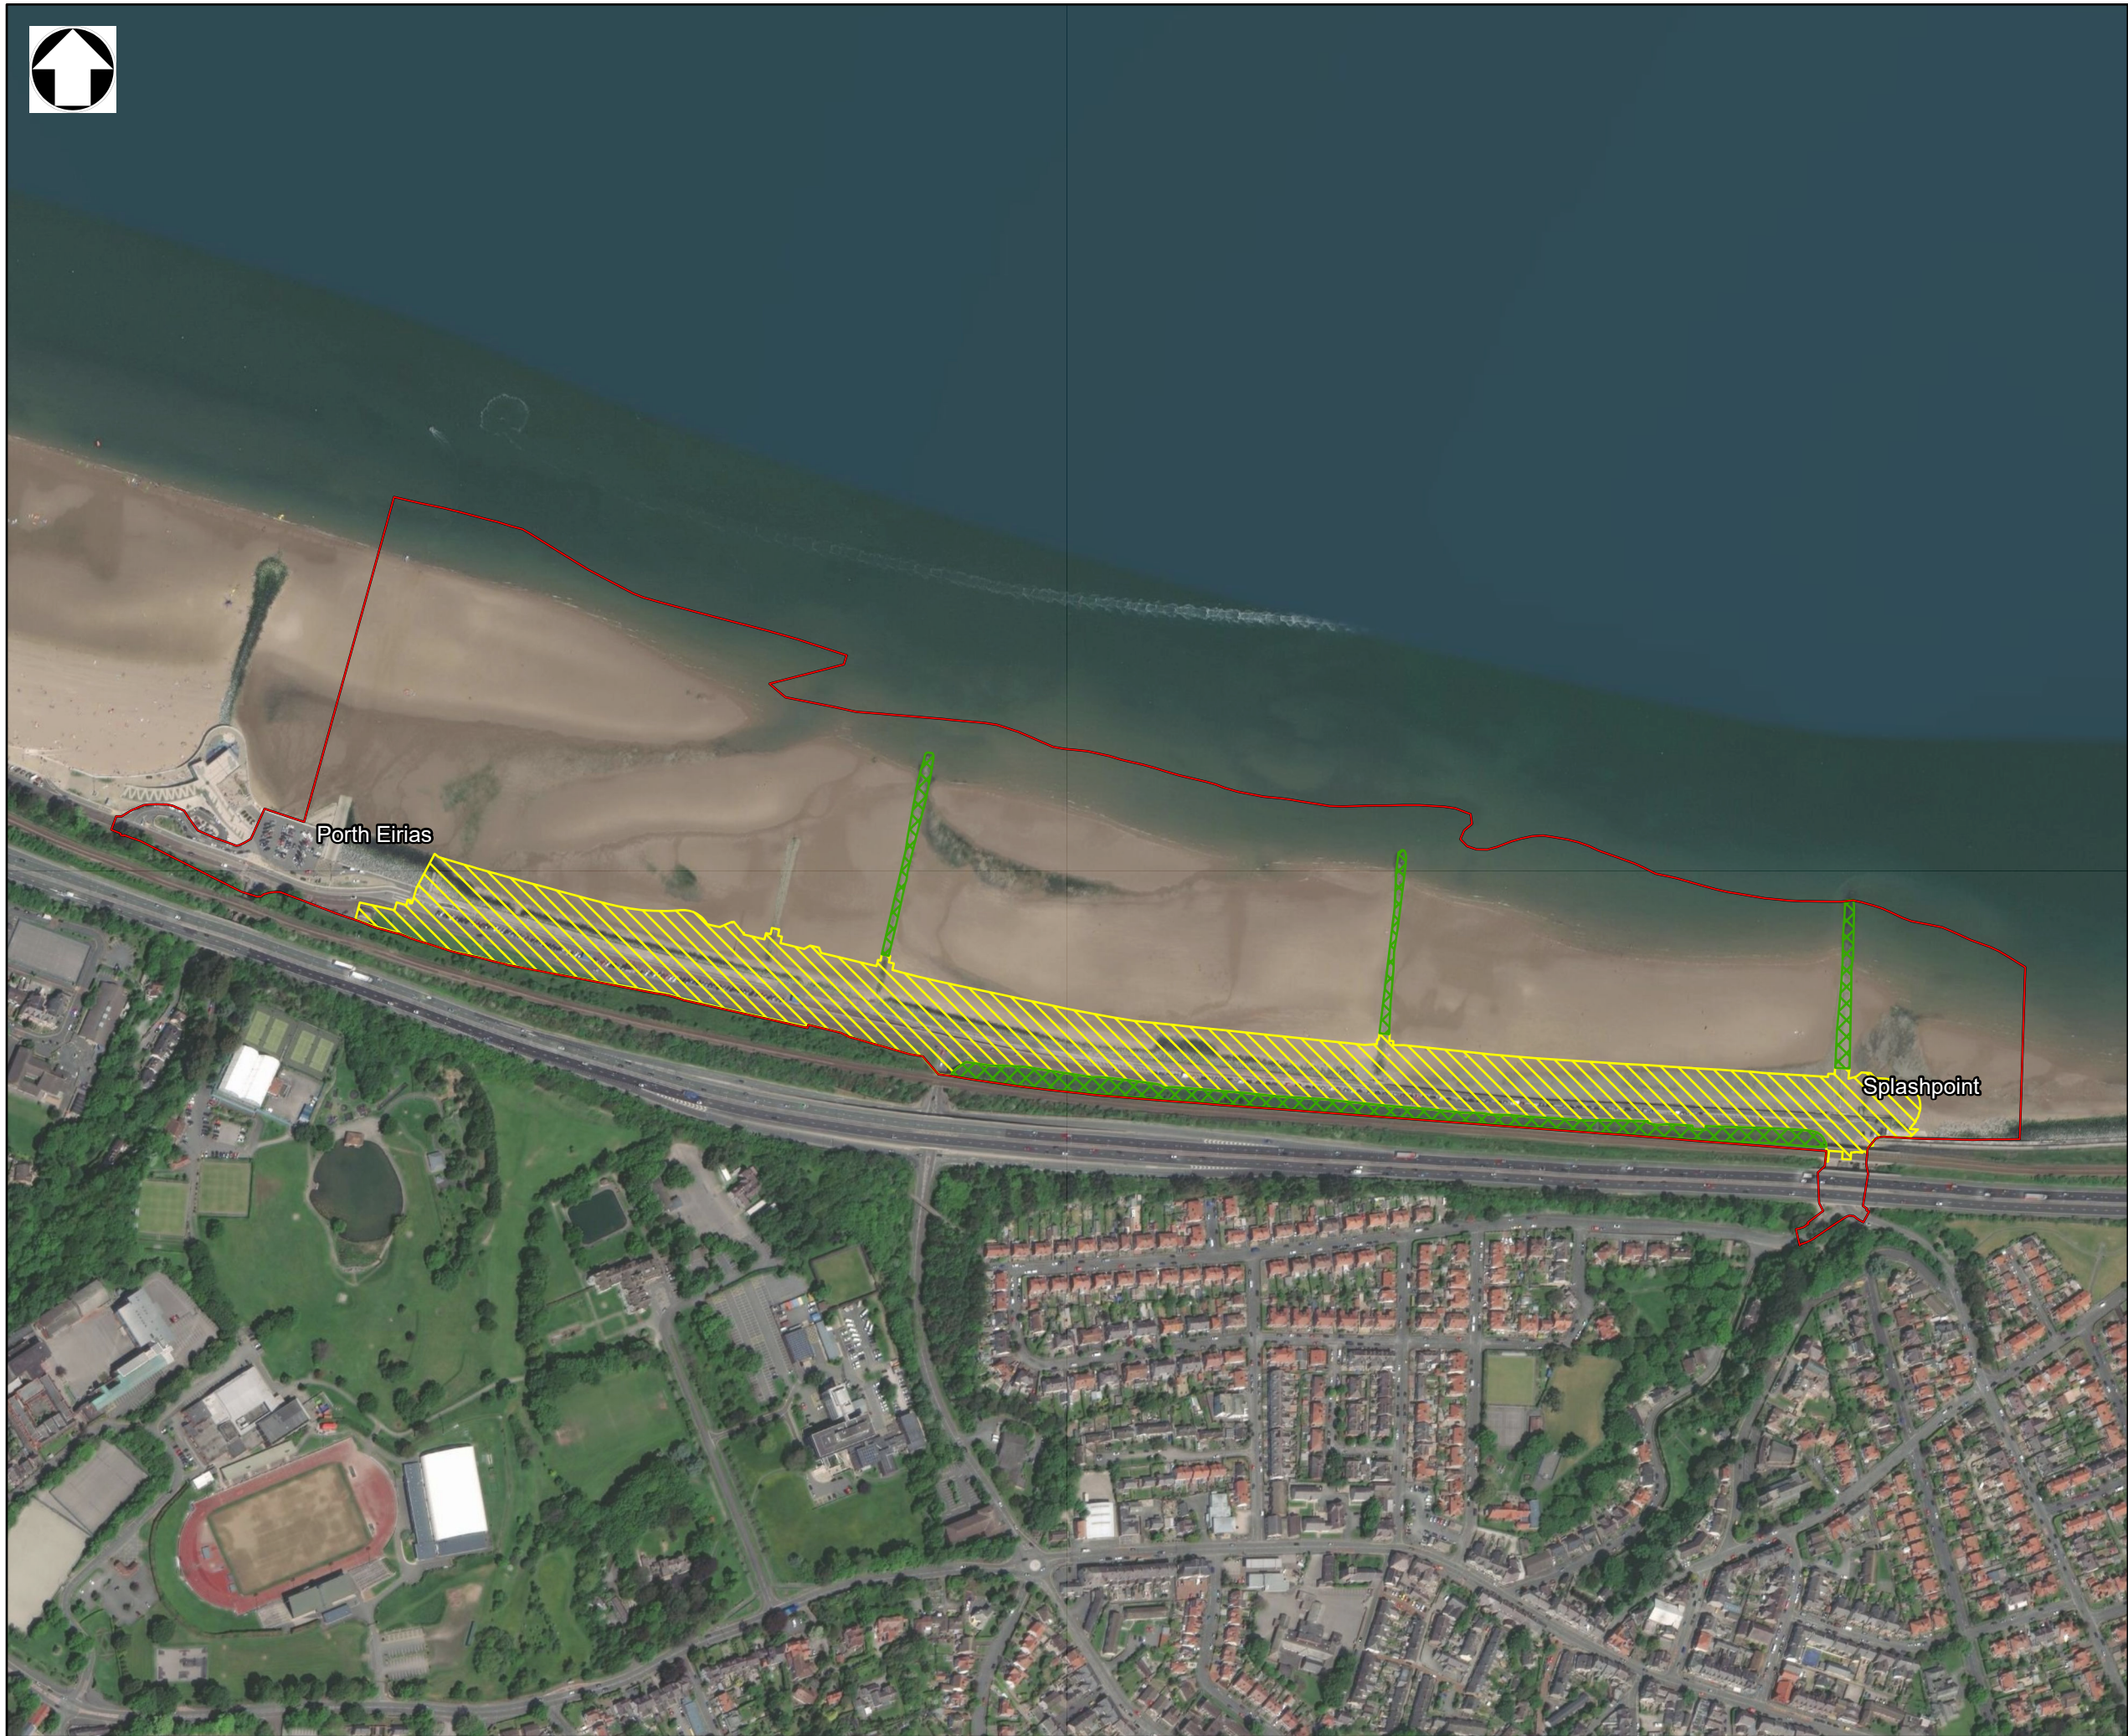
Drawing Number  
**415437-MMD-00-XX-DR-N-1707**

- Key to Symbols
- Red line boundary
  - Area of permanent construction
  - Ecological enhancements only

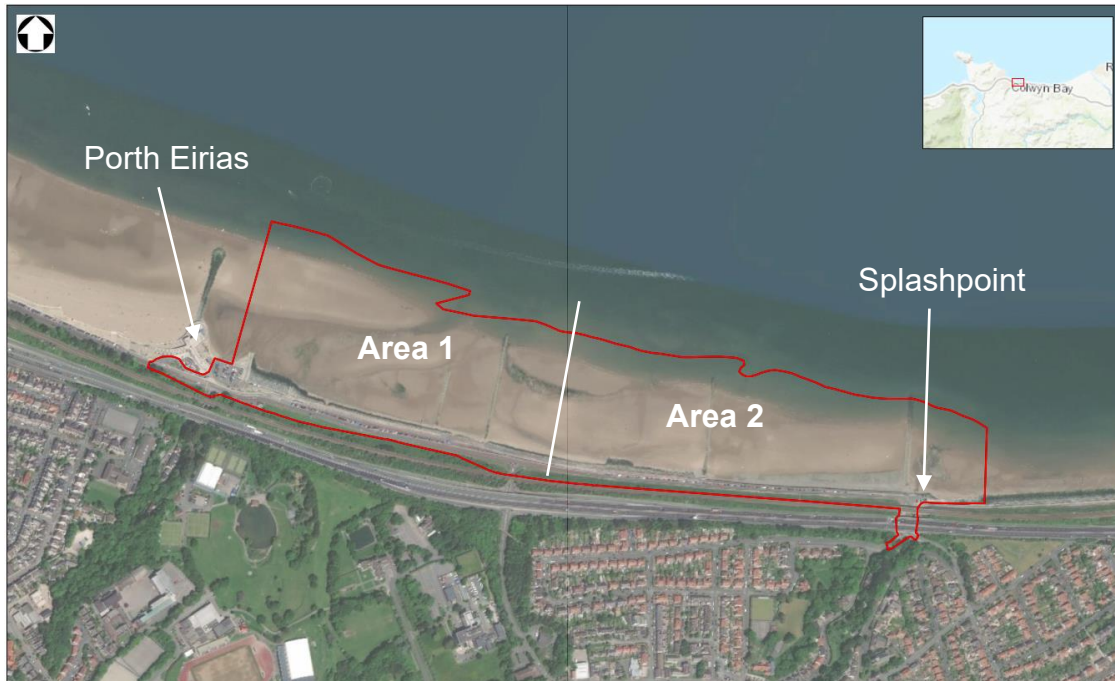
**Figure 1.2: Location of the Scheme**

The red line boundary has been extended beyond the footprint as shown in Figure 1.2 to allow for access during construction. For the purposes of this report, the site refers to everything within the redline boundary.
