# **Old Colwyn Coastal Defence and Active Travel Scheme Environmental Statement**

Volume 2: Technical Appendix 8 - Biodiversity  
(Marine and Terrestrial)

July 2020

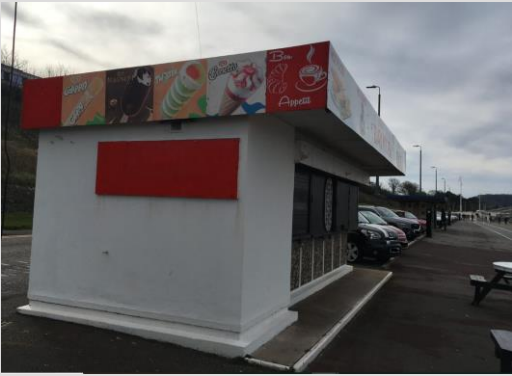
| Building Reference and Photo | Building Description | Features |
|---|---|---|
| <b>Kiosk</b><br> | <ul style="list-style-type: none"> <li>Concrete structure clad in coated wood and metal/ composite panels.</li> <li>Flat roof, supported by metal beams.</li> </ul> | <ul style="list-style-type: none"> <li>No potential roost features identified</li> </ul> |

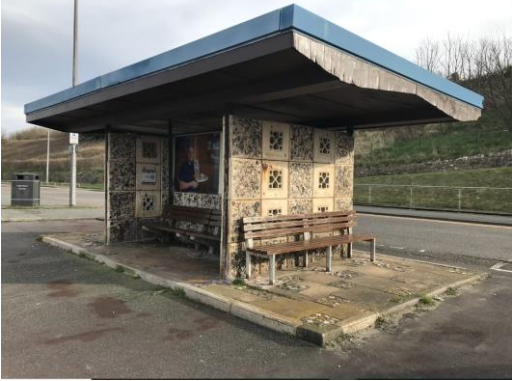
| Building Reference and Photo | Building Description | Features |
|---|---|---|
| <b>Shelter 1</b><br> | <ul style="list-style-type: none"> <li>Concrete structure, clad in pebbledash.</li> <li>Flat, hollow, wooden roof and fascia board with outer coating.</li> </ul> | <ul style="list-style-type: none"> <li>Gap under coated wooden fascia board on south west corner. This feature gives access into a hollow cavity.</li> </ul> |

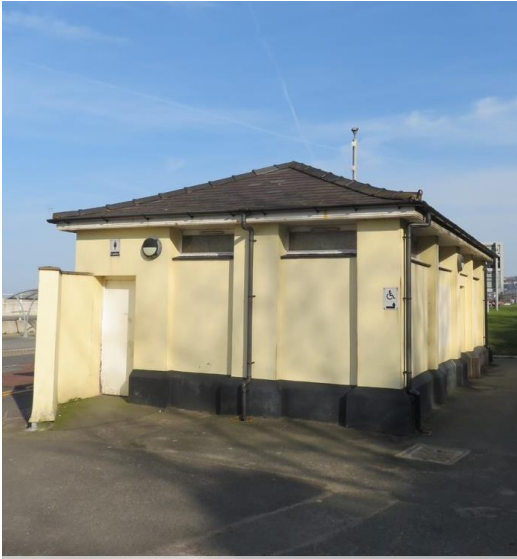
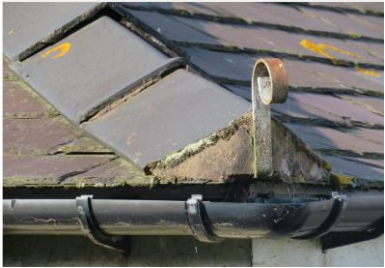
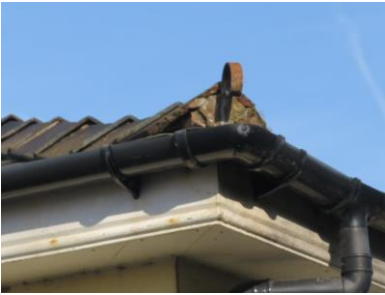
| Building Reference and Photo | Building Description | Features |
|---|---|---|
| <b>Toilet Block</b><br> | <ul style="list-style-type: none"><li>Concrete walls with pitched, tiled roof with ridge tiles.</li><li>Exterior lighting present above doorways.</li><li>Composite material soffit box and fascia board present.</li></ul> | <ul style="list-style-type: none"><li>Gaps visible under ridge tiles and other roof tiles.</li></ul> |

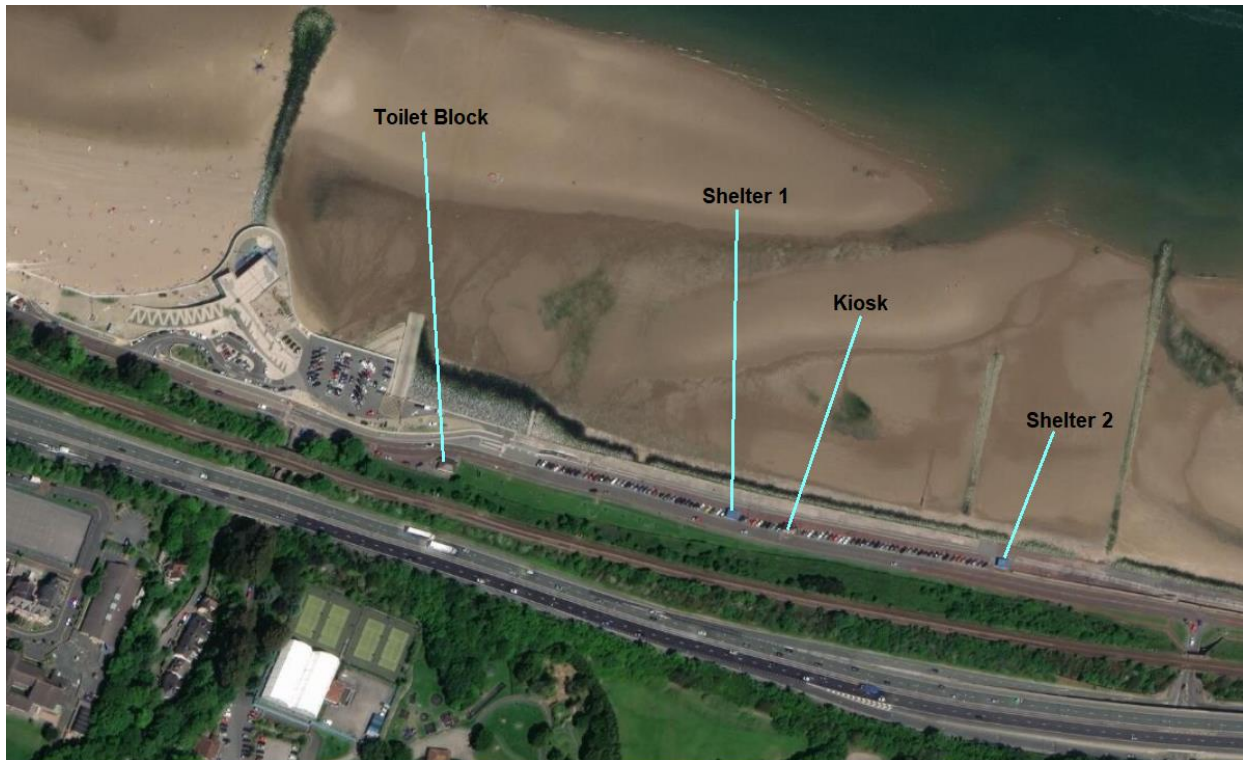
**Figure 4.1: Location of structures assessed for potential roost features**

The location of the structures described in Table 4.2 above, is shown in Figure 4.1 below:

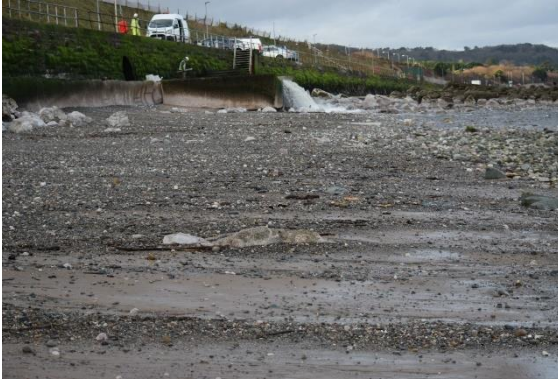
**Figure C.1: Mussel Beds**

| Terrestrial / Marine | Habitat Code | Habitat Type | Description | Colwyn Bay Waterfront Project – Phase 2b Area | Old Colwyn Coastal Defence and Active Travel |
|---|---|---|---|---|---|
| Marine | - | Dense and sparse mussel beds | Two blue mussel ( <i>Mytilus edulis</i> ) beds were identified as part of the survey work undertaken, one located in the west of the survey area and one in the far east of the survey area. Both comprise areas of denser and sparse mussels (albeit both relatively sparse), interspersed with brown seaweeds, fucoids and barnacles, which have colonised in the middle of the sand. Both areas appear to be in poor condition and appeared to have previously been dense (marked as 'dense' on the mapping as a relative term) but sparse at the time of survey, whilst there were many cracked and empty shells present.<br><br>From surveys completed for Phase 1abc EIA and Addenda in 2010 some areas of dense blue mussel aggregations were recorded at the end of groynes within the Phase 2b area (beyond the current survey area) which were noted to be larger in extent and may extend into the subtidal zone. | ✓ | ✓ |

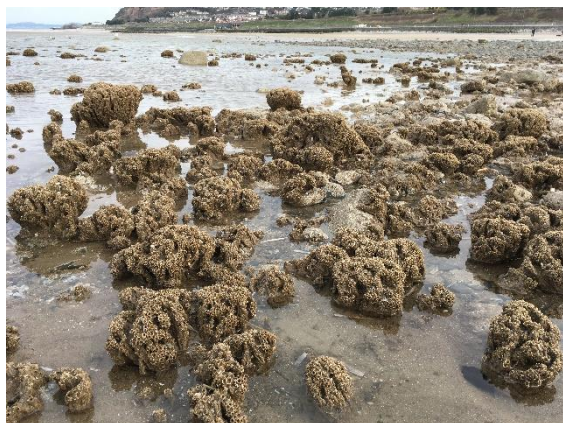
**Figure C.15: *Sabellaria alveolate* reefs**

| Terrestrial / Marine | Habitat Code | Habitat Type | Description | Colwyn Bay Waterfront Project – Phase 2b Area | Old Colwyn Coastal Defence and Active Travel |
|---|---|---|---|---|---|
| Marine | - | <i>Sabellaria alveolata</i> patches | Small patches of Honeycomb worm were noted within shingle and gravel areas in the east of the Scheme (see Appendix A for approximate location). These were recorded to be relatively isolated and small in extent and are considered to be in poor condition. | | ✓ |

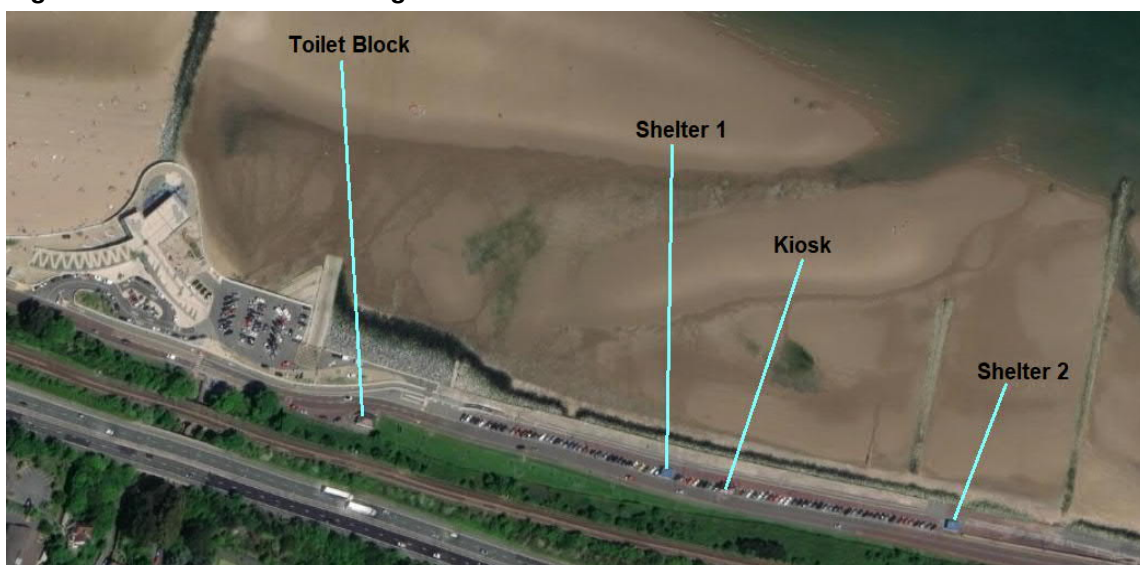
**Figure 4.1: Location of Buildings**

Four buildings were assessed within the site (buildings B1 to B4 in Figure 4.1 below).

During the emergence survey on 3 June 2020 no bats were recorded emerging from or re-entering either Shelter 1 or the toilet block. Emergence / re-entry surveyor locations are shown on Figures 4.1 and 4.2.

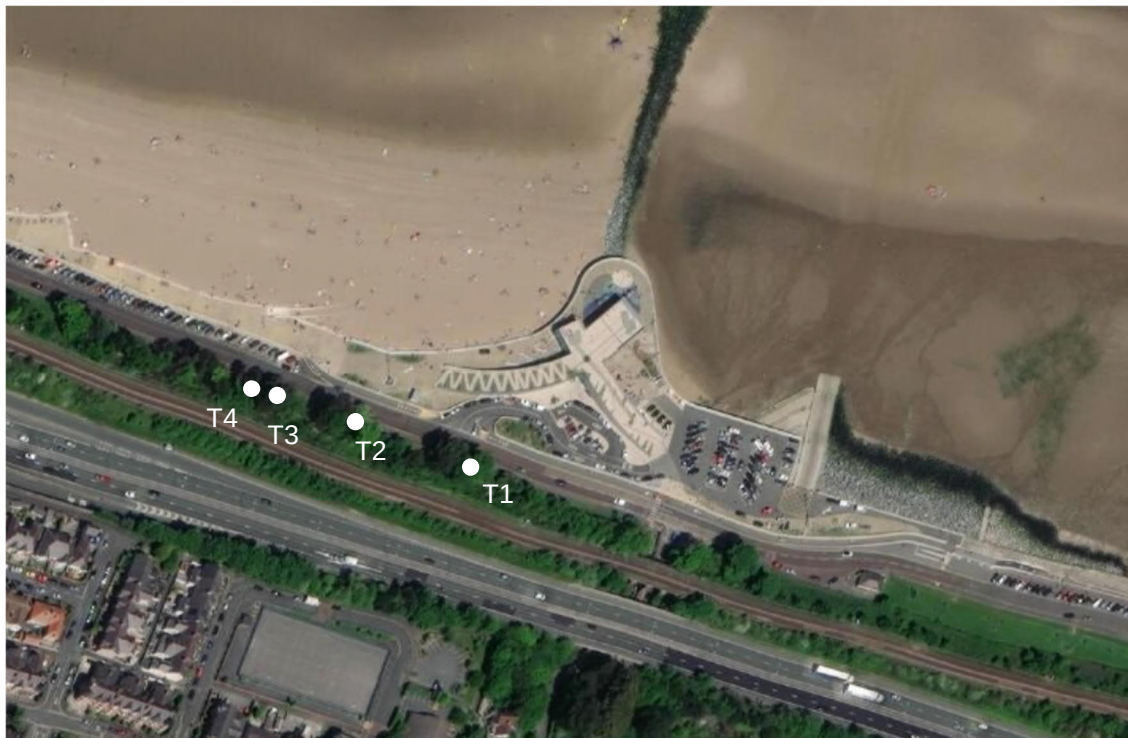
**Figure 4.2: Location of Trees with Bat Potential**

Trees within bat potential noted (trees T1-T4) are illustrated on Figure 4.2 and described below:

All of these trees were assessed as having low bat roosting potential.
