# **Old Colwyn Coastal Defence and Active Travel Scheme Environmental Statement**

Volume 2: Technical Appendix 15 - Other  
Environmental Disciplines

# **Old Colwyn Coastal Defence and Active Travel Scheme**

Transport Statement

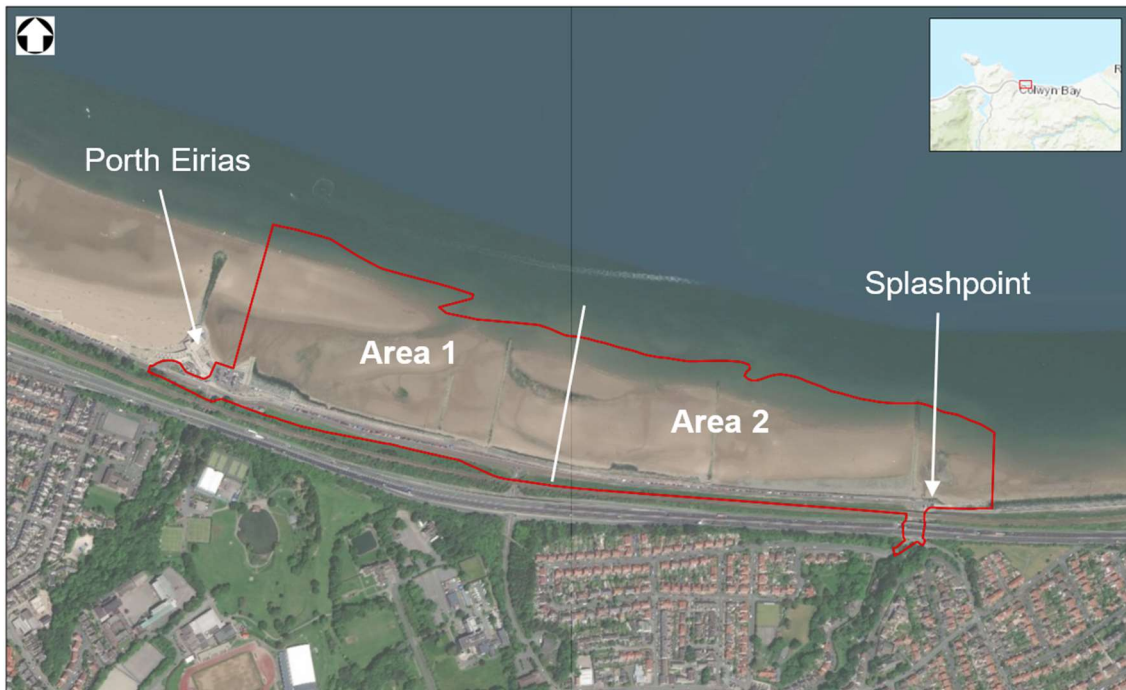
**Figure 3.2: Red Line Boundary**

The Scheme red line boundary is shown in Figure 3.2

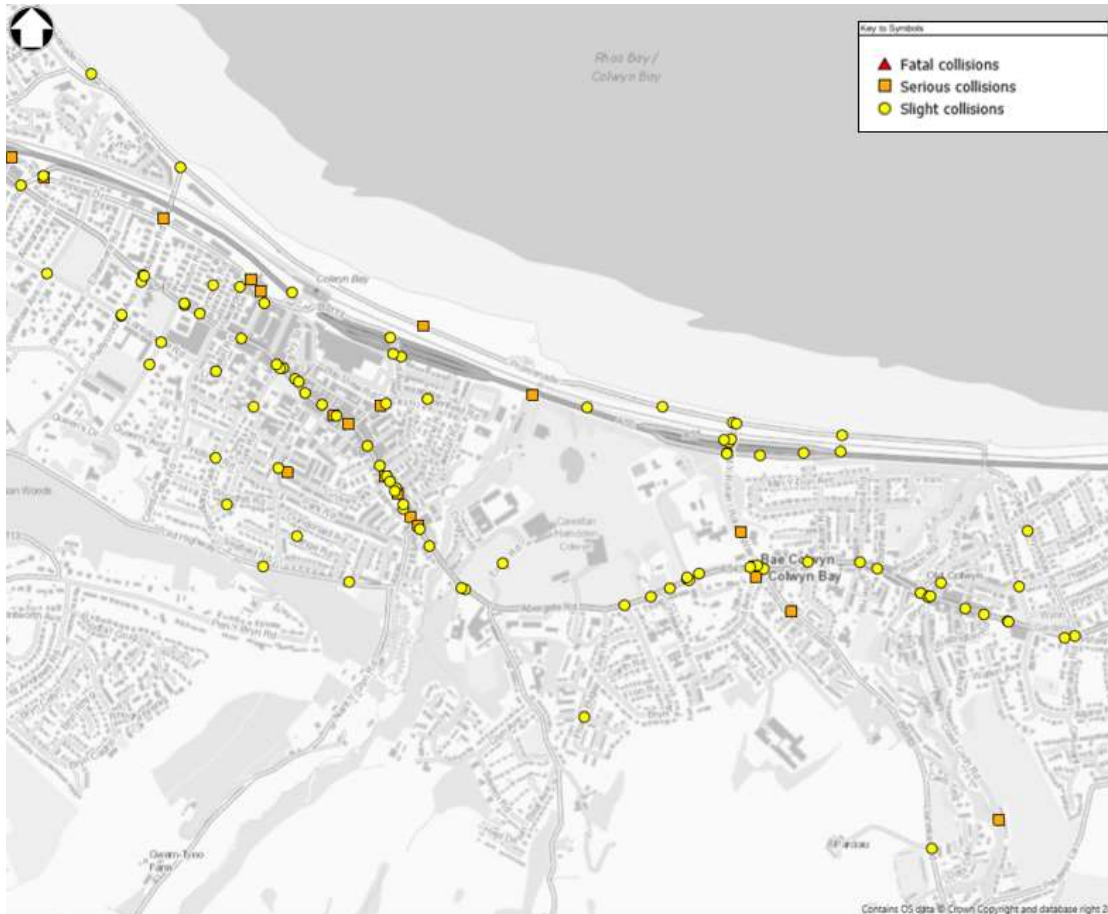
**Figure 3.6: Traffic Collisions 2014-2018**

- No fatal traffic collisions have been recorded in the five year period; and
- Five collisions have occurred at the A55 (Jct 22) and Rotary Way, all of which have resulted in slight injury.

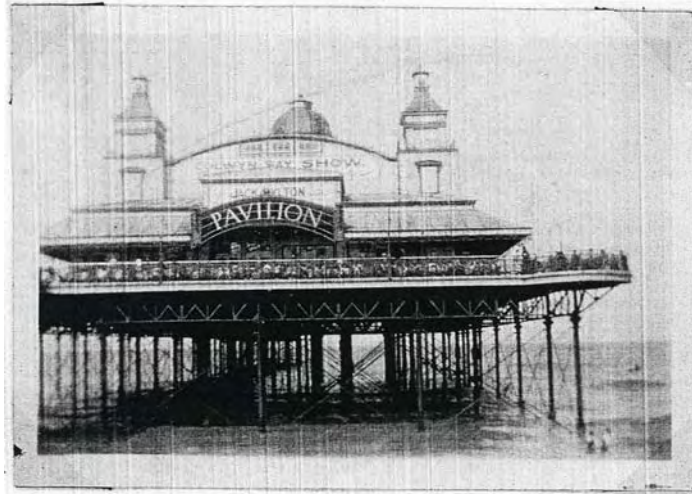
Plate 5

9.2.2. The pier pavilion was destroyed by fire in 1922 and a second pavilion was built in 1923 (Plate 5; Wynne-Jones 1995, 19). The superstructure was recorded after the pavilion was destroyed and are shown extending beyond the area of the former pavilion (Fig. 5). Plans of the second pier pavilion construction show flanking towers fronting onto a curved façade at the entrance to the pier, as with the original design, and a grand pier pavilion on a slightly smaller scale to the original (Fig. 6).

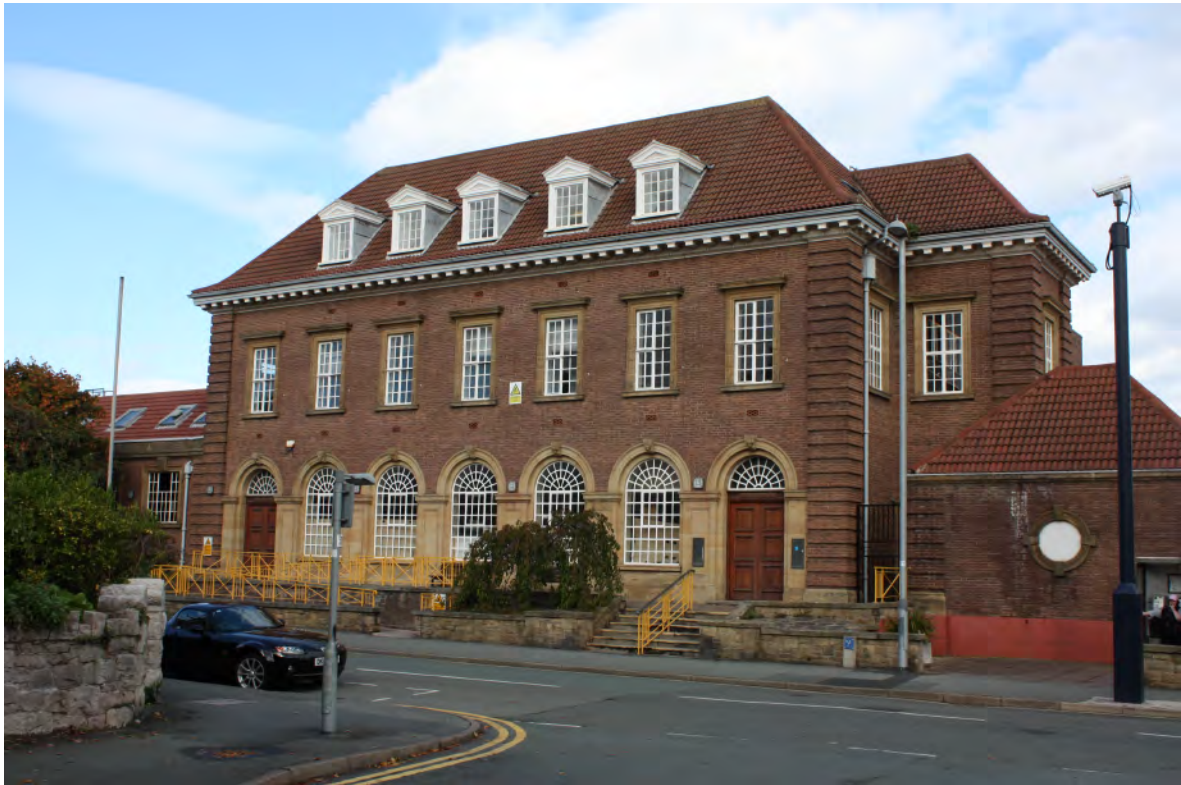
Plate 7

- 9.3.2. A number of inter-war buildings of the 1920s and 1930s have been listed for their architectural significance. These include the Neo-Georgian style Post Office built between 1923 and 1926 (Plate 7; SMR 41149; LB 14698) and the small Neo-Georgian style Ridge Cottage built in 1919, considered "remarkable" for a small house design (Cadw; Plate 8; SMR 41137; LB 14686).

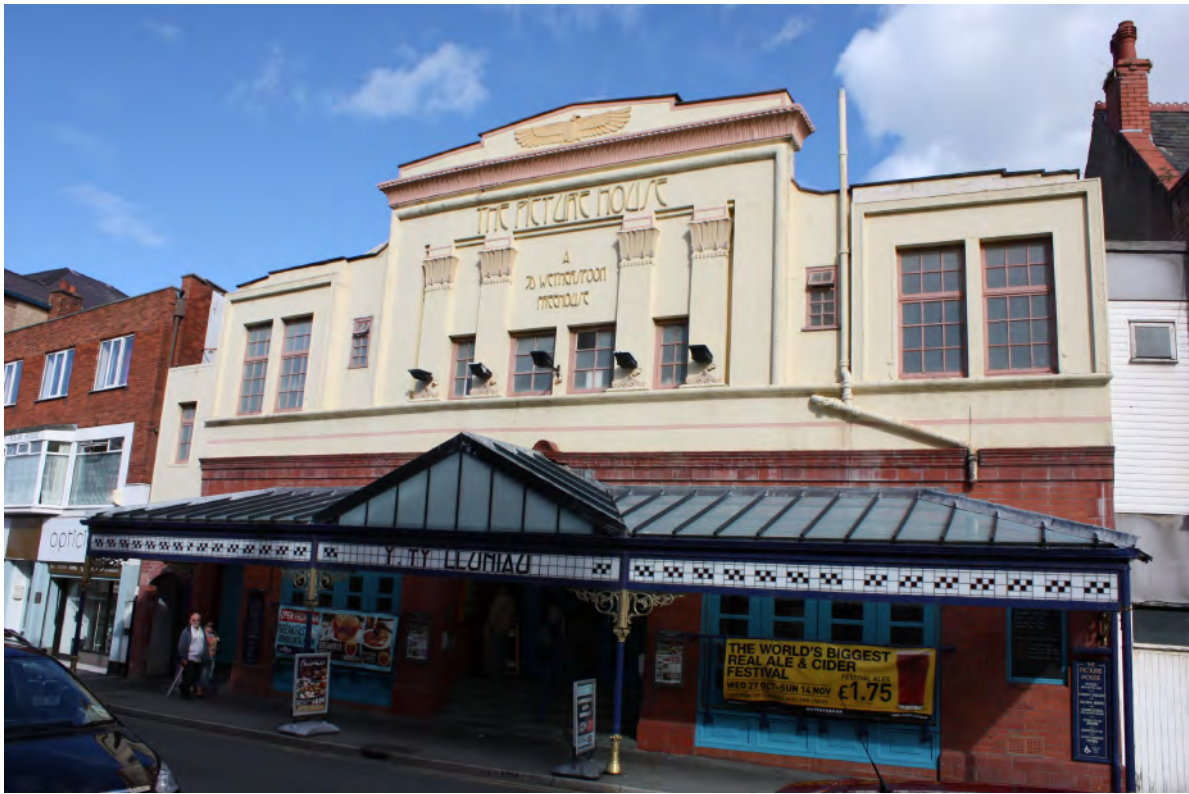
Plate 9

- 9.3.3. Three buildings from the 1930s reflect the development of Colwyn Bay as a commercial and entertainment centre. The original Princess Picture House built in 1932 (now a Wetherspoons Pub), is significant for its Art Deco interior and façade (Plate 9; SMR 41148; LB 14697).

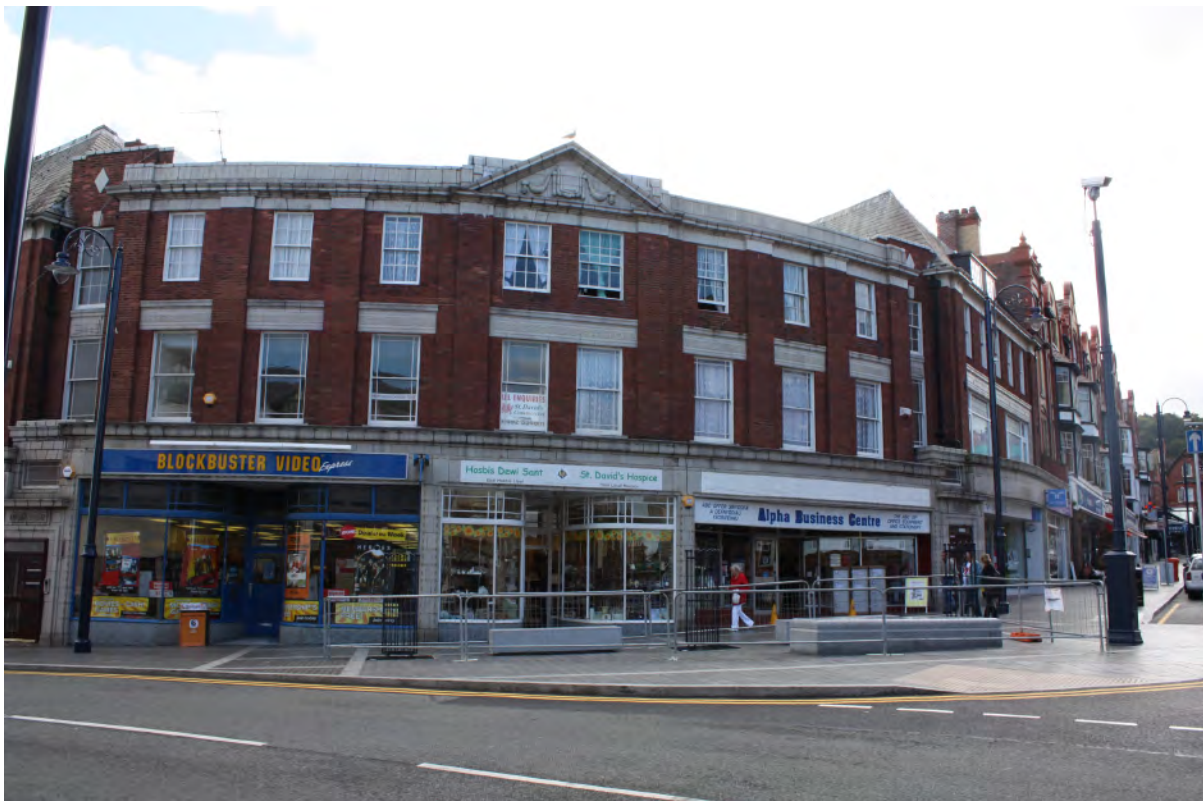
Plate 10

- 9.3.4. A shop development on the corner of Princess Drive (Nos. 1, 3, 4 and 7) and Penrhyn Road (Nos. 28, 30, 32 and 34) is significant for its Art Deco shop fronts and prominent corner positioning (Plate 10; SMR 41138-45; LB 14687-94). Just outside the study area are the Queens buildings on Station Road, comprising nine shop-fronts constructed of red brick in 1887 and considered a significant example of the second phase of construction in Colwyn Bay (Plate 11).

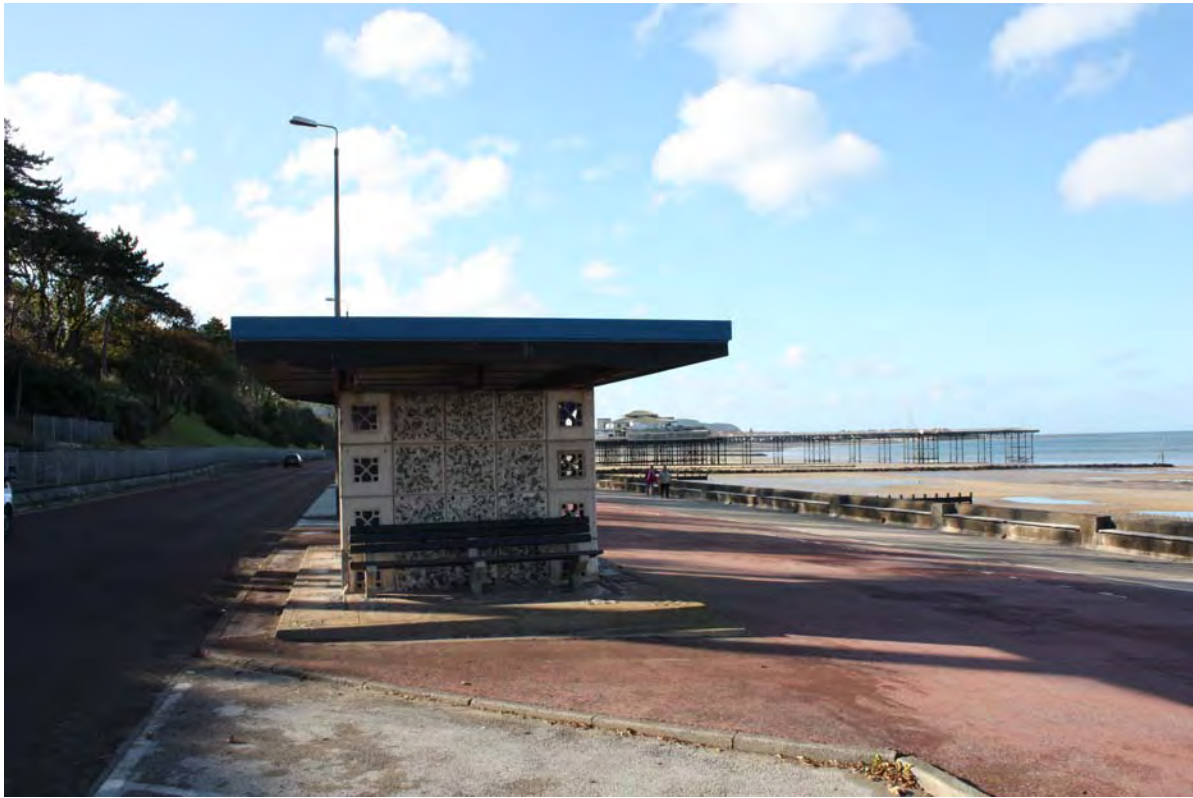
Plate 12

- 10.2.1. The promenade was characterised by 20th century shelters dating to the 1960s (Plate 12) and late twentieth century street furniture. A toilet block dating to 1908 was noted on the south side of the promenade road.
- 10.2.2. A railway viaduct at the southern end of the study area provides a road link with Eirias Park to the south (Plate 13). This feature is contemporary with the original railway, and has also been subject to a number of historic photographs dating to the mid-twentieth century, which emphasise the link between the park and the promenade (Plate 14). Further to the north-west a small access road was present directly opposite the pier connecting with the town, and running beneath a cast-iron railway bridge. A sandstone railway bridge was noted alongside the modern A55 flyover, where Marine Road links the town and promenade and sea-front (Plate 15).

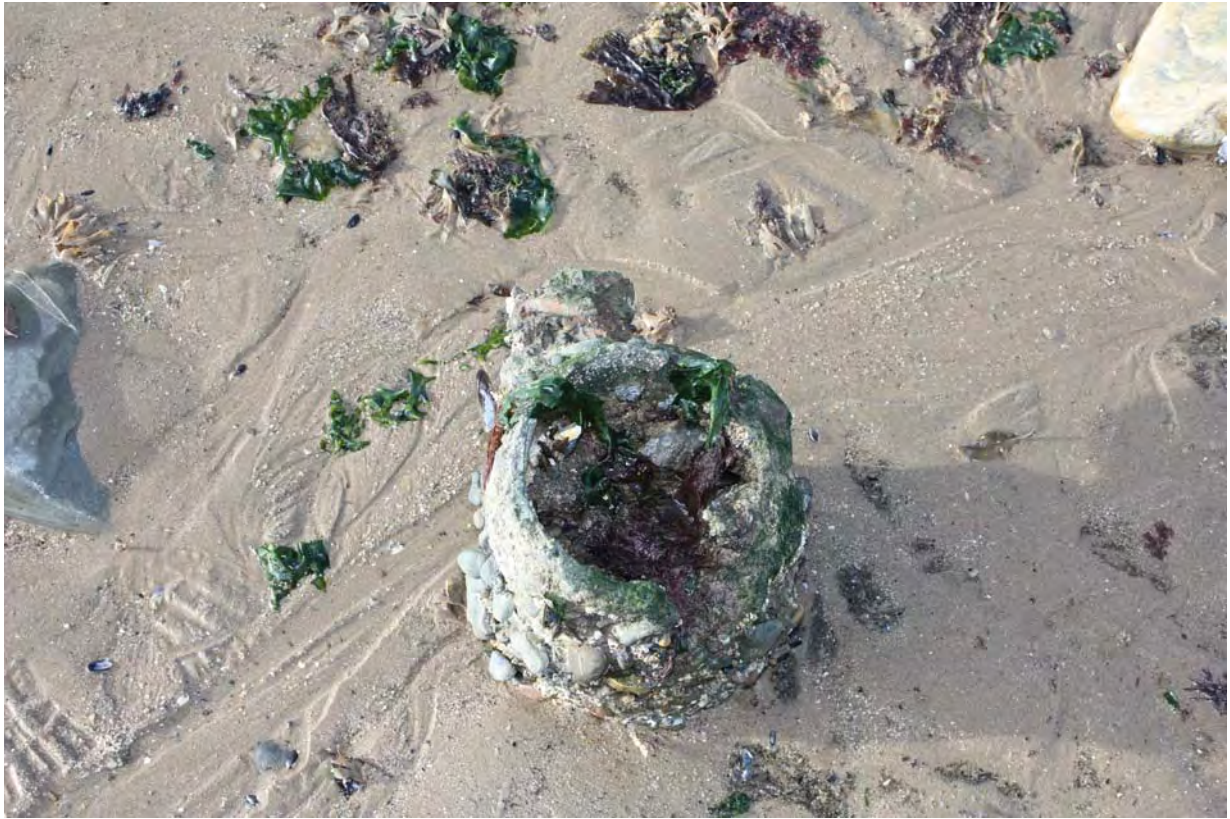
Plate 31

- 10.4.2. To the west of the pier the small stumps of iron posts were noted alongside lengths of tubular cast iron (Plate 31). These appear to relate to a slip-way feature depicted on historic photographs contemporary with the first phase of the pier pavilion in the early 1900s. This feature is also present on the historic mapping, and the features recorded are located at the end of the former slipway.

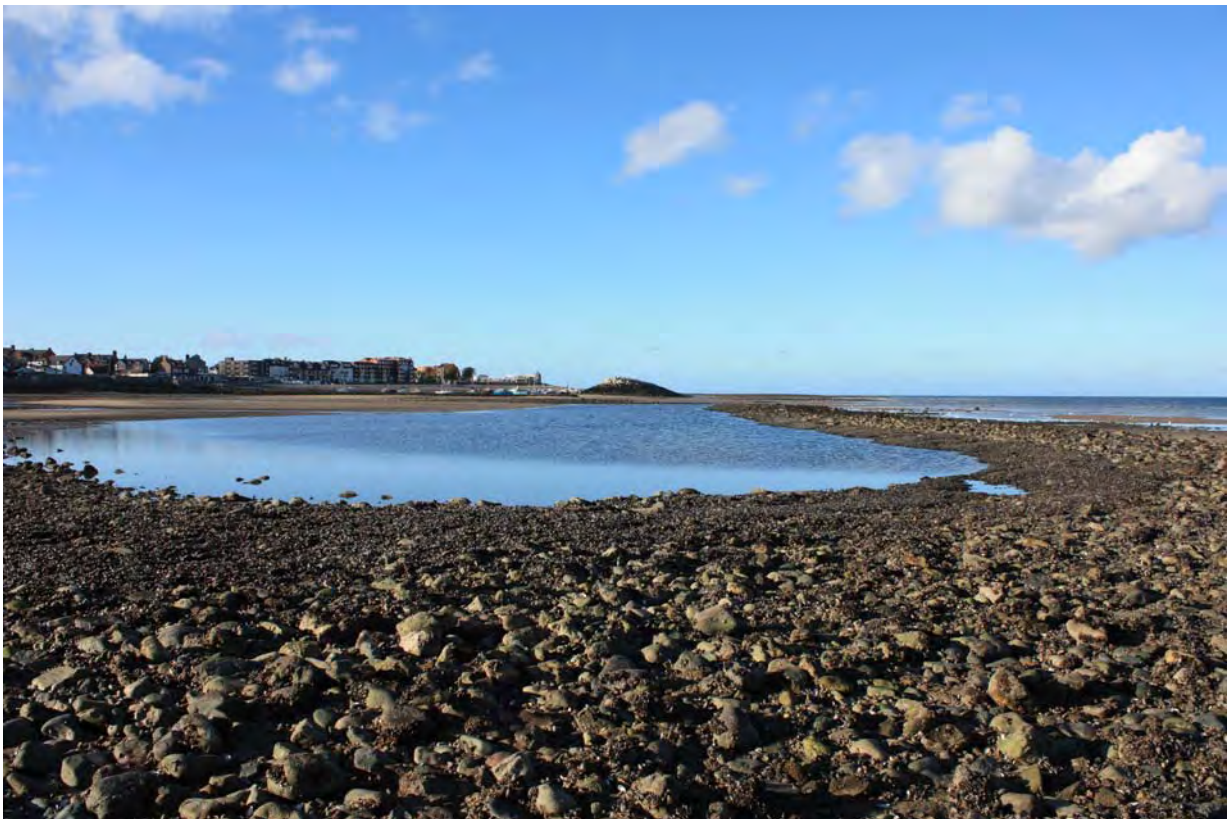
Plate 32

- 10.4.3. The fish weir was located to the northern end of the study area, and was clearly visible close to the low tide mark (Plate 32). This feature was constructed of banks of larger pebbles in a sub-rectangular arrangement, and survived as recorded in 1997 (Jones 1997). The feature appears to have been designed to retain sea water at low tide and water was visible within the weir at a higher level than the surrounding beach and tide (Plate 33). A preserved wooden timber was noted amongst the stones (Plate 34) and there may potentially have been further such timbers within the pebble structure.

- 11.2.3. Archaeological remains dating to the medieval period have been found within the study area. The remains of the medieval fish weirs that continue to be occupied into the post-medieval period at the northern end of the beach are archaeologically significant but are not designated as a Scheduled Ancient Monument.

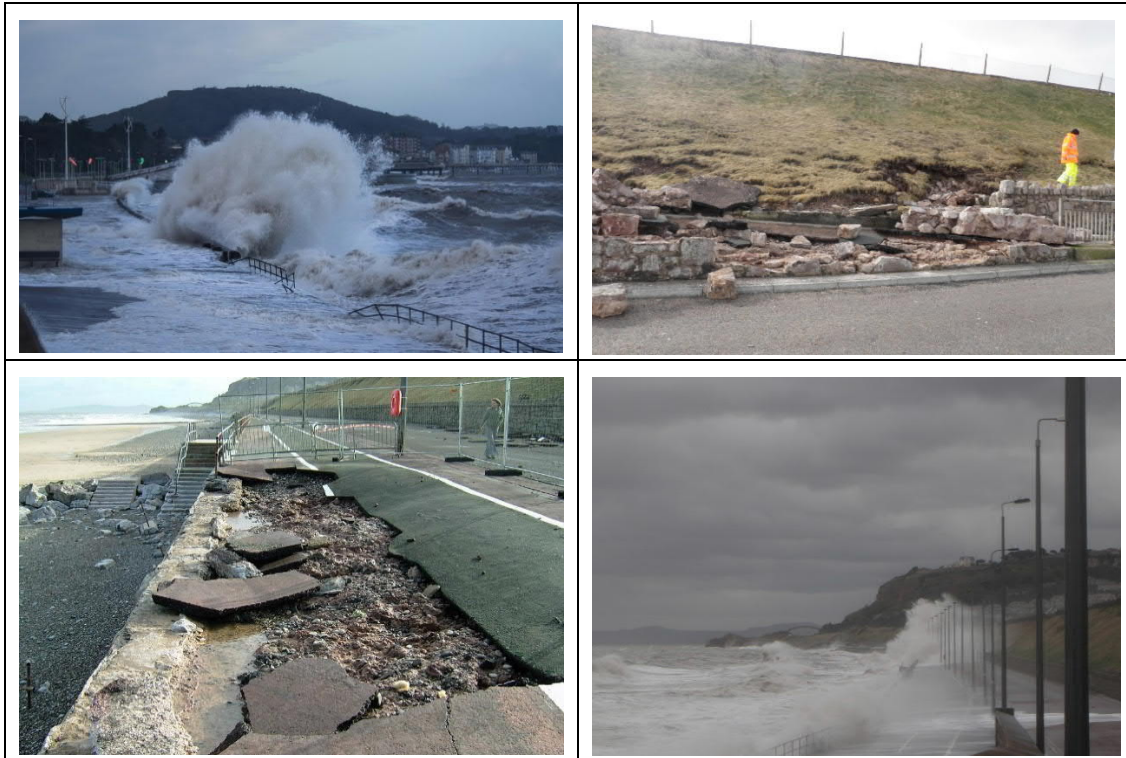
**Figure 1.1: Examples of Coastal Overtopping and Damage at Old Colwyn**

The Promenade highway is often closed when spring high tides occur at the same time as onshore winds, during storm events and while subsequent damage is repaired. As a result of the poor standard of coastal protection, there has been a lack of investment in the Old Colwyn Promenade area in comparison to the Colwyn Bay Waterfront Project Phase 1 area to the immediate west with the construction of Porth Eirias and the recharged beach.

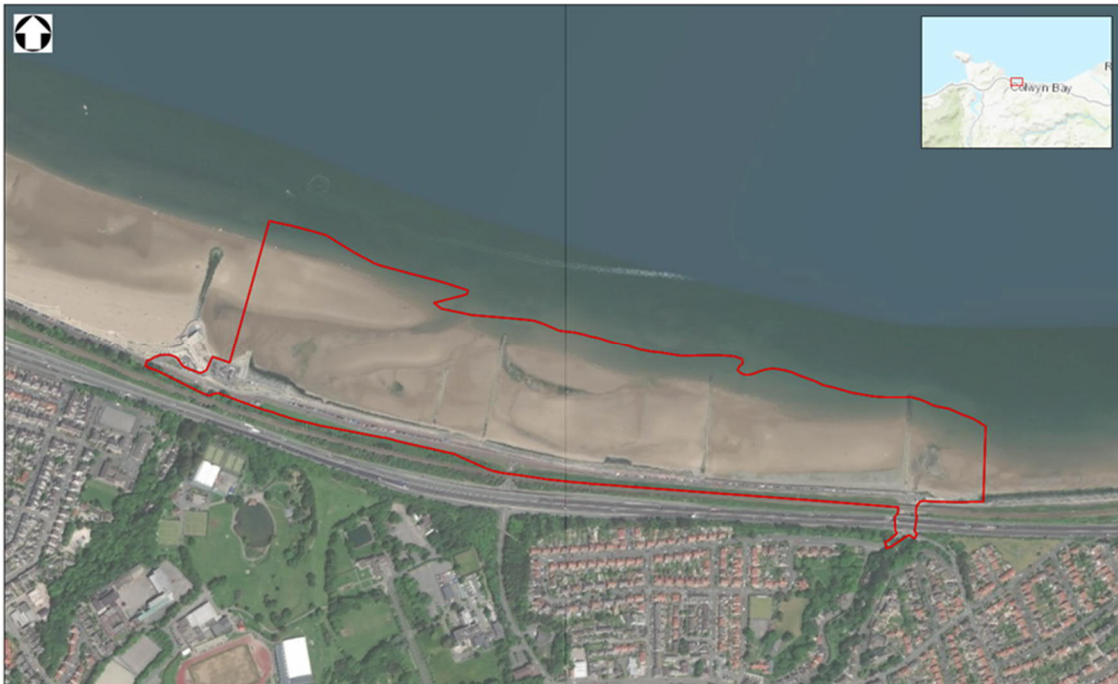
**Figure 1.2: Location of the Scheme**

The red line boundary has been extended beyond the footprint to as shown in Figure 1.2 to allow for access during construction.

Source: Environmental Statement. Red Line Boundary Plan Drawing 410895-MMD-00-XX-DR-N-1707

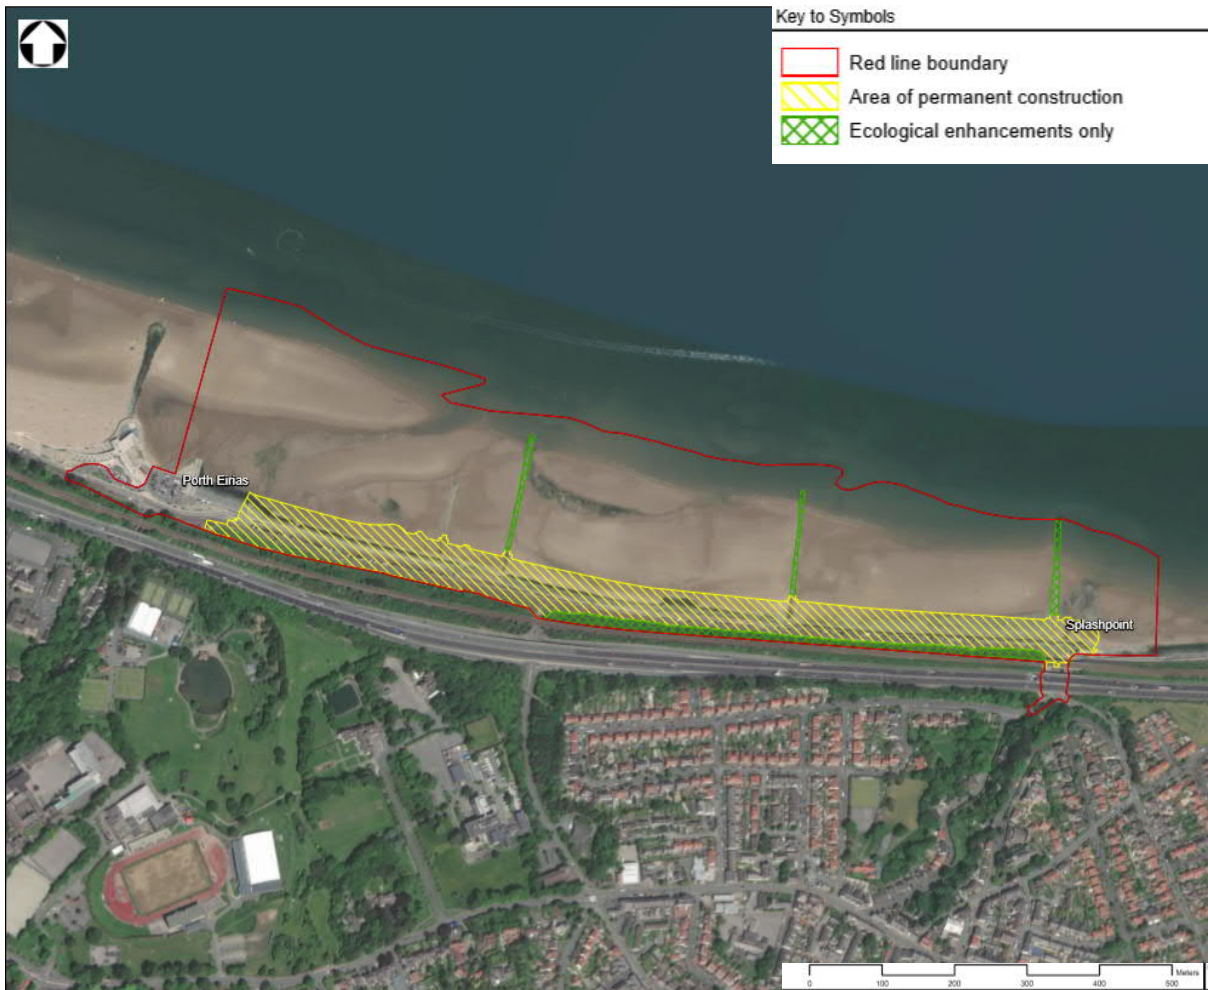
**Figure 1.2: Plan showing the Red Line Boundary and Area of Permanent Construction**

- the use of planting and seeding mixes within the picnic and outdoor area; and
  - planting of wildflowers along the railway embankment (currently in considered).
