Old Colwyn Coastal Defence and Active Travel Scheme Environmental Statement

Volume 2: Technical Appendix 10 - Coastal
Processes and Flood Risk

Water Framework Directive Assessment

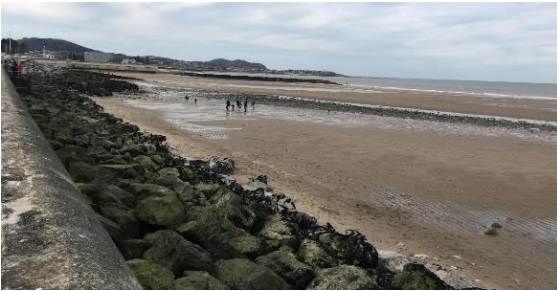
Photo 1.1: Looking North-West from Area 1 Promenade Across Old Colwyn Beach

The toe of the sea wall has been protected from erosion and undermining by a variety of defences. Across the first 750m west to east, rock armour has been placed directly in front of the wall (Photo 1.1, Photo 1.2), while over the remainder the toe has been protected either by reinforced concrete aprons or steel sheet piling (Photo 1.3).

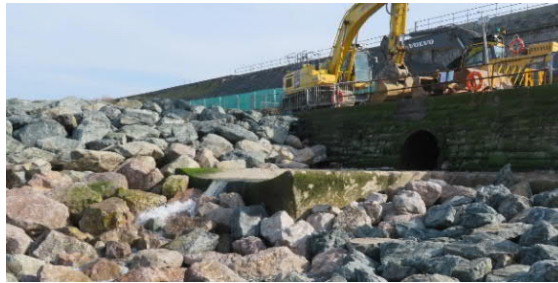
Photo 1.4: Looking North-East At Splashpoint Nant y Fynnon Outfall During Revetment Construction

There are slipways located at Porth Eirias to the immediate west of the Scheme footprint and Splashpoint in the far east for beach access along with four sets of pedestrian access steps in various states of disrepair with some currently deemed unsafe and blocked-off. Rock groynes are present at four locations, outfalls are culverted beneath two groynes while other outfalls currently discharge directly to the beach (Photo 1.4).

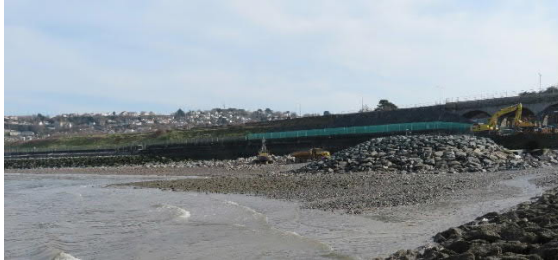
Photo 1.8: Looking South-East Across the Transition between the Existing Splashpoint Revetment (Area 2) and the Area to the East of the Scheme

In addition, at the far eastern end of the Scheme, as part of the Splashpoint Project a rock revetment section of similar width with a 1:2.5 slope was constructed earlier in 2020 (Photo 1.8 **Error! Reference source not found.**) to curve around the eastern corner of the promenade highway to the point at which it makes a right angle turn southwards beneath the A55 Expressway and NWC Railway Line towards Beach Road/Cliff Gardens.

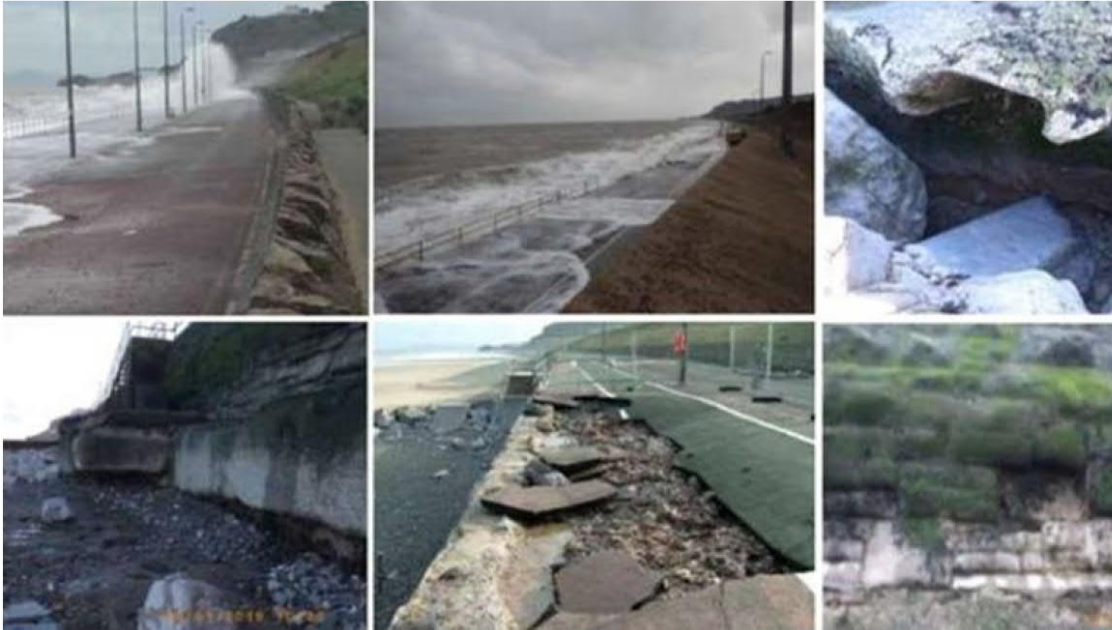
Figure 1.2: Examples of Old Colwyn Promenade Storm Damage

- Damage/Loss of Railings;
- Damage to promenade/highway surfacing and removal of fill behind the sea wall;
- Damage to boundary wall and erosion at toe of railway embankment;
- Lowering of beach levels in front of the sea wall;
- Undermining of the sea wall; and
- Removal of facing blocks to the sea wall.

The impact of present day conditions is shown in visual and recorded evidence from more recent storm events (Figure 1.2), which confirms the overtopping behaviour and also identifies the following as taking place:

Examples of this damage are provided in Figure 1.2.

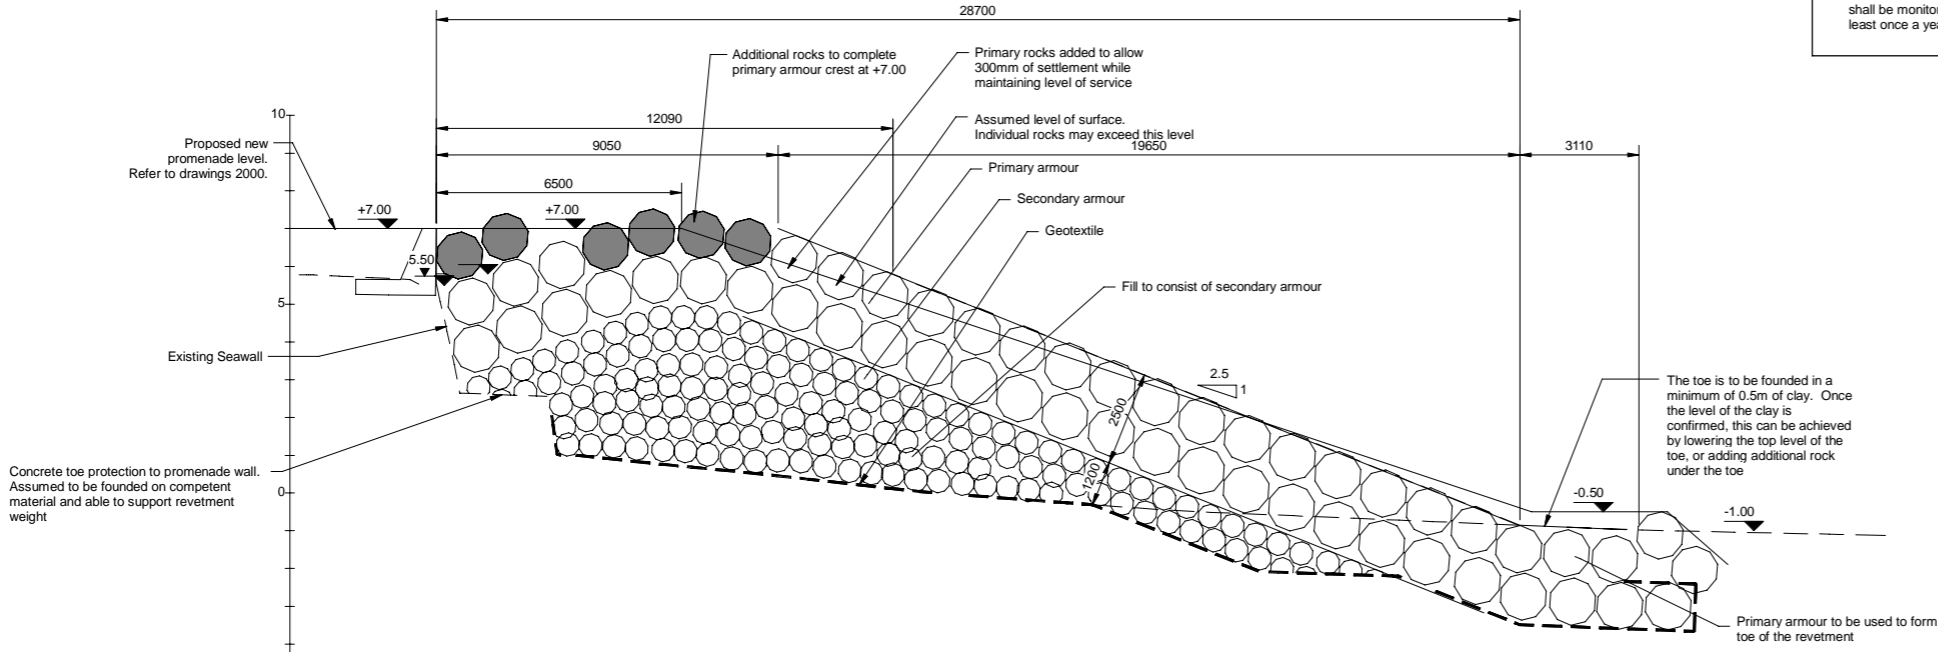
Section 4 - Section through Rock Revetment at Splash Point

- 4 Beach levels to be maintained to within 0.5m of current levels. Beach levels shall be monitored at regular intervals including before and after storms and at least once a year in spring (DHER Ref. 4).

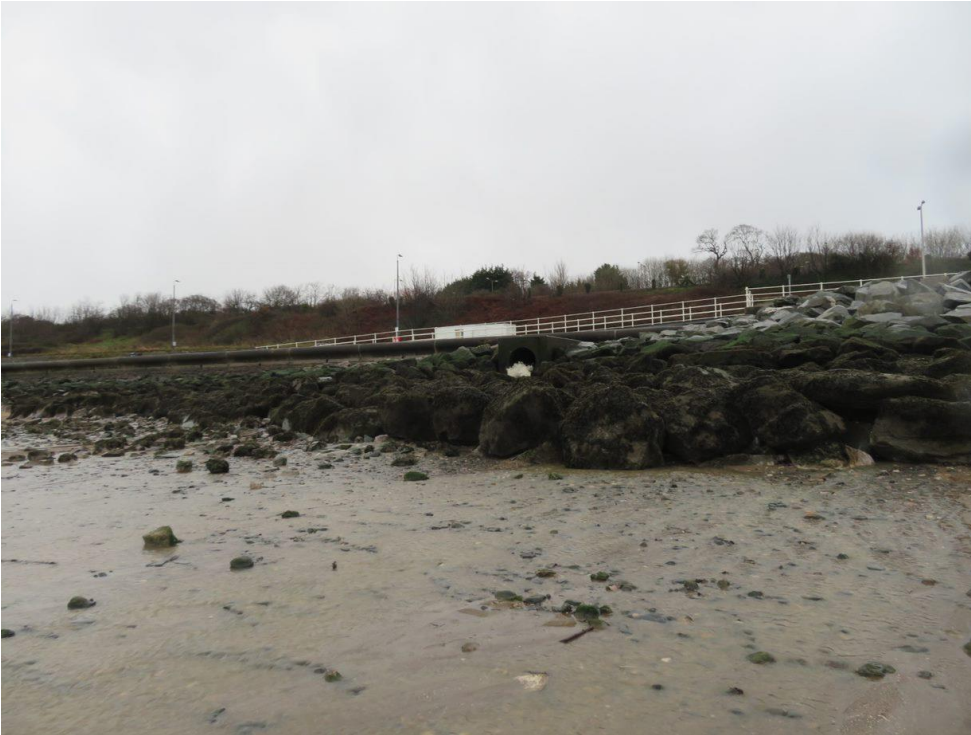
Photo 2.1: Profile 1

Photos of the structures and the beach at those profiles are shown in Photo 2.1 to Photo 2.4 below.

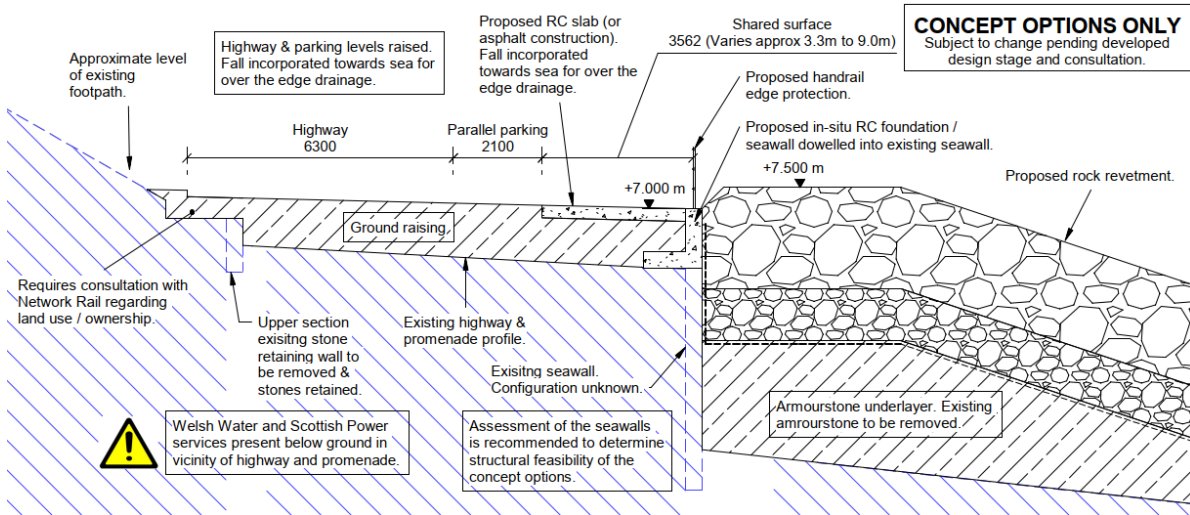
Figure 4.1: Illustration of proposed promenade raising and rock revetment crest

Mitigation measures such as promenade/ road closure are required to keep the crest level at the reasonable level proposed.

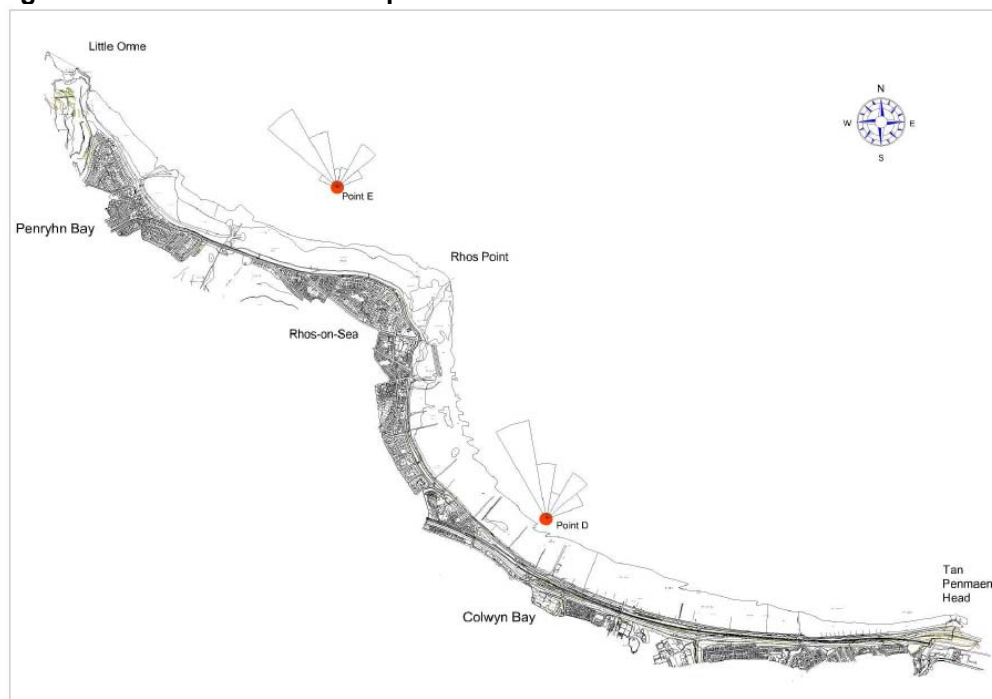
Figure 2: Locations of inshore point D and E

Return Period (years)	Offshore		Nearshore point			
			Point D		Point E	
	Hs(m)	Tm(s)	Hs(m)	Tm(s)	Hs(m)	Tm(s)
1	4.78	10.1	2.04	6.6	3.25	8.3
10	5.56	10.9	2.27	7.0	3.84	9.1
50	6.11	11.4	2.43	7.2	4.24	9.5
100	6.33	11.6	2.5	7.3	4.4	9.7
200	6.57	11.8	2.57	7.4	4.57	9.9
500	6.88	12.1	2.66	7.5	4.80	10.1
1000	7.11	12.3	2.73	7.6	4.97	10.3

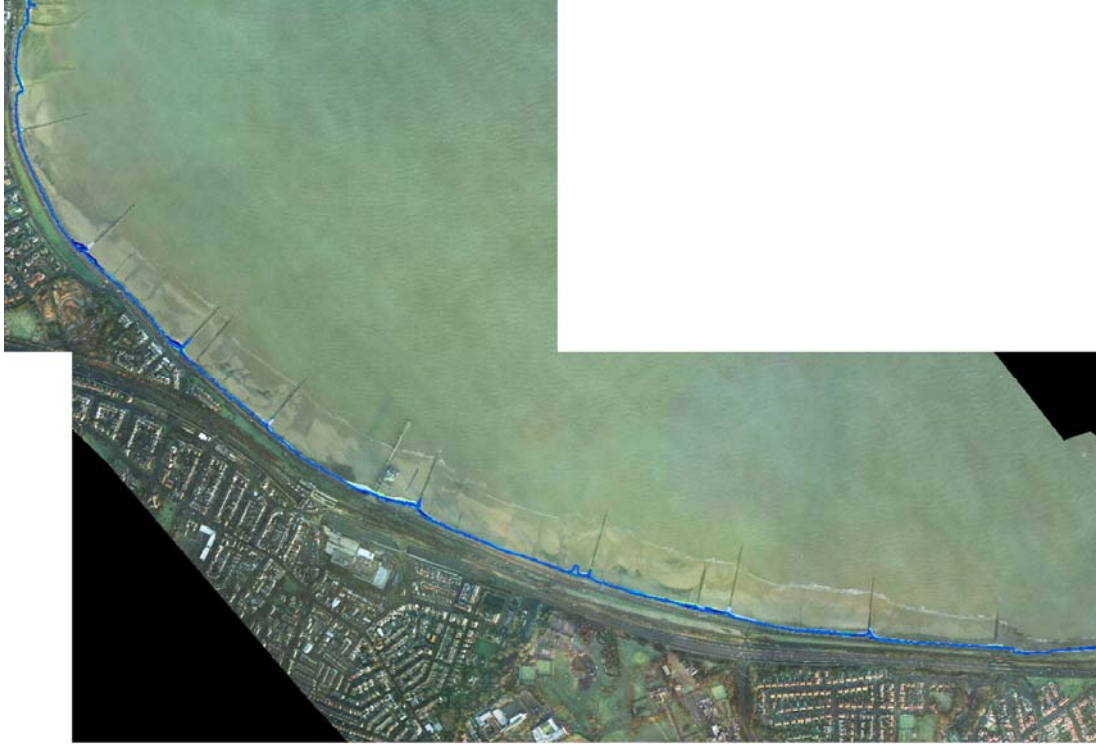
Figure 3: +2m (OD) beach level lines (October 2001 to November 2007).

The +2m OD beach level lines were presented in **(Figure 3)** extracted from the beach survey data collected between October 2001 and November 2007. It clearly shows that the +2m OD lines were more or less at the toe of the sea wall along the entire frontage. As the Mean High Water Neap Tide (MHWNT) level in Colwyn Bay is at +2m OD, it means that high water reaches the wall on almost every tide. In the later beach recharge scheme test, this would constitute a failure of a scheme.

- Severe storms were the main cause of beach retreat in the Colwyn Bay. This is confirmed by visual evidence which identified reductions in beach levels at the toe of the existing structures of up to a metre following storm events, e.g. February 2002, February 2005 and most recently in March 2010. The latter two of these required emergency works to protect the toe and prevent failure of the defences.
- Near the west and east ends of the studied coastline, the beach was suffering steady retreat resulting in the 0m OD (mean sea level) line being dangerously close to the hard defences in places;
- The shore position and beach conditions in middle section were more dynamic but relatively stable comparing to other parts of the coastline.

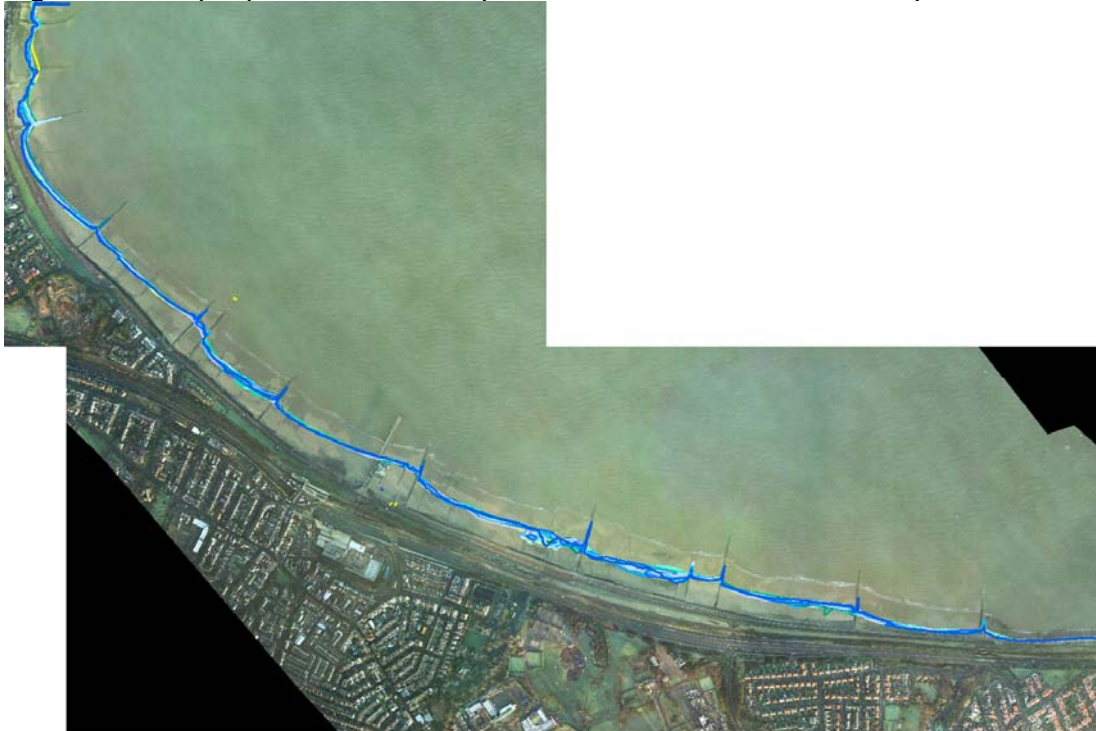
Figure 4: +0m (OD) beach level line (October 2001 to November 2007).

From the 0m OD beach level lines **(Figure 4)**, further observation can be made as follows:

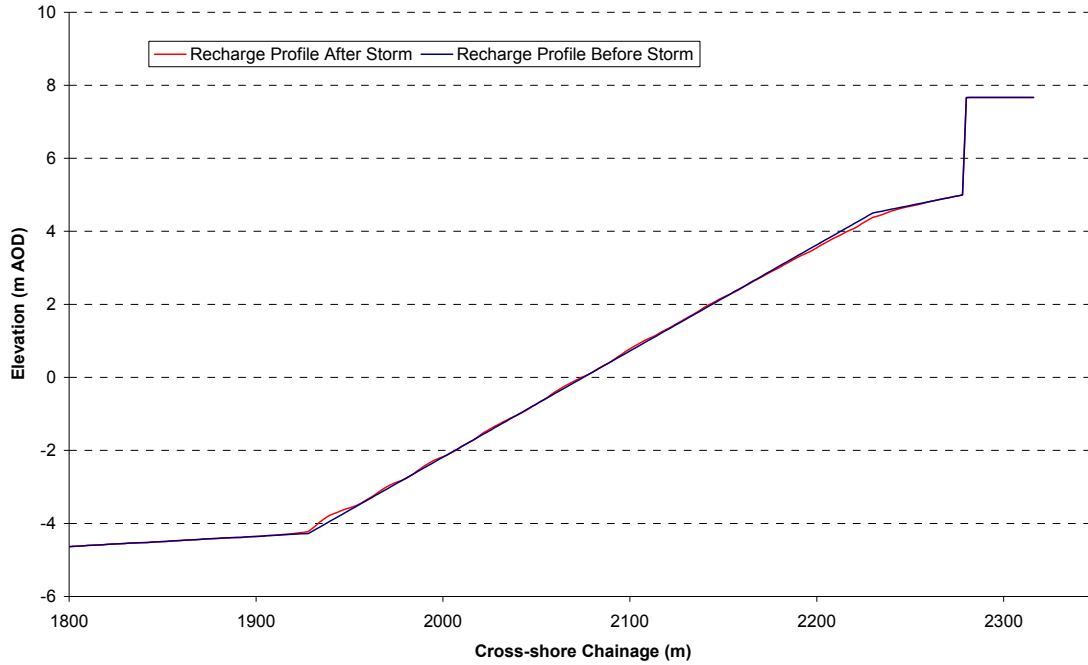
Figure 15: LITPROF result on the recommended recharge profile ($d_{50}=0.25\text{mm}$)

The LITPROF results of the modified recharge profiles are presented in **Figures 15-16**. These revised profiles provided a 25% reduction in the berm width impacted by the storm compared to the lower EBP profile for the 0.25mm d_{50} sediment size but no change for the 0.45mm d_{50} sediment size, whilst providing for a zone of beach recharge that does not extend beyond the inter-tidal area.
