## Compliance Assessment Report CAR\_NRW0037143

**Permit being assessed:** PP3993VS.

For: Atlantic Recycling Limited, held by Atlantic Recycling Limited

**Type of assessment carried out:** Site Inspection, Reason: Routine.

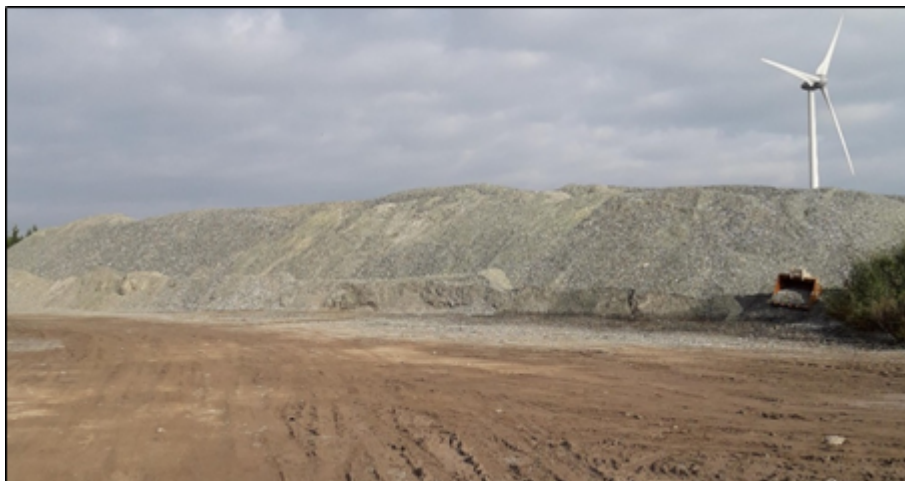
At the time of the inspection this area was filled with a considerable volume of inert material with a high glass content, as per image 1. The intention for this material is to be stored on Field 4 before being taken to the Transfer Station and put through the MRF to obtain the recyclables. We would remind the business that the permit requires wastes such as wood, SRF and RDF to be stored on impermeable surface with sealed drainage. As this area does not yet benefit from a fully sealed drainage system like one for Field 1, this location would be unsuitable for most current onsite activities.

**Image 1 – showing the large volume of inert material deposited on Field 4**

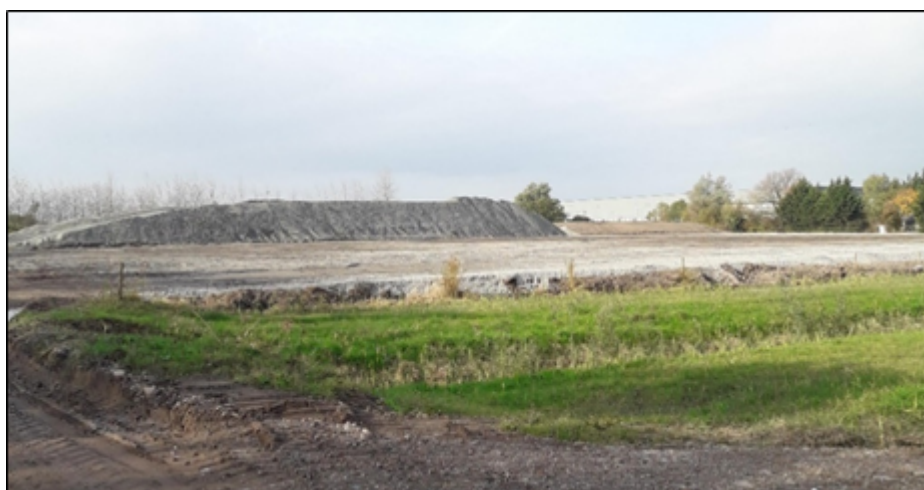
It was also stated that Field 4 could be a potential quarantine area for isolating and segregating fire-affected waste in the event an incident, as per image 2.

**Image 2 – showing the opposite end of Field 4 with the inert waste pile seen in the distance**

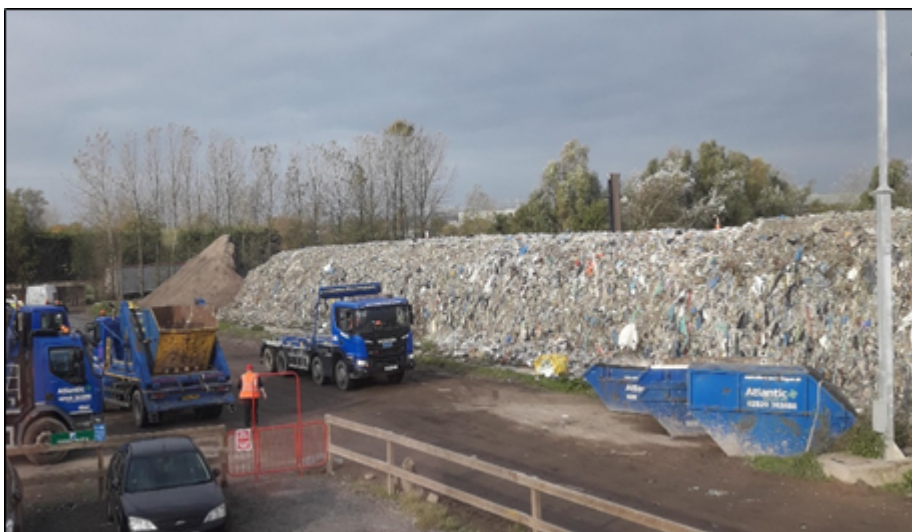
**Image 3 – taken from the office stairwell showing one end of Stockpile 2 on Field 1**

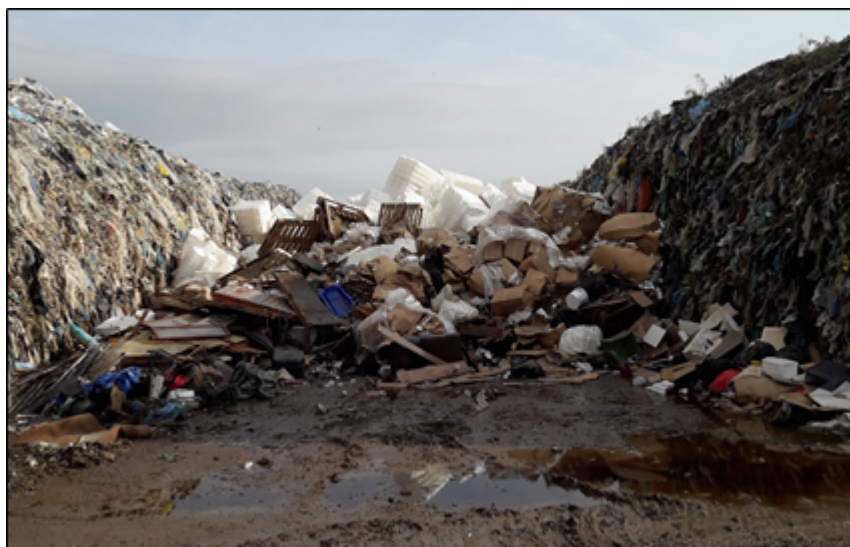
During the inspection, it was highlighted to the operator that loose general waste consisting of cardboard, plastics and pallets had been deposited in more than one of the separation breaks between neighbouring stockpiled waste on Field 1. It was stated that this waste had come in over the weekend and had been purposely tipped in these locations. This is likely due to the lack of space available on Field 1 and across the Transfer Station.

**Image 4 – showing general waste deposited in a fire break between stockpiles on Field 1**

Officer BOWDER asked the business to implement measures to ensure that fresh material is not deposited in this manner again. Phil RIDLEY agreed to remove this material as a priority and to send images to NRW once completed. On Friday 30 October 2020 the operator sent photographs confirming that all the deposited material had been cleared from the fire breaks.

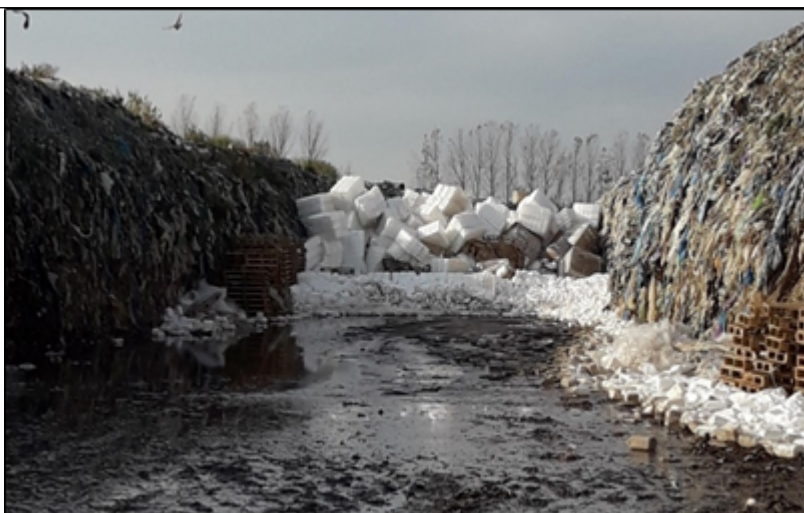
**Image 5 – showing rear view of Image 4 general waste deposited in a fire break between stockpiles on Field 1**

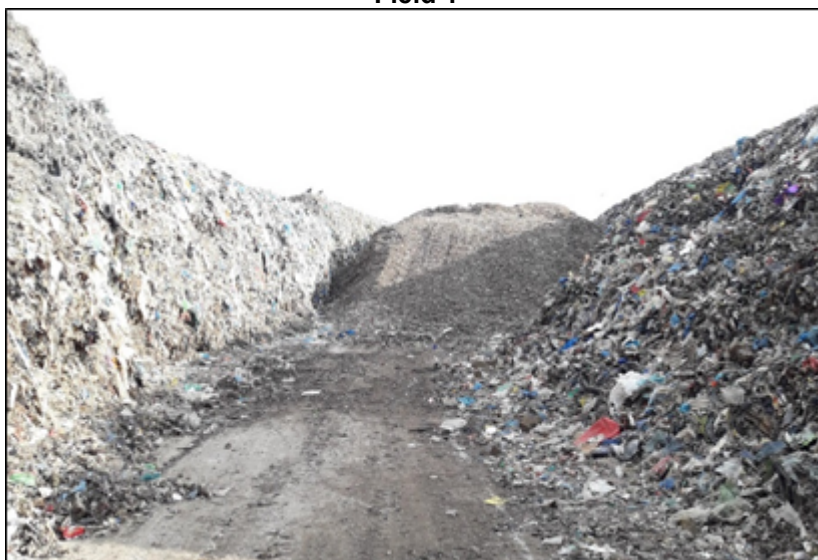
**Image 6 – showing waste deposited in a fire break between stockpiles on Field 1 with inadequate separation distance**

Separation distances are required to prevent the spread of fire between stockpiled waste. As the site is aware, fire breaks need to be established between stockpiled waste and buildings to allow access to material in the event of a fire. On the inspection, it was evident that some of the fire breaks between various loose stacks on Field 1 were less than 12 metres, as per image 6.

This was due to the excessive volumes of material on site and the consequential lack of room available to increase stockpiles sizes without increasing the risks. It is imperative to keep these spaces established and clear to be able to manage a fire incident.

Create a clear separation distance of 12 metres between all neighbouring stockpiles.

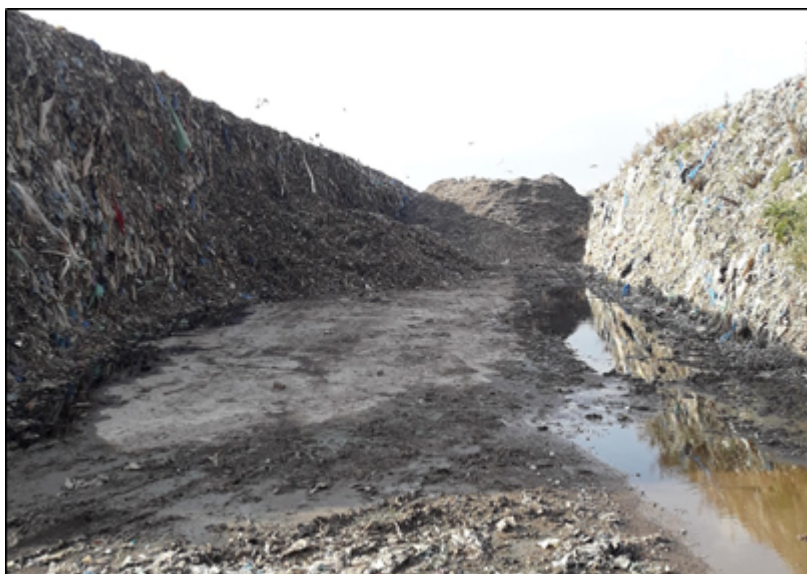
**Image 7 – showing waste deposited in a fire break between stockpiles on Field 1**

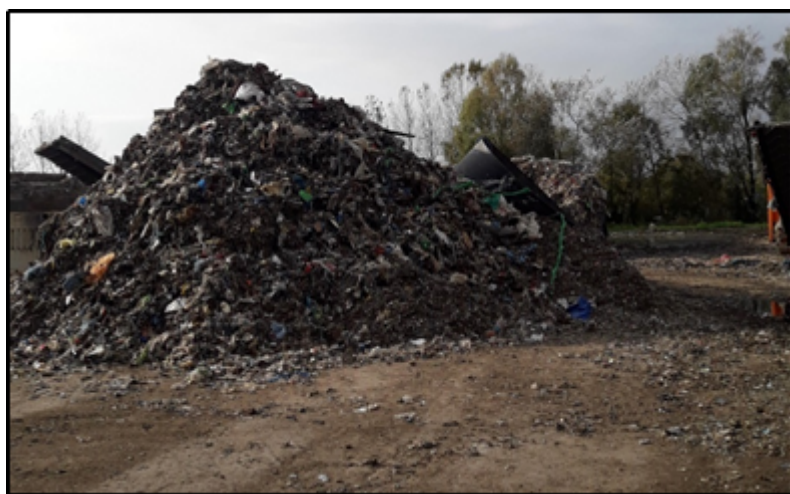
New material was being deposited in a pile on Field 1, as per image 8. It was surprising that this free area was not being used to downsize, sort or process the historic stockpiles. Removal of the waste stockpiles older than six months should still be the priority for the site.

Image 8 – showing new material being deposited on Field 1

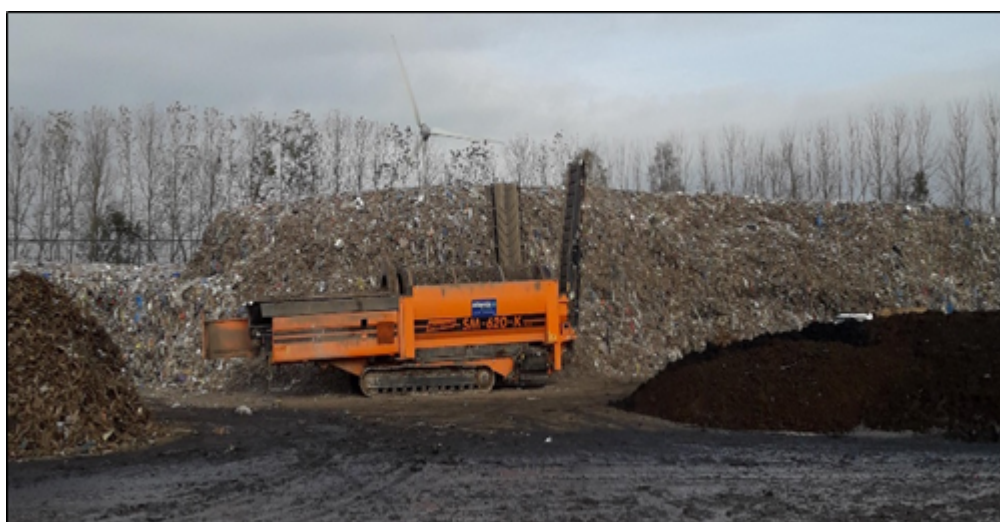
The MRF was operational at the time of inspection separating the various recyclable waste streams from the input. The Officer highlighted that there was a very large continuous stockpile of loose residual waste from the MRF being stored parallel to the mesh fencing boundary of the Transfer Station, as per image 9. The classification of this material was questioned and how it differs from the waste stockpiled on Field 1; it was stated that it was largely the same EWC code.

**Image 9 – showing large amount of loose residual material from the MRF stored in the Transfer Station**

Officer BOWDER raised concerns as there was too much waste in the Transfer Station area to reasonably control and comply with the permit conditions. Phil RIDLEY stated that, since April 2020, the lockdown pandemic restrictions has brought issues with staffing and industry outlets. This has created pressures on being able to process the volumes of waste that is normally produced from the daily site activities. This, paired with threats made against the business, has caused operations to focus its management strategy on security rather the volumes of material present across the permitted areas.

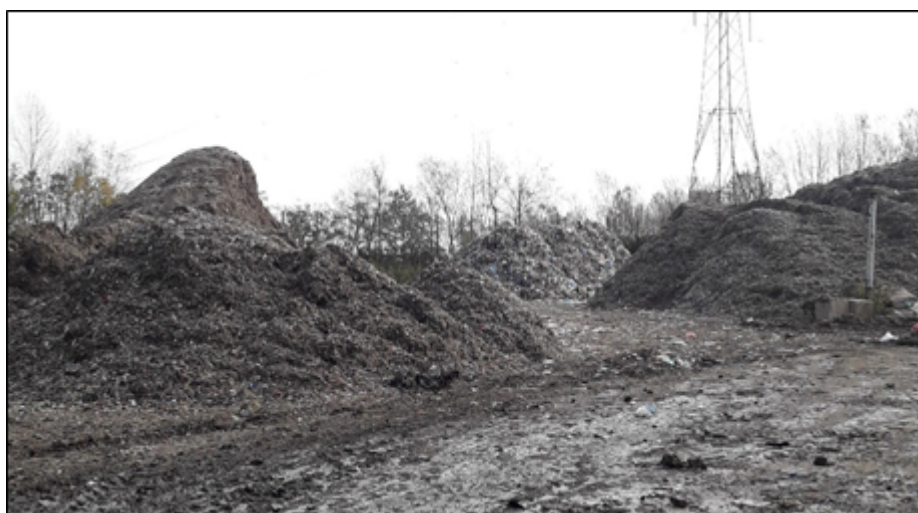
The SRF process offers a means of recovering a significant proportion of household and industrial waste. The SRF activity area in the Transfer Station has increased in its operation size since last inspection. This area has been solely allocated for the storage, processing and blending of waste to produce the SRF product, as per image 10.

**Image 10 – showing SRF storage area in the Transfer Station**

Because the recent permit variation has increased the tonnage throughout per annum, it is essential to manage stockpiles effectively. The mound seen in the left of image 10 was piled very highly - please be mindful of all stockpile sizes and manage them in accordance with guidelines.

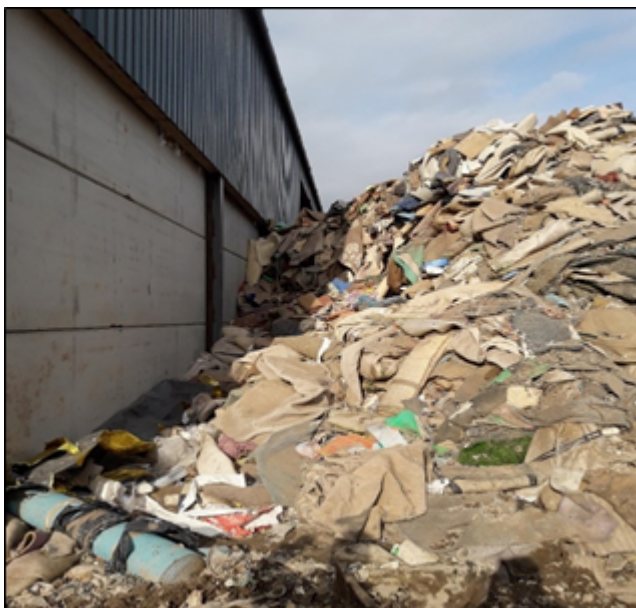
Officer BOWDER highlighted that the carpet pile (used for blending with the waste) was pressed up against the side of the unit, as per image 11. Although carpet waste can be stored inside the building, this is not good storage practice to deposit waste in this manner. This is again due to the primary issue of the limited space availability.

Image 11 – showing carpet waste pile stored up against the SRF unit with no clear gap

Establish clear gaps between all stored wastes and buildings on site.

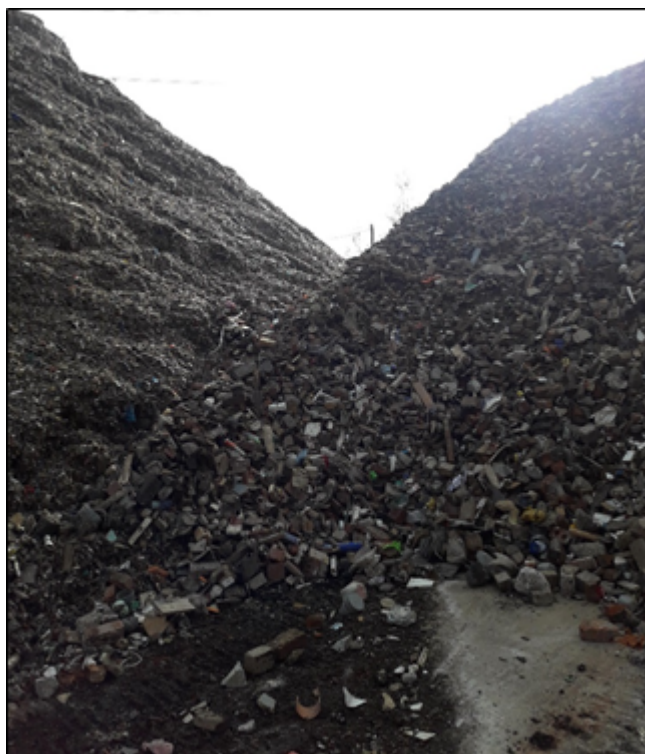
Stockpiles of separate waste type were also witnessed merging at the base due to the lack of room.

Image 12 – showing waste stockpiles of different type merging at the base
