Sundorne Products (Llanidloes) Ltd

BRYN POSTEG LANDFILL SITE (EPR/BU7766IC)

Surface Water Pollution Risk Assessment

Doc ref 3400-CAU-XX-XX-RP-O-0302.A0.C3

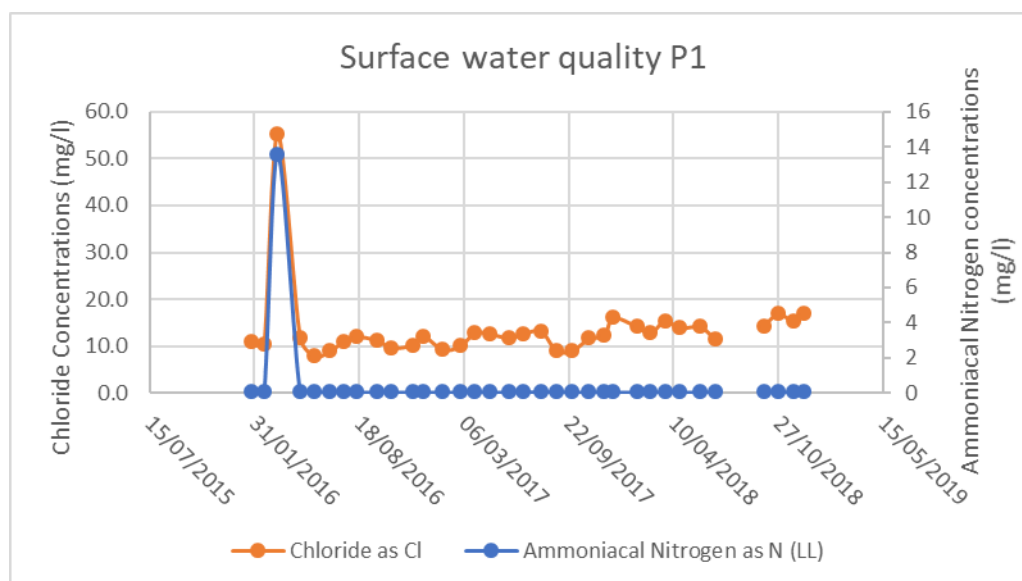
3.1.2 Routine surface water monitoring data is undertaken at P1 located at the discharge point of the eastern catchment. This data indicates that with the exception of an event occurring in early 2016, the contaminant concentrations are low (data is contained in Appendix 2)

3.1.3 The data collected from this event has been excluded from the calculation of the average and 95%ile values in the table above. All concentrations below the laboratory detection limit of 0.06 mg/l for ammoniacal nitrogen have been taken to be at this detection limit within the graph above.

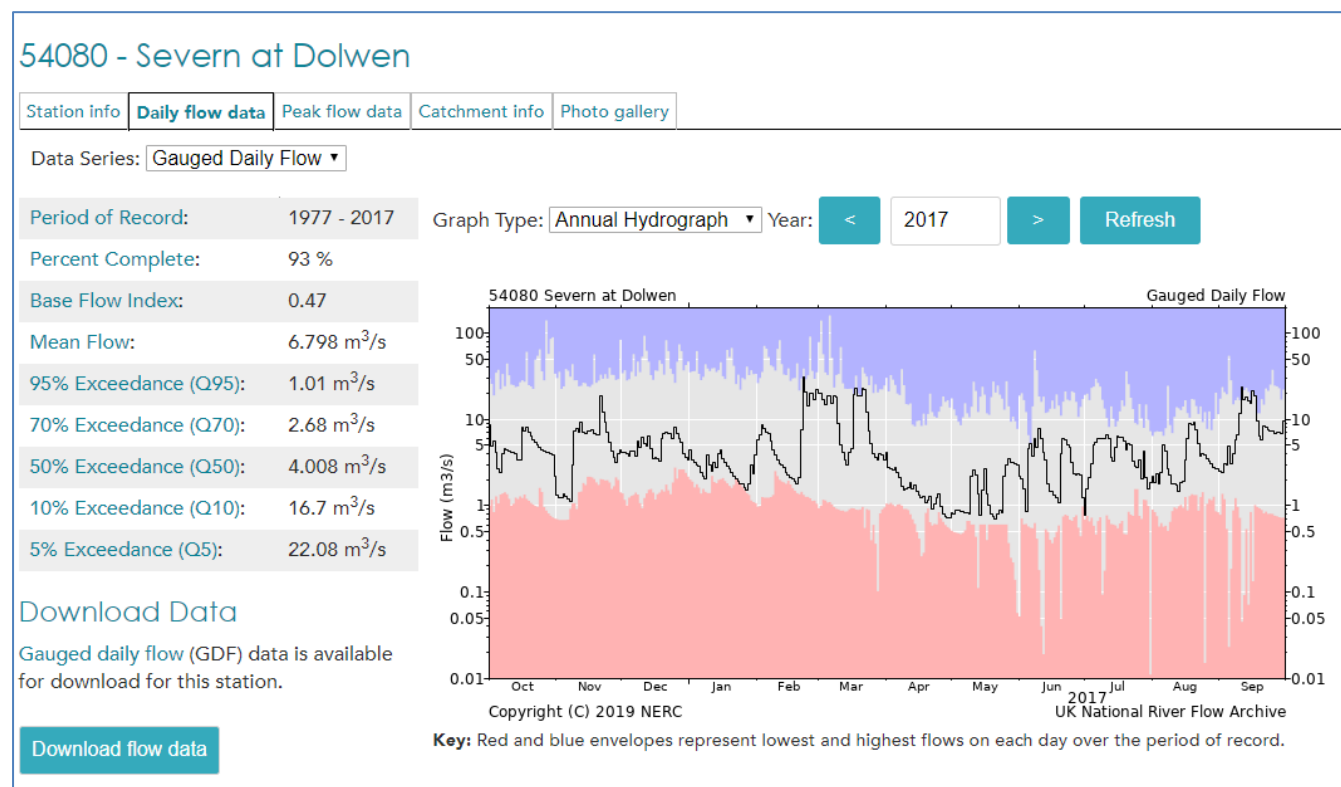
- 4.2.5 An extract from the Nation River Archives is presented below. This indicates that the Q95 flow within the R. Severn at Dolwen is 1.01 m³/s. The maximum discharge from the site is 0.03m³/s (30 L/S).

Data was sourced from <http://nrfa.ceh.ac.uk/data/search>.
