Project: **Newport Transporter Bridge**

Orig Title: **Proposed Repair Details Marking Plan**

| 072084 - CUR - ZZ - ZZ - DR - S - 27003 - | | | | | | | |

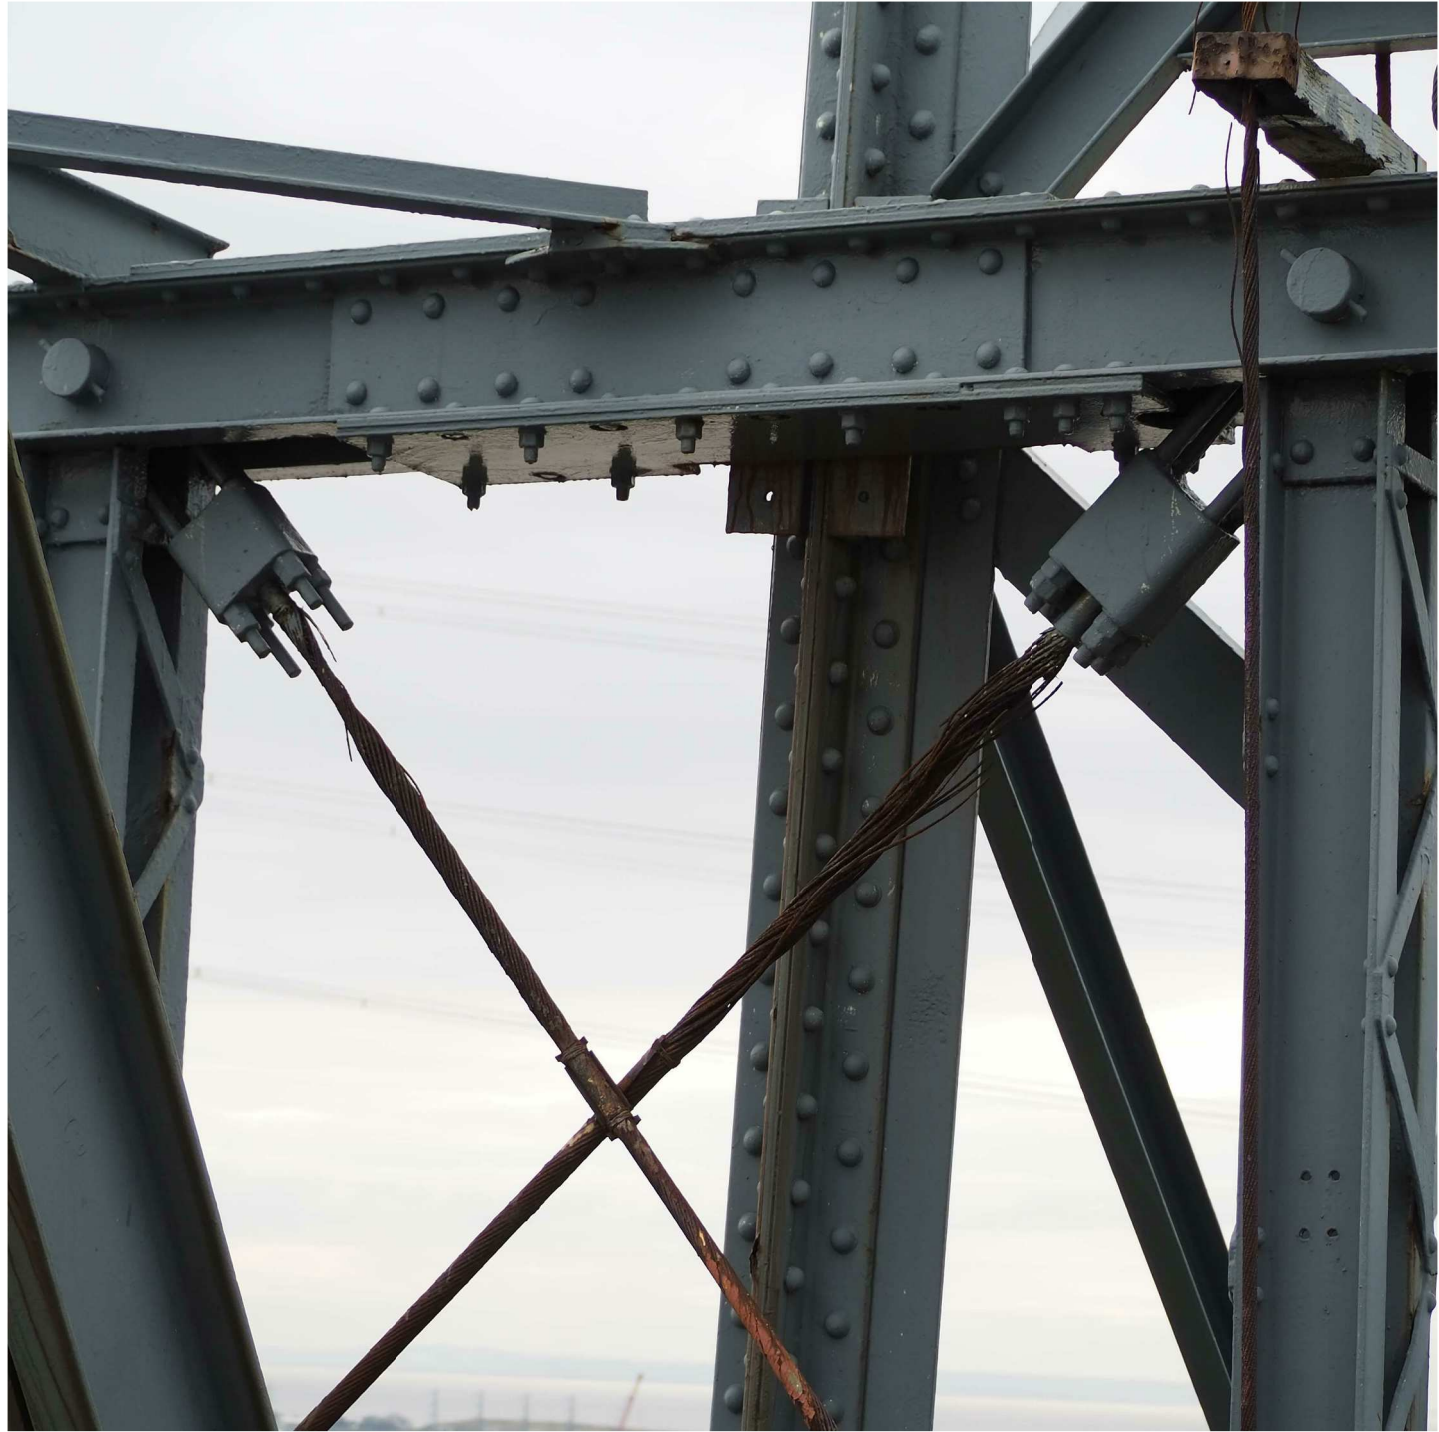
Typical In-situ condition

For typical repair detail of element  
shown refer to drawings  
B072084-CUR-ZZ-ZZ-SK-D-27110/111

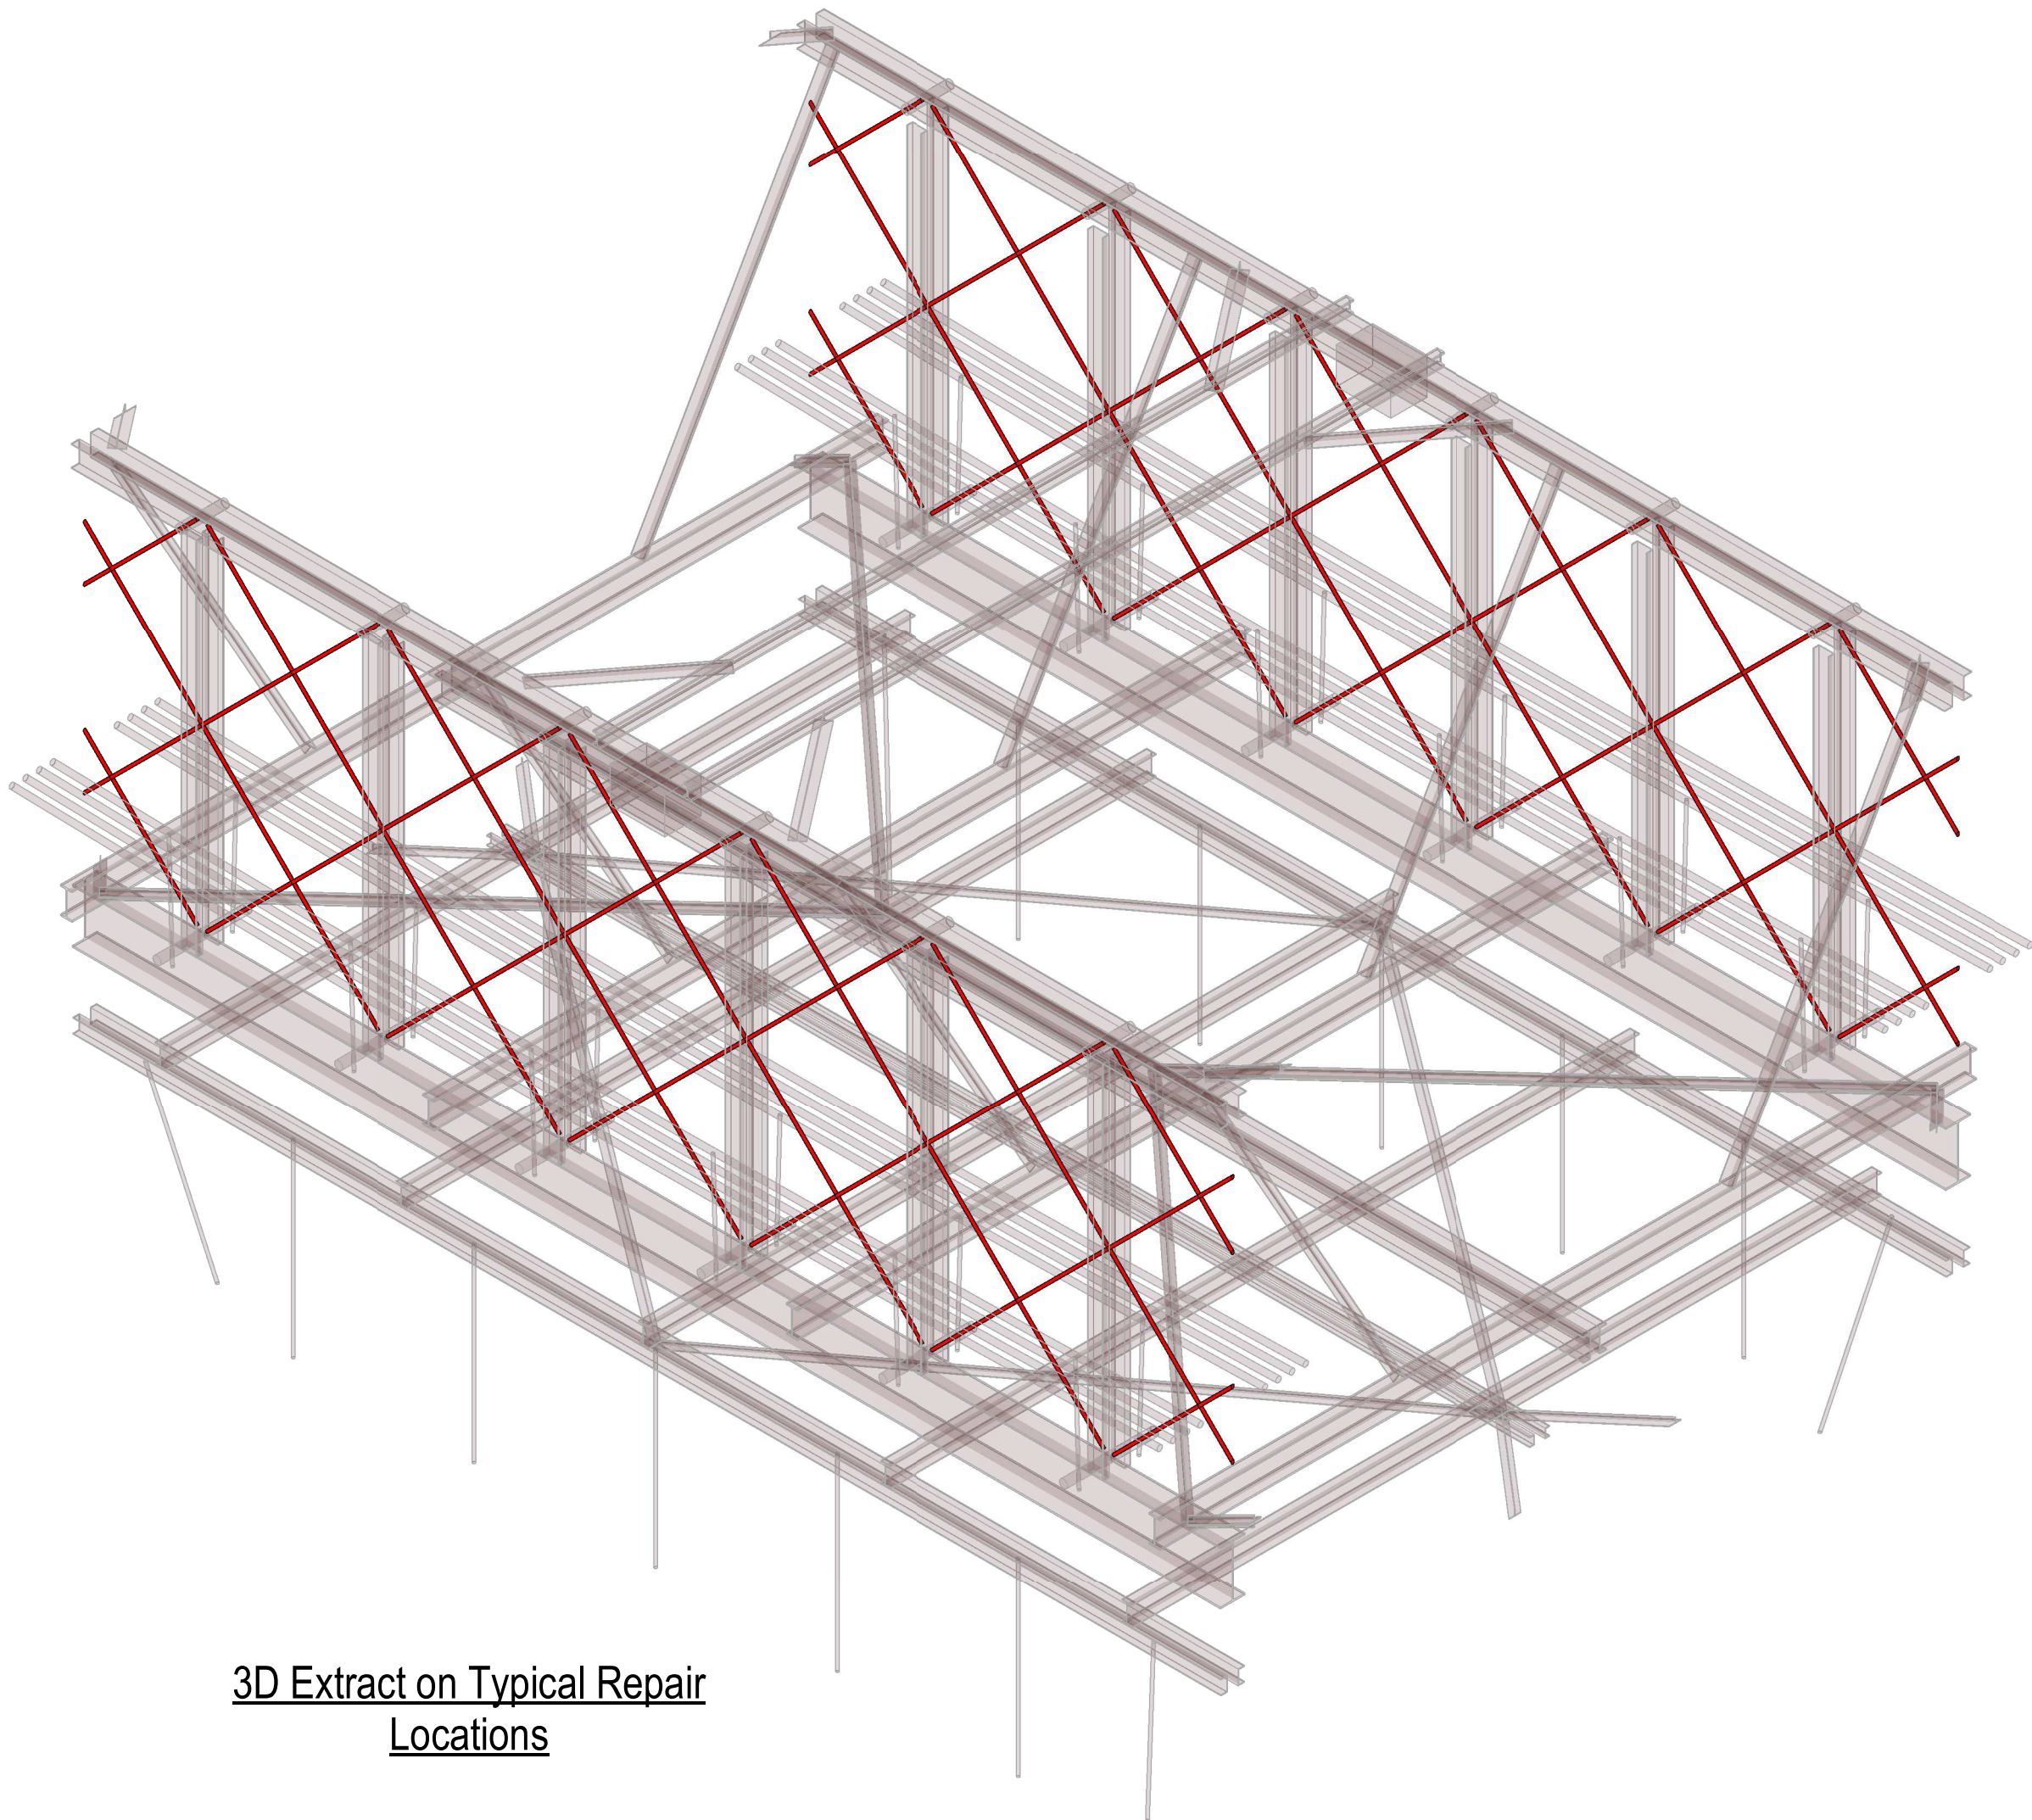
3D Extract on Typical Repair  
Locations

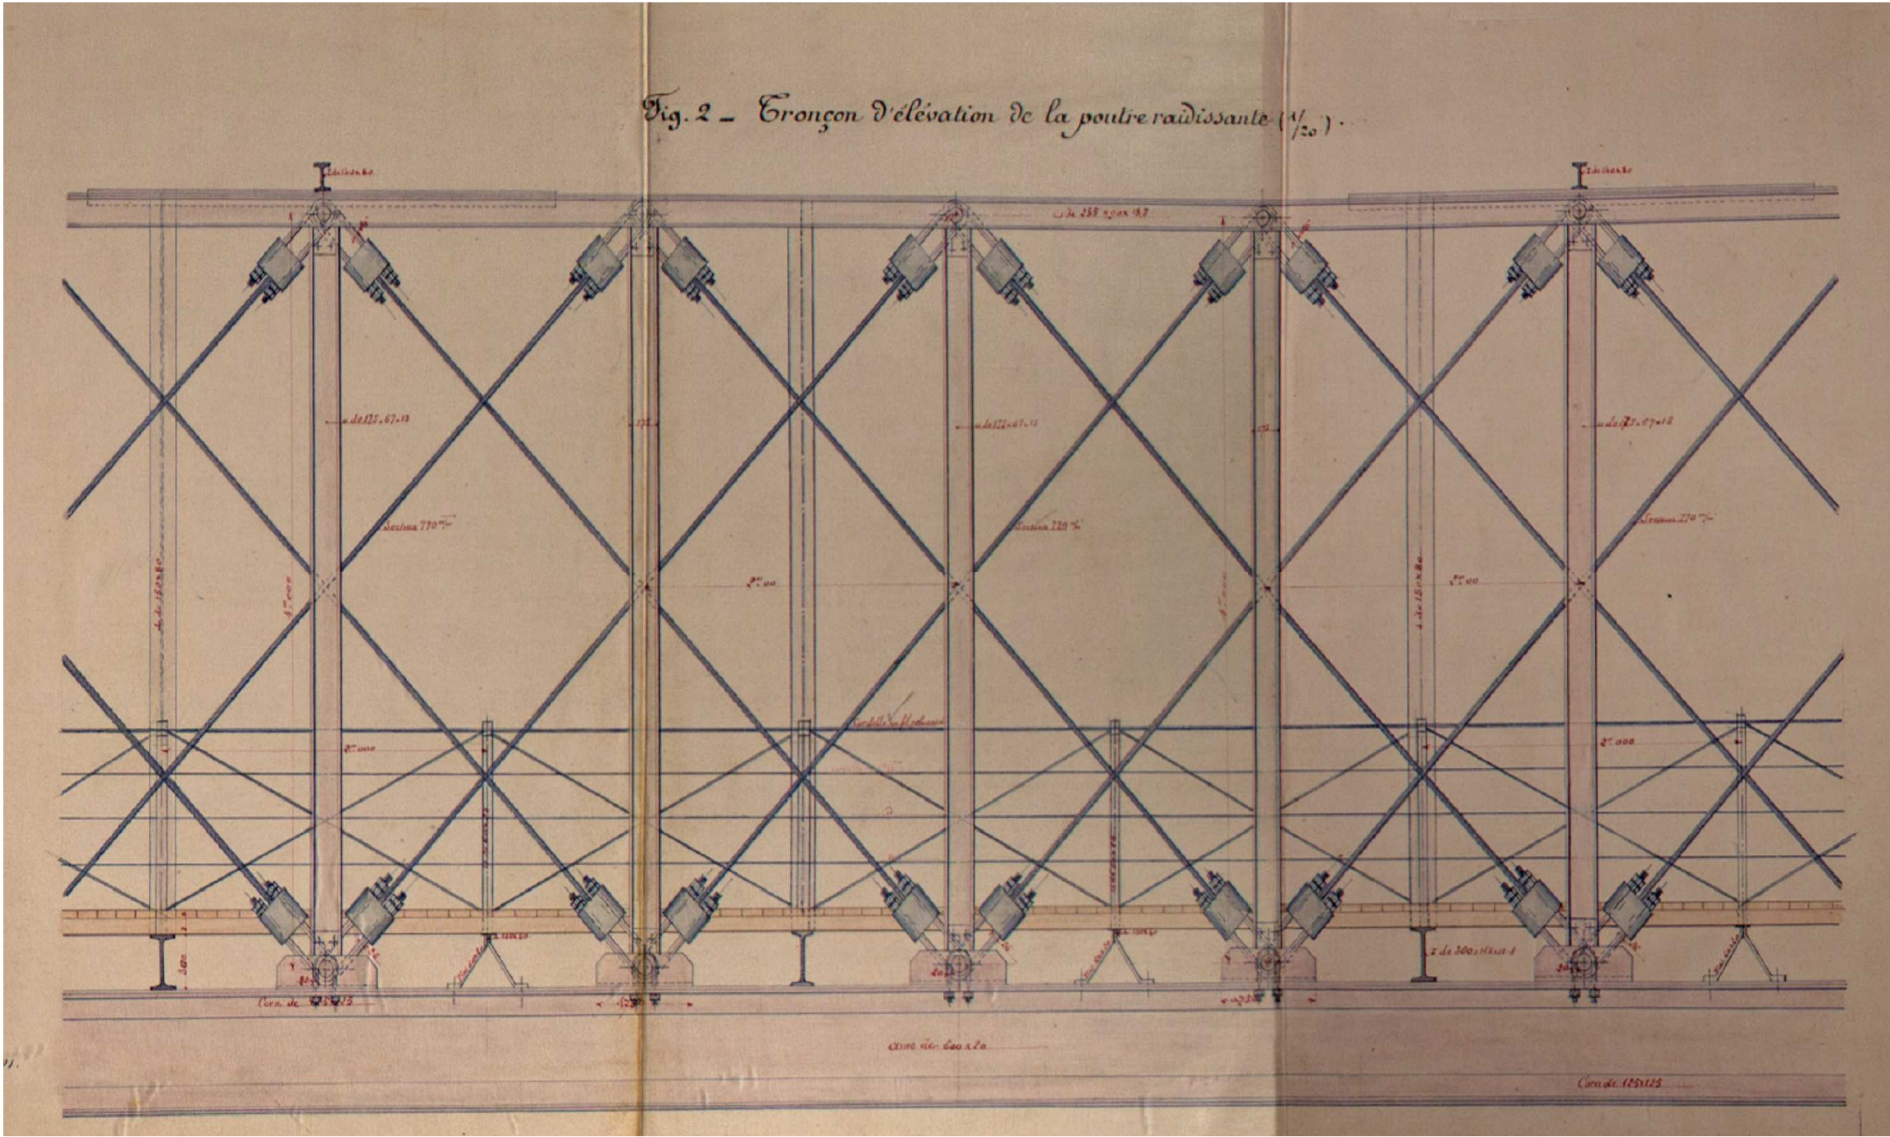
Existing Drawing Extract on Typical Repair Locations
