Bridge GA
SCALE: 1:100

Project: **Newport Transporter Bridge**

Orig Title: **East Landing Bridge GA**

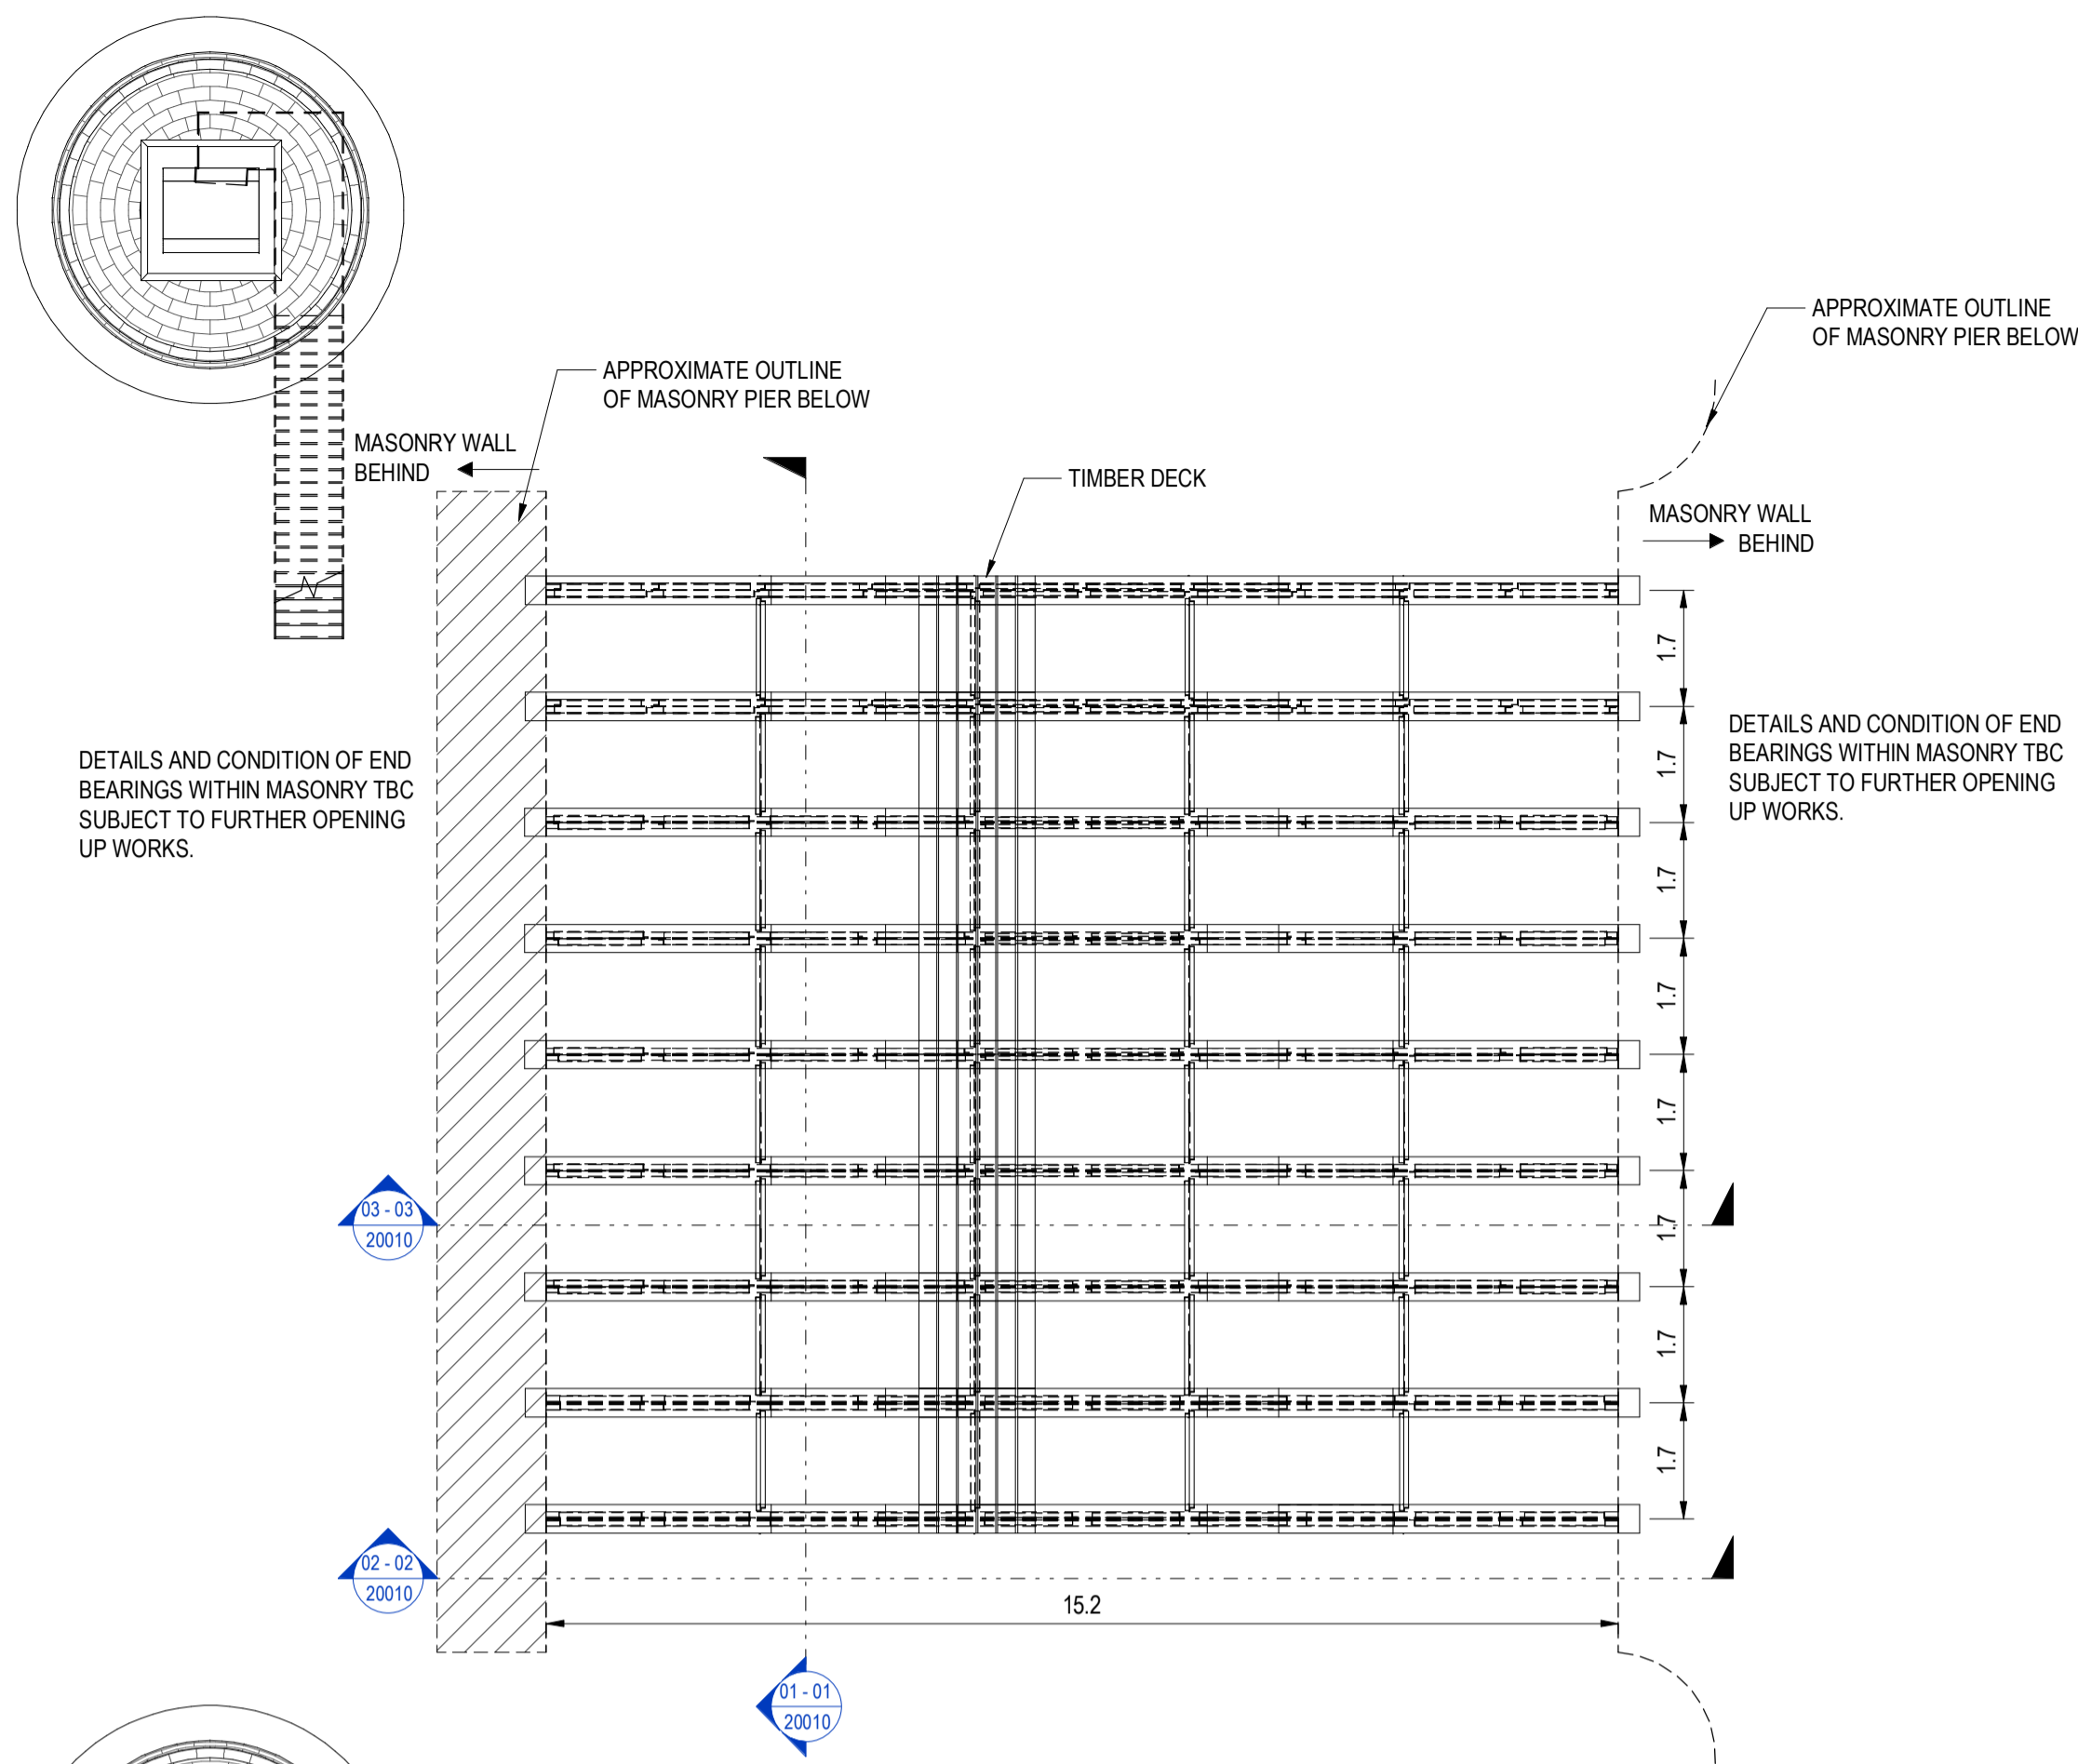
- - NEW STEELS
- - EXISTING STEELS FORMED INTO 4 REFURBISHED MEMBERS

REFER TO STRATEGY, REPAIR JUSTIFICATION AND PROPOSAL NOTES

1. Remove all timber decking members and set aside for reuse.
2. Remove masonry to East & West end bearings to allow full inspection of truss ends.
3. Blast clean existing steelwork in-situ with sufficient containment to prevent loss of arisings into local environment.

4. Undertake thorough inspection of all elements to determine extent of corrosion and section loss throughout with an aim to identifying the extent of material to be reused. This is to be logged via marking plans and photographic evidence throughout.

5. Remove all primary steelwork elements; this should be undertaken by removal of a singular beam in its entirety or by partial removal of sections via breaking out of riveted connection points to be agreed with the engineer.

6. For the refurbished members the elements identified as suitable for reuse as item 4 should be utilized to replicate the structural arrangement, section sizes and dimensions of the original construction. Connections will be formed via dome headed standard or TCB bolts to replicate as much as possible the existing riveted details. It is envisaged that this will allow for the 4 refurbished elements to be constructed.

7. For the remaining 5 internal elements new trusses are to be fabricated which as closely as possible replicate the structural arrangement, section sizes and dimensions of the original construction. A typical layout with preliminary sections sizes have been present with final dimensions to be confirmed subject to final inspection of the existing construction.

8. Refurbished members are then to be placed at the outermost two members to the North & South of the Eastern approach to ensure that the most visible elements are visually unaffected by the works.

9. New members are to be placed within the remaining central locations, replicating the original arrangement.
10. Timber members are then to be reinstated over new and refurbished members with suitable waterproofing to underside to prevent trapped moisture. Fixing details for the timbers over are to as closely as possible replicate the existing condition, however previous installations need to be investigated for suitability.

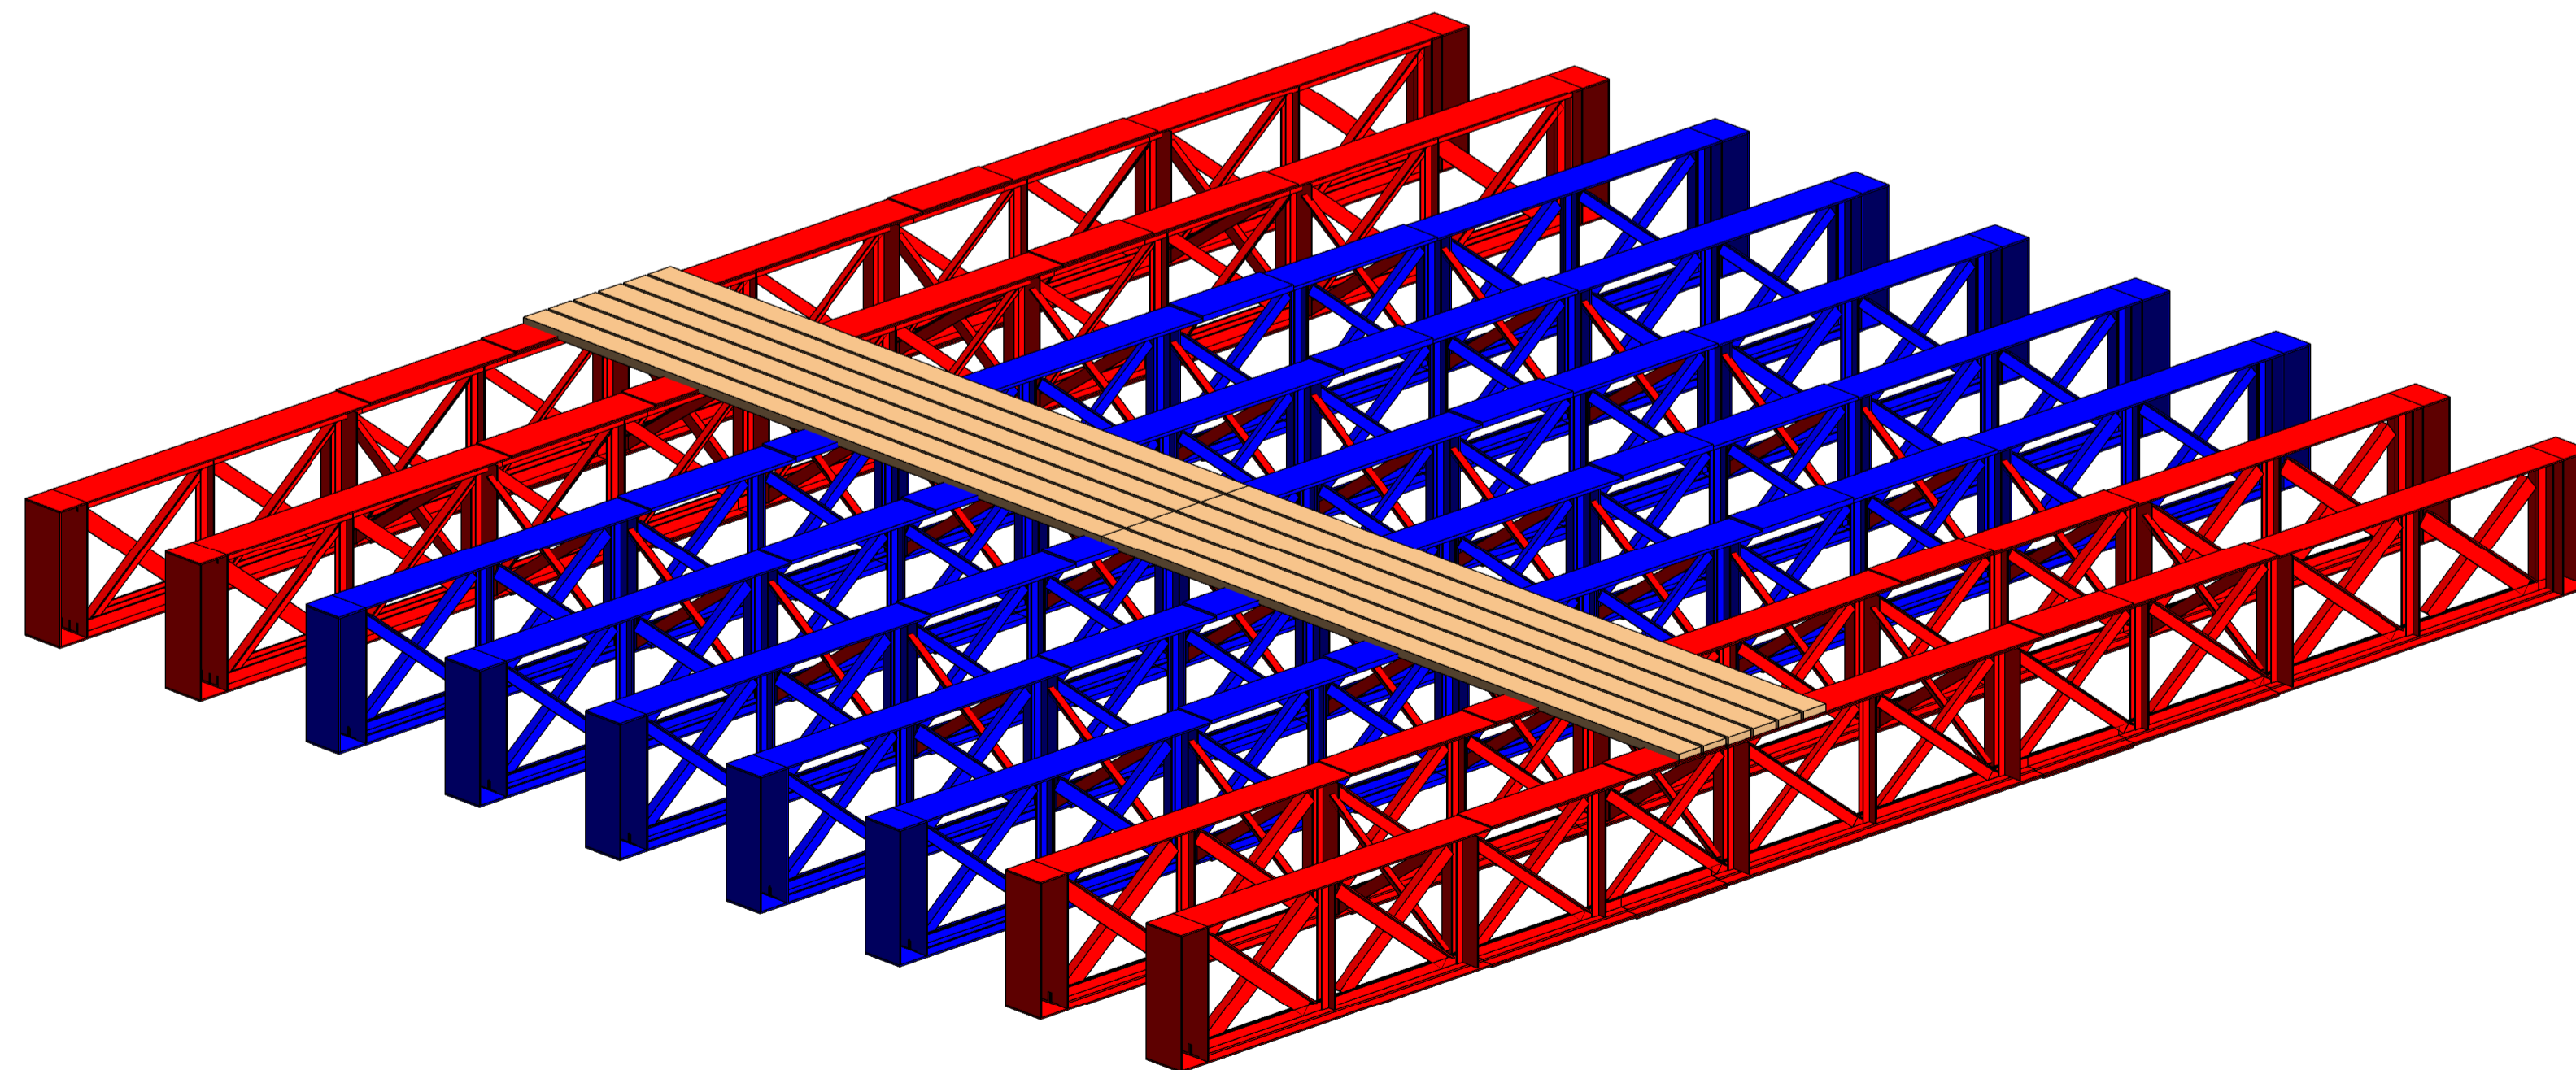
Location	Approach
Orientation	East
Element	Multiple

Bridge Beams 3D View
SCALE:

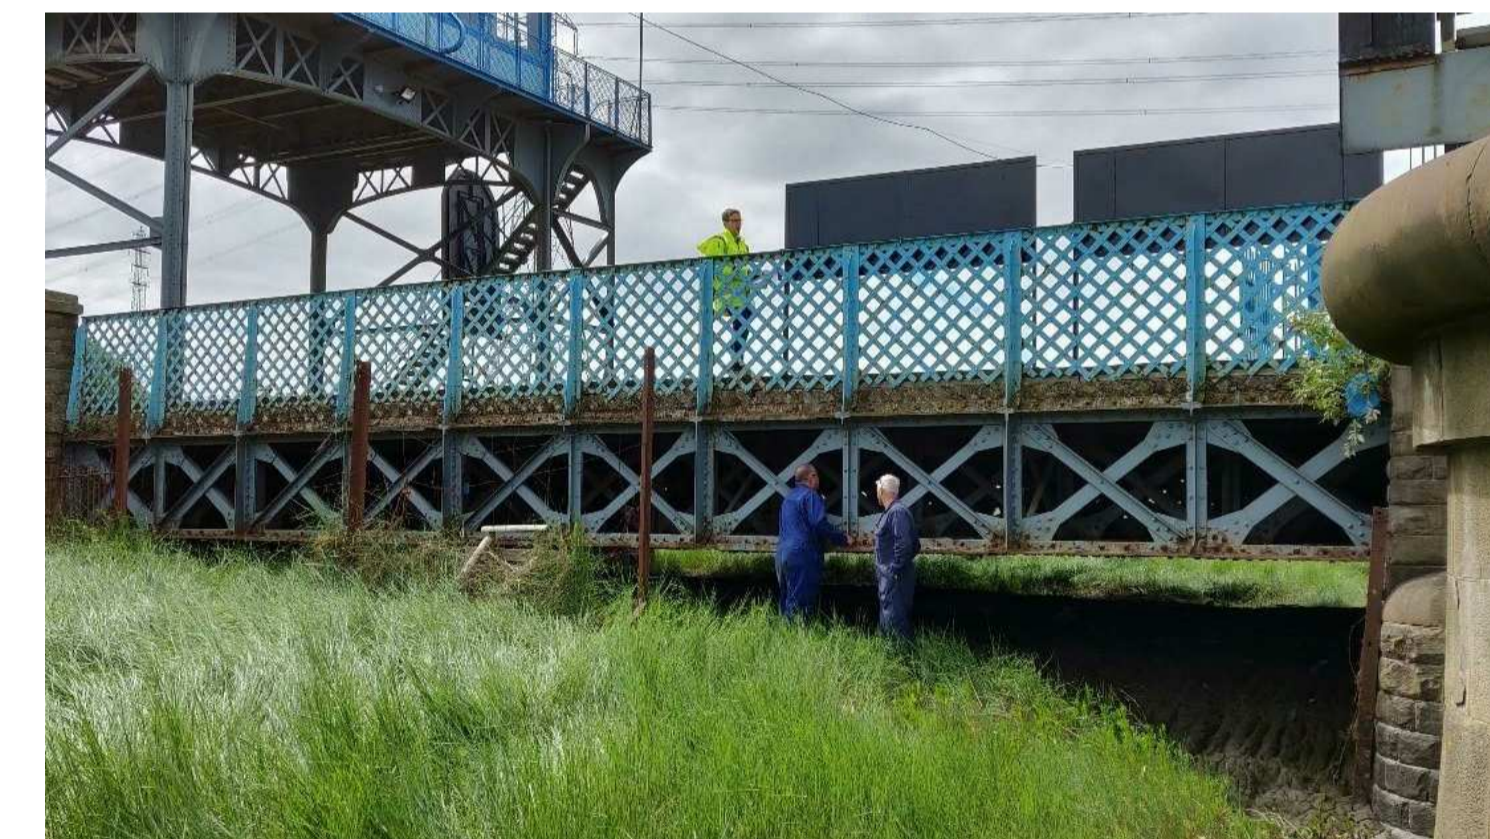
The information within this page provides a view on the extent of the Eastern bank approach structure. Although not exhaustive the typical conditions of primary elements are described briefly below;

Bottom Chord Steelwork – Paint loss and heavily corroded steelwork with some total section loss to Southern extent. Multiple failure of rivets within connections to vertical steelwork.
Top Chord Steelwork – Paint loss and heavily corroded steelwork with major section losses to Northern and Southern extents. Multiple failure of rivets with connections to vertical steelwork.
Vertical Steelwork – Paint loss minor corrosion throughout with some examples of 50% section loss. Multiple failure of rivets with connections to top and bottom chord steelwork.
Cross Bracing – Paint loss and minor corrosion throughout with some example of 50% section loss.
Masonry Embedment – The end bearing to the East & West extents of the trusses is formed via embedment within the masonry embankment construction and are at high risk from uncontrolled corrosion. At present the condition of steelwork within these embankments cannot be fully assessed but poses a major risk to the wider structure.

The approach is a highly visible element and is one of the first interactions with the bridge from the Eastern bank. The structure is also of vital importance for the long-term life of the structure providing support of pedestrians and vehicle access and egress onto the bridge. In the short term as part of the reopening of the structure it is likely to be at its most heavily loaded and its condition and capacity is therefore of vital importance. In its current condition the residual strength cannot be assessed appropriately due to the extent of corrosion, section loss and failure of rivets.

Options such as strengthening plates, although feasible do not offer a long-term viable solution and are likely to add significant weight to the structure without guaranteeing long term structural performance. Likewise, wholesale removal and replacement pose a risk to the heritage of the structure in terms of visual, cultural and historic structural standing. In order to maintain long term structural integrity and performance of the structure it is therefore proposed that the following works are undertaken;
