## Compliance Assessment Report CAR\_NRW0037934

**Permit being assessed:** JB3036RA.

For: Pen Y Wain Farm, held by A Q A ( Cardiff ) Ltd

**Type of assessment carried out:** Site Inspection, Reason: Routine.

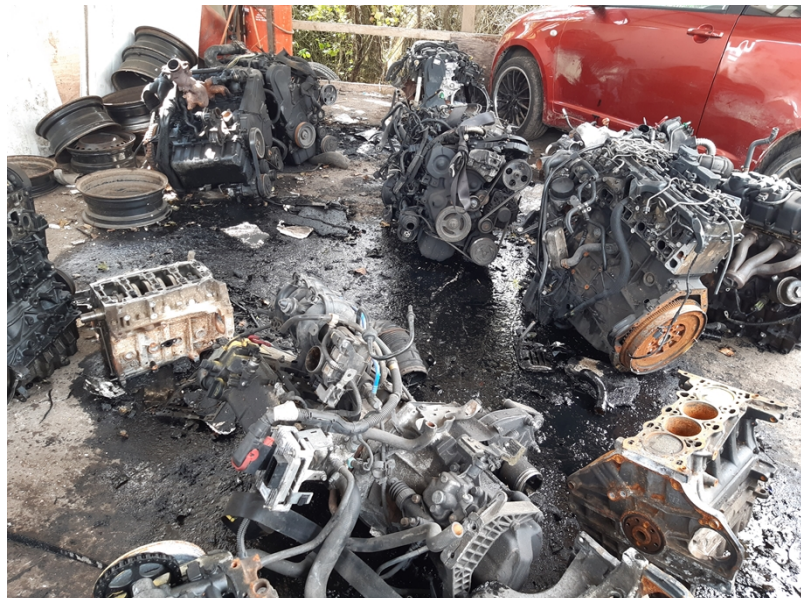
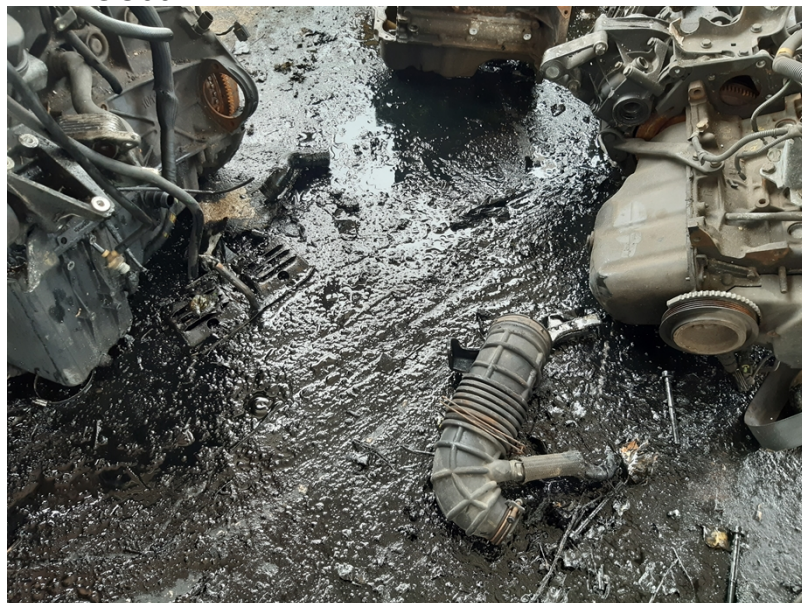
CC & GC walked through the Marshfield Motors garage and into the rear of the garage into AQA's section of the workshop. Two vehicles were being de-polluted at the time of the inspection. Officers walked out of the workshop into the rear yard and noticed that there were a number of engine blocks stood out under the lean-to shed on the right hand side of the yard. The engine blocks were stood in an oily puddle that was not contained or being treated with spill granules or sawdust and are pictured below:

1. The oil spilled around the engine blocks and the brake fluid spilled by the skip were to be urgently treated with spill granules and swept up for correct disposal with hazardous waste
2. The tyres and waste that were in the reën and along its banks should be removed and stored / disposed of correctly on site
3. The fence alongside the reën to be replace as soon as possible to prevent further waste escaping from site
4. AQA to submit hazardous waste returns and quarterly waste returns within the next two weeks

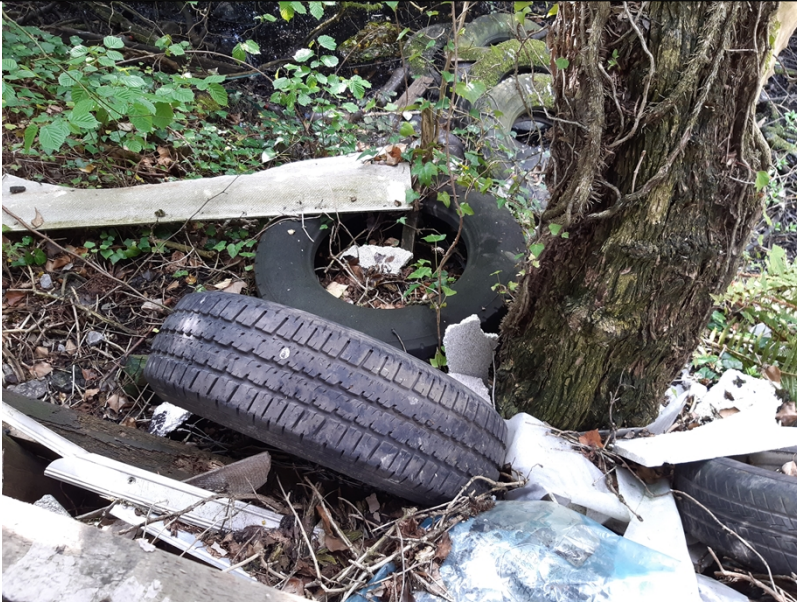
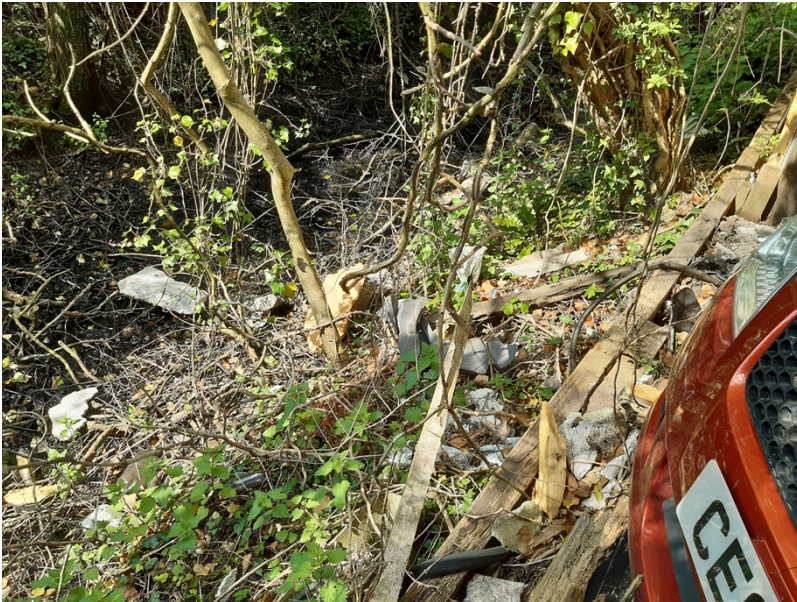
During the inspection Officers found that waste tyres and other car parts had spilled outside of your site both into the reën which runs to the south side of your premises. Because there was not suitable secure boundary fencing in the area of the lean to shed these items were not being stored on the hardstanding specified. Officers also found spilled oil and brake fluid which were not being treated as required by your spill procedure at the time of the inspection. You were given a Category 3 breach for this condition of your permit for wastes not being kept in accordance with Table S1.1 of your permit.

Beyond the engine blocks the officers noted a large gap in the fence and went forward to check the site perimeter and security. A reën runs along the southerly edge of the permitted area and a number of tyres and waste had fallen through the gap in the fence and were in the reën and on its banks as pictured below:

| Criteria | Action needed | Complete by |
|---|---|---|
| B4 | Operator is required to remove all tyres and waste from the ree and its banks and place them in appropriate containment ready for disposal or recycling.<br><br>Operator to repair or replace damaged / missing boundary fencing to ensure that tyres, vehicle parts and waste remain on site and under their control at all times | 25/06/2021 |

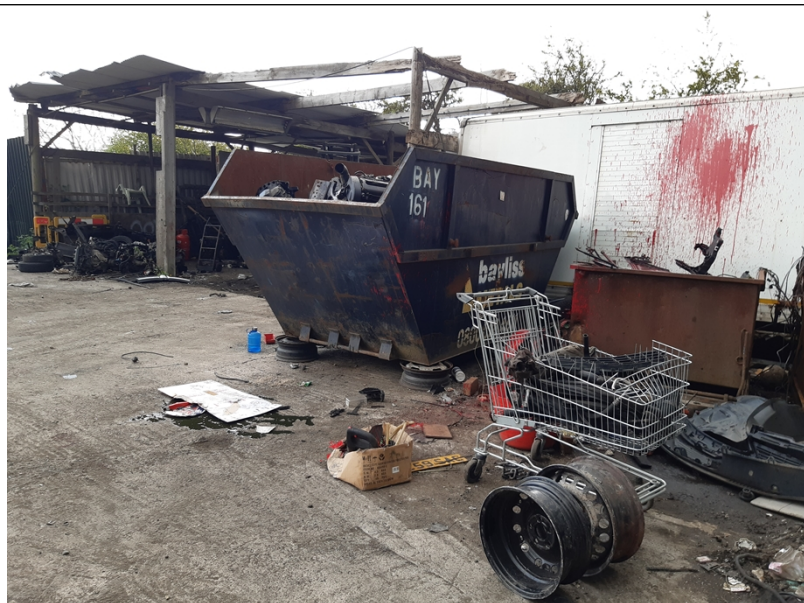
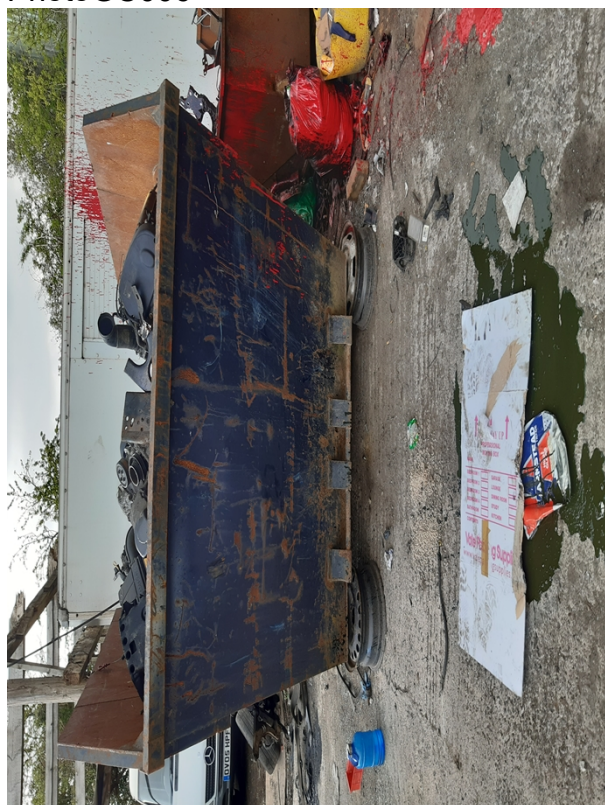
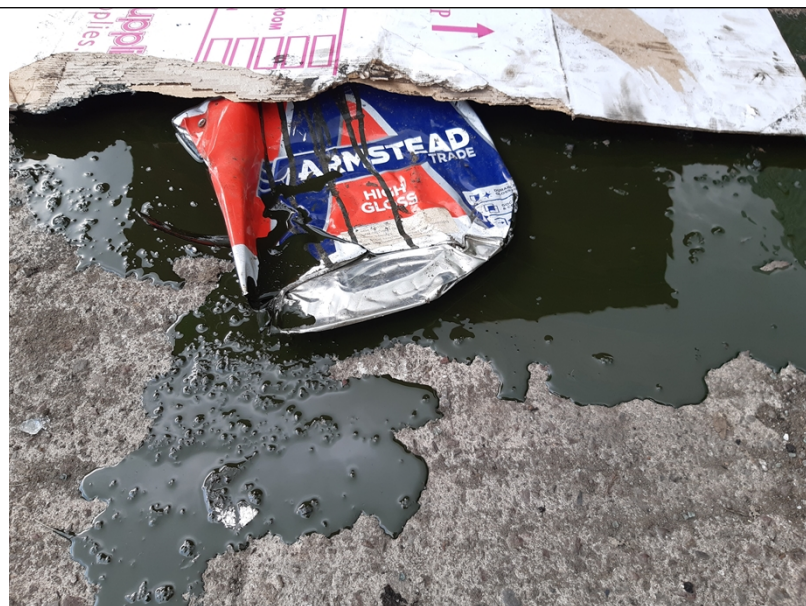
A Bayliss Metals skip was situated in the yard, to the front of the skip Officers observed a puddle of brake fluid which was not being treated with spill granules or sawdust as shown in the photos below:

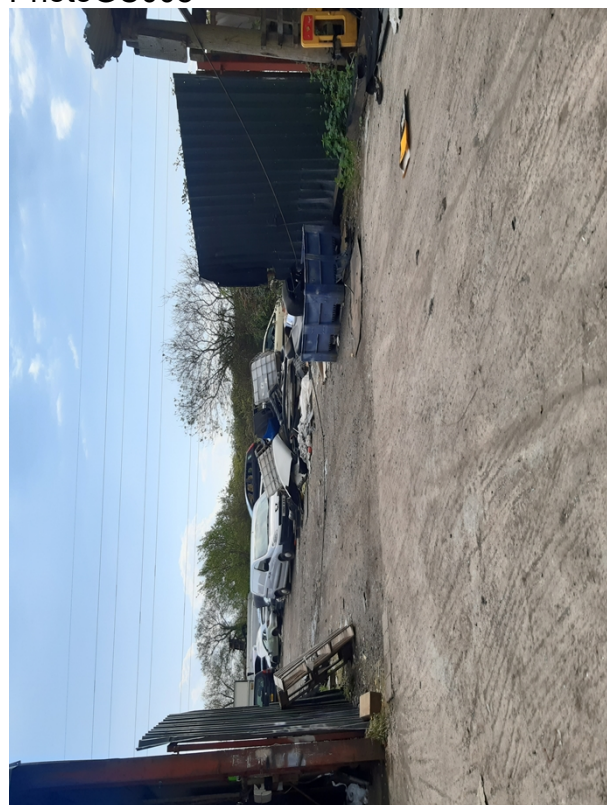
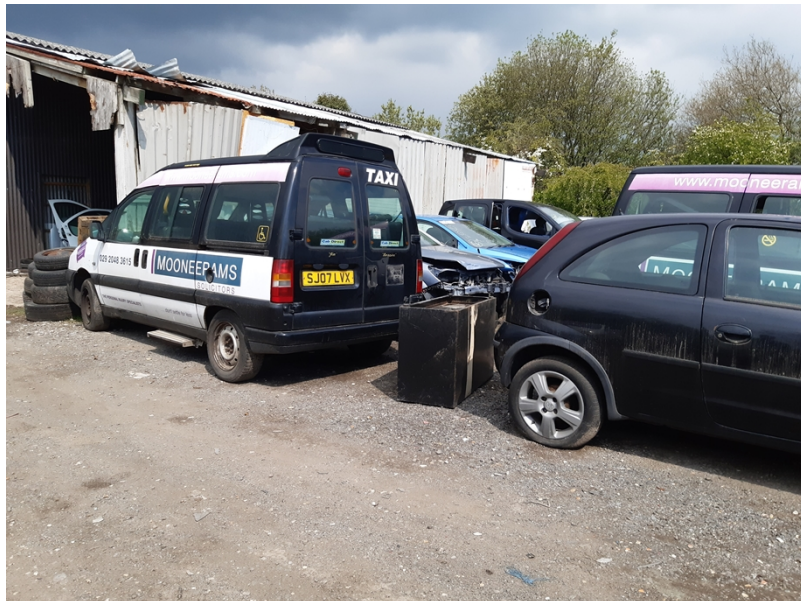
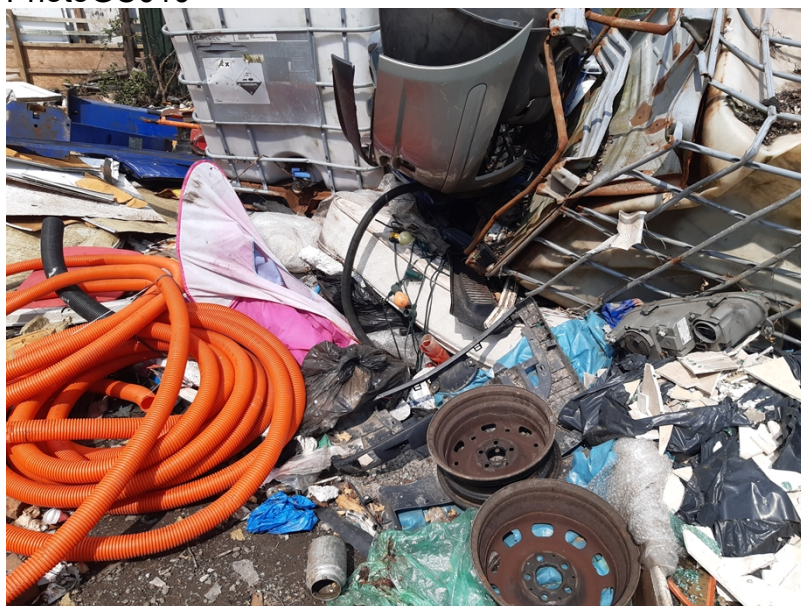
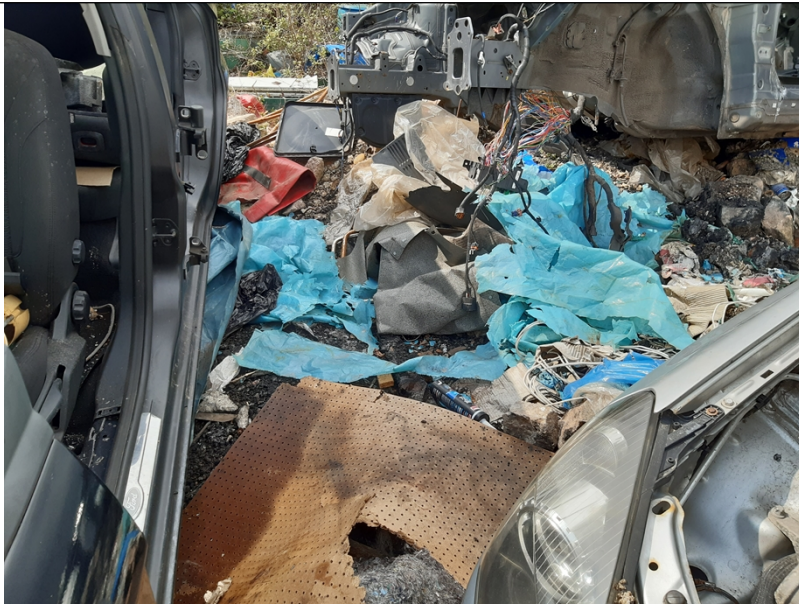
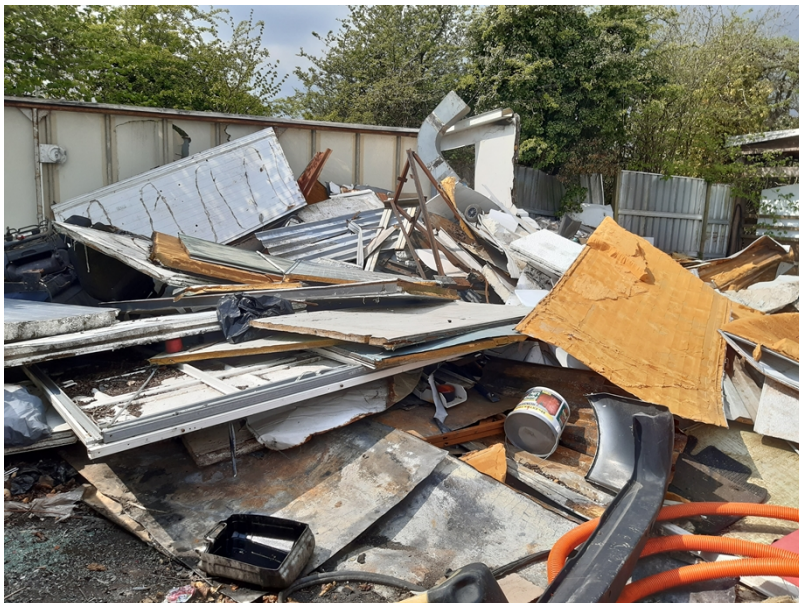
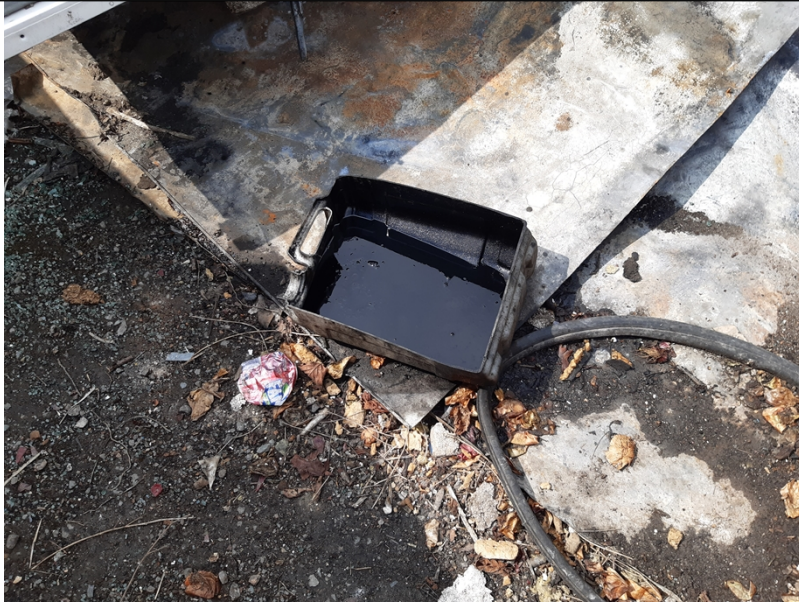
When asked about the vehicles, vehicle parts and other items you confirmed that you were operating your business in the red outlined area (shown in photos GC008 to GC013 below) with the agreement of your landlord Farid Akthar. Storing vehicles, vehicle parts or operating any of your permitted activities outside of the green edged area specified in Schedule 7 does not comply with your permit and you were given a category 3 breach under this condition.

Officers noticed that the gates at the rear of the yard were propped open and that there were many vehicles stored there along with a large quantity of waste materials and walked into this extension of the yard for a closer look. The waste comprised of construction type materials - broken brick, wall panels, stone, broken tiles, uPVC window frames along with household type items such as plastics, containers and a mattress plus commercial source items including as piping and IBCs. Interspersed with the waste were car parts and a open metal container containing waste oil. Photos of the waste and cars in the rear yard are pictured below:

Officers asked about the cars and the waste that were being kept in the rear yard and MA replied that the cars belonged to AQA and the waste had been put there by the landowner Mr Farid Akthar. MA explained that the waste came from the demolition of some offices and workshops on site arranged by Mr Akthar.

| Criteria | Action needed | Complete by |
|---|---|---|
| A1 | Operator must remove all vehicles, vehicle parts and wastes from the rear yard to within the green edged boundary shown at Schedule 7 of the permit. See Photos GC008 to GC012. | 25/06/2021 |

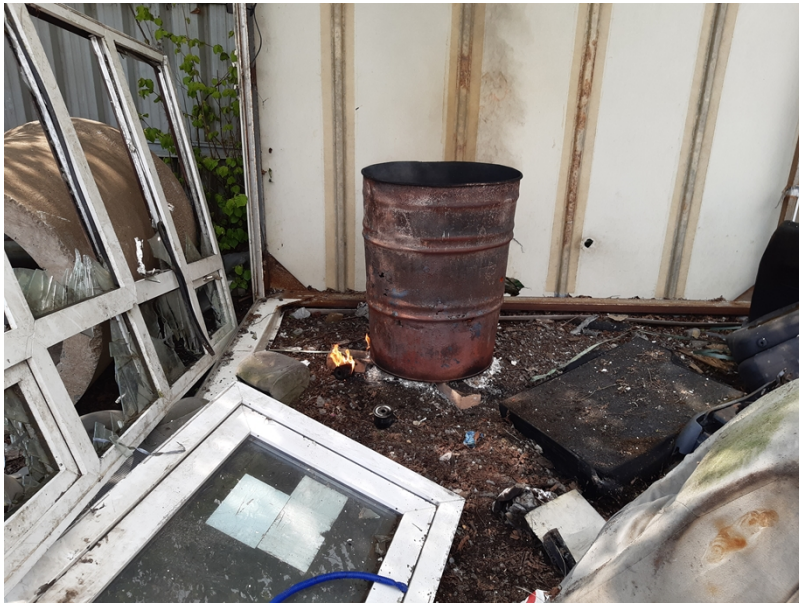
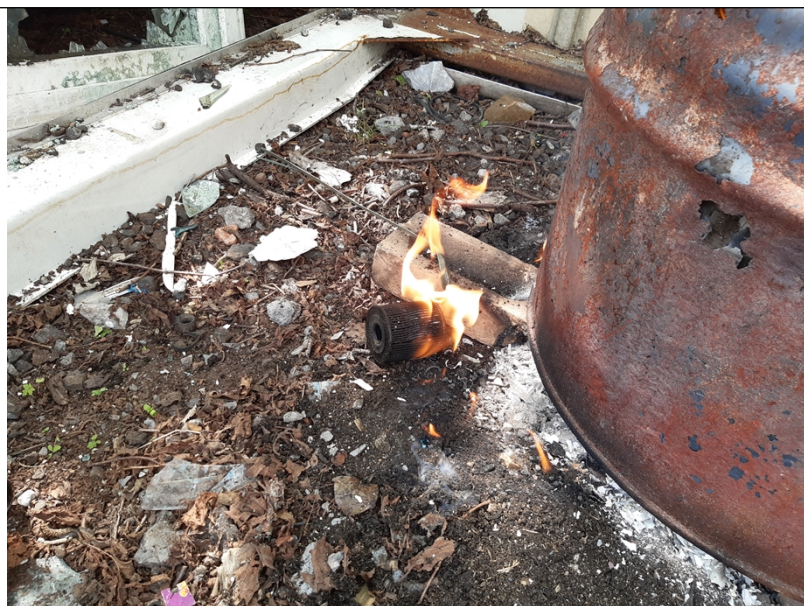
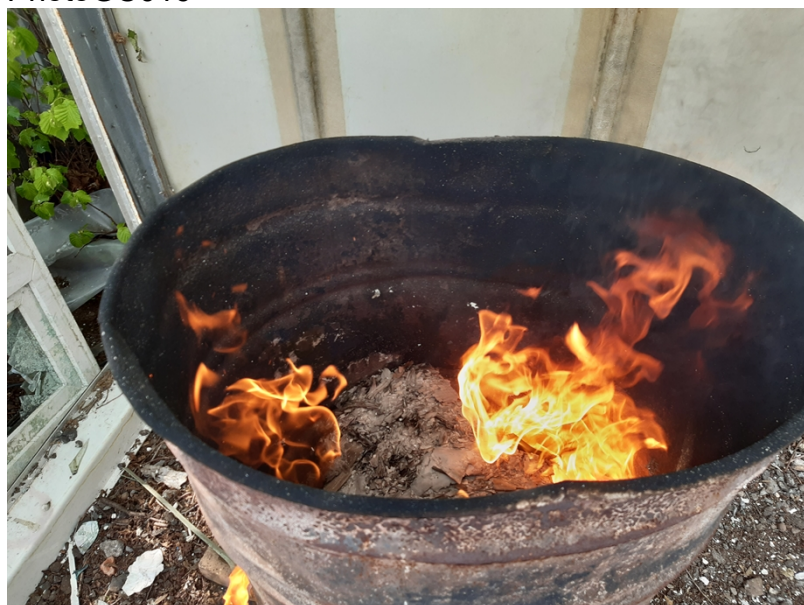
During the inspection Officers found that waste from your site was being burnt inside an incinerator drum at the rear of your premises. The waste being burnt included waste oil filters, which are hazardous waste, burning on the ground next to the drum. Photos GC014, GC015 and GC016 below show the waste being burnt. Burning is not a treatment operation that is specified in your permit and you have been given a Category 2 breach under this condition.

While looking at the cars and waste in the rear yard Officers smelt smoke and located a fire in a metal drum next to the fence behind the piles of waste and cars. The smoke coming from the metal drum was black and acrid and there was an oil filter in flames on the floor next to the drum. The fire drum is pictured below:

Shortly after the fire was discovered Mr Muhammad Ali (MA) returned to the site and Officers were able to ask him about site activities. Firstly MA was asked if he was aware of the fire to which he replied he was not and that he thought it might have been started by his staff who had newly started with his company. CC asked him to douse the fire and MA instructed staff to do this. Officers witnessed the fire being extinguished with a watering can of water.

| Criteria | Action needed | Complete by |
|---|---|---|
| E5 | Operator to stop all burning of waste and hazardous waste materials with immediate effect. Operator to produce detailed waste management plan showing all waste streams and their authorised disposal / recycling routes including spill containment procedures within 1 month. | 25/06/2021 |
