Project:  
**Aberaeron Geophysical Site Investigation**

Description  
**Geophysical Survey**

Project Number:  
**CS0590**

Document Type  
**Operations Report**

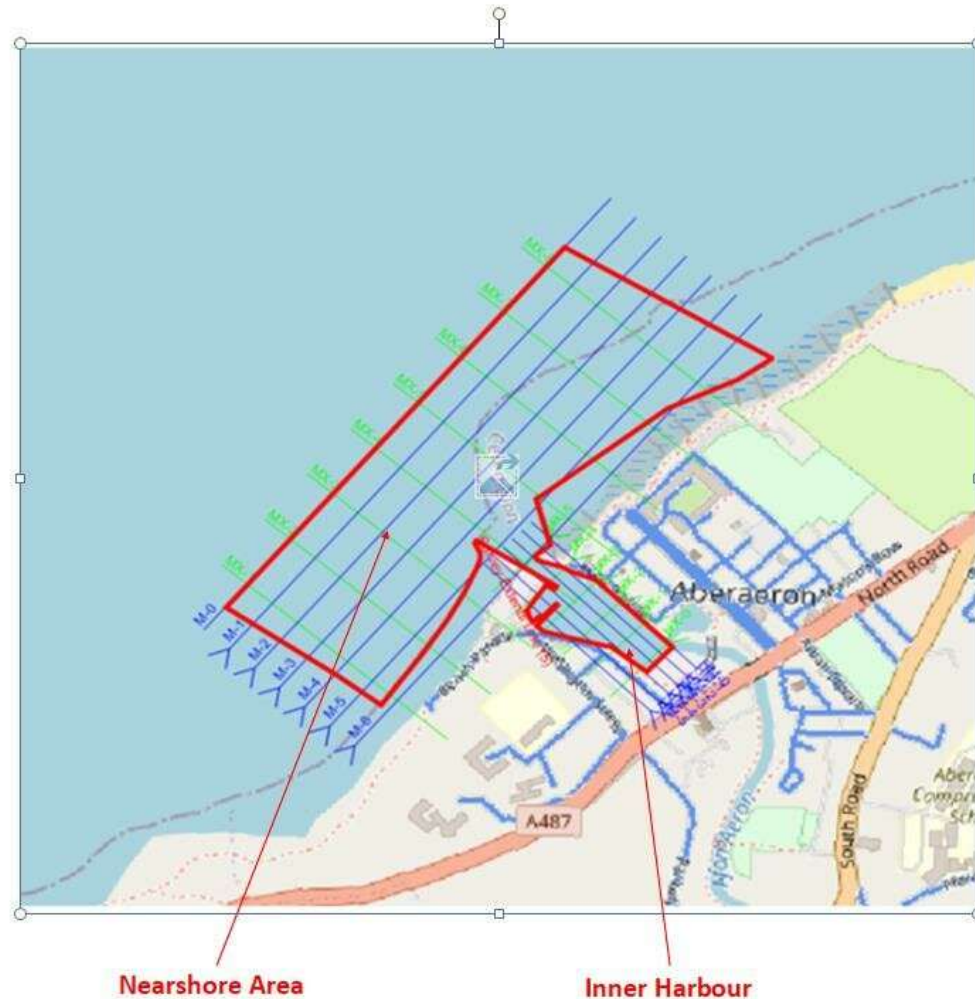
To complete the survey within the boundary provided by the client the area was divided into two sections, the inner harbour and nearshore area as defined in Figure 2.1.

**Figure 2.1 Overview of nearshore area, inner harbour area and line plans**

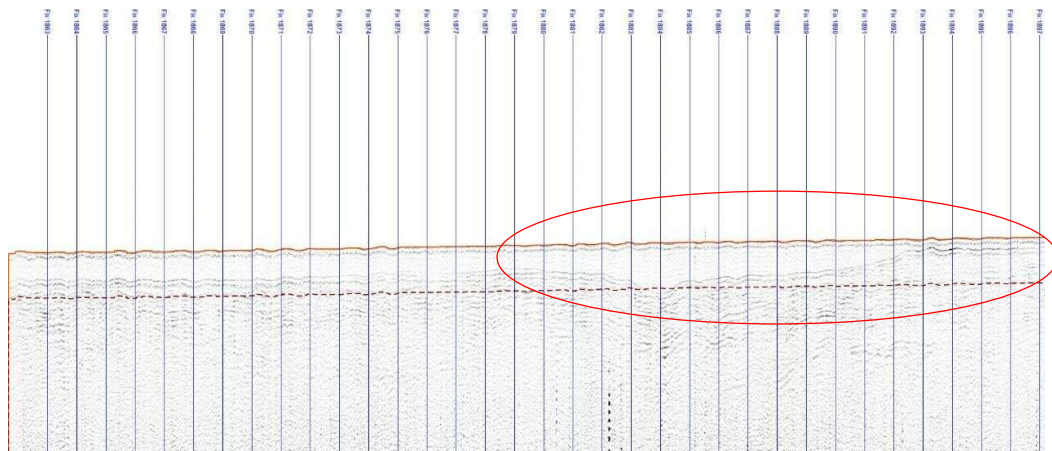
An SBP verification line was run offshore of the survey area to prove the system was operating correctly. The horizon below the surface horizon disappears the closer the vessel moves towards the shoreline where the seabed is formed by hard constituents. The results of the verification can be seen in Figure 5.2.

Figure 5.2 SBP Verification over a geological feature

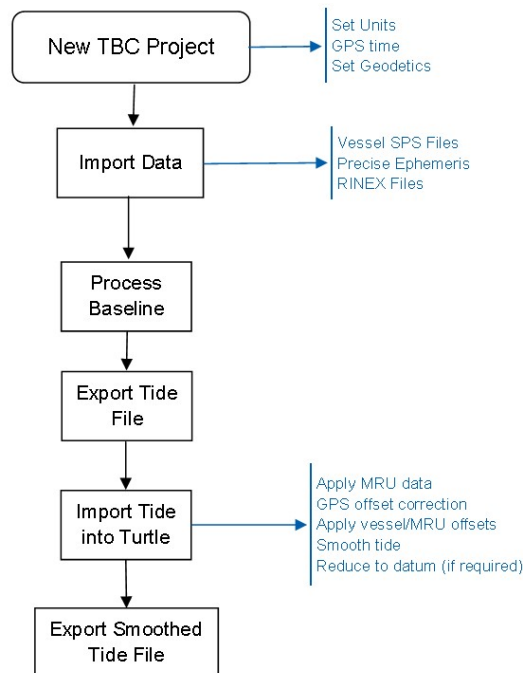
The processing workflow is outlined in Figure 6.1.

**Figure 6.1 PPK Processing workflow**

Titan processed observed tidal heights from the SPS system using Trimble Business Centre (TBC) to derive a PPK tide, which was later used to reduce bathymetry data to the specified vertical datum.

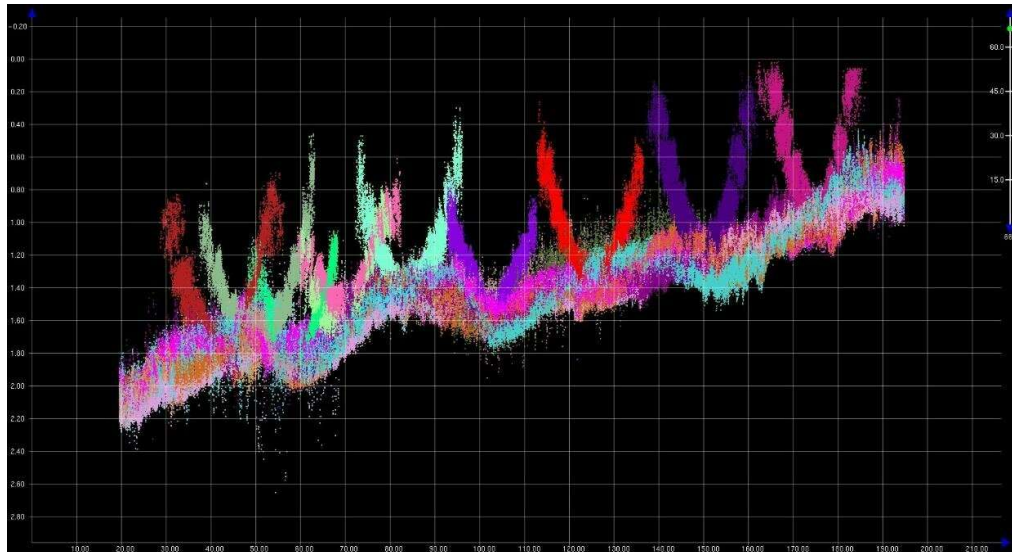
Sound velocity profiles were applied to the data before processing to correct for changes in sound velocity within the water column. Sound velocity was largely uniform outside of the harbour but changed rapidly on entering the harbour due to freshwater input of the Afon Aeron. This had a significant effect on bathymetry data collected within the harbour which resulted in the characteristic 'smiles' in the data shown Figure 6.2. This was corrected for within GS4 software.

**Figure 6.2 Inner harbour bathymetry data relative to the outer harbour bathymetry**

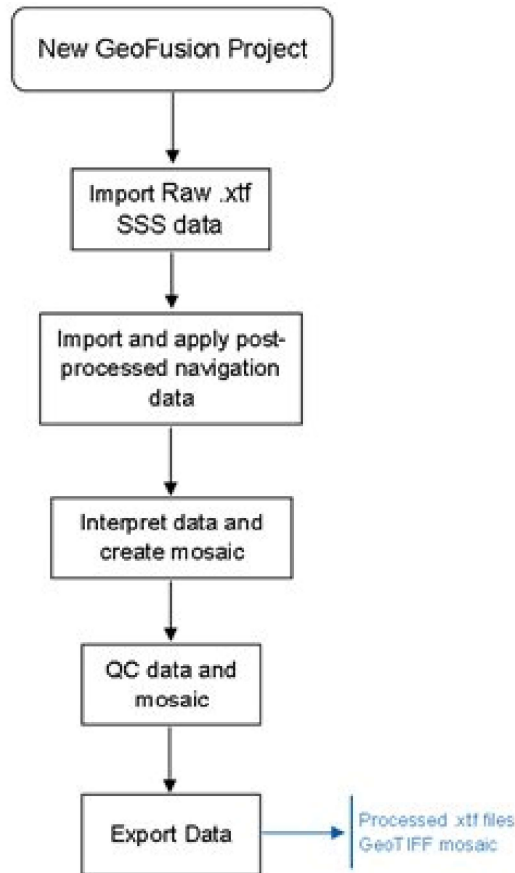
Figure 6.3 Sidescan sonar interpretation Workflow

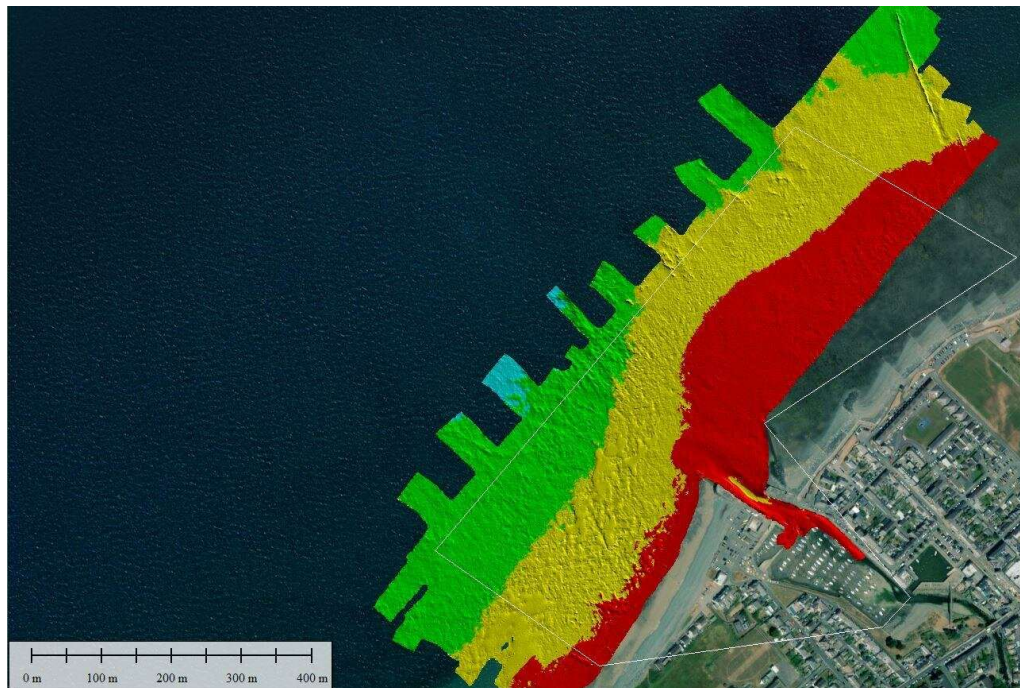
Figure 7.1 shows the full extents of MBES coverage relative to the survey area, and to the shoreline/inner harbour.

**Figure 7.1 Multibeam coverage overlay**

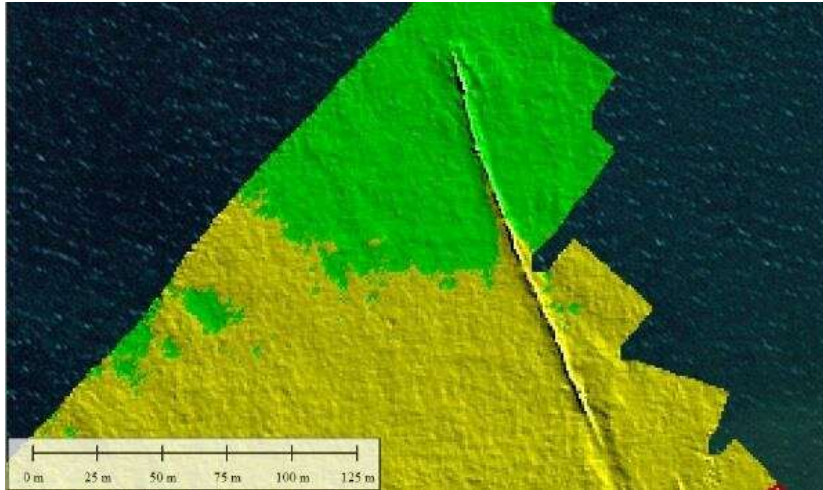
Seabed features were picked up well by the Geoswath system, further seen in Figure 7.1 and Figure 7.3, where nearshore groynes in the southern nearshore of the survey area, and a pipeline outfall can be seen to the northeast of the survey area respectively.

**Figure 7.2 Pipe Outfall**

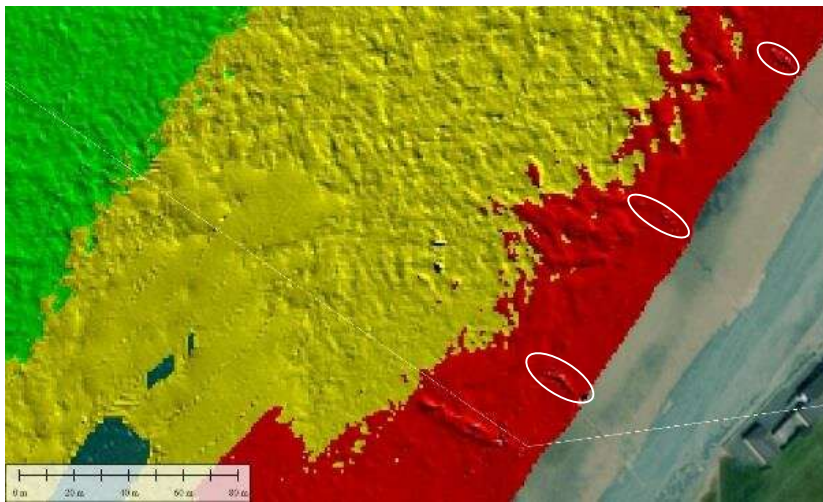
**Figure 7.3 Groynes in the nearshore**

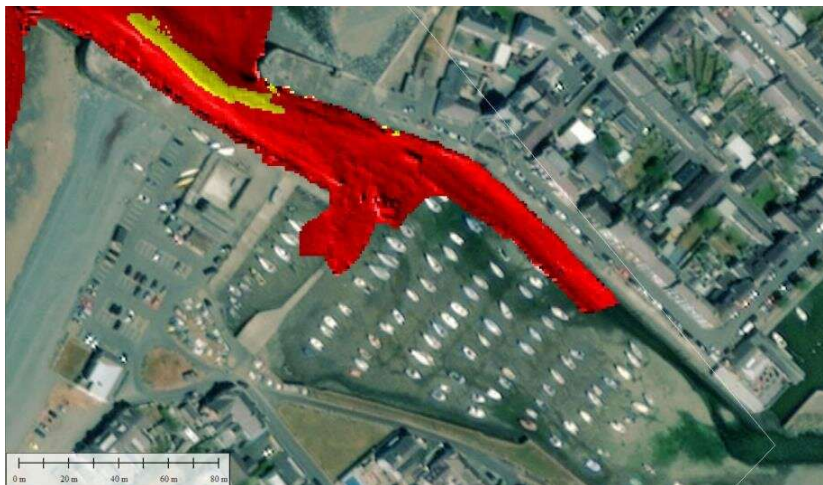
**Figure 7.4 Multi-beam coverage of the inner harbour**

Figure 7.4 illustrates the coverage achieved in the inner harbour. A slim strip of MBES data is sandwiched between the harbour wall and the mooring buoys. As mentioned previously, after this line was run, it was decided that the vessel could not safely collect any more data due to the close proximity of the buoys (denoted by the numerous sailing boats in the figure), the strong river flow and shallow water depths. No further data collection could be carried out around the boat launch also for these reasons.

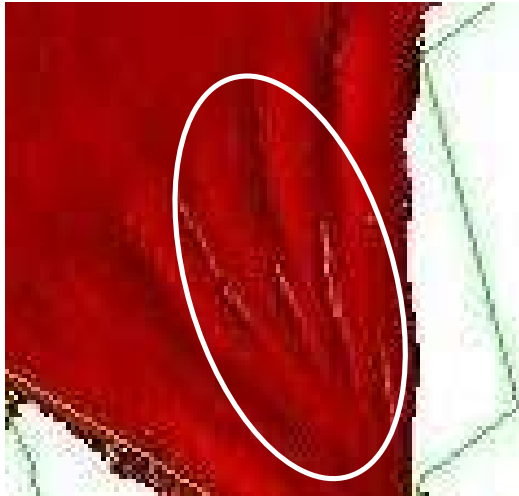
**Figure 7.5 Seabed sound velocity artefacts**

Figure 7.5 illustrates the strong effects of the freshwater input from the River Aeron on sound velocity in the water column. Taken from a raw MBES coverage chart and seen in the harbour entrance, the sound velocity changes rapidly from brackish to much more saline, which creates these false seabed features or 'smiles' that needed to be rectified during post processing.

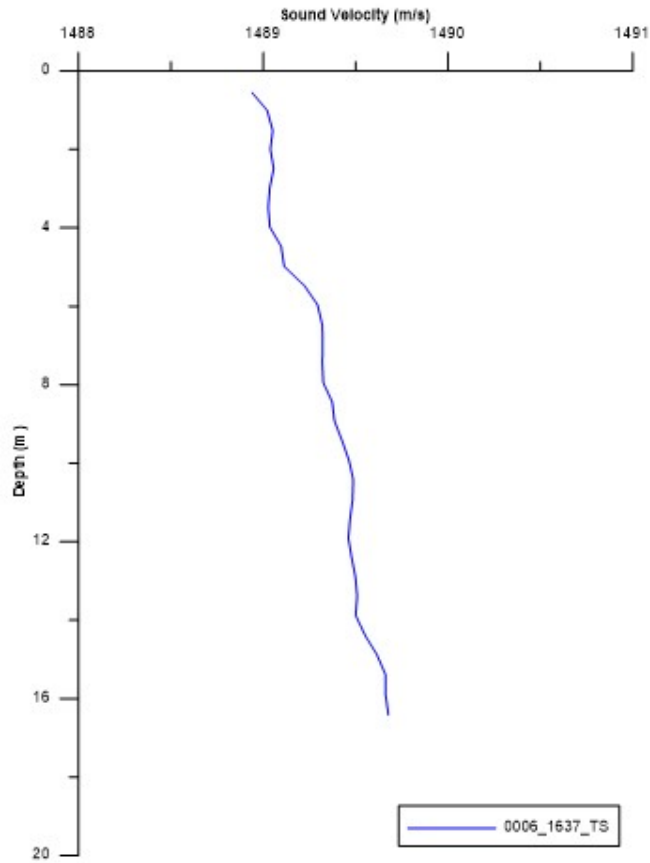
**Sound Velocity Graph**

A visual comparison was made between the data from the SVP and the value of the SVS positioned on the transducer head and both sets of data were found to agree to within 0.3 m/s.

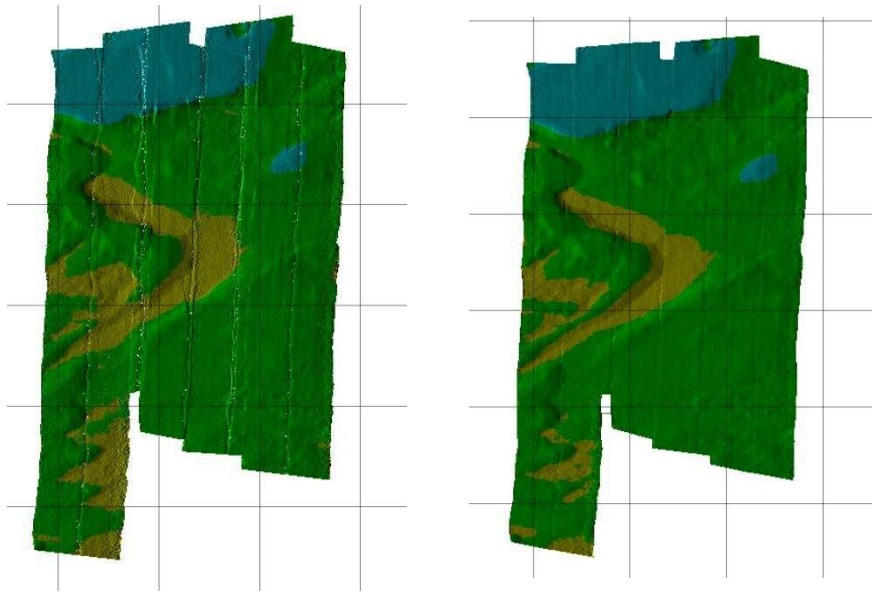
The patch test values were re-computed and applied to the Titan Surveyor GS4 MBES configuration. The GS4 MBES data collected during the patch test on 29/11/2020 was reprocessed with the patch test values with results shown below before and after application of the values.

Pitch and Yaw lines Pre-application and post application of the calibration results

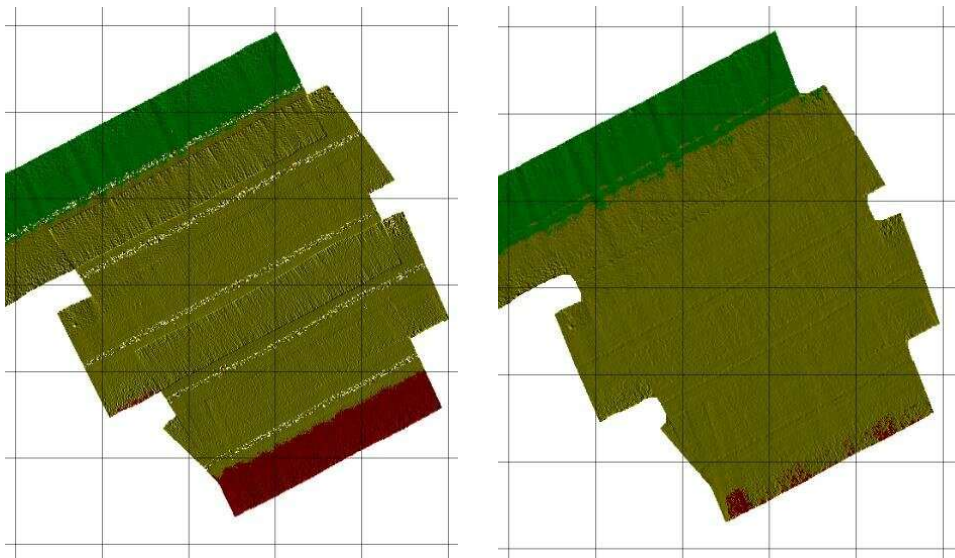
Roll lines Pre-application and post application of the calibration results

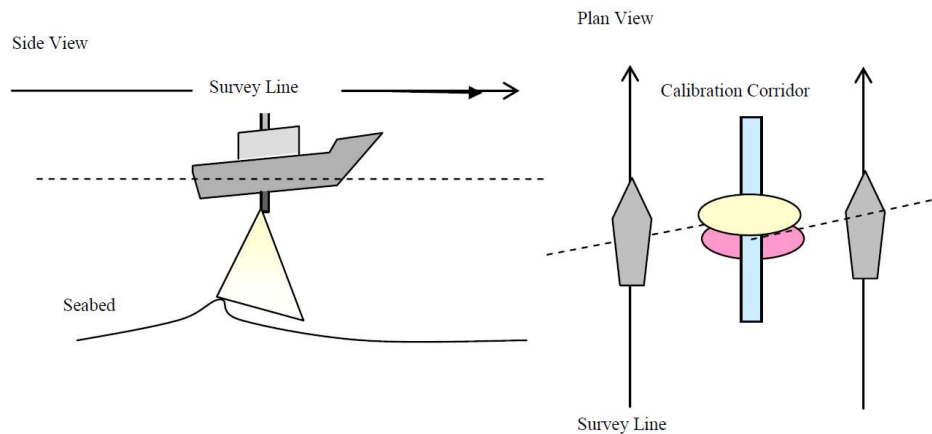
## Pitch Calibration

Pitch calibrations required the survey vessel to steam at constant speed along 3 to 5 parallel and adjacent lines over a well-defined feature to determine the effects on the transducer heads.

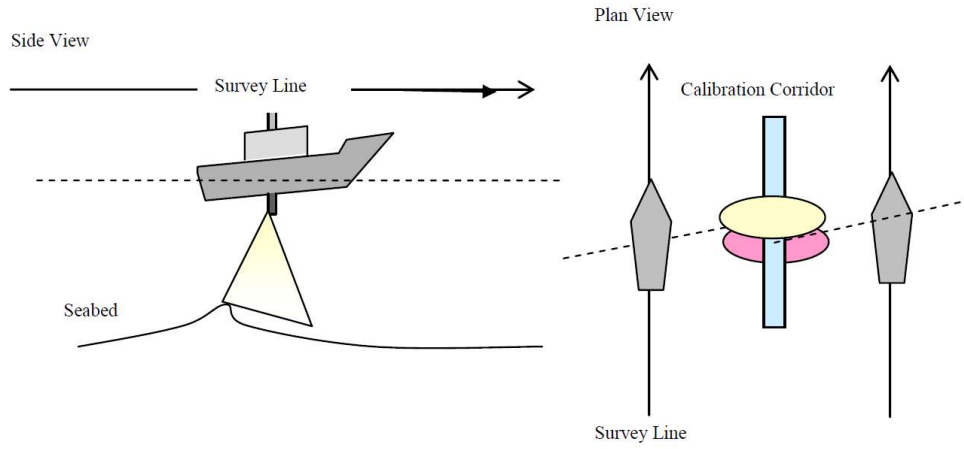
### Horizontal Alignment Error (Yaw)

Yaw calibrations required the survey vessel to steam at constant speed along three parallel and adjacent lines over a well-defined feature to determine the effects on the transducer heads.

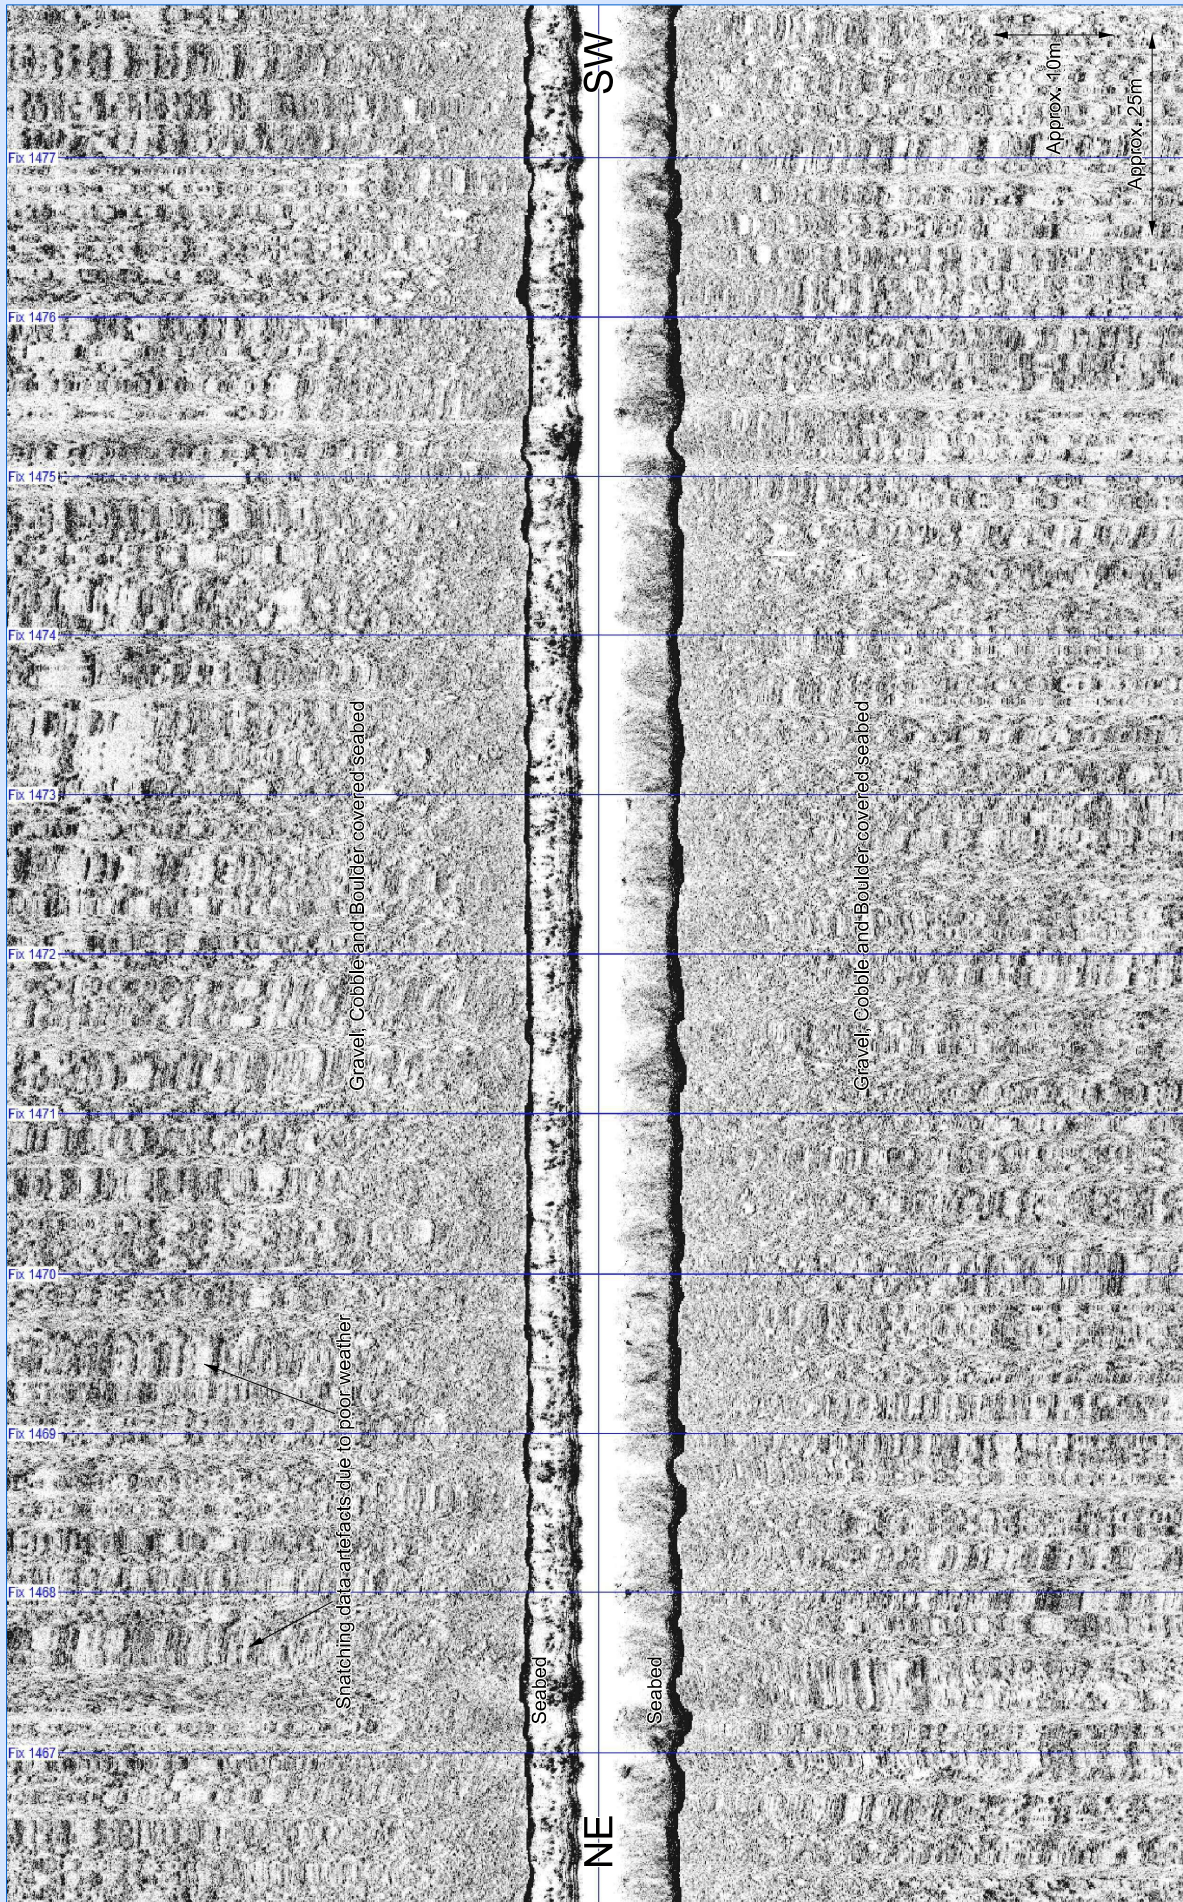
Figure 1.1

SIDE SCAN SONAR  
Illustrating Gravel, Cobble and Boulder sediments

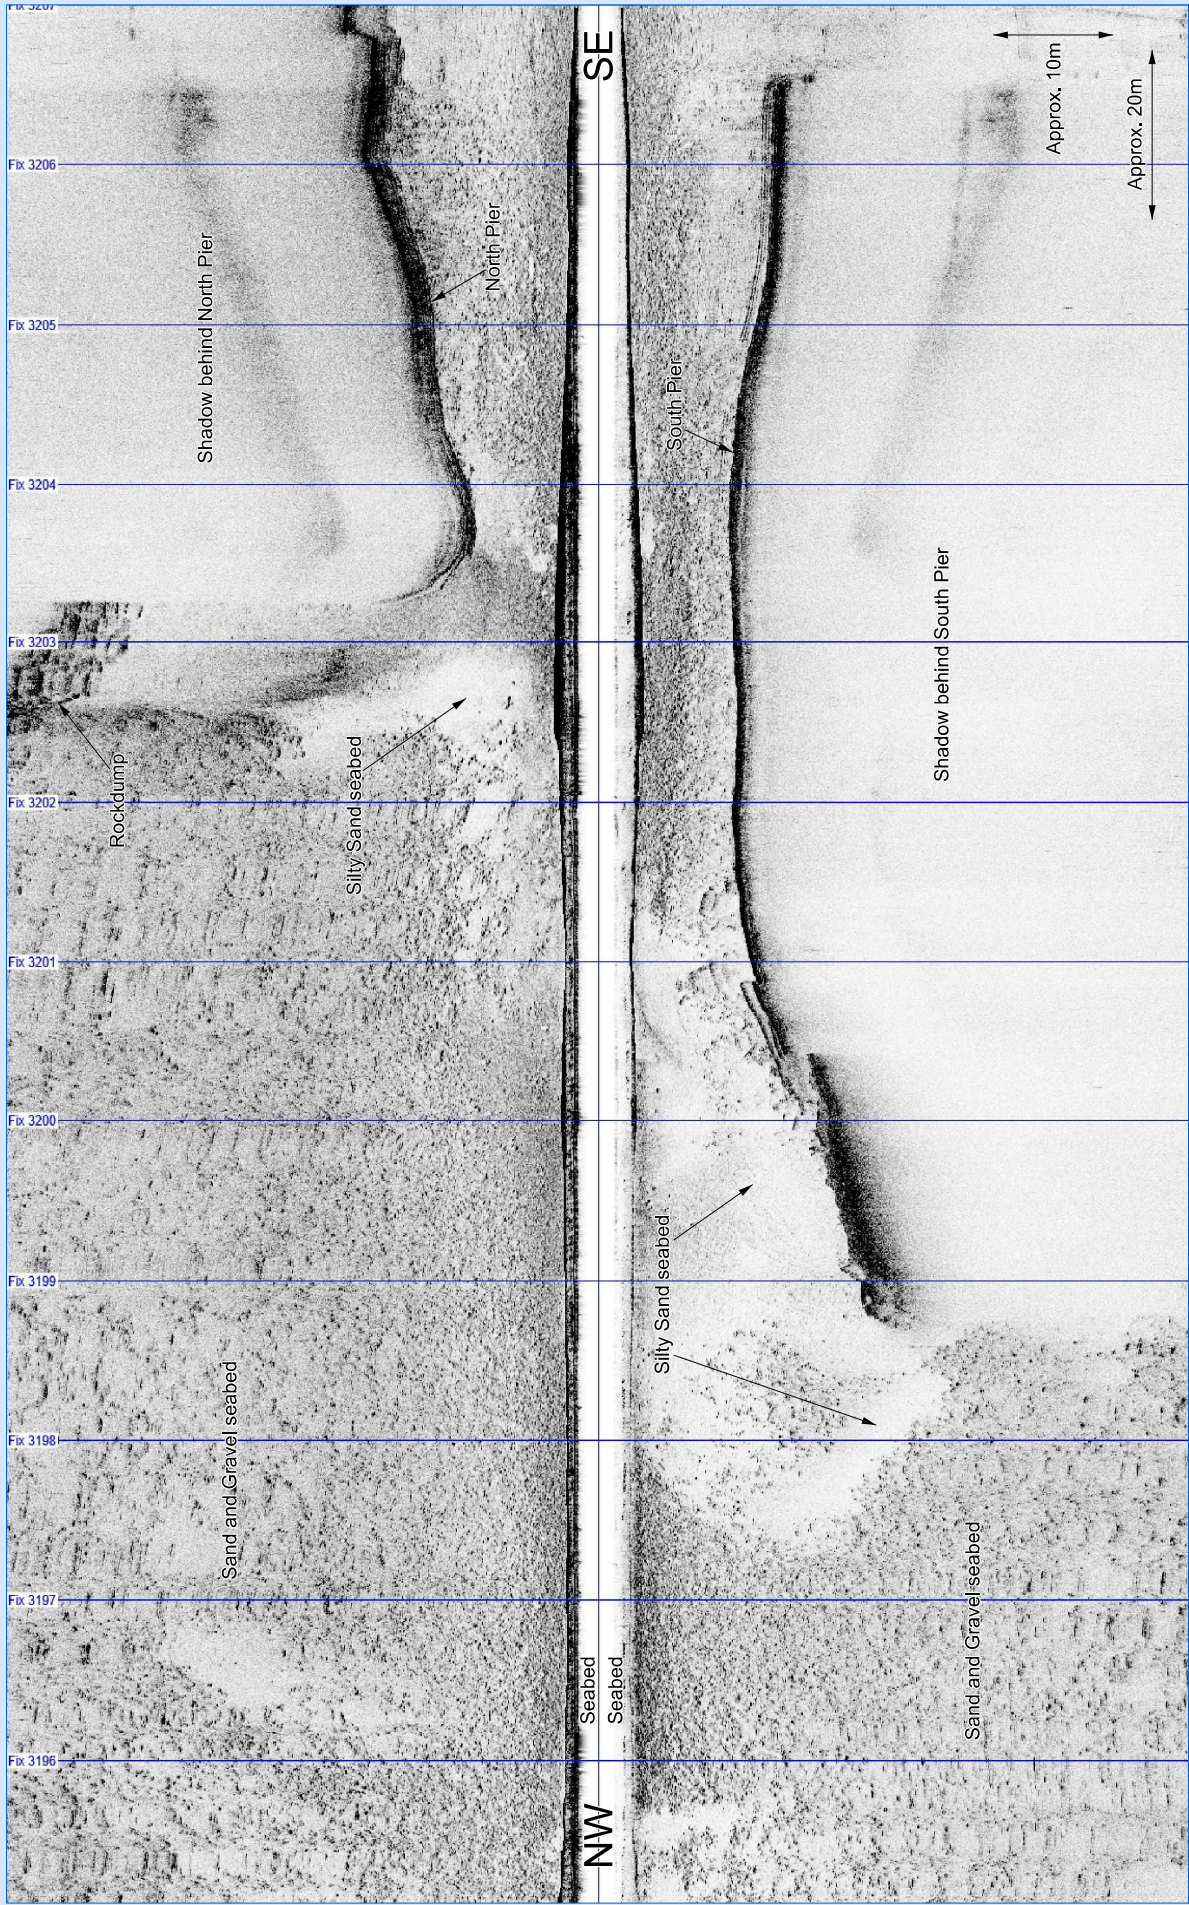
Figure 1.2

SIDE SCAN SONAR  
Illustrating Silty Sand sediments

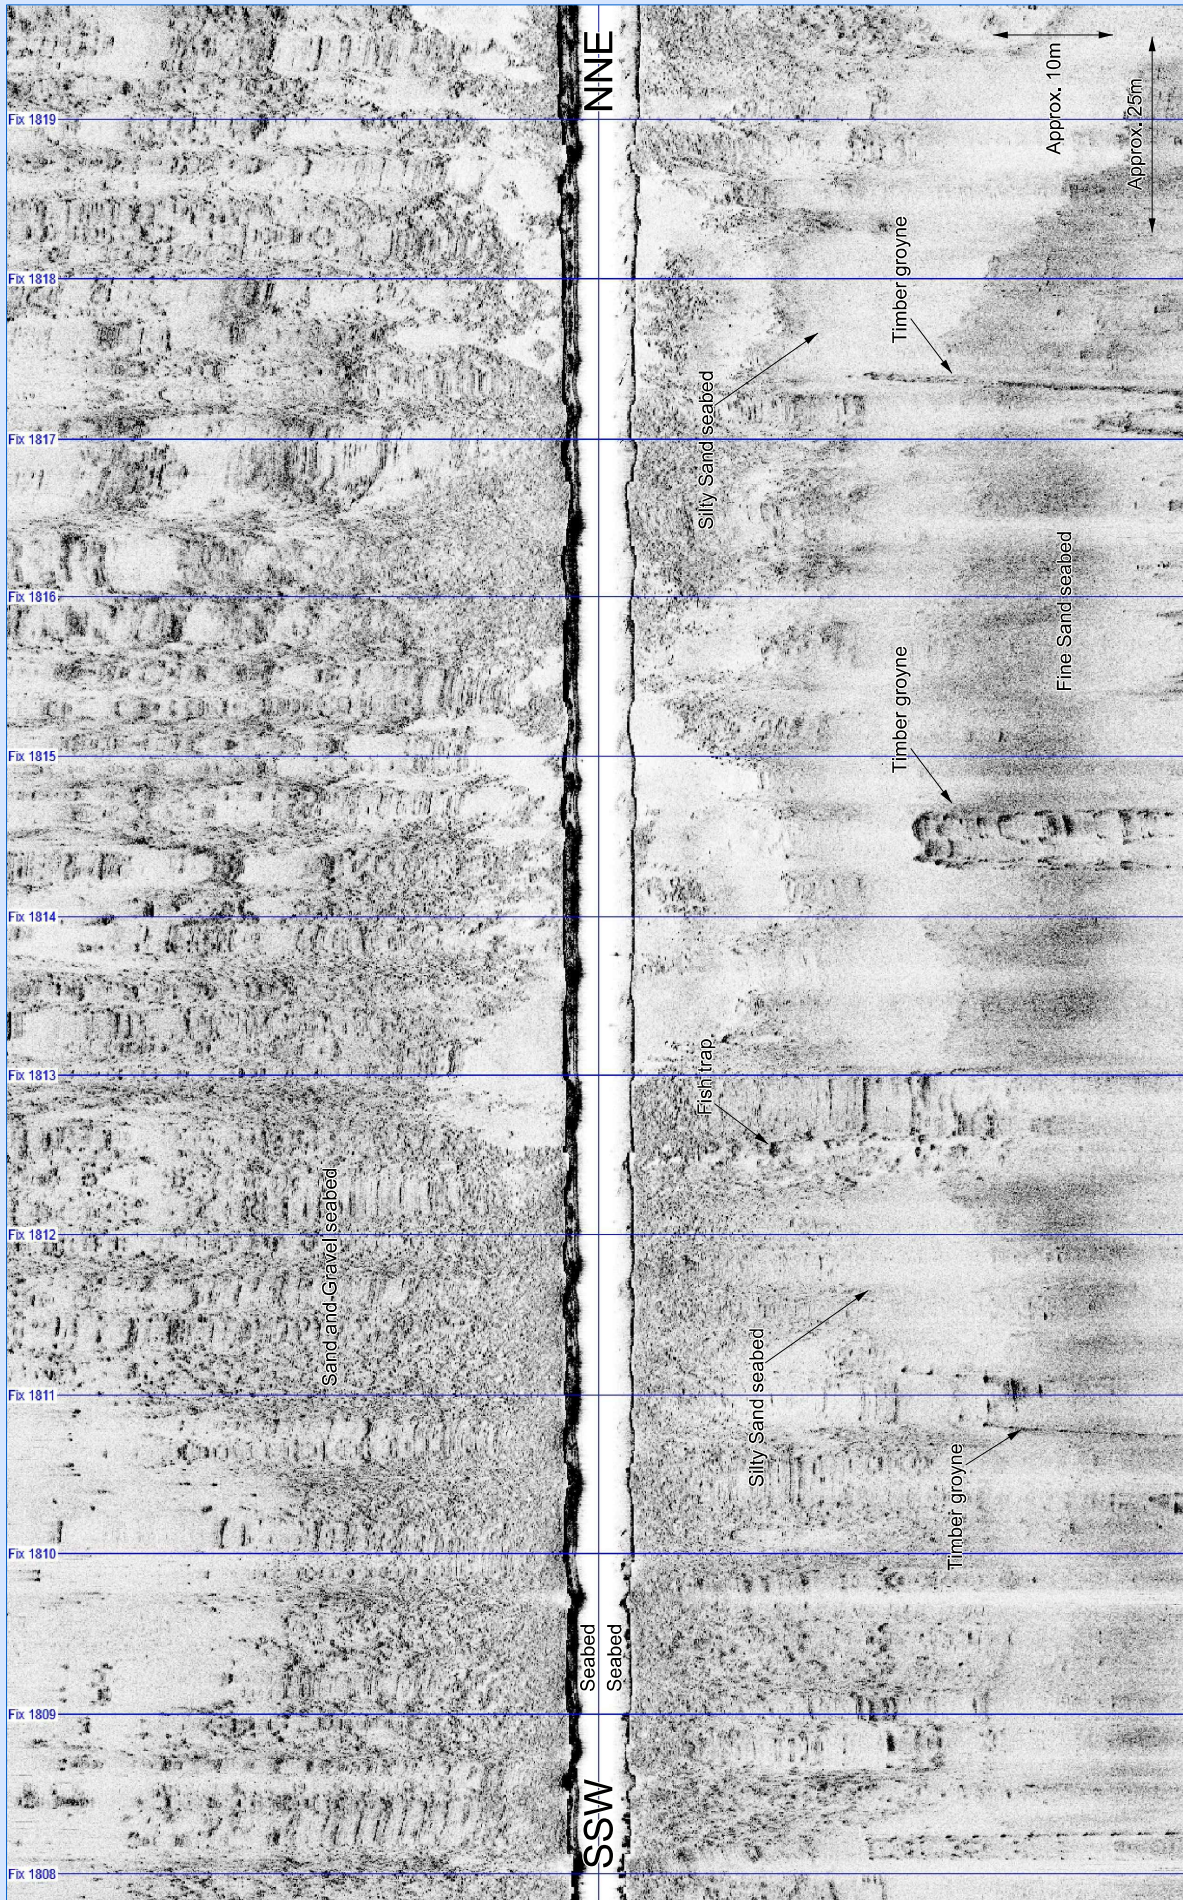
Figure 1.3

SIDE SCAN SONAR  
Illustrating fish trap and groyne

A series of groynes are observed on the data to the south of the site, orientated from southeast to northwest and are shown in [Appendix C3](#). A linear contact identified on both the bathymetry and side scan sonar datasets is thought to represent a fish trap as detailed on client supplied infrastructure information ([Appendix C4](#)).

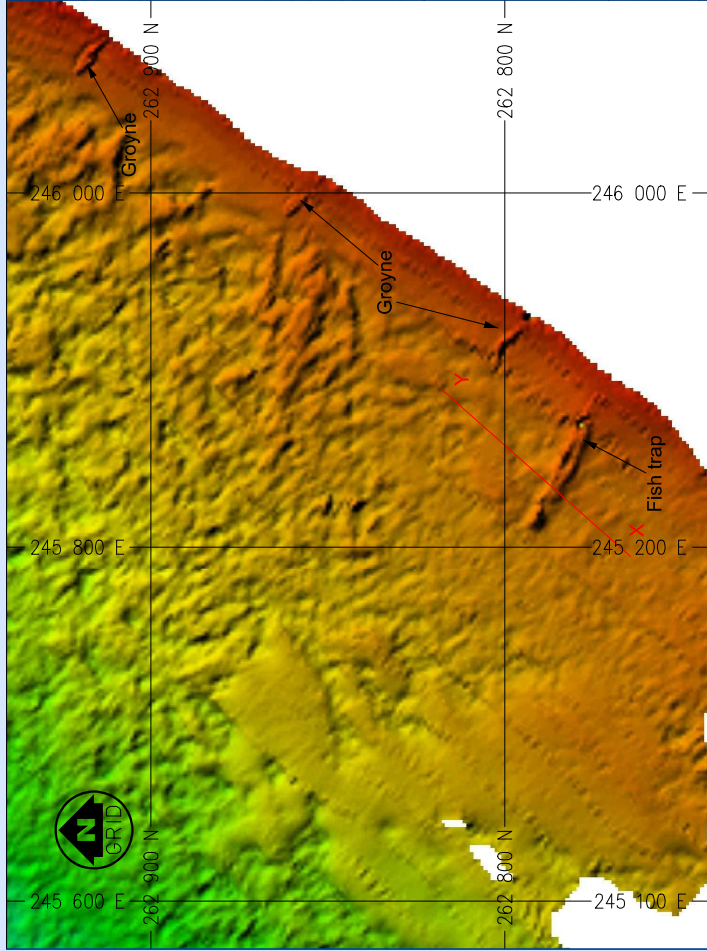
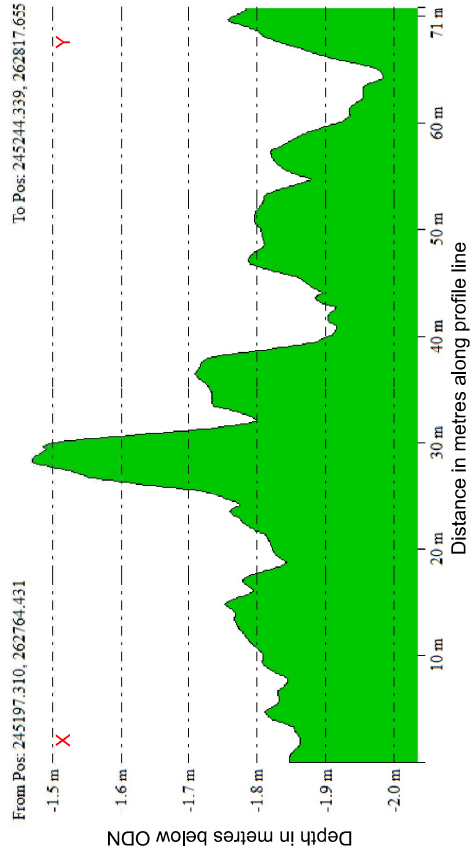
## **C.4 DATA MONTAGE ILLUSTRATING FISH TRAP AND GROYNES**

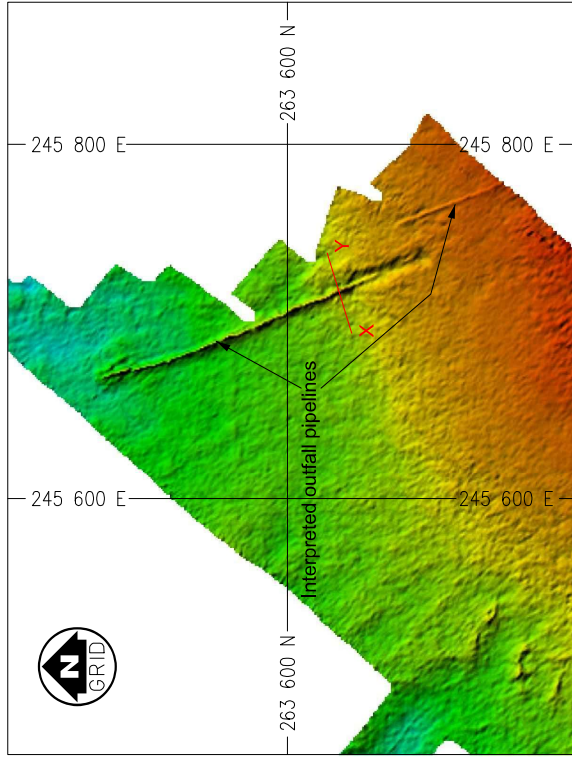
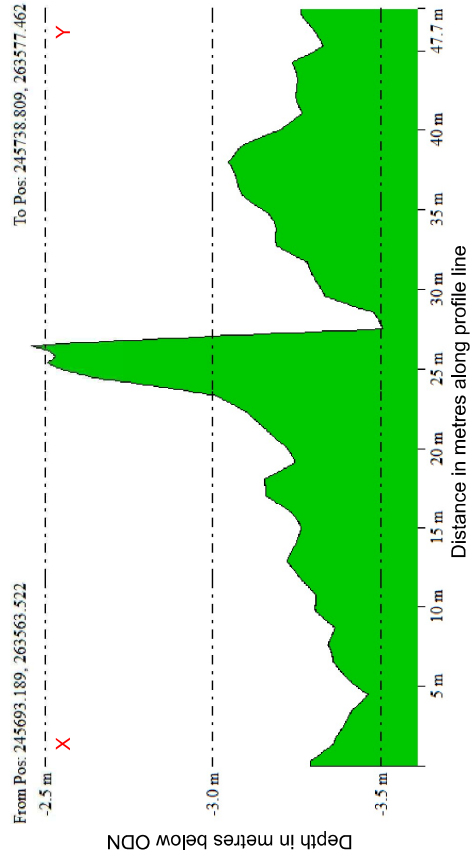
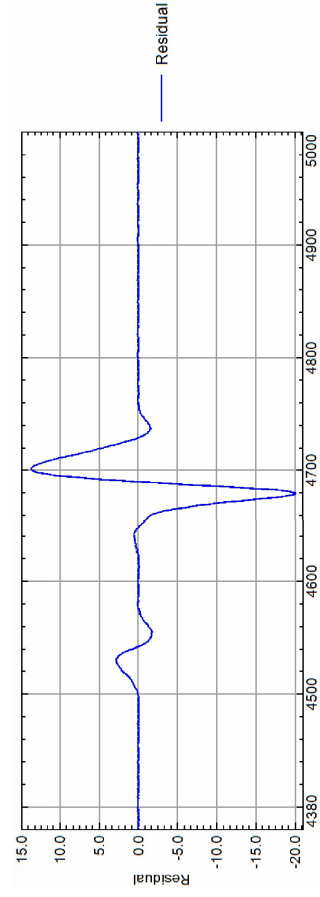
DATA MONTAGE  
Illustrating interpreted outfall pipelines

In the northeast of the site, two linear features are observed at seabed heading northwest from the beach as illustrated in [Appendix C5](#). These are not included on the client supplied infrastructure information but are expected to represent outfall pipelines. The more significant interpreted pipeline measures some 200m long, with evidence of trenching associated with it. Both features have associated magnetometer anomalies.

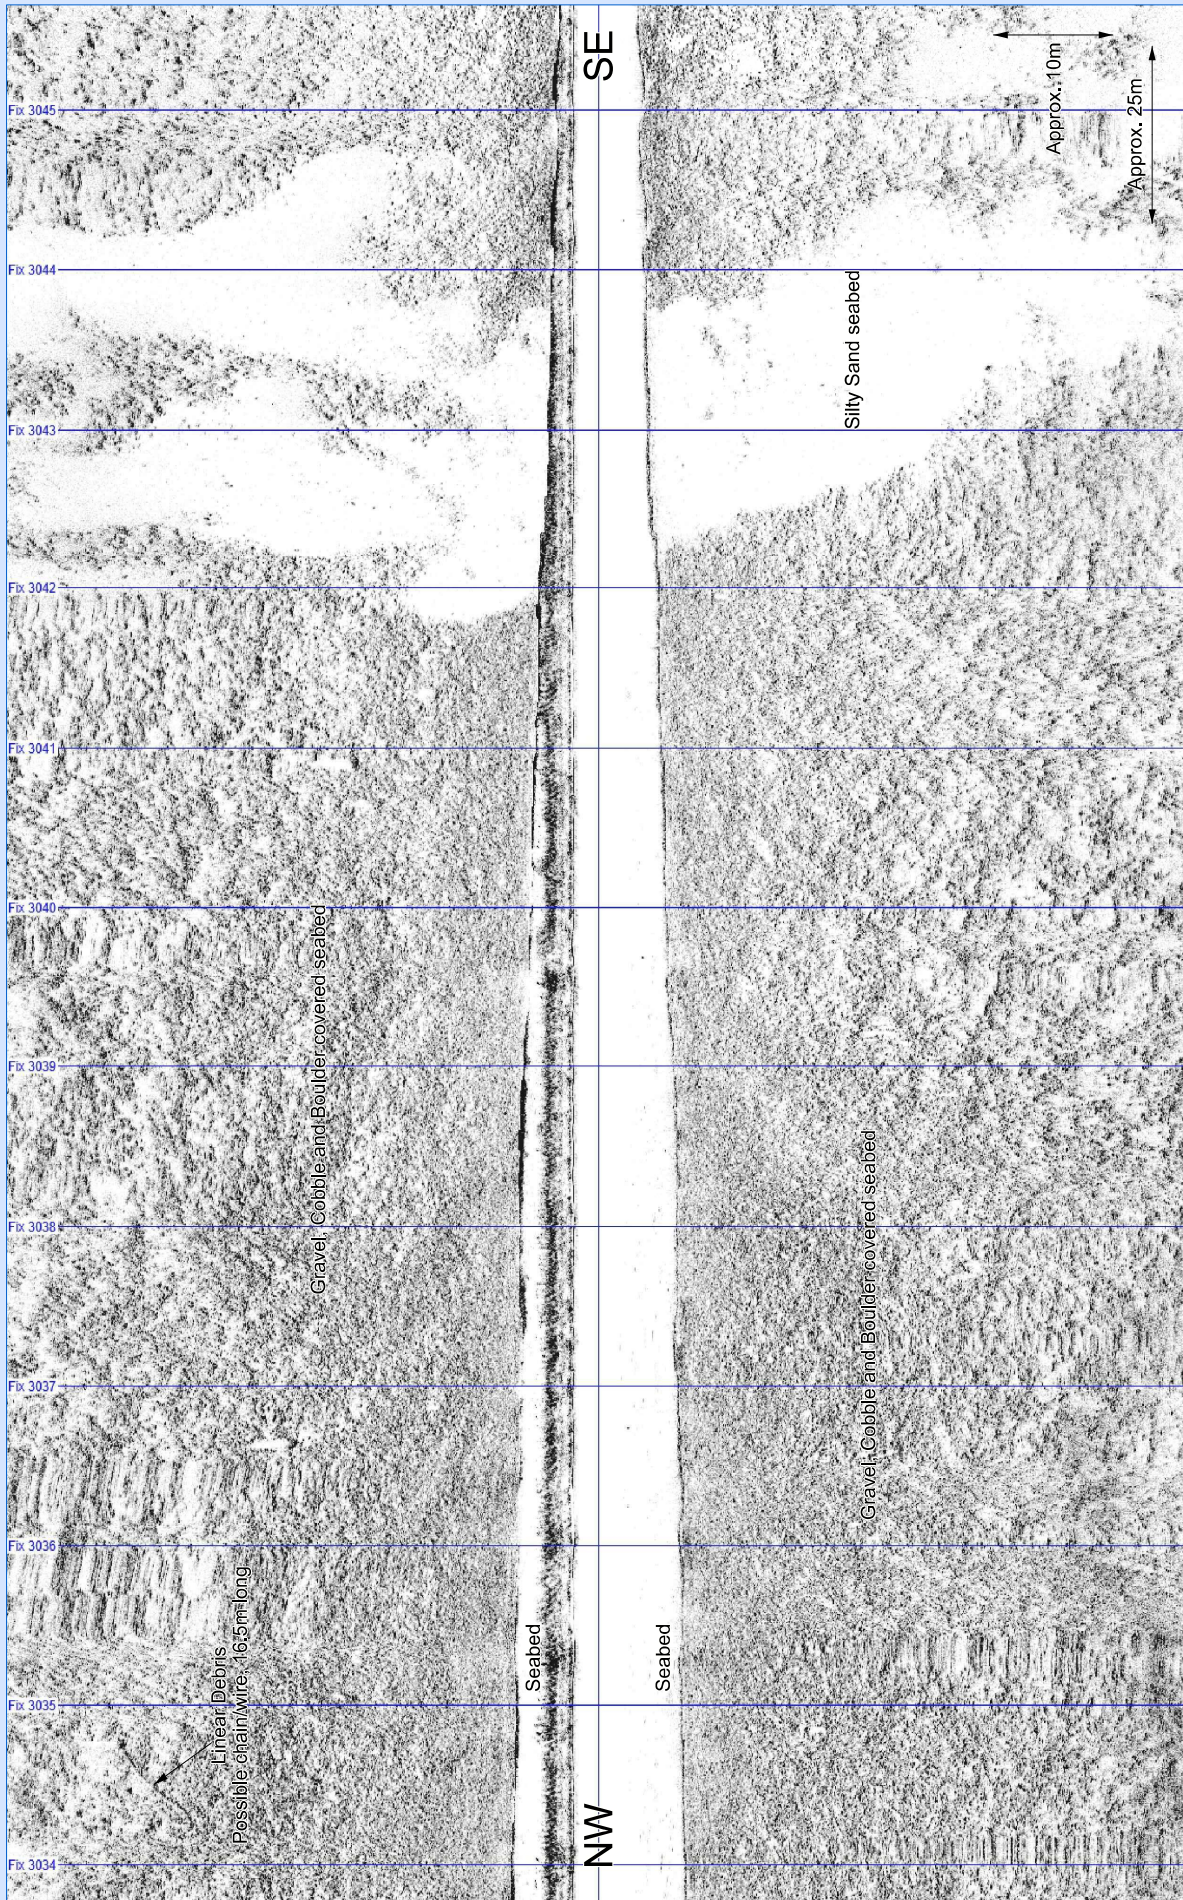
Figure 1.6

SIDE SCAN SONAR  
Illustrating linear debris

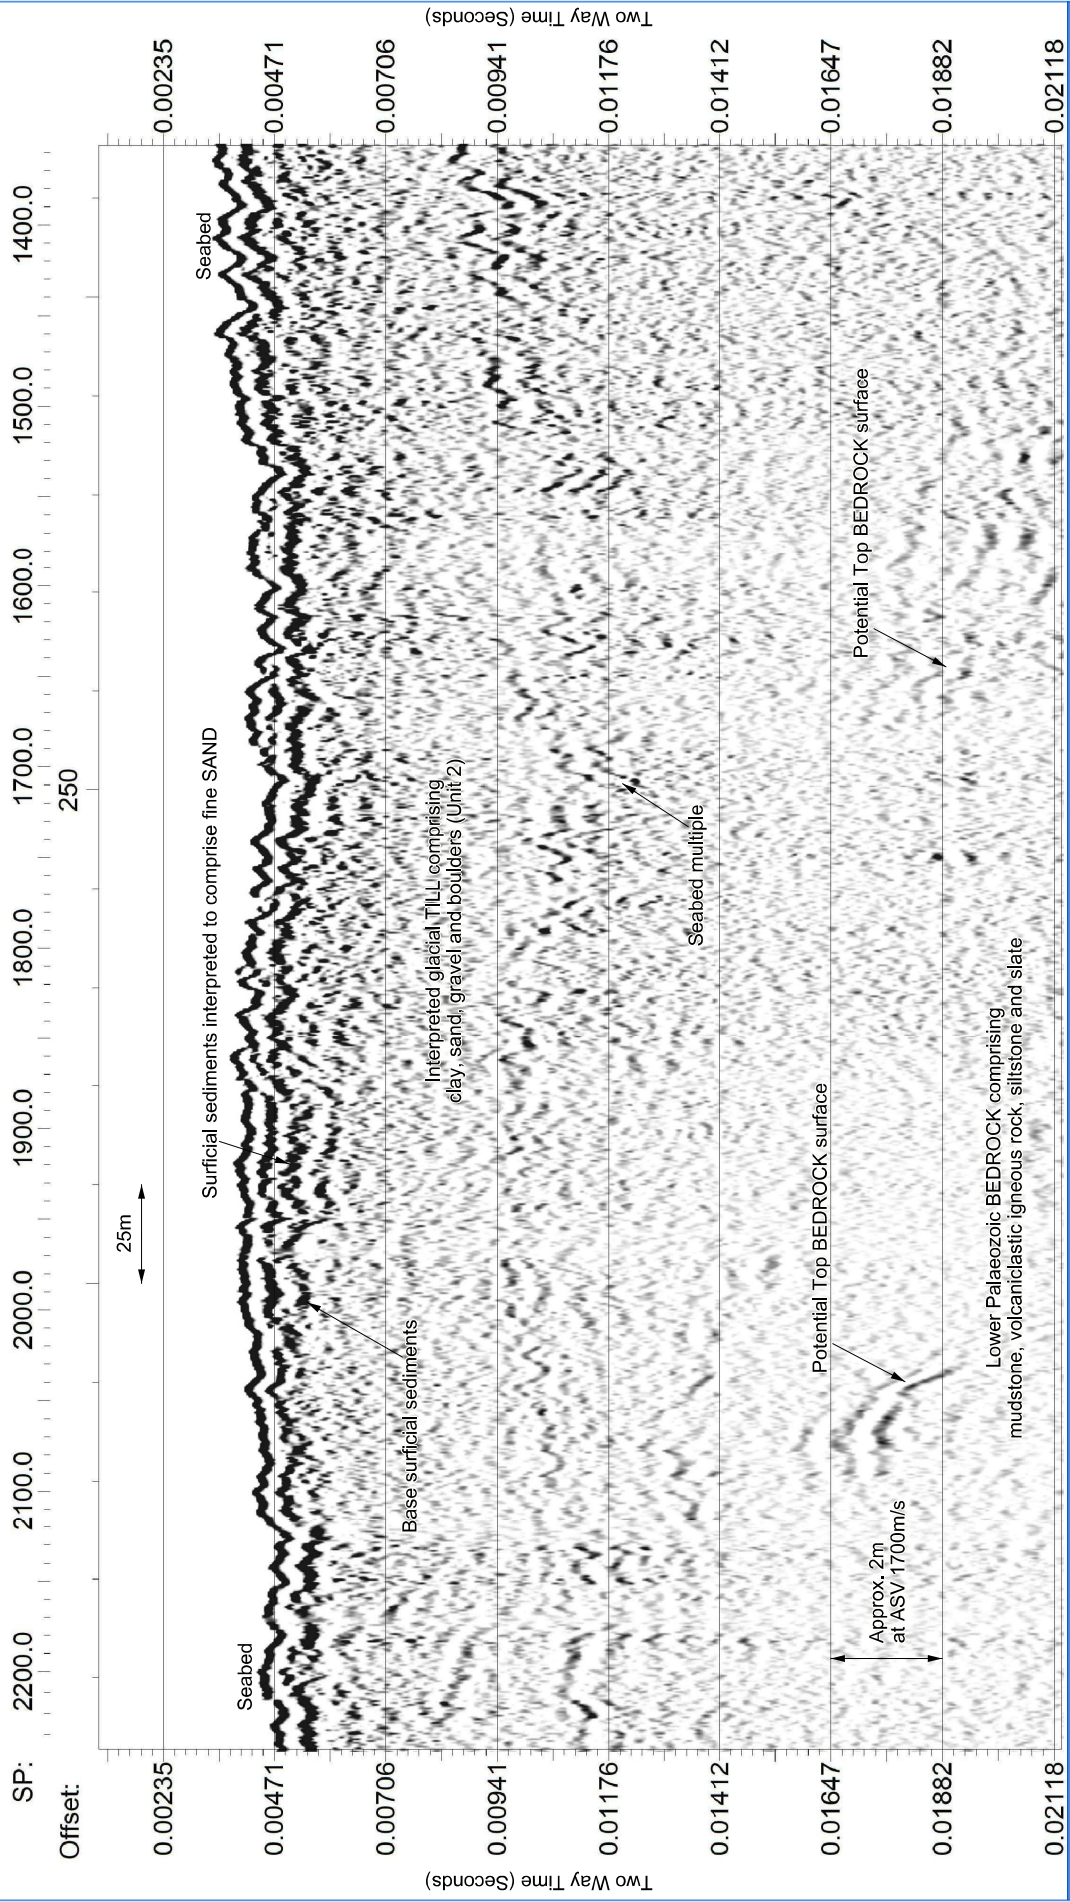
Line SB\_20201126165521

BOOMER  
Illustrating typical nearshore profile
