Project:  
**Aberaeron Geophysical Site Investigation**

Description  
**Geophysical Survey**

Project Number:  
**CS0590**

Document Type  
**Operations Report**

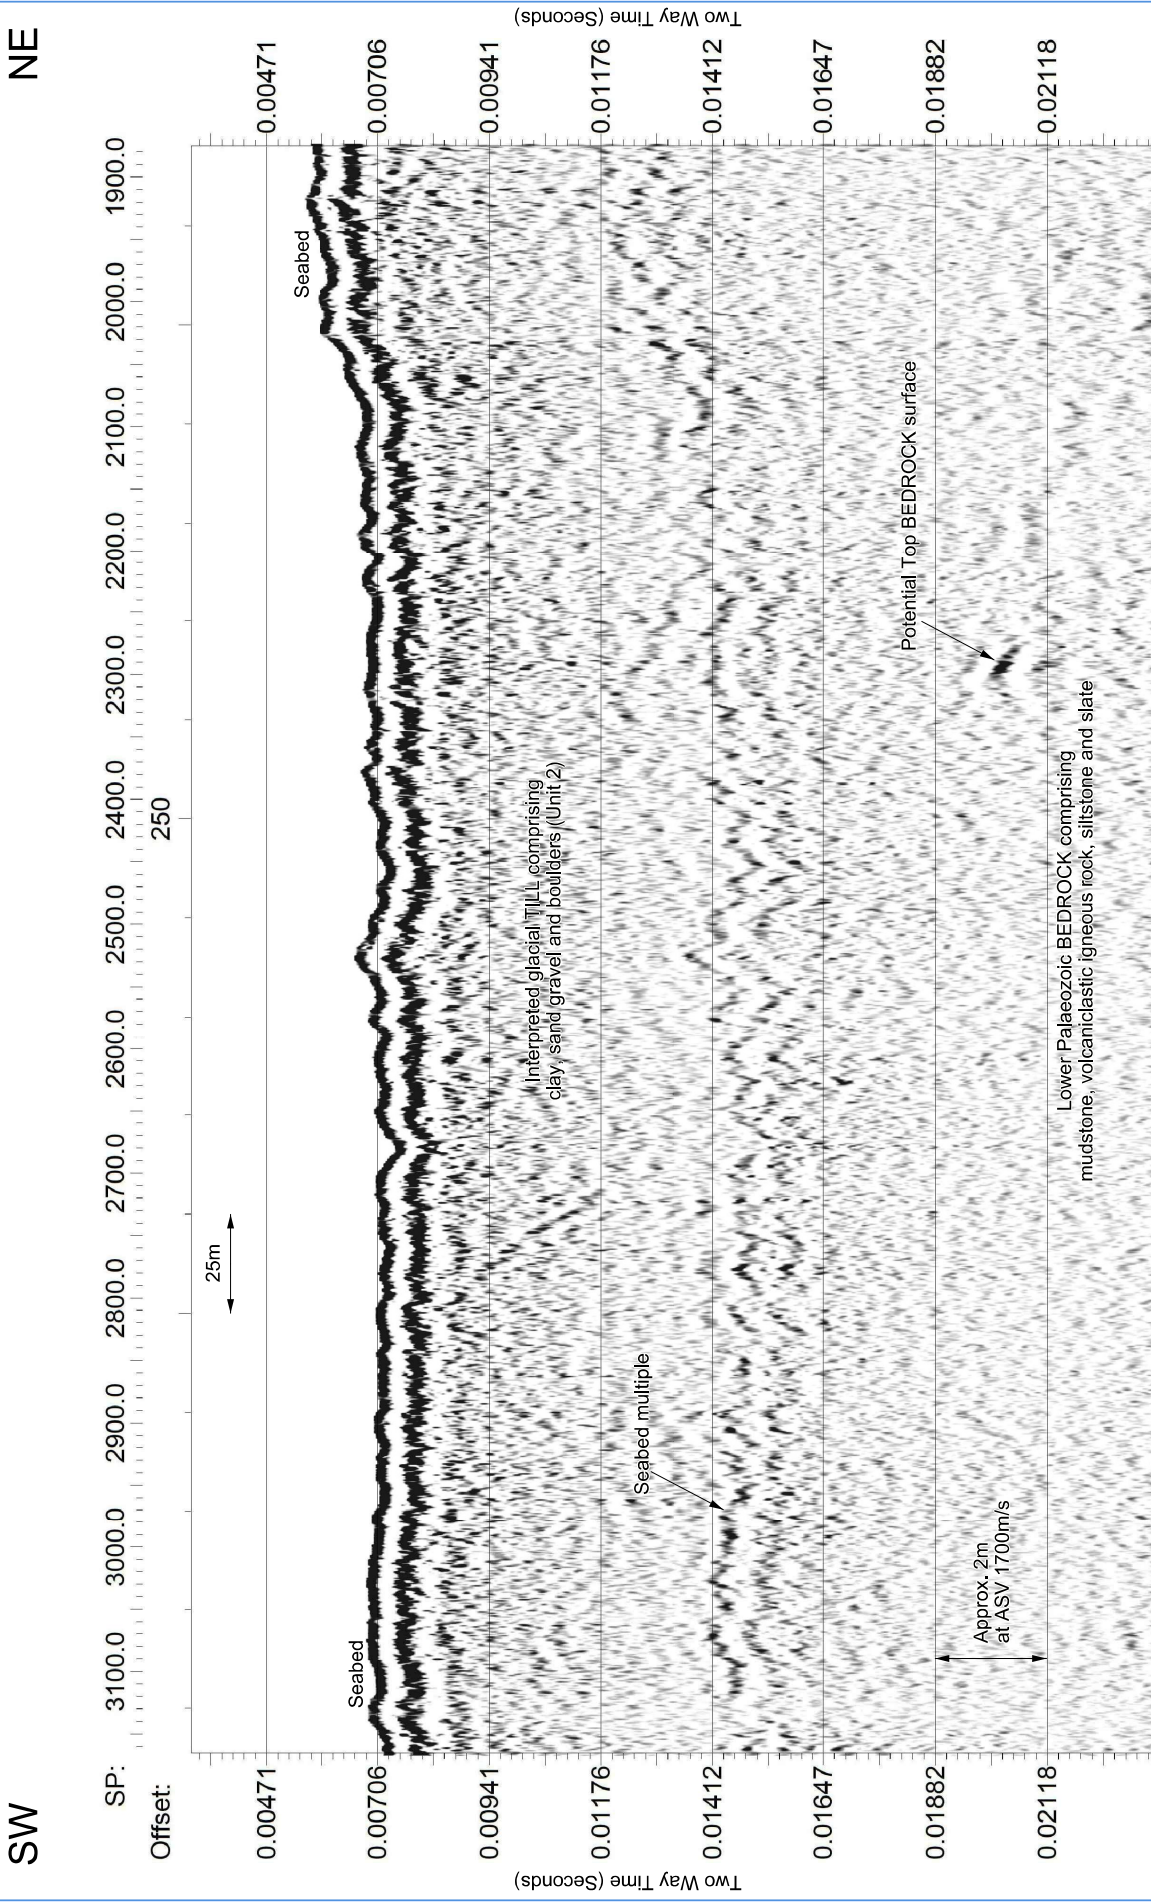
Line SB\_20201126140005

BOOMER

Occasional intermittent reflectors are observed at depths of 10-12m below seabed on the boomer data, which may represent the top of the regional bedrock in the area. Background BGS, as well as Client-supplied information indicate the bedrock in the area to comprise lower Palaeozoic bedrock comprising mudstone, volcanoclastic igneous rock, siltstone and slate. Due to the lack of coherent reflectors the top of the bedrock has not been mapped and thus the Isopachs deliverable and Shallow Geology chart has not been done as there is very little to show.

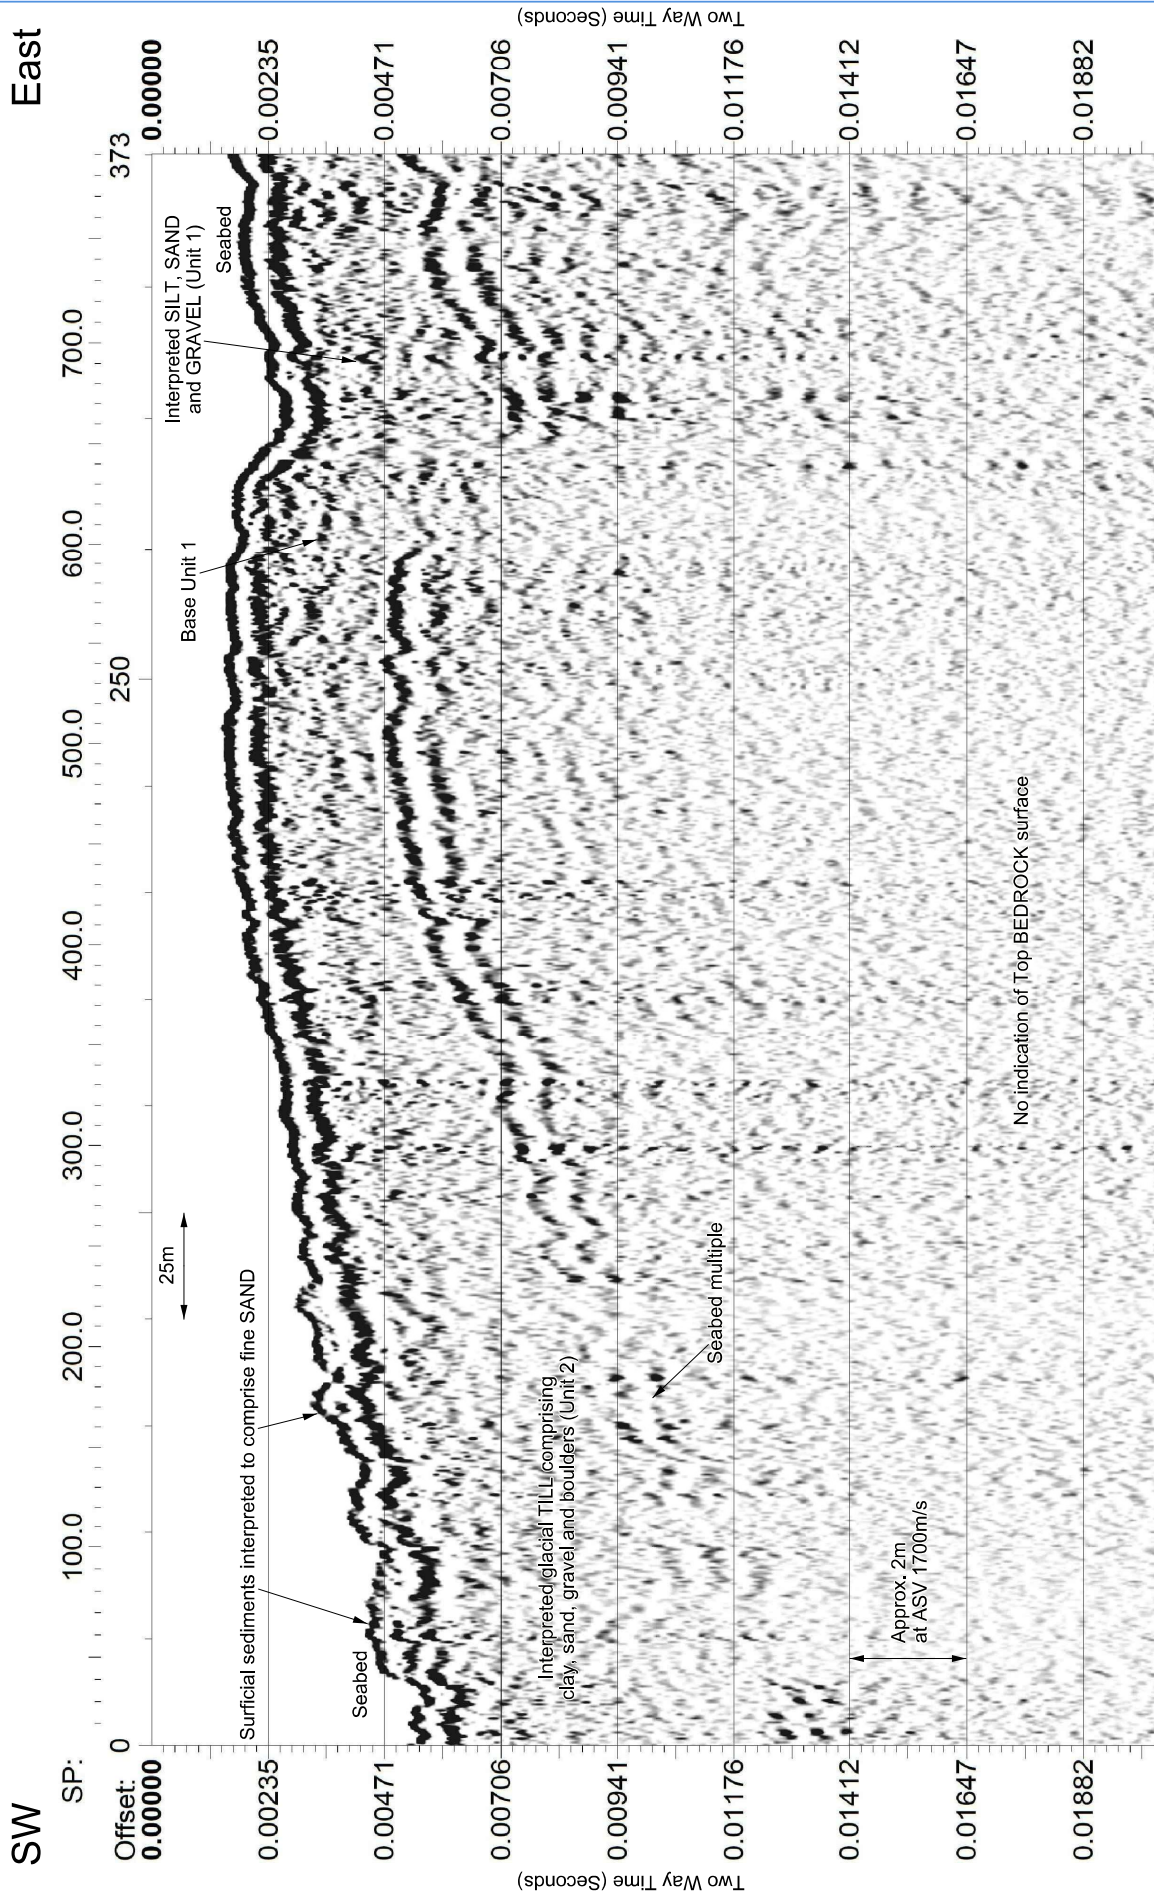
Line SB\_20201129073830

BOOMER  
Illustrating proposed breakwater centre line profile
