Pant Eidal Bridge

PROPOSED GENERAL  
ARRANGEMENT OF EAST  
(LOW MILEAGE) CILL BEAM

162906-CGE-WLS-DJP-DRG-ECV-000008

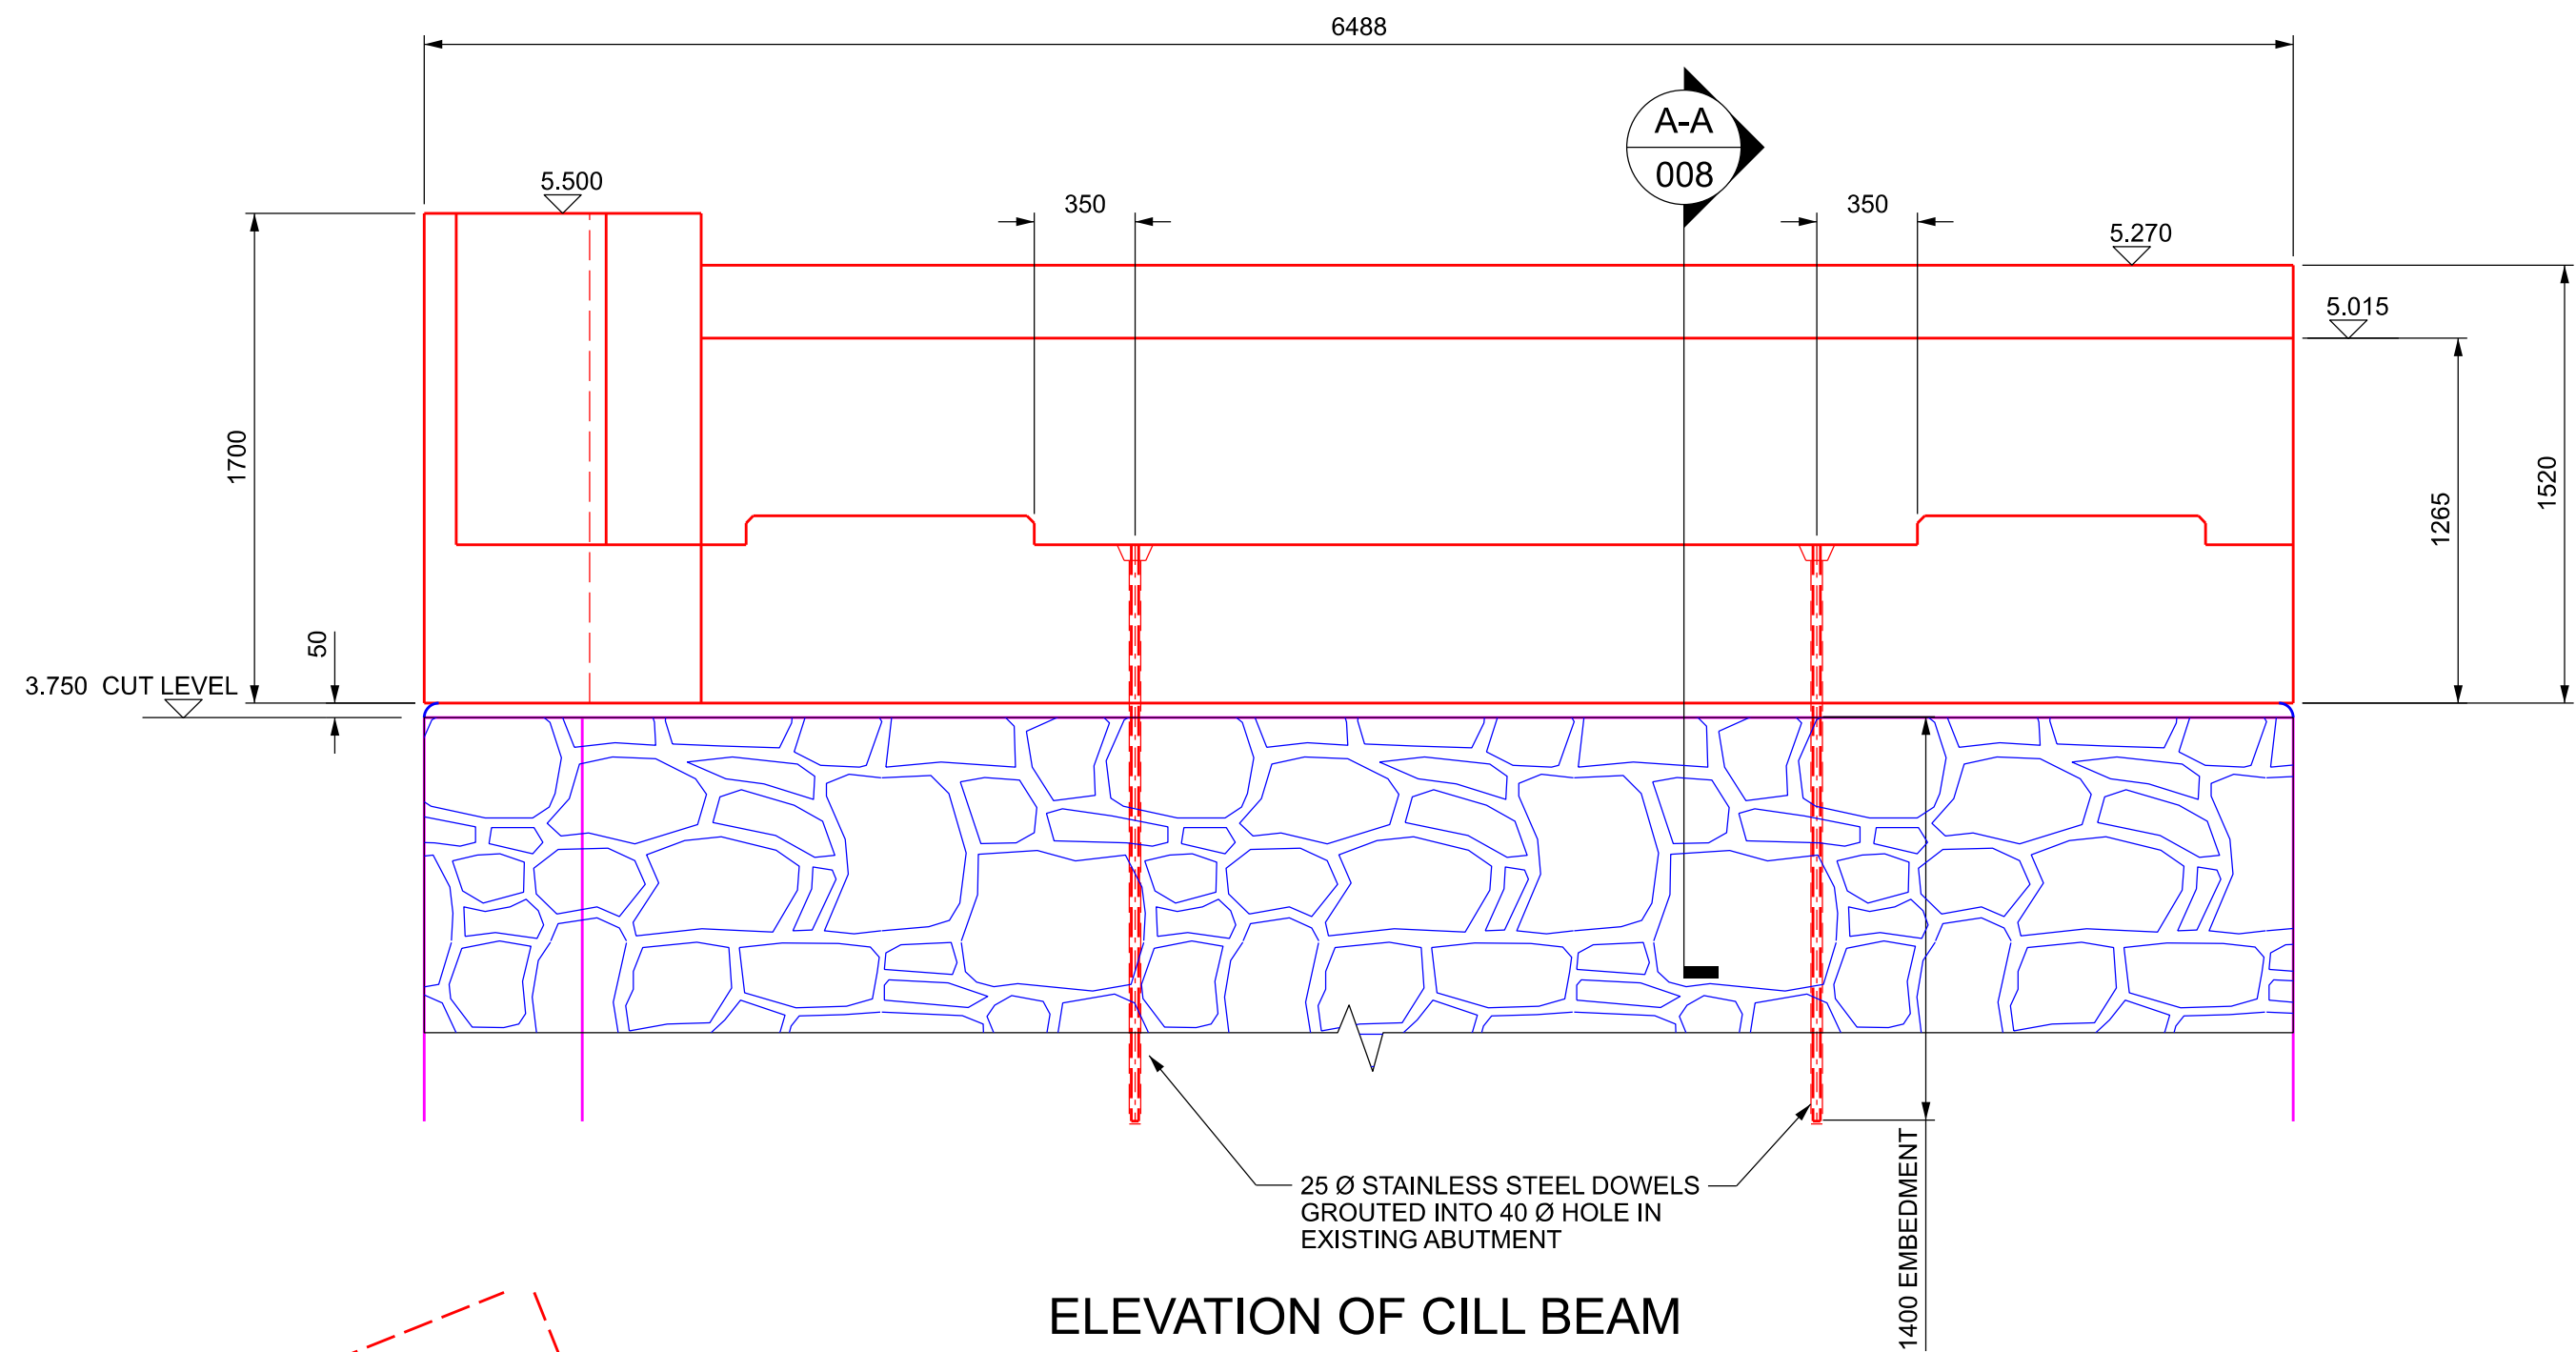
ELEVATION OF CILL BEAM

NOTE:  
WEIGHT TO BE ALLOWED FOR LIFTING -  
CILL BEAM UNIT WEIGHT IS 18.5  
TONNES (UNFACTORED)
