# Cardiff Coastal Defence Scheme

## Ground Investigation Report (GIR)

July 2020

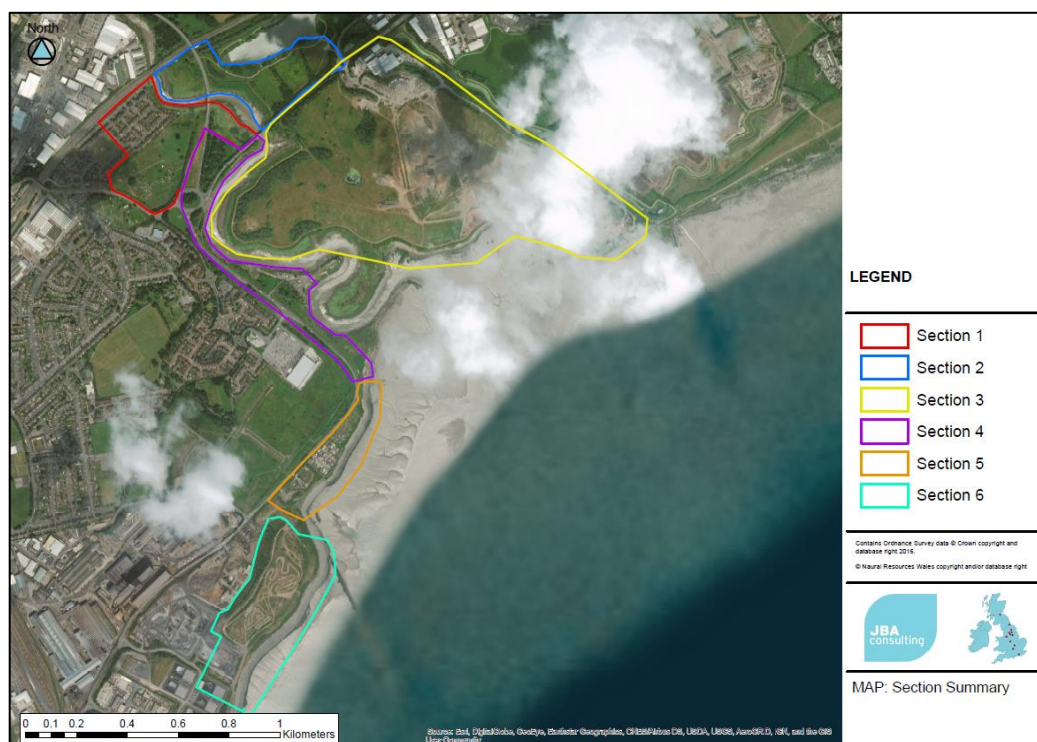
**Figure 2-1: Subdivisions of the site into six sections**

The site has been divided into six sections as shown in Figure 2-1.

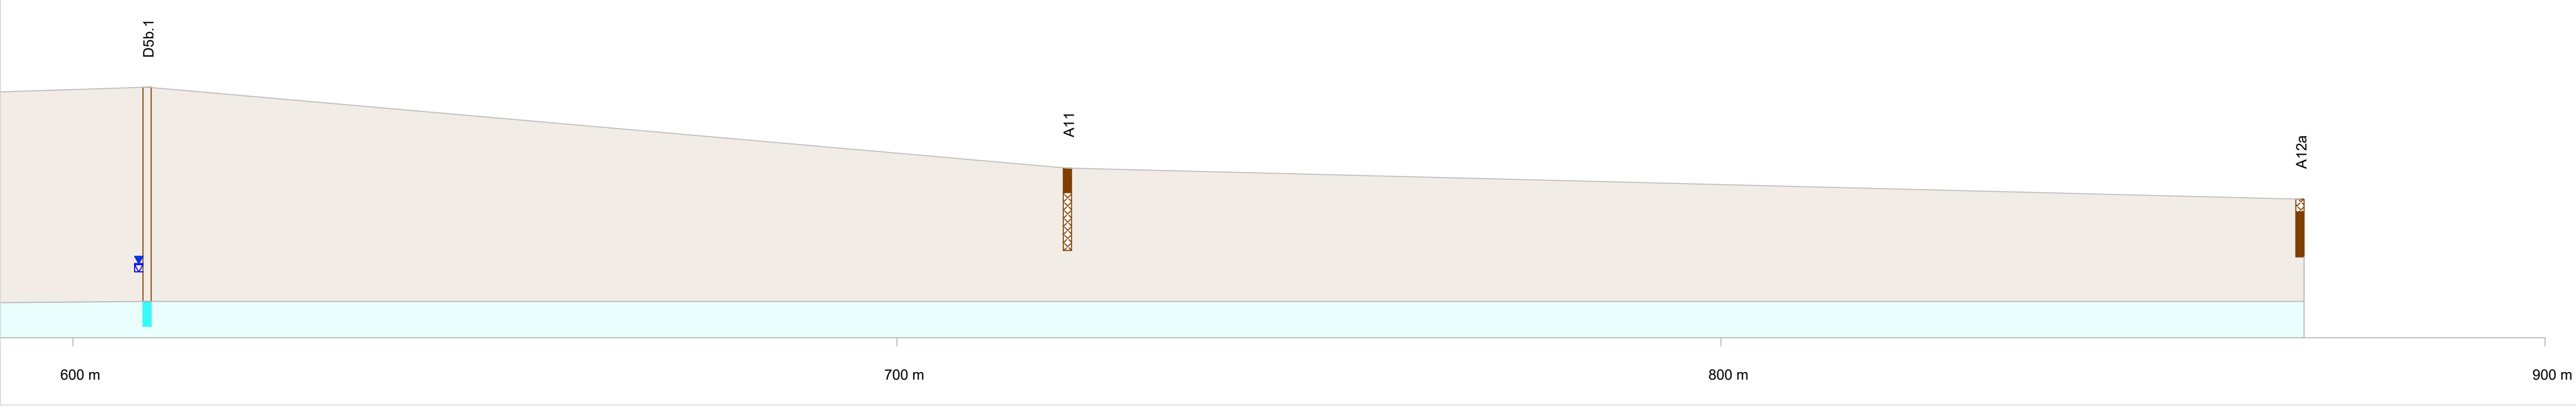
FRAG TIP

Profile Overview  
Scale 1:2500

Geological Profile  
Scale 1:500
