Colwyn Bay Waterfront Project Phase 2b Environmental Statement

Volume 2: Technical Appendices
Technical Appendix 9 - Biodiversity

September 2021

Appendix 9.7 – Cayley Embankment Technical Note

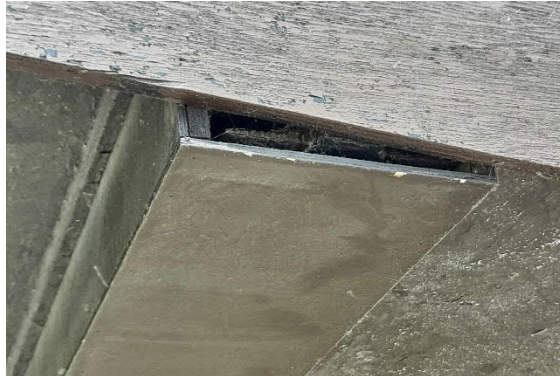
Figure A.10: Cavity within soffit box on south-east corner (B5) Note: during the period of rain, water was pouring out of this cavity

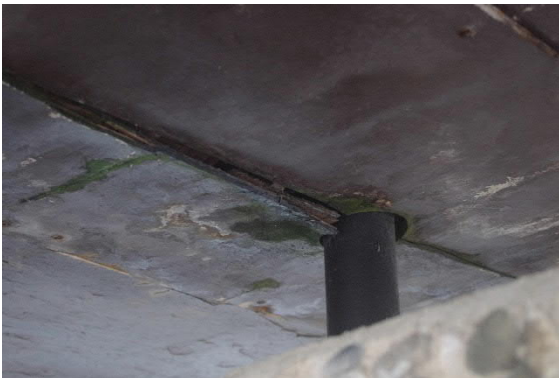
Figure A.11: Cavity around drain pipe with leaky roof (B5)

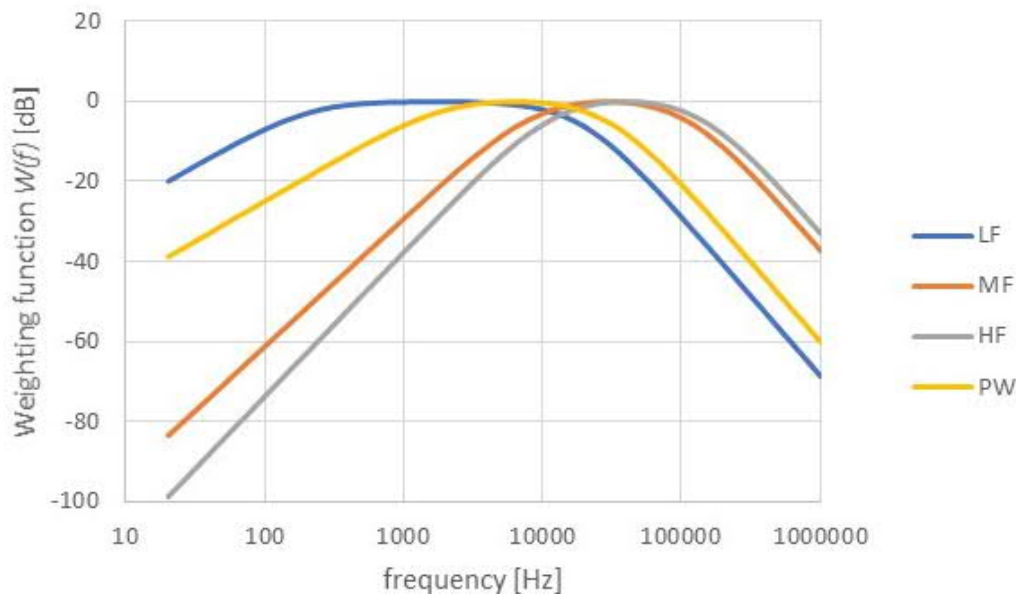
Figure 1: Gain $W(f)$ of the mammal hearing groups
