## Compliance Assessment Report CAR\_NRW0038643

**Permit being assessed:** BB3299FN.

For: SL Recycling Ltd, held by SL Recycling LTD

**Type of assessment carried out:** Site Inspection, Reason: Routine.

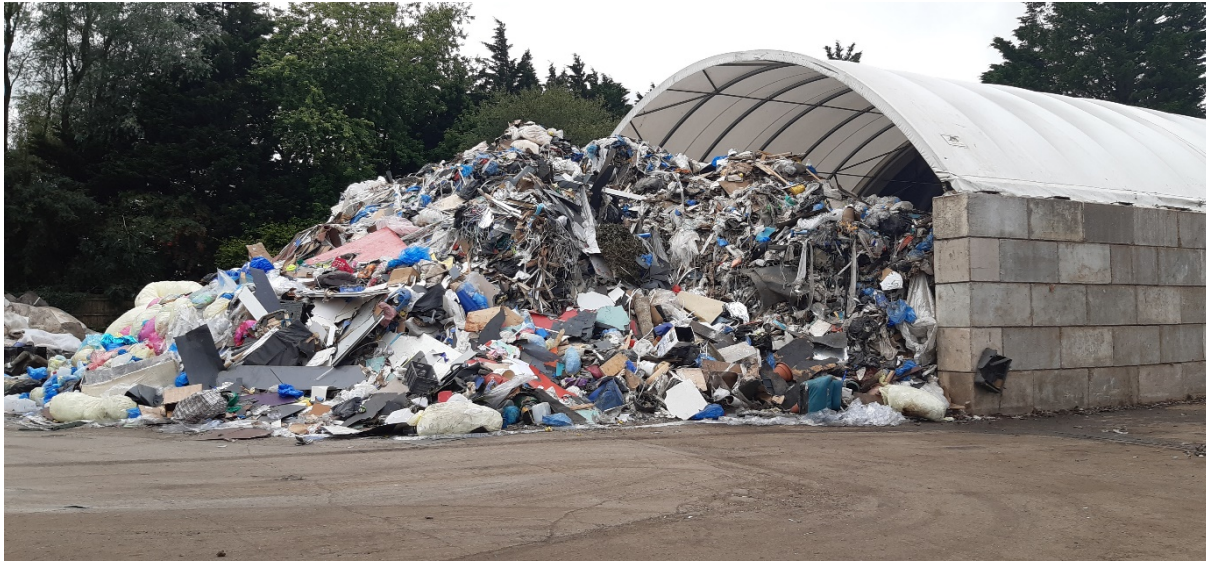
Mixed general waste was witnessed being stored outside of the building structure and so did not benefit from appropriate cover, as seen image 1.

Photo 1 - General waste deposited outside of building structure not benefitting from cover

At the time of the inspection, a large proportion of the mixed general waste was deposited outside of the designated shelter which, as a result, did not benefit from any cover. The operator stated that, the building was not full and so had the room to accommodate the material under cover when moved. This material is currently being sent to landfill due to the market.

- Ensure all mixed general waste is stored within the building in-line with permit conditions.
- Create appropriate separation distances between waste streams and boundaries to allow suitable access in the event of fire incident.

As a reminder, except for specified waste, all bulking, transfer or treatment of waste must be carried out **inside a building** in-line with permit conditions. Wastes can be bulked up for disposal or recovery elsewhere but, must be should benefit from cover to prevent saturation with rainfall and any subsequent leachate that may occur as a result.

Officers also highlighted that the mixed waste should be reduced in volume for fire mitigation. Officers reiterated that, the height of the waste must be under 4 metres and clear separation distances exercised for proper material management and to prevent fire spread. It was indicated that, no further general waste had been accepted to site and plans are in place to reduce the general waste stockpile size imminently.

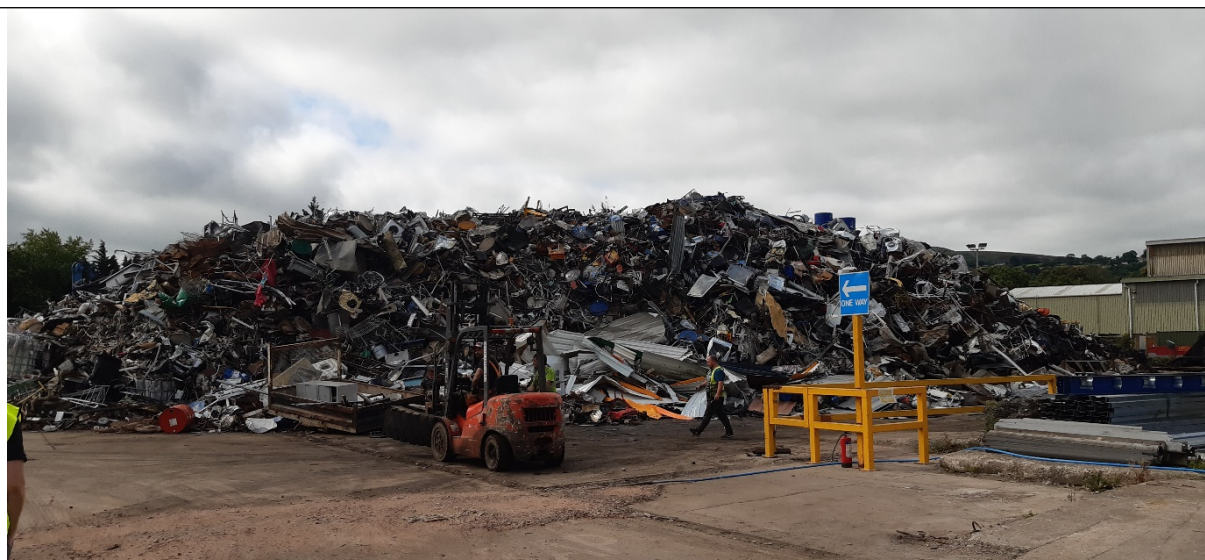
The primary activity on site remains to be scrap metal recycling. The site contained quantities of metal intended to be treated, baled and sent to the relevant downstream scrap metal dealers. It was noted that, the size of the central waste stockpile was higher in parts at the time of the inspection. It was mentioned that, this needs to be reduced and consistently managed on a daily basis. The operator expressed that; they wanted the material to be removed from site urgently, however had been let down by logistical issues preventing the usual turnaround time of sorting materials.

Image 2 - stockpile of scrap metal waste located in the centre of the yard

NRW Officers reiterated to the operator that the height of stockpiles must not exceed **4 metres**. Additionally, clear separation distances between stockpiles need to be established to enable access in the event of a fire incident.

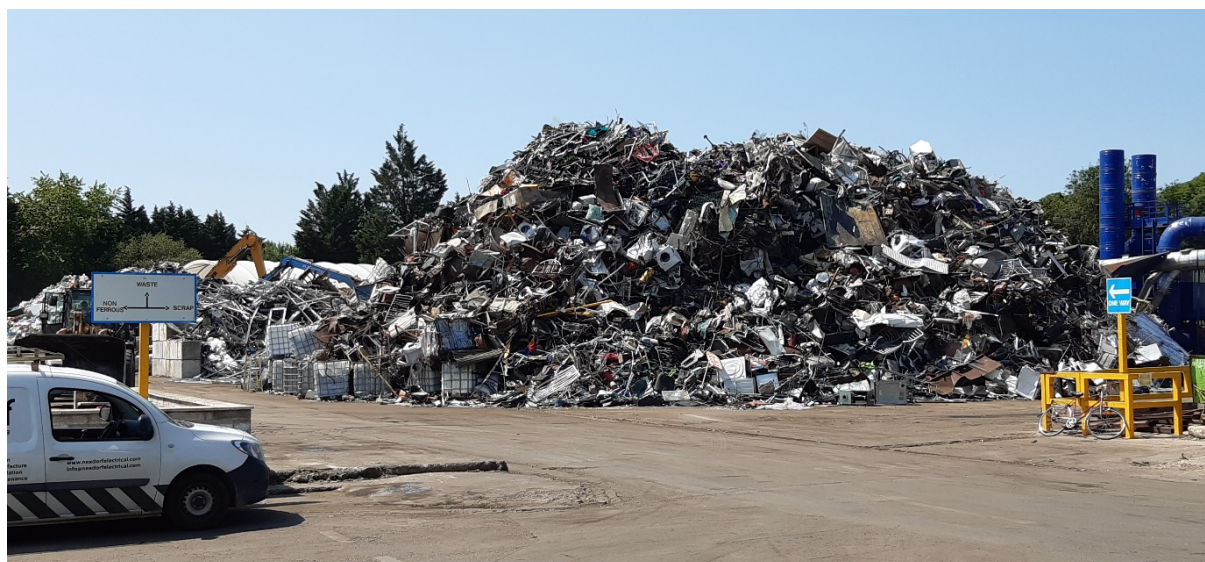
On 21 July 2021, the excess height of scrap metal stockpile was noted by NRW Officers Jonathan LEE and Greg GARDNER on a previous visit to SL Recycling Ltd, (see image 3).

Image 3 - Showing the large height of stockpile of scrap metal stored on site - taken on 21 July 2021

- Reduce all heights of stockpiled waste to **4m**. Do not allow waste stockpiles to exceed this height restriction in future.
- Reject material if there is unsuitable capacity on site to compliantly accept more waste.
- Use appropriate preventative measures and operate activities in accordance with the Noise Prevention Plan.

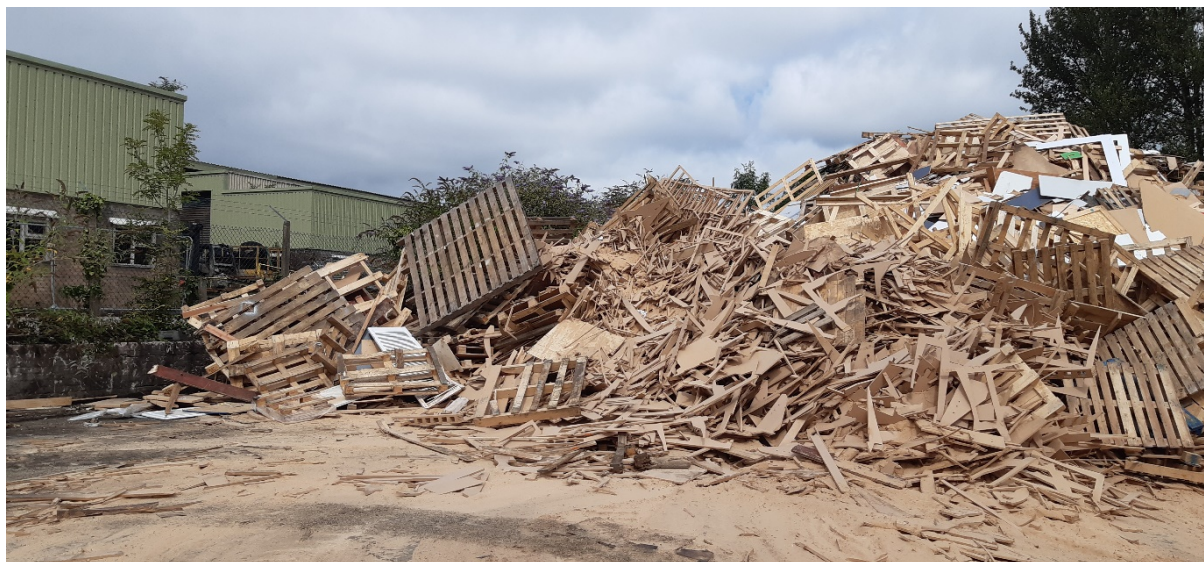
The operator indicated that, they have recently moved their storage area for the wood material extracted from the general waste pile next to the ELV section of the yard. This needs to be reflected in the Environmental Management System (EMS) and Site Plan. The operator also stated about the intention to construct bay walls to assist with separating and containing waste streams. There was a lack of a clear separation between the metal and wood waste to the site boundary. This point has been highlighted on previous inspections

**Image 4 – showing new location for wood waste, limited separation distance between waste and site boundary.**

- Establish separation distances across all waste streams on site to allow emergency service access in the event of an incident.
- Please update site plan and EMS to reflect new location of waste(s) storage areas. Once updated, please submit this to NRW for review.

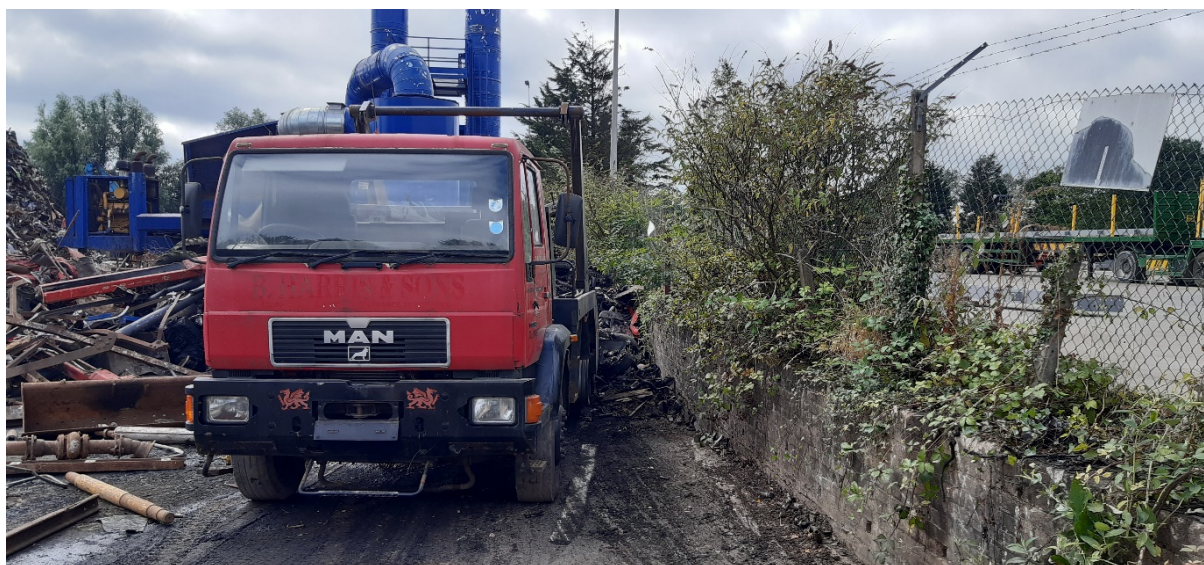
**Image 5 - Metal stockpile with limited separation distance between waste and site boundary**

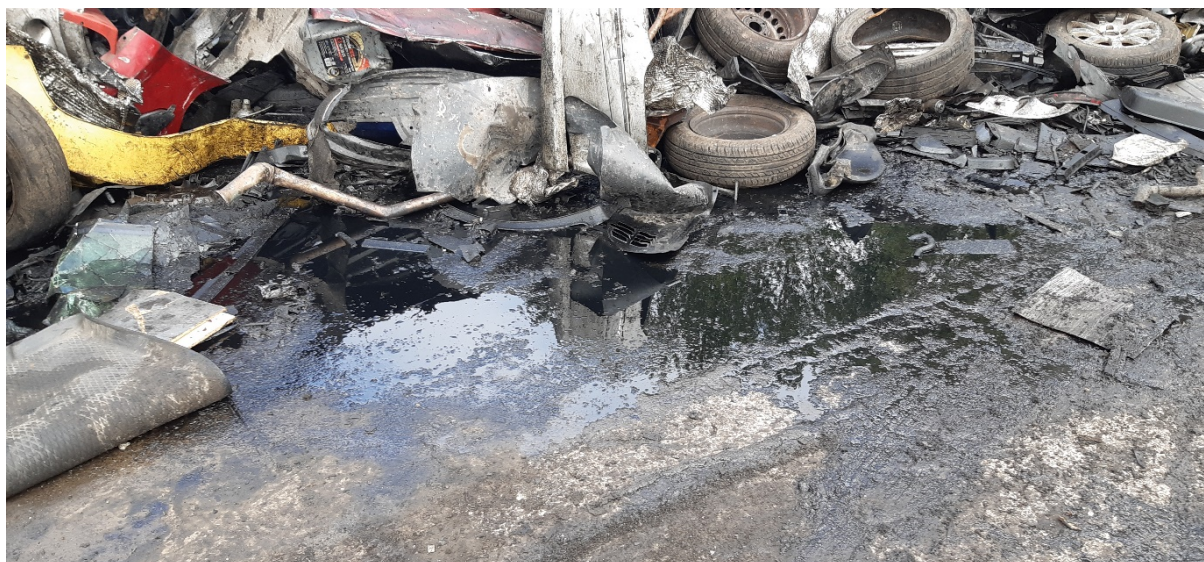
The general housekeeping on the site was in good condition with no major amounts of loose debris located on the floor. It was noted that, one area of the section contained a pooling of excess oil (see photo 1). Staff were aware of this and were working to clean up the residual pollutants with appropriate clean-up kits.

**Photo 6 - Pool of residual oil located near ELV section of site**

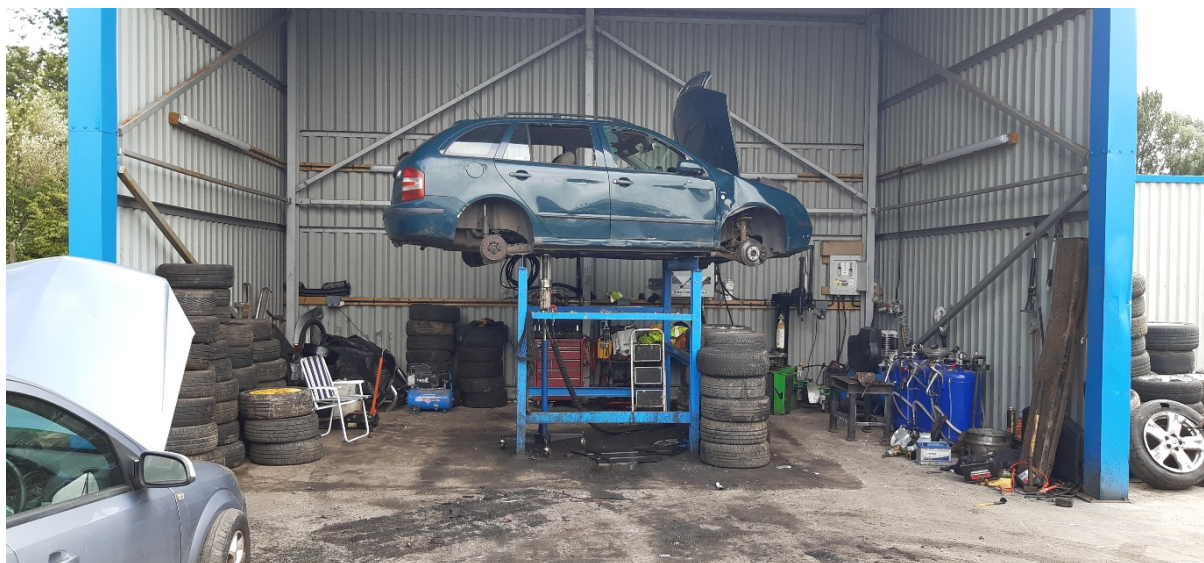
The depollution bay is now fully operational (as per image 7). The flooring infrastructure was in excellent condition which is all linked to the sites interceptor drainage system. Removed vehicle tyres were stored in a tidy manner, with appropriate separation

**Photo 7 - Fully operational ELV depollution bay**

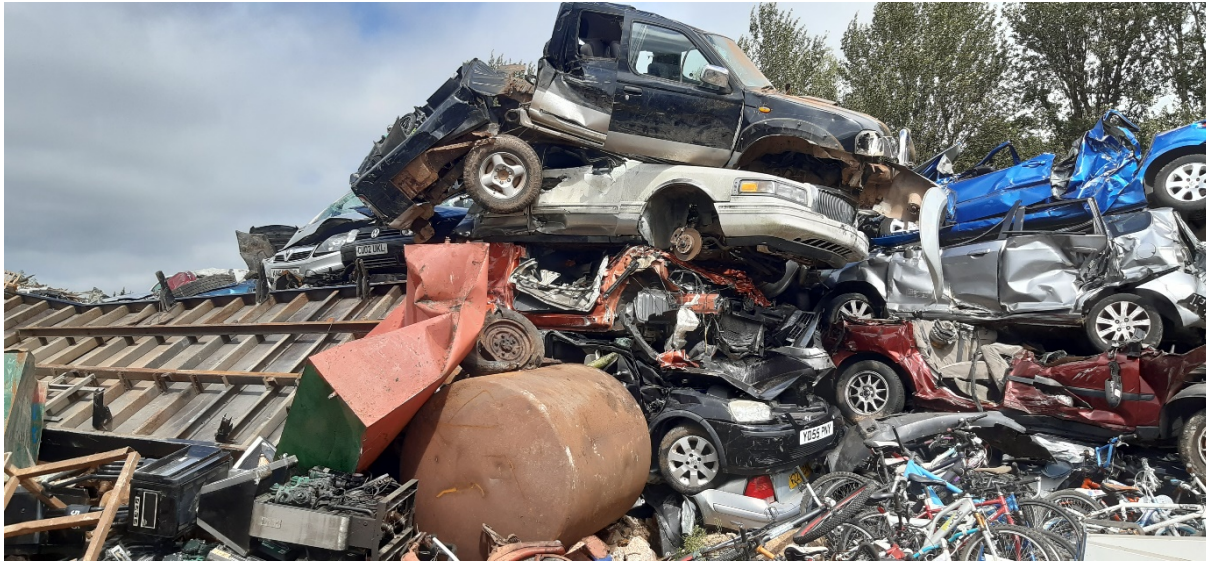
It was noted that, the scrap vehicles on site were stored higher than the recommended three-vehicles-high. This concern was raised at the time of the inspection and the operator stated that this would be immediately actioned. Please see below the extract from the UK Government website regarding the storage of whole ELV's. This information can also be found on [Fire prevention plans: environmental permits - GOV.UK \(www.gov.uk\)](https://www.gov.uk/guidance/fire-prevention-plans-environmental-permits) - section 10.

Photo 8 – consecutive stacking of vehicle shells

Where you store vehicles one on top of another, or on racking, you must limit this to 3 vehicles high so the stack can remain stable during a fire. You must maintain a separation distance of 6m between rows or blocks of vehicles.
