## Compliance Assessment Report CAR\_NRW0037700

**Permit being assessed:** PP3993VS.

For: Atlantic Recycling Limited, held by Atlantic Recycling Limited

**Type of assessment carried out:** Site Inspection, Reason: Routine.

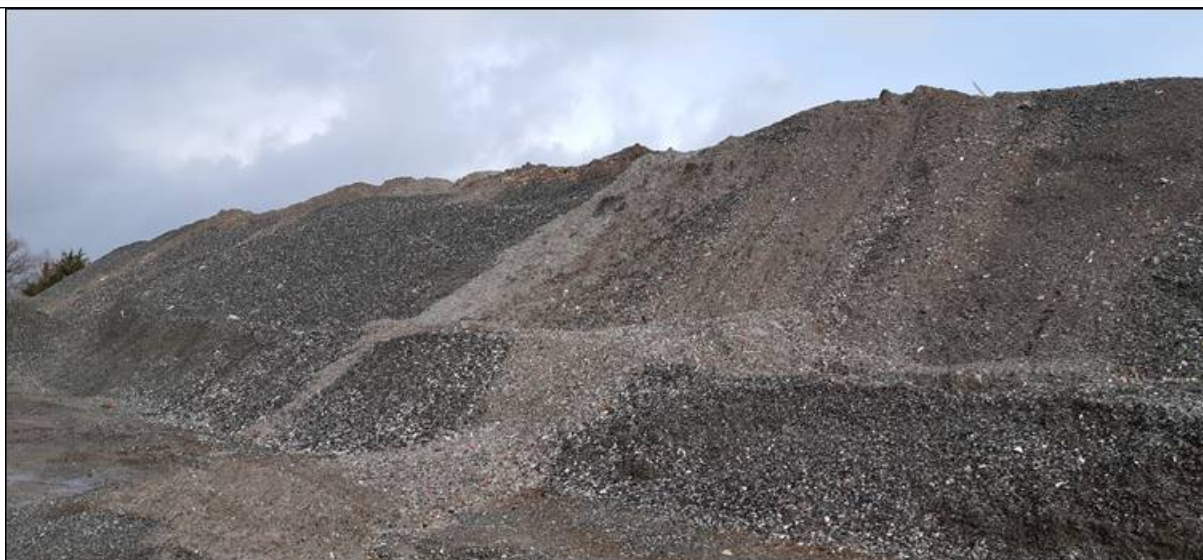
Officers started the visit by inspecting the waste deposited on Field 4. It was apparent that large stockpile of inert glass-based waste noted on the last inspection was still present, as per image 1. The intention for this material is still to be stored on Field 4 before being taken to the Transfer Station and put through the MRF to obtain the recyclables. The operator intends to surcharge the ground in this field to make an appropriate surface for future activities. Please note the retention times and maximum stockpile dimensions for this waste to ensure that it is treated and removed accordingly.

Image 1 – showing the large volume of inert material stored on Field 4, taken 16 February 2021

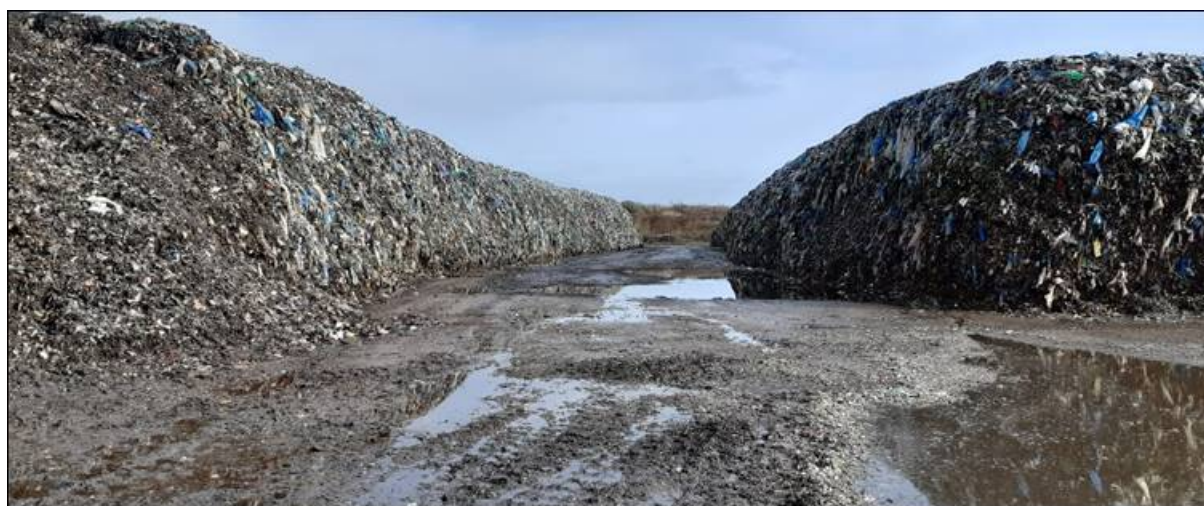
On 3 October 2020, the operator sent photographs to confirm the clearance of the fire breaks between stockpiles. NRW agreed that operator had sufficiently cleared all material from the fire breaks and had established complaint separation distances between all stockpiles. Thank you to the site for actioning this promptly and diligently. All separation distances were adequate at the time of inspection.

Image 2 – showing clear the separation distance between loose waste stockpiles on Field 1, taken 16 February 2021

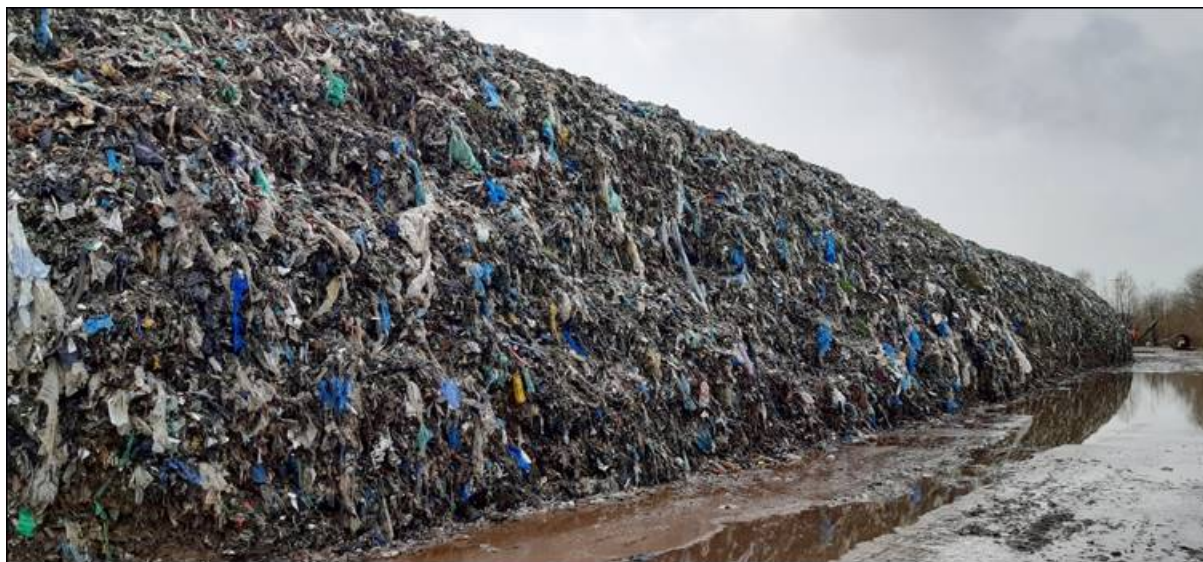
From observations made on the inspection, the operator has failed to fully satisfy step 1 of the Notice to reduce heights of stockpiles above four metres. It was estimated that stockpiles 1, 2, 3, 6 and 7 were between 5 - 6 metres high, with stockpiles 4 and 5 being slightly over:

The site has begun processing and removing the oldest stockpile 6 (as per step 2 of the Notice). The operator stated that, from 01 January 2021, their books should show just under a 5,000-tonne deficit in material leaving site. The operator also stated that they have begun taking material to landfill as a last resort. Weather permitting, they aim to have an average monthly net reduction of between 6 to 8,000 tonnes going forward. The operator has claimed to be working towards a nett reduction of 8-10,000 tonnes of Field 1 waste for Quarter 1 2021.

Image 3 – showing the height and length of stockpile 6 on Field 1, taken 16 February 2021

| Criteria | Action needed | Complete by |
|---|---|---|
| D2 | (1) Reduce all heights of stockpiled waste stored above four metres.<br>(2) Remove all stockpiled waste deposited over six months. | 24/05/2021 |

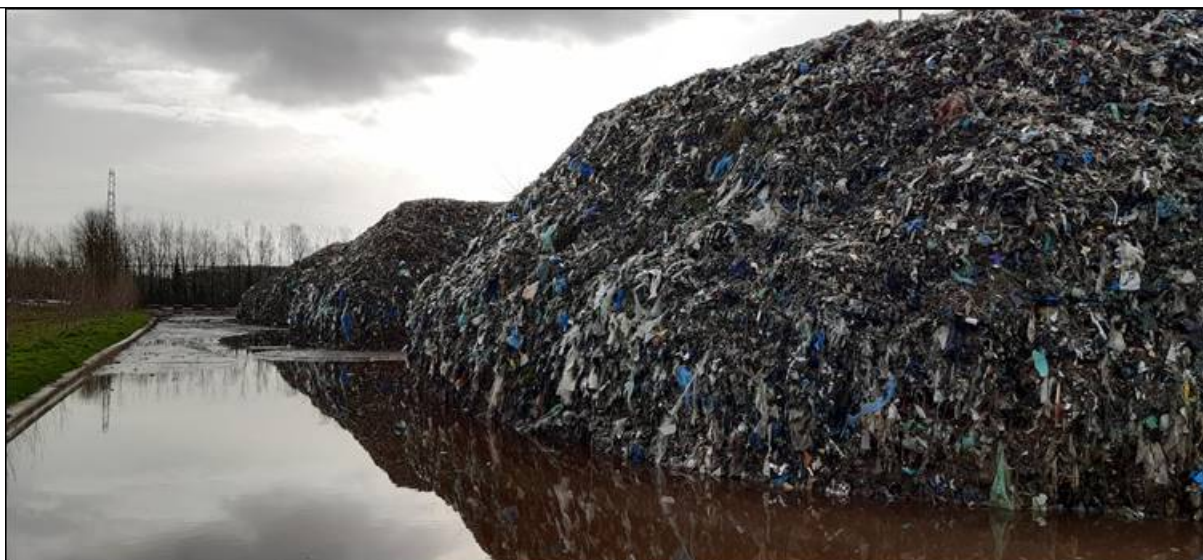
Image 4 - showing the ends of three of the stockpiles on Field 1, taken on 16 February 2021

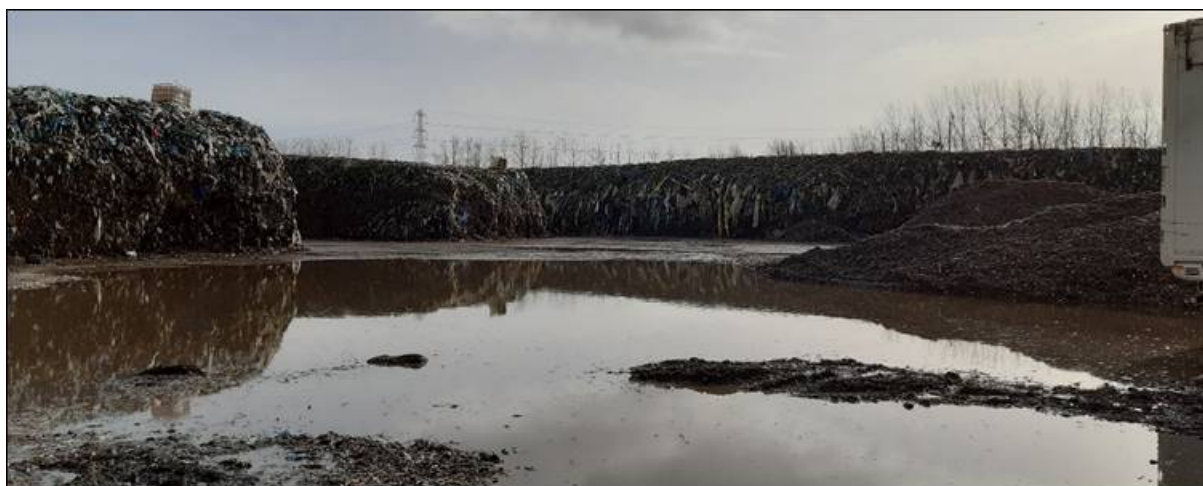
Image 5 - showing various stockpiles and the open space where processing of the material takes place on Field 1, taken on 16 February 2021

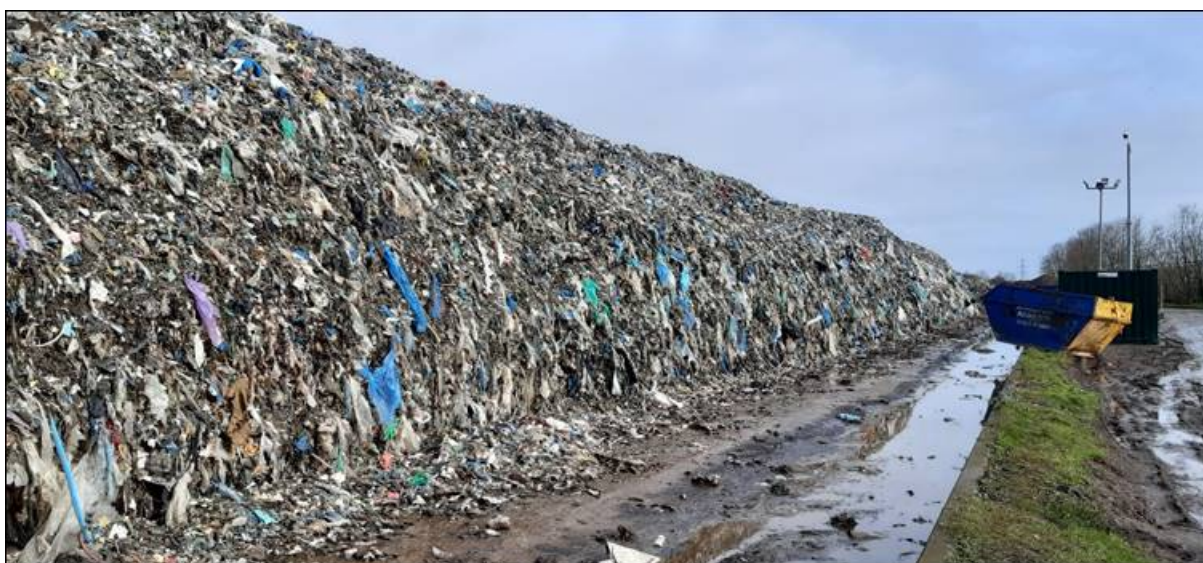
Image 6 - showing the height and length of Stockpile 2 on Field 1, taken 16 February 2021

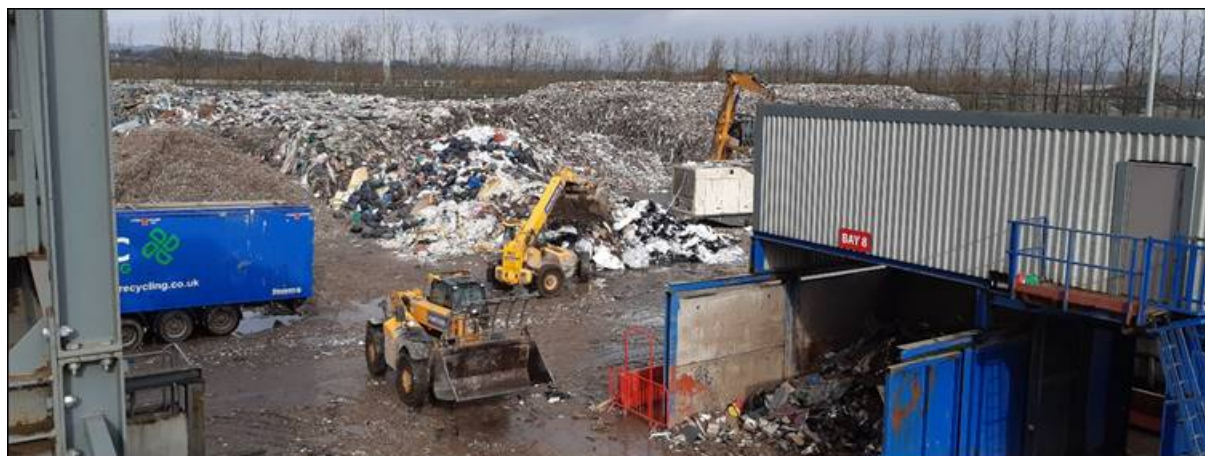
It was evident that there was less waste stored in this work zone compared to the last visit, however large amounts were still present across the area. The operator stated that this is the working area with a high turnover of material - which they are in constant control of. We must reiterate that stockpiles should not be exceeding height restrictions, and despite high turnover of deposited material, waste piles should be distinctly separated to distinguish material age/type and to uphold fire safety principles. If this is not possible due to lack of room, the operator should stop processing and stockpiling material to account for this.

Image 7 - showing volumes of waste stored in the Transfer Station viewed from the MRF, taken 16 February 2021

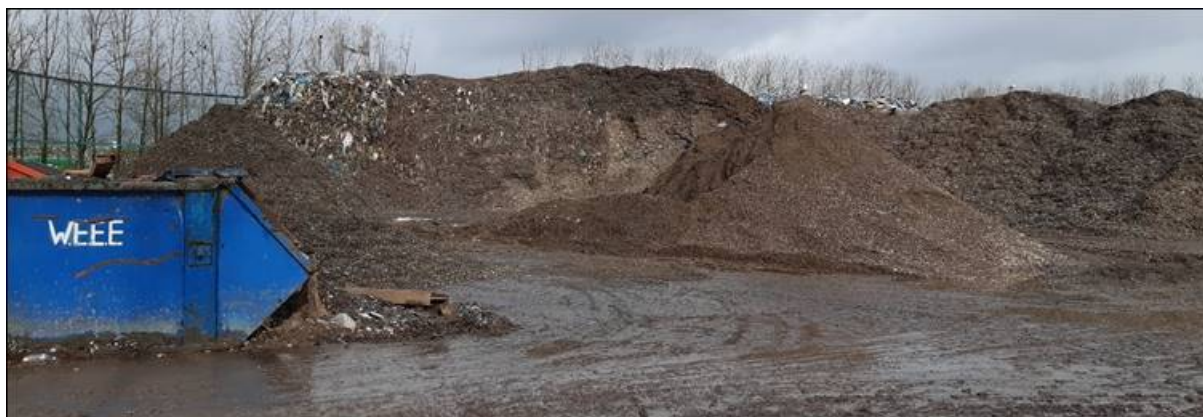
Image 8 - showing processed material stored in one corner of the Transfer Station, taken 16 February 2021

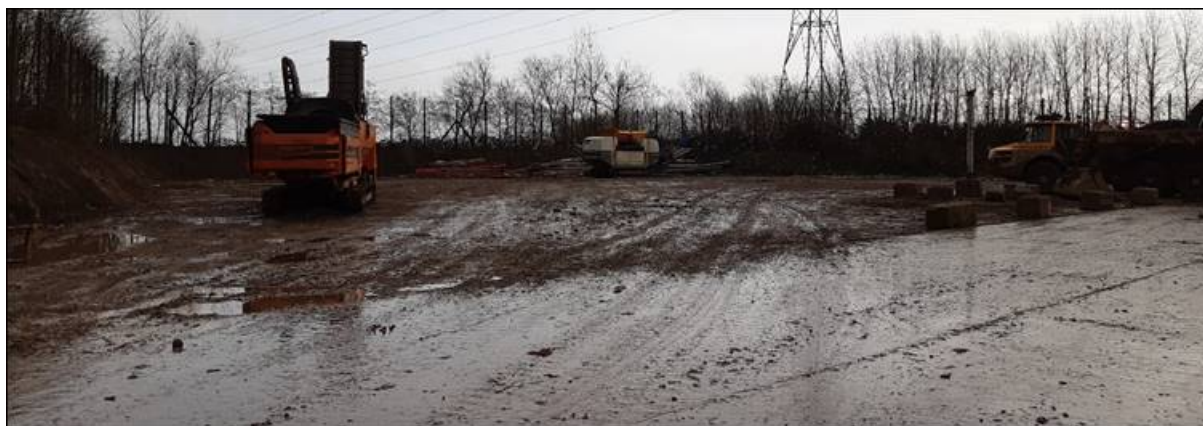
On the last inspection, there were large amounts of material stockpiled opposite the SRF unit with limited room for manoeuvre. This SRF area was now completely cleared, as illustrated in image 9 - this indicates that the operator can get rid of waste. Better separation distances were also observed in this area between the waste streams and units.

Image 9 - showing the SRF area cleared of all material, taken 16 February 2021

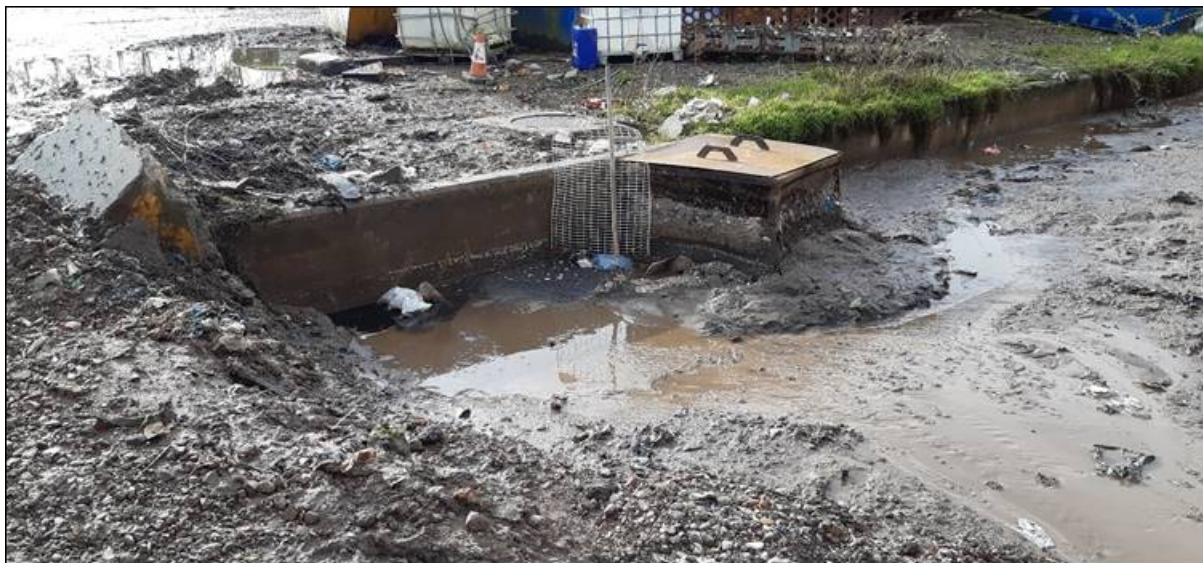
The reed network surrounding Field 1 appeared clear with no obvious signs of contamination. The drain entrance on Field 1 was a little clogged at the time of inspection - please ensure this area is always cleared to maximise the efficiency of the drainage system.

Image 10 – showing the drain entry on Field 1, taken 16 February 2021

| Criteria | Action needed | Complete by |
|---|---|---|
| B3 | The drain entrance on Field 1 was slightly congested at the time of inspection - please ensure this area is always cleared to maximise the efficiency of the drainage system. | 05/03/2021 |
