# Llyn Bran Environmental and Ecology Baseline Report

Report for Dŵr Cymru Welsh Water

# FINAL REPORT

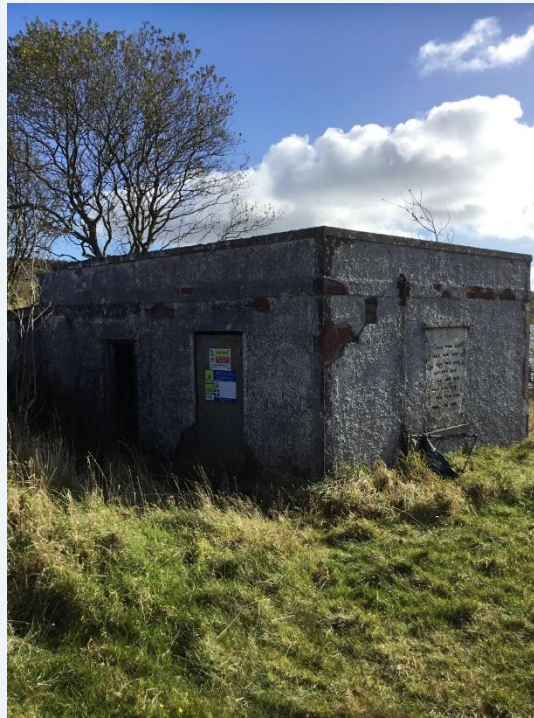
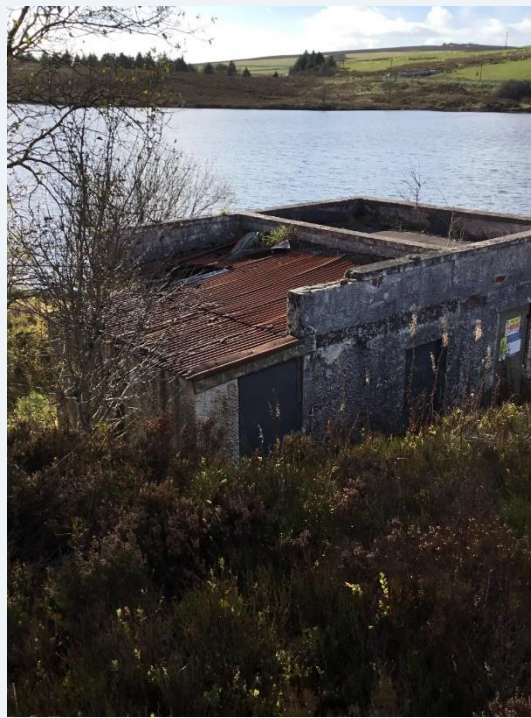
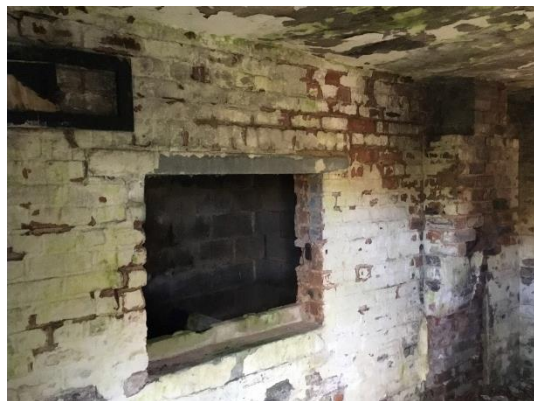
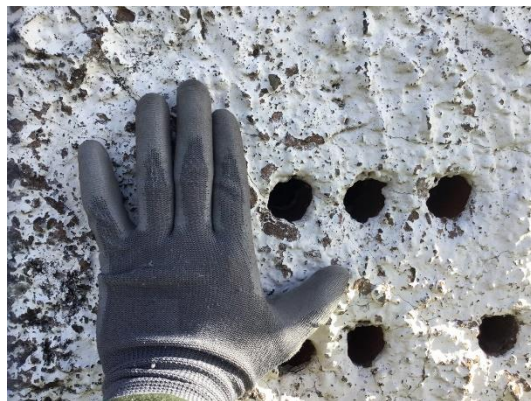
Above (clockwise from top left): 1 – External view from north of Utility Building. 2 – View of roof. 3 – Access opportunities via ventilation holes. 4 – Internal view of eastern section of building.

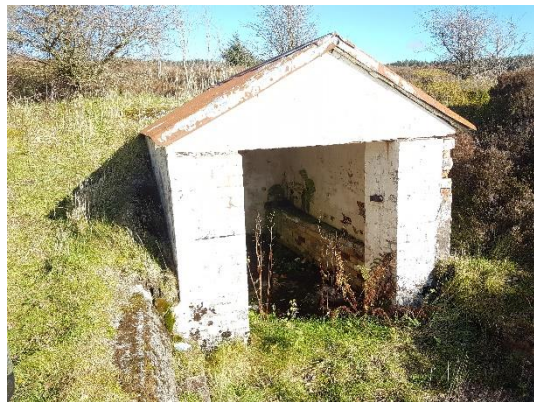
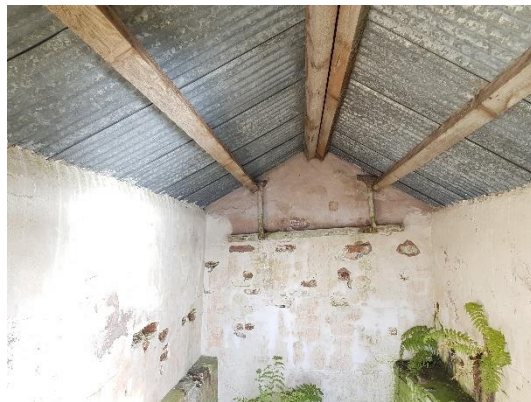
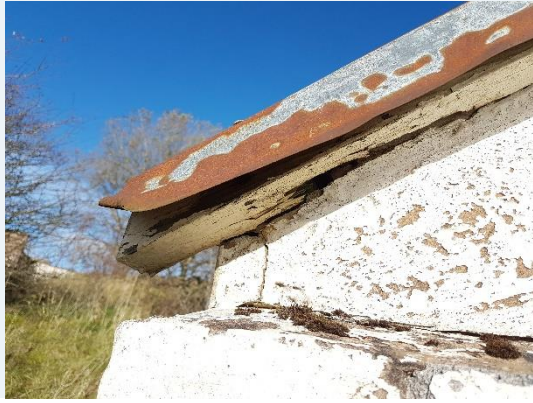
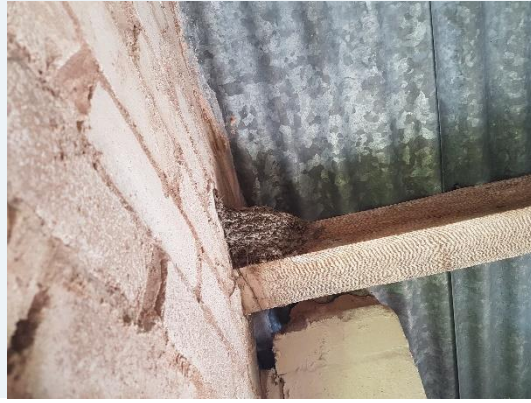
Above (clockwise from top left): 1 – External view from west of Boat House. 2 – Internal view of Boat House. 3 – Swallow nest. 4 – Rotten beam and loose roofing sheet.
