Llyn Bran Environmental Report

Assessment of Potential Impacts and Proposed Mitigation Measures
Associated with Single Drawdown Event

Report for Dŵr Cymru Welsh Water

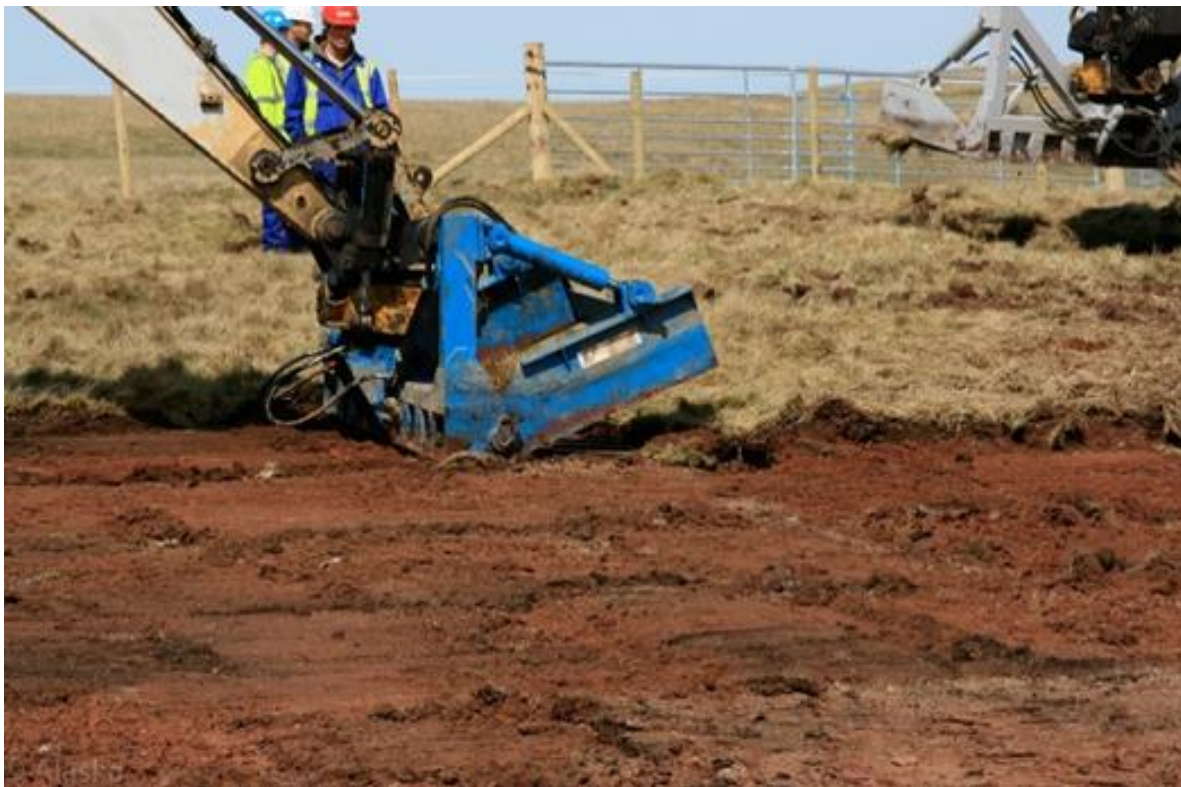
Figure 3-1: Mechanised harvesting of vegetated turf

Translocation of vegetated turf will commence once the reservoir drawdown has been completed (Figure 3-1). An ecologist will identify suitable turf and undertake a survey prior to any turf being cut. A suitably experienced and qualified ECoW will mark out the turf to be cut and will be present on site during all turf cutting

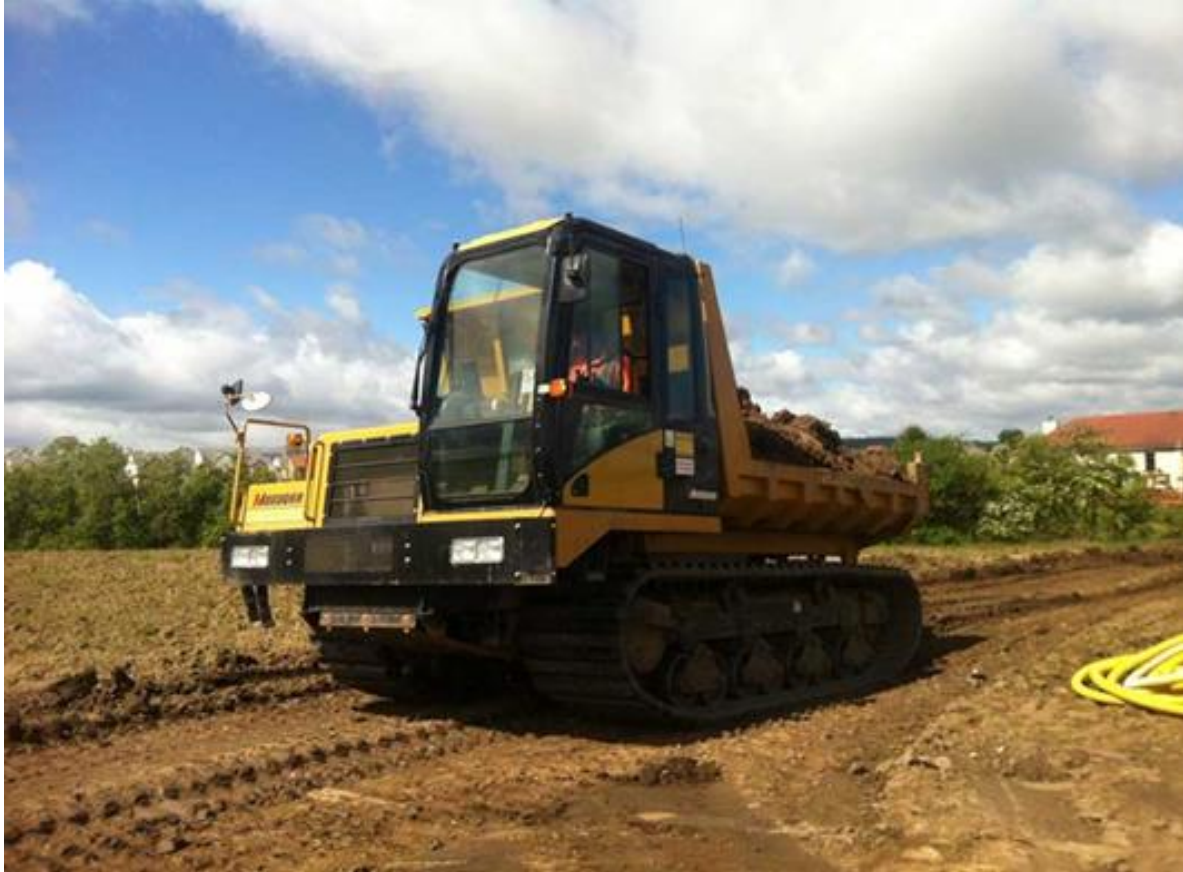
Figure 3-2: Harvested turf will be loaded onto flat backed ultra low ground pressure tracked dumpers

Turf will be loaded onto flat backed ultra low ground pressure tracked dumpers (Figure 3-2). The route from the donor site to the receptor site will be marked out and agreed to by the ECoW prior to movements of machines. If the route starts to cut up or vegetation becomes damaged, then new routes will be used. If the ground is too soft for tracked dumpers at the time of works then temporary trackway will be laid. A key unknown is how firm the lakebed sediments will be. If a tracked dumper is unable to track down over the exposed lake sediment, then a second amphibious machine may be needed to ferry turfs down to the receptor site.

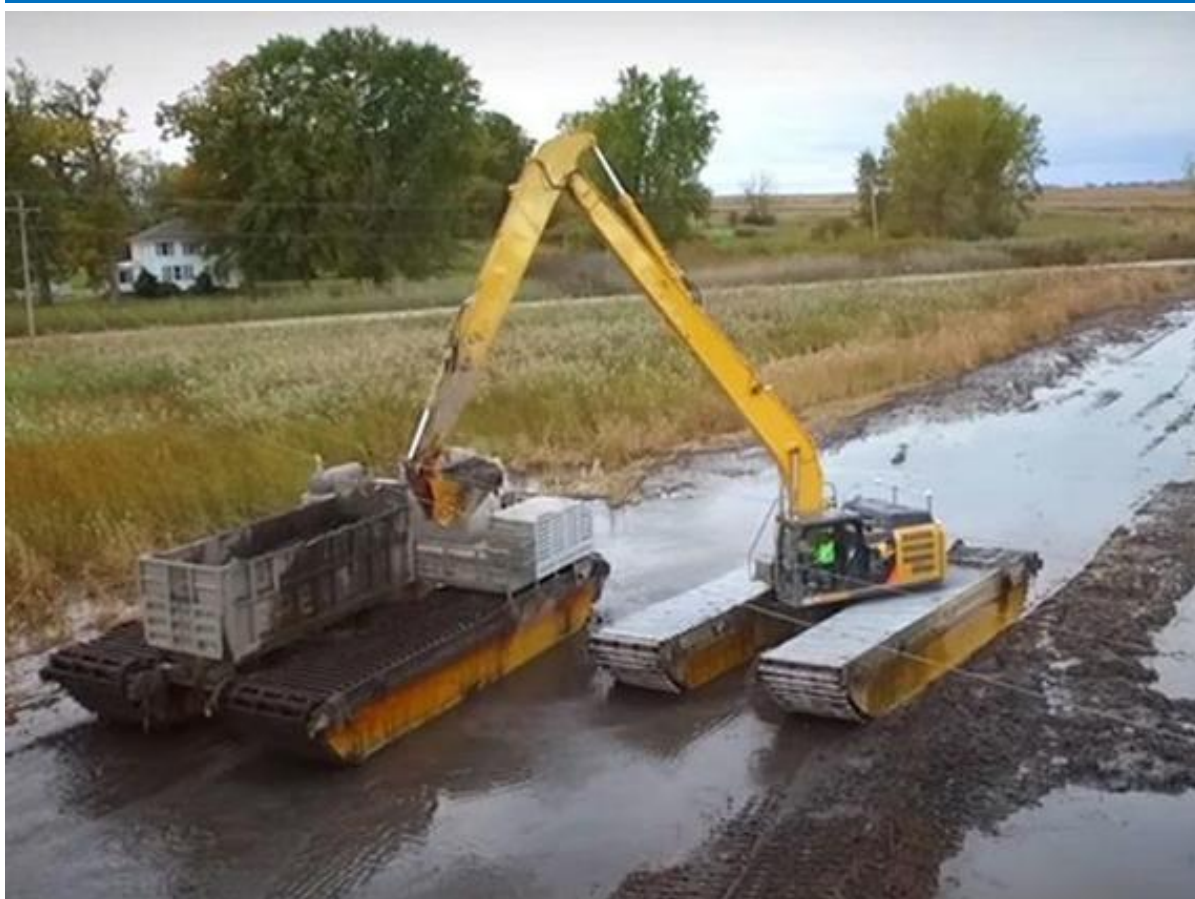
Figure 3-3: An amphibious excavator will be used to unload and place the turf without damaging it.

An amphibious excavator will be fitted with a flat plate bucket in order to unload and place the turf without damaging it (Figure 3-3).
