## Reservoir Discontinuance - Brithdir Mawr Reservoir

Aber Eilun and Afon Alun walkover survey and WFD assessment

Report for Dwr Cymru Welsh Water

ED 14544100 | Issue number 1 | Date 6 Oct 2021

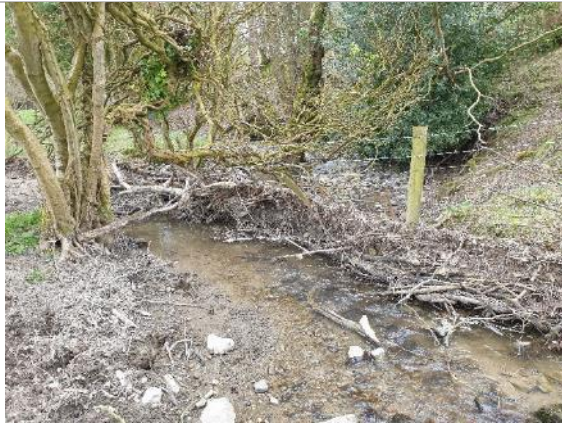
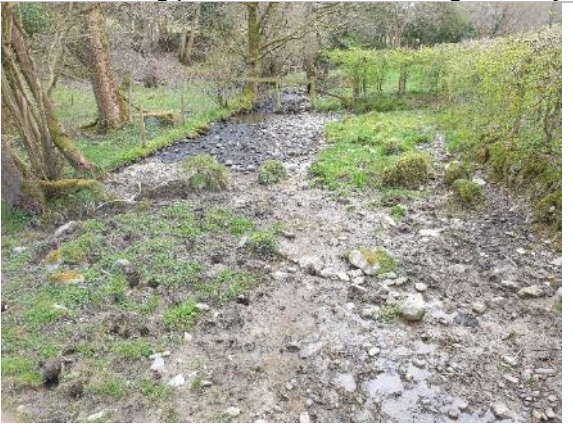
**Table 2-5**      **Reach E character photos**

a) Looking downstream from the mid-point of the reach.	b) Looking upstream from the end of the reach. Cattle drinking point and small inflowing tributary.

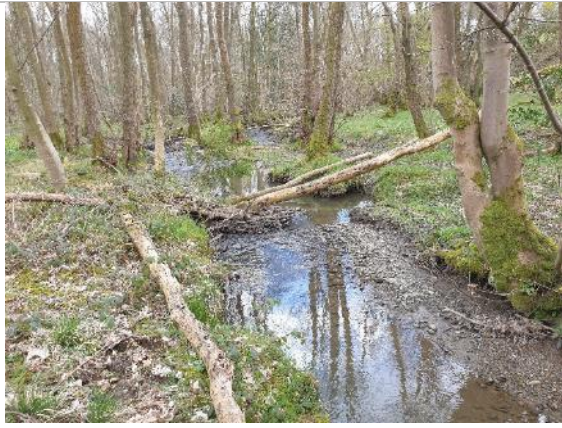
**Table 2-6**      **Reach F character photos**

<p>a) Looking downstream from the upstream end of the reach. Note large woody debris and sediment bars.</p>	<p>b) Looking downstream from ~0.15km along the reach. Note large woody debris, sediment bars and diversity of flow and sediment.</p>

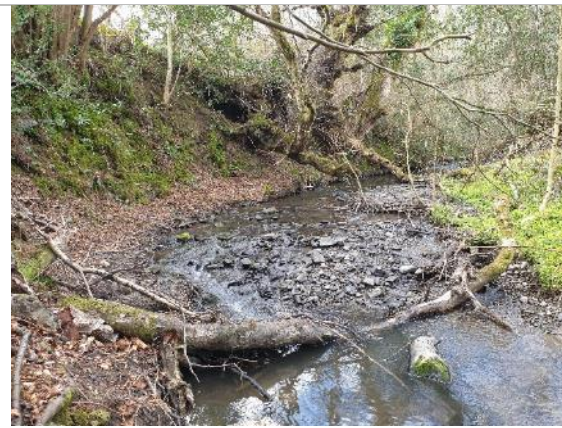
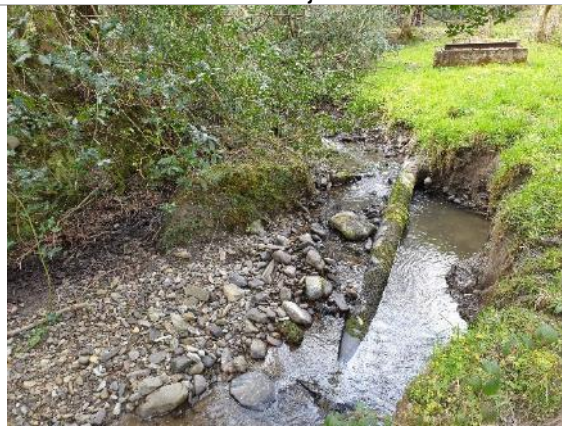
<p>c) A view looking upstream from ~0.38km along the reach.</p>	<p>d) A view looking upstream from ~0.43km along the reach. Pipe within the channel is leading to erosion of the left bank adjacent to it.</p>

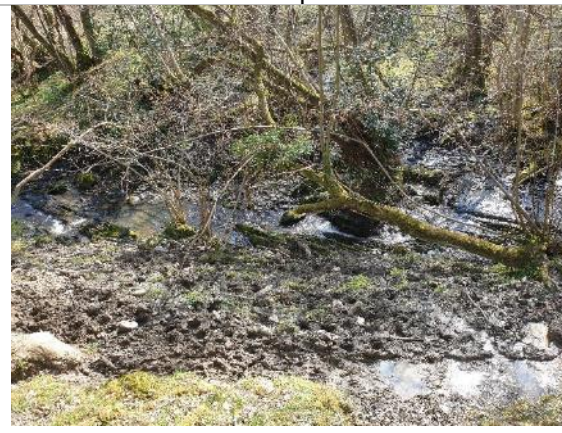
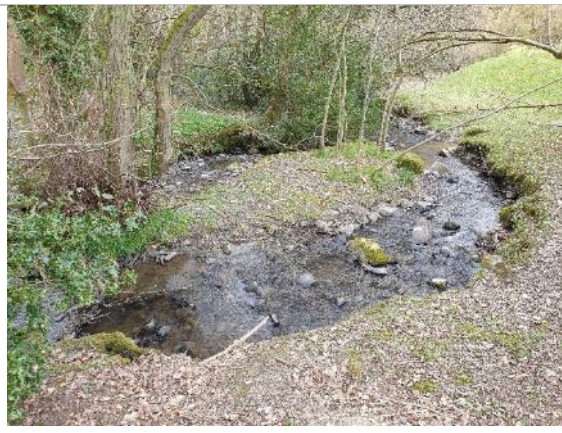
<p>e) A view looking south across the channel from ~0.5km along the reach. A heavily poached section with some fine sediment input. This reach is a series of bedrock steps.</p>	<p>f) A view looking upstream from 0.6km along the reach with a small island in the centre of the channel.</p>

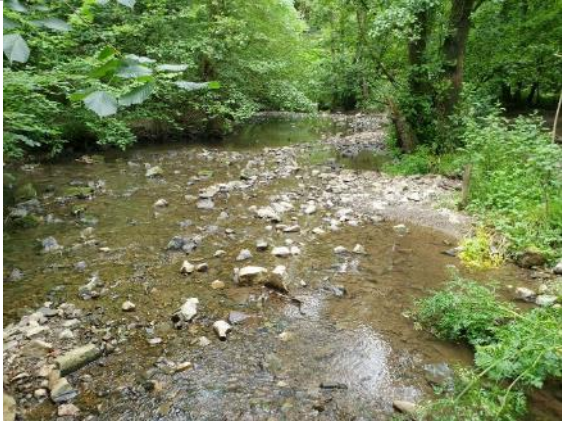
<p>a) Looking downstream ~60m downstream from the start of the study reach.</p>	<p>b) Looking downstream from ~0.1km downstream from the start of the study reach. Note the temporary weir positioned in the channel. This will likely be displaced by higher flows.</p>

<p>c) A view looking downstream ~0.26km downstream from the start of the study reach. Note the diversity of sediment.</p>	<p>d) A view looking downstream ~0.38km downstream from the start of the study reach. Note the diversity of sediment and variation in flows caused by protruding sediment.</p>

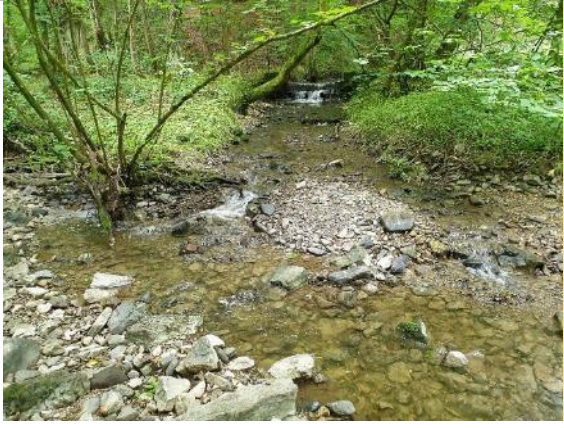
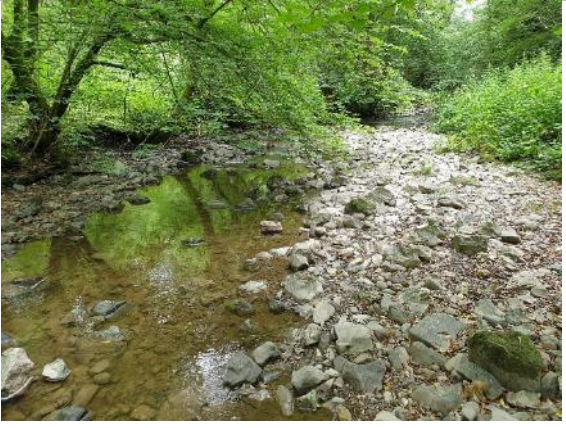
**Table 2-12** Reach K character photos

a) Looking upstream into the Aber Eilun from the confluence with the tributary and the Afon Alun. Note the flow from the Aber Eilun wetting the reach.	b) Looking downstream from the start of the reach. Note the flow in the reach contributed by the Aber Eilun which is insufficient to fill the entire channel of the Afon Alun.

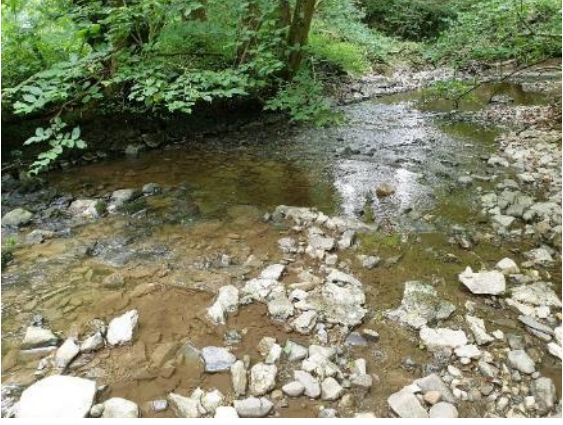
c) A view looking downstream from ~15m downstream from the start of the reach.

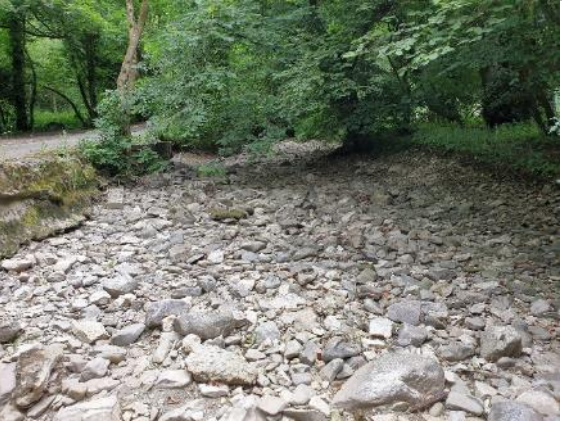
**Table 2-13** Reach L character photos

<p>a) Looking downstream from the start of the study reach. Note the flow from the Aber Eilun has mostly been lost and is represented by shallow and stagnant pools in the bed.</p>	<p>b) Looking upstream from the end of the reach. Note the dry channel and bank reinforcement on the right bank due to the presence of a road.</p>

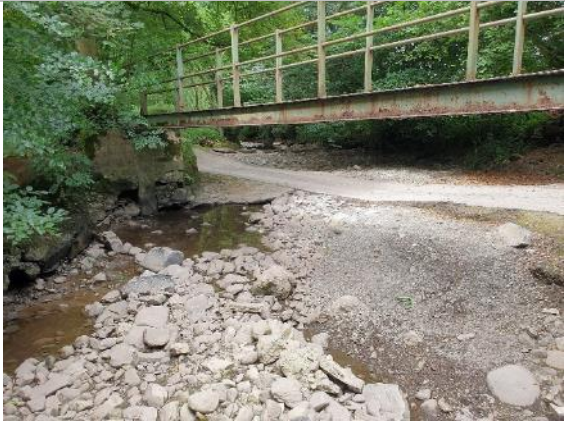
<p>c) A view looking downstream from the end of the reach. Note some ponded flow on the left bank, the ford with concrete bed and the metal footbridge. The Meas-Y-Groes STW is located on the left bank.</p>

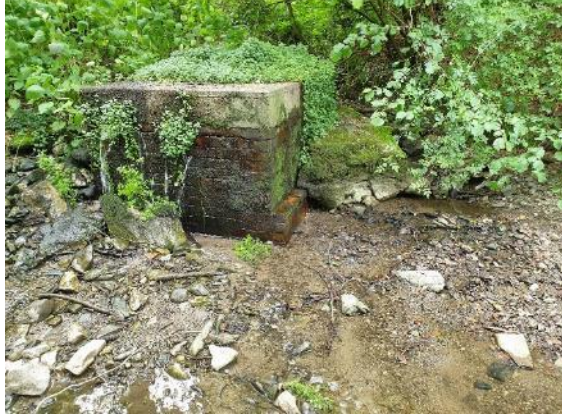
**Table 2-14**      **Reach M character photos**

<p>a) Looking towards the Meas-Y-Groes STW outfall at the start of the reach. No distinct outfall is apparent, with flow seemingly seeping out of the structure.</p>	<p>b) Looking downstream from the start of the reach. Notice the coarse substrate and pooled flow and the extensive bankside slumping and fallen trees on the left bank.</p>

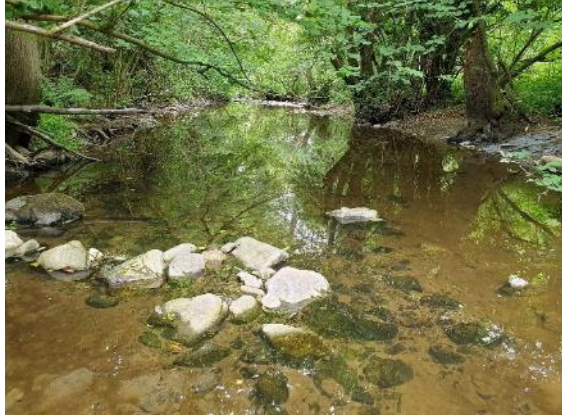
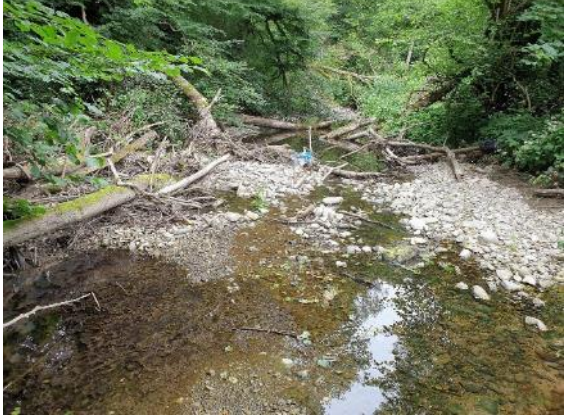
<p>c) Looking downstream from ~0.18km downstream of the start of the reach. Here the channel is nearly fully wetted however there is essentially no flow.</p>	<p>d) Looking downstream from ~0.29km downstream of the start of the reach. Note the sediment bars and large woody debris leading to much sediment and flow diversity.</p>

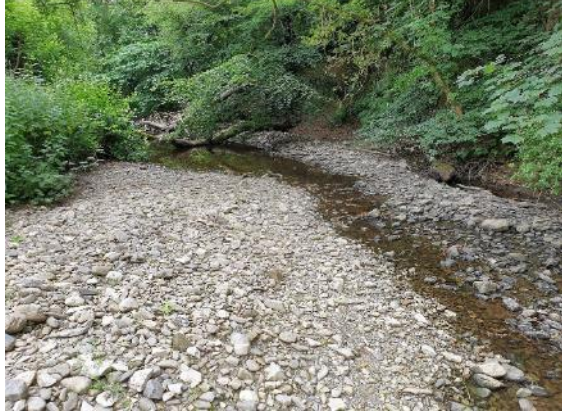
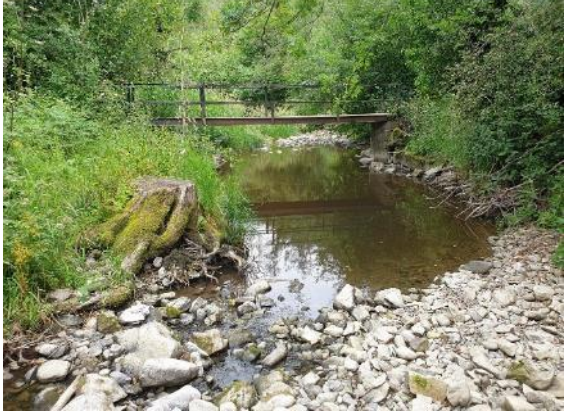
<p>e) Looking upstream from ~0.32km downstream of the start of the reach. Note the thread of channel flowing from the large woody debris upstream. Most of the pooled sections in this reach have some degree of connectivity.</p>	<p>f) Looking downstream at the end of the reach. Note the pooling of flow and the footbridge.</p>

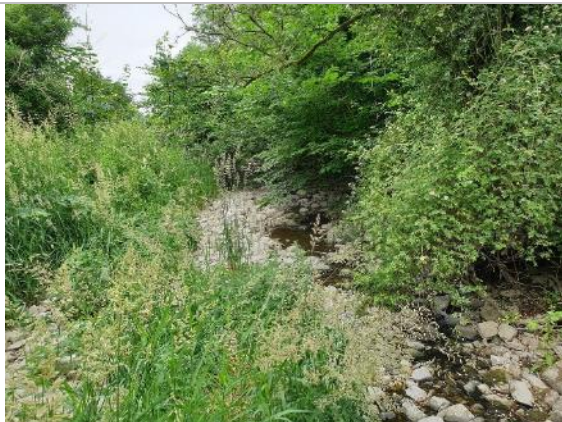
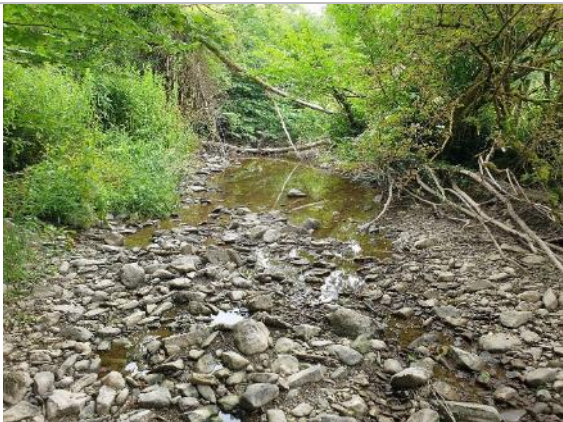
**Table 2-15**      **Reach N character photos**

<p>a) Looking downstream from the start of the reach. Note the in channel vegetation and the presence of sky indicating a change in valley form.</p>	<p>b) Looking downstream from ~60m downstream of the start of the reach. The large woody debris is controlling flow and causing pooling.</p>

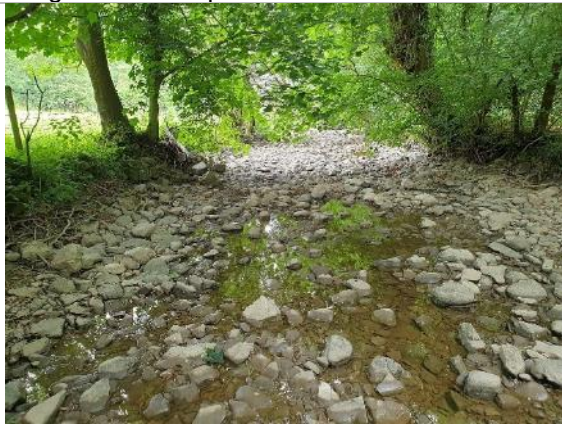
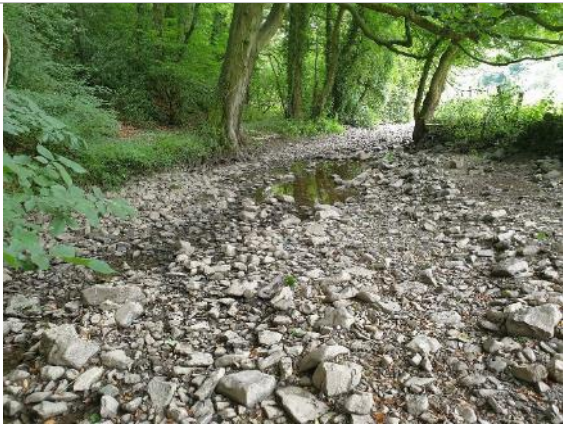
<p>c) Looking downstream from ~90m downstream of the start of the reach. Note pooled flow in the reach and the coarse cobble substrate and the flat grassed floodplain on the left bank.</p>	<p>d) Looking upstream from the end of the reach. The flow is essentially lost to the ground at this point.</p>

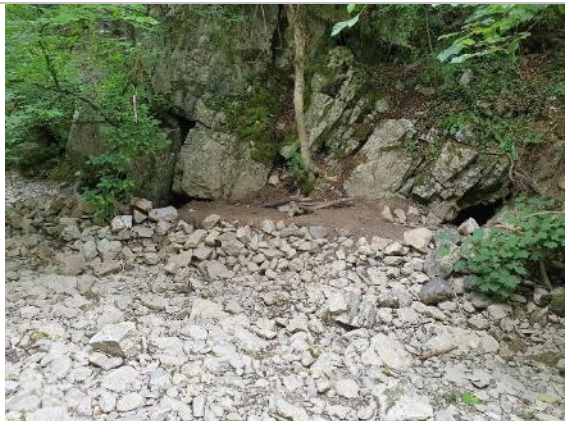
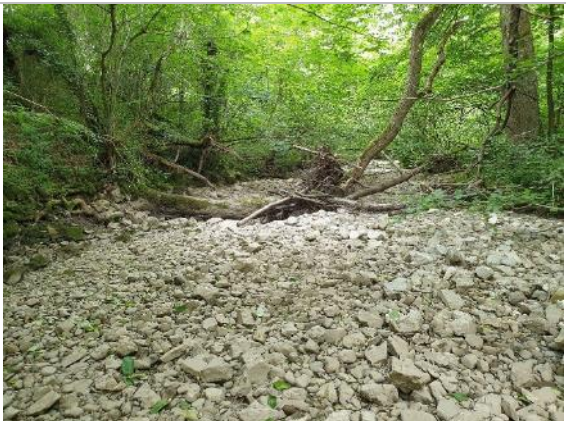
<p>c) Looking downstream from ~0.35km downstream of the start of the reach. Note the fining of bed particle size compared to upstream sections. A discrete disconnected pool of flow was present in a depression in the channel.</p>	<p>d) Looking downstream from ~0.38km downstream of the start of the reach. A wide range of sediment sizes are present in the channel. Note the extensive vertical limestone cliff towards the rear of the image.</p>

<p>e) Looking downstream from ~0.52km downstream of the start of the reach. The limestone exposure on the right bank contains multiple caves/sinkholes with an artificially created embankment around them.</p>	<p>f) Looking downstream from ~0.68km downstream of the start of the reach showing large woody debris located within the channel.</p>

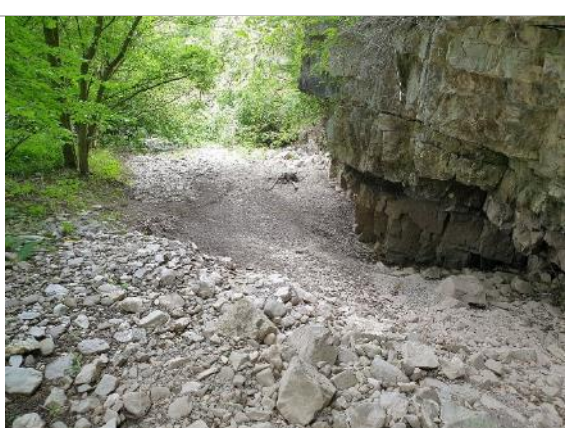
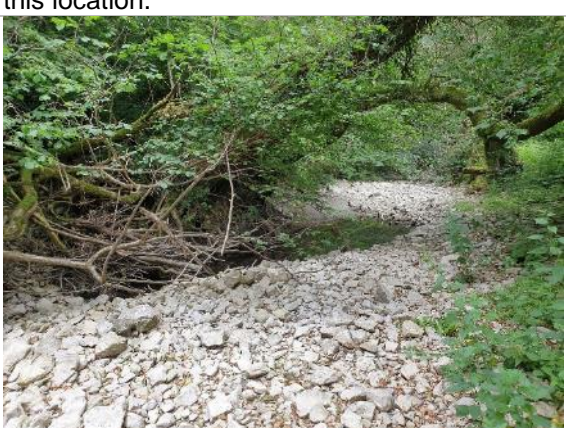
<p>g) Looking downstream from ~1.23km downstream of the start of the reach. Note the vertical limestone cliff with extensive scour around the base of the cliff.</p>	<p>h) Looking downstream from ~1.34km downstream of the start of the reach showing a disconnected pool of water at the base of a tree. The spring inflow is located ~20m downstream of this location.</p>

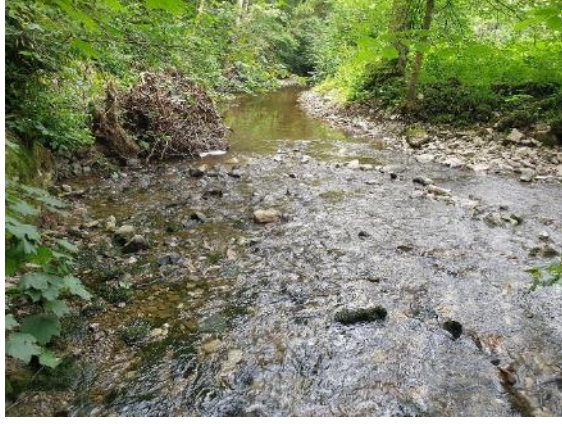
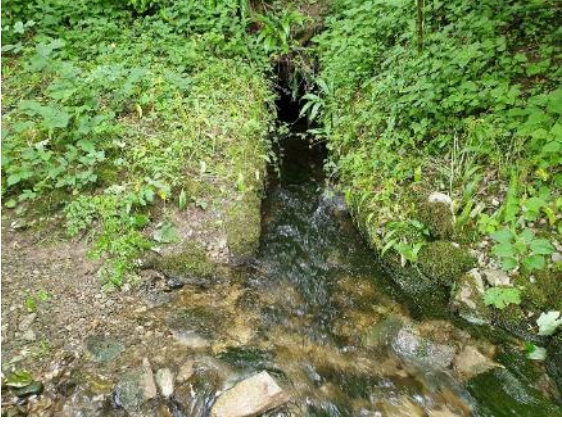
**Table 2-17**      **Reach P character photos**

a) Looking downstream from the start of the reach.	b) Looking towards the spring from at the start of the reach. The outlet of the spring has been artificially modified using laid stone.

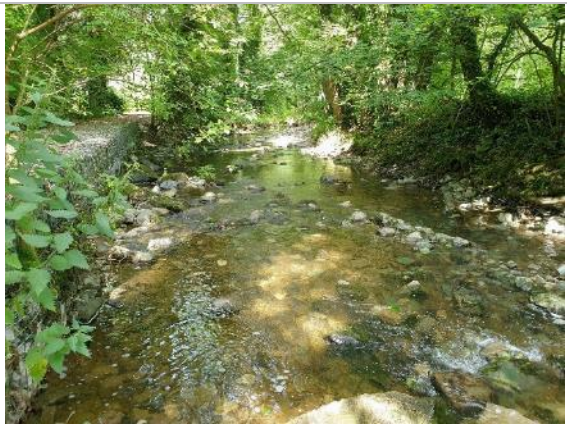
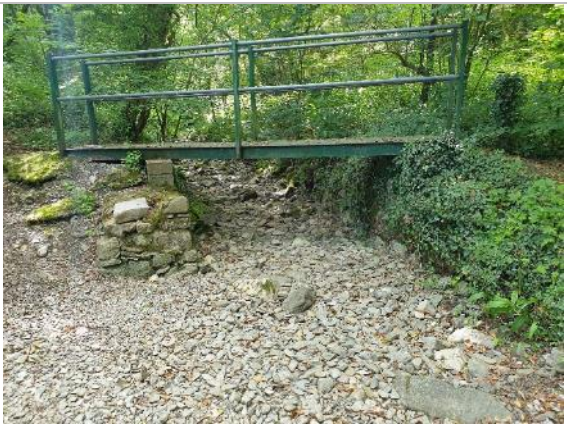
**Table 2-18**      **Reach Q character photos**

<p>a) Looking downstream from the start of the reach. The Nant Gain joins from the left immediately upstream of the gabions on the left bank.</p>	<p>b) Looking upstream into the Nant Gain. Note the channel is dry.</p>

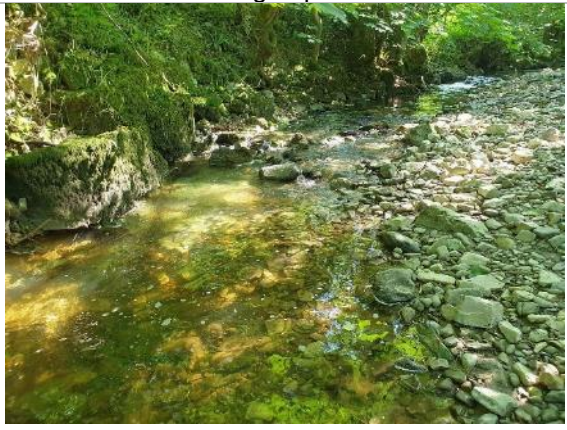
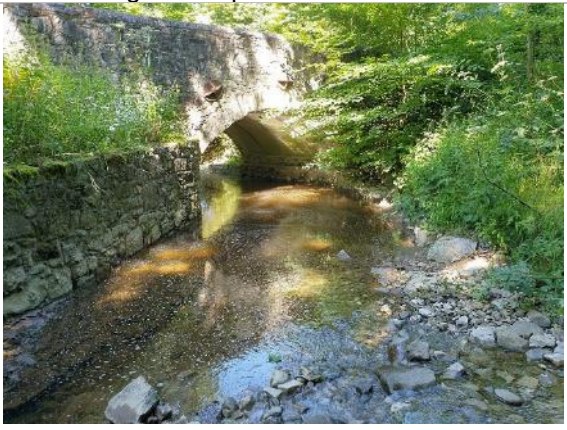
<p>c) Looking upstream from ~0.1m downstream of the start of the reach. Flow is being lost to the ground at this point on the right bank. Note the transition from moving to pooled flow.</p>	<p>d) Looking downstream from ~125m downstream of the start of the reach. Note pooled flow beneath Cilcain Road bridge. Most flow has been lost to the ground upstream.</p>
