# Garnswllt WWTW

## Garnswllt Water Features Survey

*300392-DEL-XXX-RP-00001 P01*

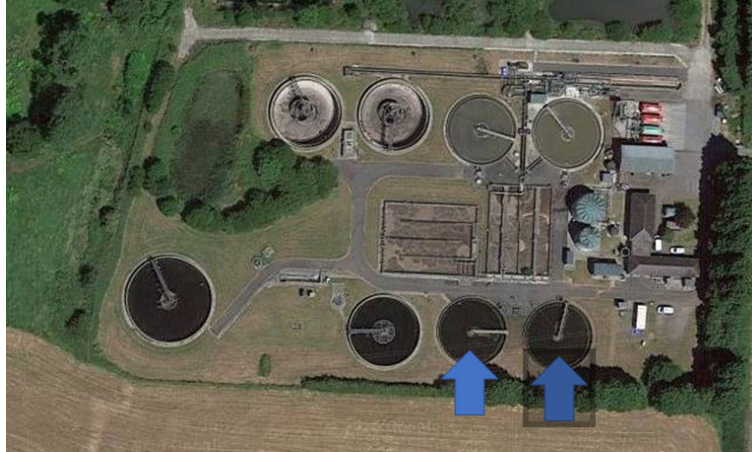
**Figure 1. Location of tanks in question**

The tanks in question are indicated in Figure 1 below.
