## Rhyl Harbour Maintenance Land Based Dredging

Water Framework Directive  
Assessment  
November 2021

Denbighshire County Council

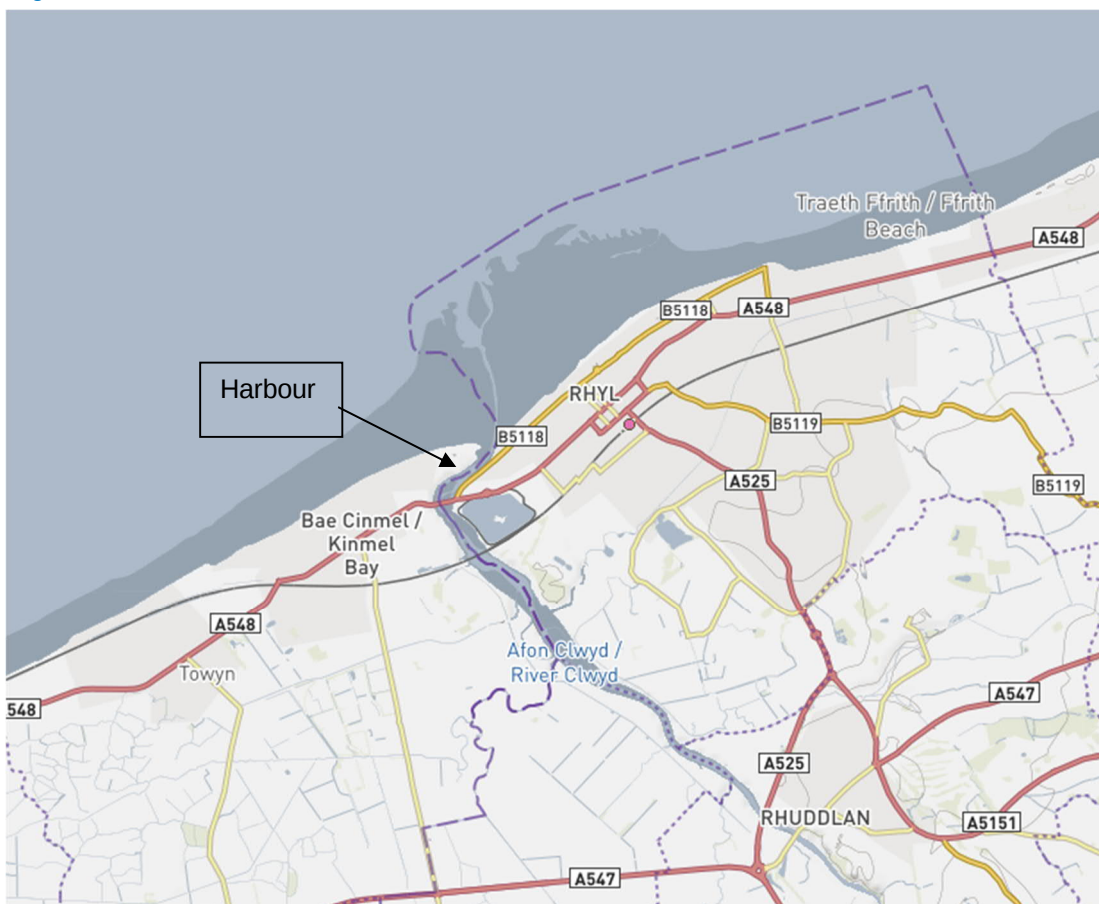
Figure 1: Site Location

The northern boundary of the harbour area (from west to east) comprises the Rhyl Yacht Club building and boat yard, the Rhyl Harbour boat yard, car park and quay wall, the harbour building and public square and the extended quay wall. Horton's Nose Lane serves the northern area of the harbour. The southern boundary (from west to east) is formed by the inner and outer sea walls (West Parade road runs beyond and parallel to the sea walls), and the training wall guiding the navigable channel out to the north-east. The western boundary of the harbour basin is formed by the Rhyl Harbour Bridge (the Blue Bridge) and a recently constructed Pont y Ddraig bridge spans the harbour from the public square to the junction of West Parade and Quay Street for pedestrians and cyclists.
