Bioaerosol Sampling Report 2021

FCC Environment

Bryn Lane IVC (Phase 1)

06<sup>th</sup> October 2021

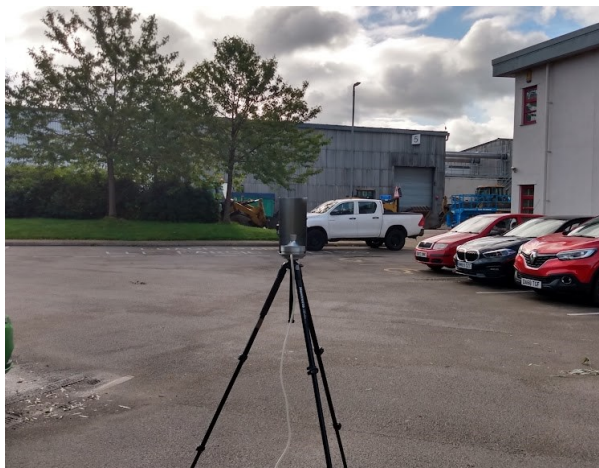
Upwind location 1 – Position of the upwind sampler facing the IVC facility

**Upwind location:** The upwind sample location was in the car park next to the visitor entrance of the main office by the site boundary fence.

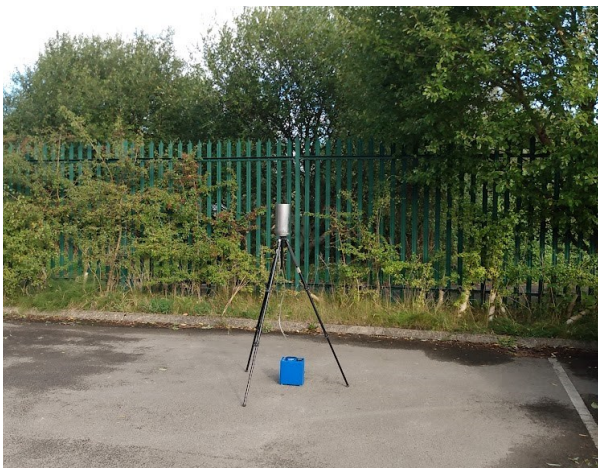
Upwind location 1 – Position of the upwind sampler facing away from the IVC facility

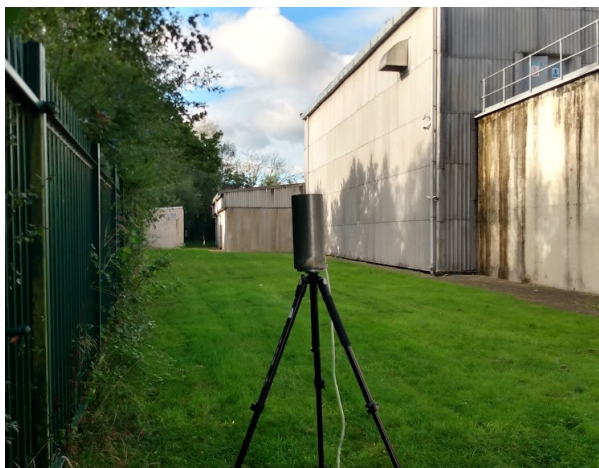
Downwind location 2 – Position of the downwind sampler, looking towards IVC facility

**Downwind location:** The downwind location was located on a grass area by the site boundary fence near thick vegetation and trees downwind of the IVC.

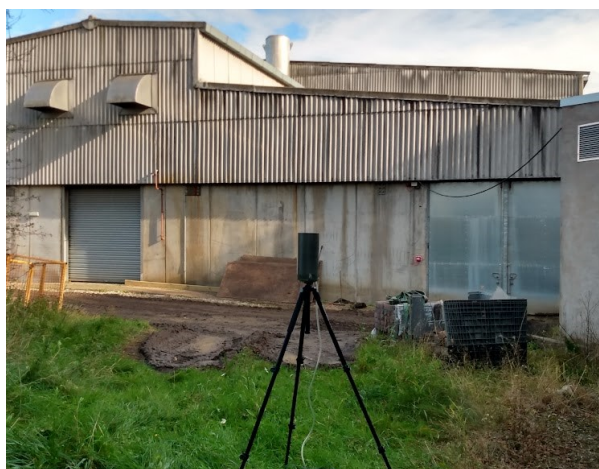
Sensitive Receptor location 3 – Position of the receptor sampler, looking towards the IVC facility

**Sensitive Receptor Location:** The sensitive receptor location was placed on a grass area to the south-west site boundary between the IVC and the council offices. It was noted that vegetation of trees, weeds and tall grass was present close to the sample location.

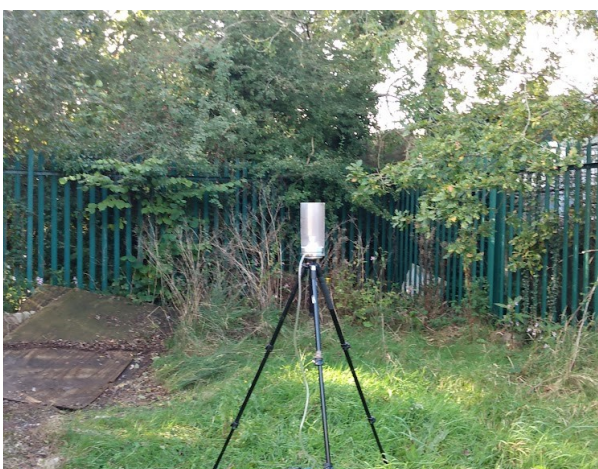
Sensitive Receptor location 3 – Position of the receptor sampler looking away from the IVC facility
