**MILFORD HAVEN PORT AUTHORITY**

**DREDGING  
STRATEGY DOCUMENT**

**Revision 3**

**October 2021**

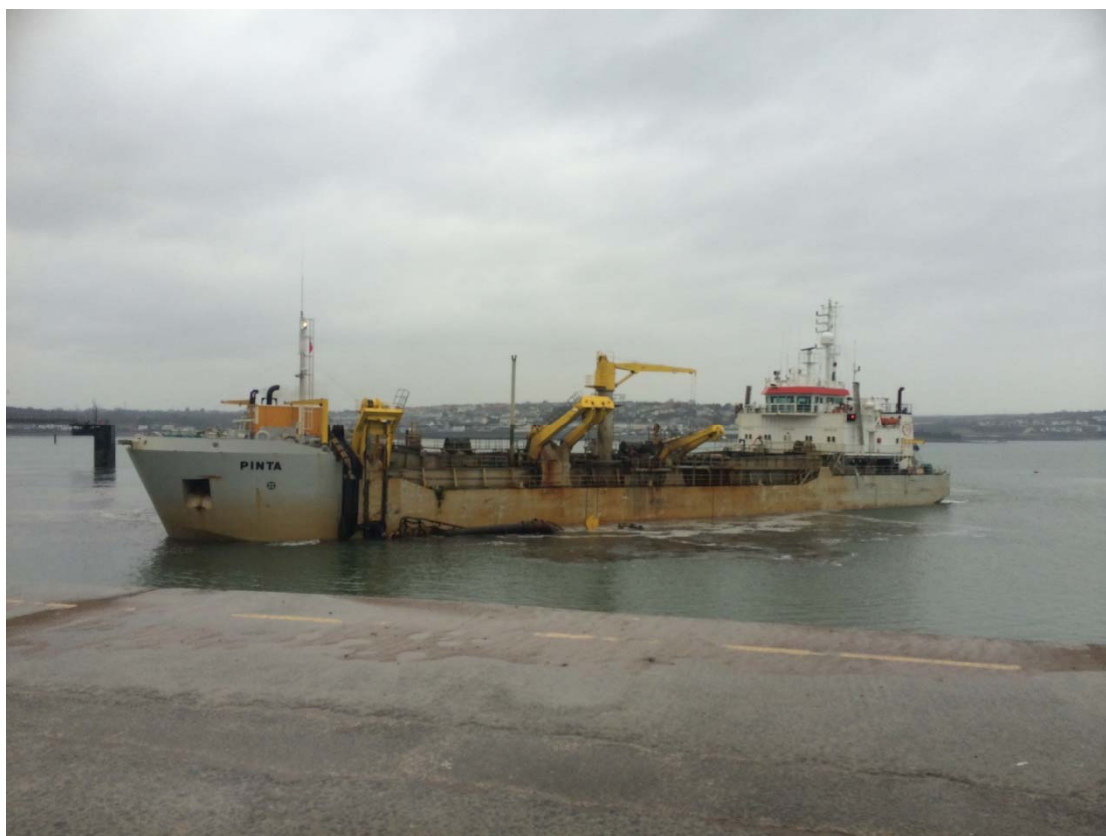
Plate 1. The TSHD “Pinta” working in Pembroke Dock in 2016

The dredged sediment is raised to the surface by hydraulic action and stored within the hopper of the vessel. Once the vessel is full of a mixture of sediments and water the dredging process may continue in order to increase the sediment to water ratio in the hopper. This is achieved by allowing the surface water, in the hopper, to overflow through a dedicated weir system within the hopper. The optimum period of the overflow will depend on the particle size and density of the material being dredged. Where soft mud and silt are being dredged there is usually very little to be gained by extended periods of hopper overflow, as the dredging action puts a high proportion of the fine sediments into suspension, creating dense slurry, from which the solids will not settle out of suspension during the dredging operation. If overflow is permitted when dredging fine silts the hopper load will not increase significantly, as the density of the material overflowing will be similar to the density of the material being dredged from the seabed. This is not the case when dredging sands and gravels, which typically contains a low percentage of finer material. The use of the overflow when dredging coarse material can safely be permitted for some considerable time without causing significant impact on water turbidity levels, as the sand settles to the bottom of the hopper and only the supernatant water flows out of the overflow weir. The use of overflowing, or weiring as it is sometimes called, when dredging sands and gravels results in a more economic and efficient dredging operation as the load is maximised prior to the vessel departing to the disposal site. This is a very important consideration in Milford Haven as the offshore disposal sites are a significant distance from the port (LU169 = 35km). To transport a hopper load that contains a high proportion of water is very inefficient, both environmentally and economically. By maximising the load the CO<sup>2</sup> emissions associated with each m<sup>3</sup> of dredged material is minimised. The trade-off between local turbidity, the overall environmental impact of the whole process and the financial cost all have to be taken into account when formulating a 'best practice' approach to dredging.

Once the hopper is full, dredging stops and the suction pipe is raised to the surface and stowed on the deck of the vessel. The vessel sails to the designated disposal site under its own power. When the disposal vessel has reached the designated licensed disposal site the doors at the bottom of the hopper are opened and the contents of the hopper are discharged. Once the hopper is empty and flushed clean, the vessel closes its bottom doors and returns to the dredging site on a reciprocal course.

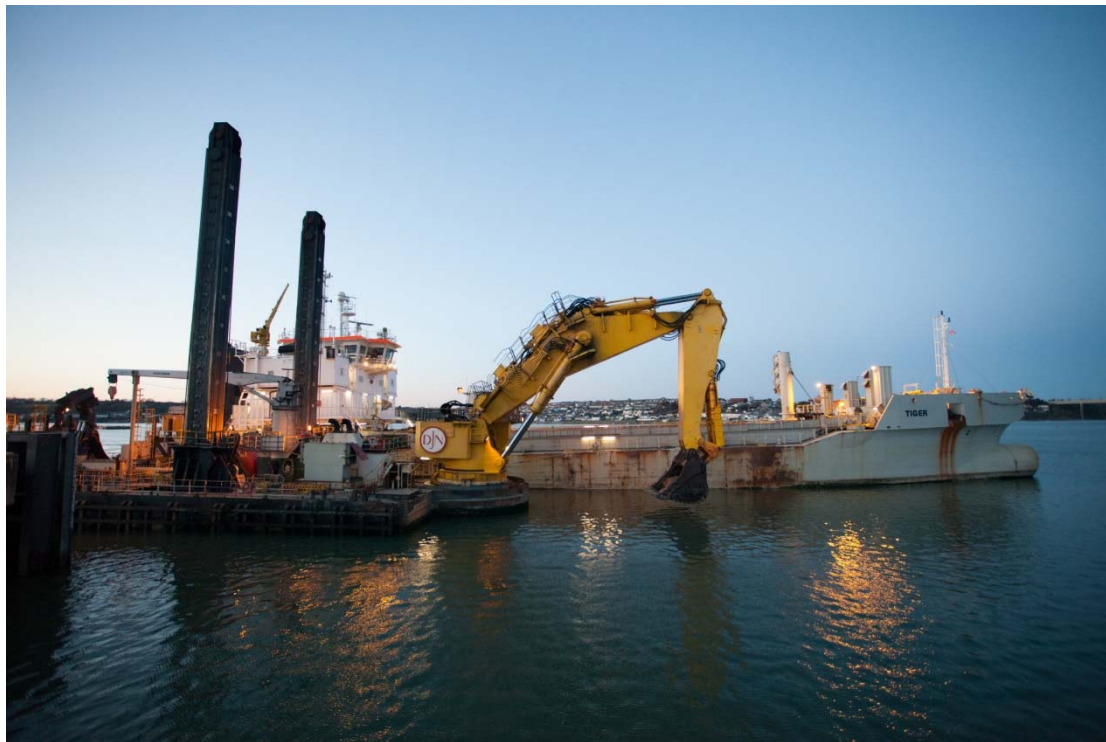
Plate 2. *The Backhoe dredger “Mimar Sinan” loading dredged material into the split hopper barge “Tiger” at the PDFT Milford Haven in February 2016.*

and that the deepening work required excavation using a large backhoe. A backhoe was also used in 2015/16 to dredge material from the inaccessible areas between the berths and the mooring dolphins at Semlogistics and also close to the fender piles at the Pembroke Dock Ferry Terminal (PDFT), which are both areas that a TSHD cannot easily access.

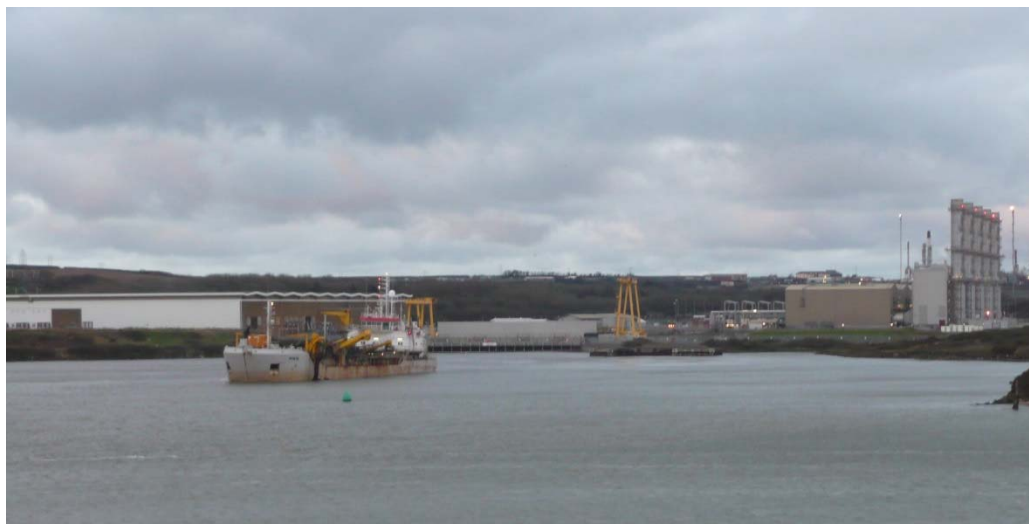
Plate 3. TSHD 'Pinta' dredging in Powerstation intake channel in January 2016.

This same method of dredging was also used for the ‘capital’ dredging required in association with the new Pembroke Power Station development. Although, at the time, the regulators classified this particular dredging as ‘capital’ dredging it was in fact infrequent maintenance dredging. Due to the closure, and subsequent demolition of the old power station, maintenance dredging had not been carried out for over 10-years and hence was classified as ‘capital’ works by the regulator. The main reason that a backhoe was considered the most suitable plant for that particular dredging was due to the shallow nature of the site. Backhoe dredgers and their associated barges generally have much shallower draught limitations compared to a TSHD and are therefore less prone to tidal restrictions. Maintenance dredging of the outer portion on the intake approach channel of the power station was successfully carried out by a shallow draught TSHD in January 2016 (See Plate 3).

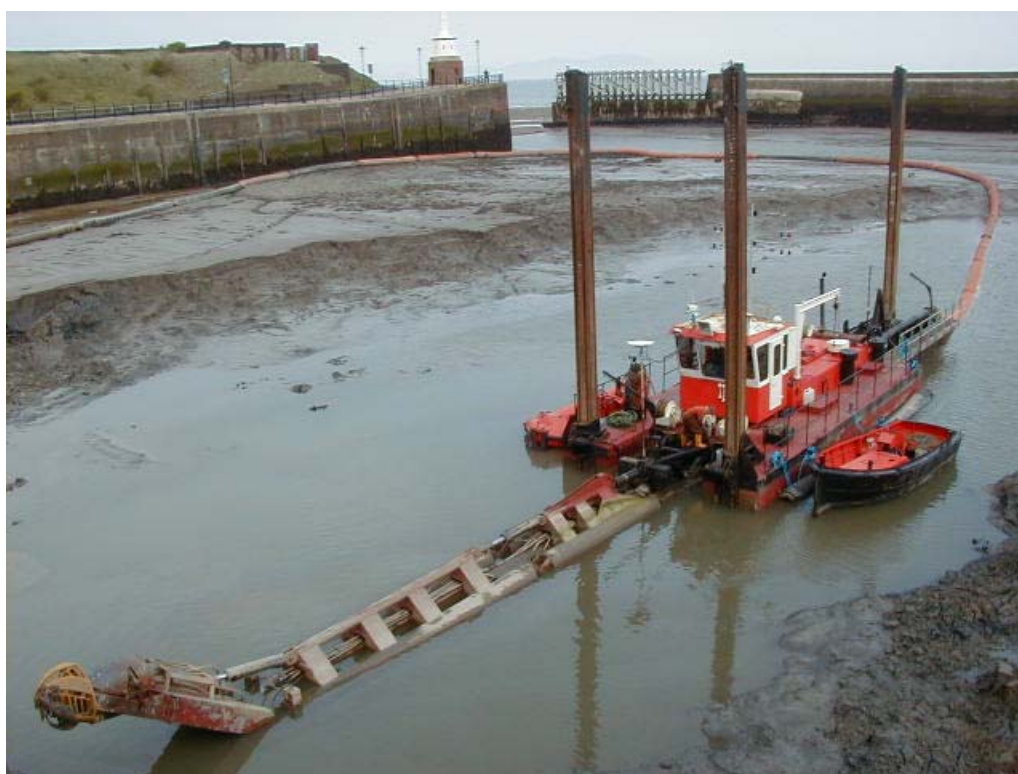
Plate 4. A small Cutter Suction Dredger working in a shallow channel. The discharge pipe can be seen trailing out behind the vessel.

Cutter suction dredgers come in various sizes, the largest of which are capable of cutting and transporting solid rock. They are particularly efficient at transporting material short distances (<2km) from a dredge/winning site to the disposal/reclamation area, as the excavation is almost continuous and does not require the interruption to the dredging process as that associated with a TSHD. Longer pipeline lengths/distances can be achieved with an auxiliary in-line booster pump(s).

Due to the suction orifice being located within the cutter head crown the vast majority of disturbed material is sucked up into the discharge pipe. With the correct operation, the release of suspended sediments into the local environment can be kept to a minimum.

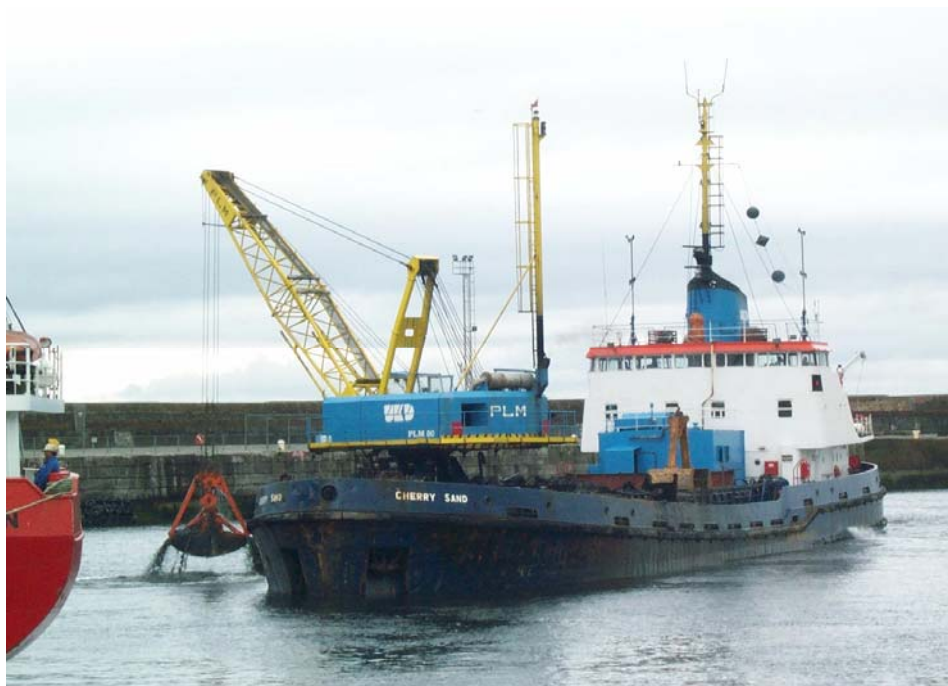
Plate 5. Grab hopper dredger “Cherry Sand” working inside a dock

The above grab hopper dredger was used in Pembroke Dock in June 2020 to remove sediments that had accumulated within Berth2. Some of the material to be removed was located at the inner end of the berth, which was very difficult for another dredger type to access.

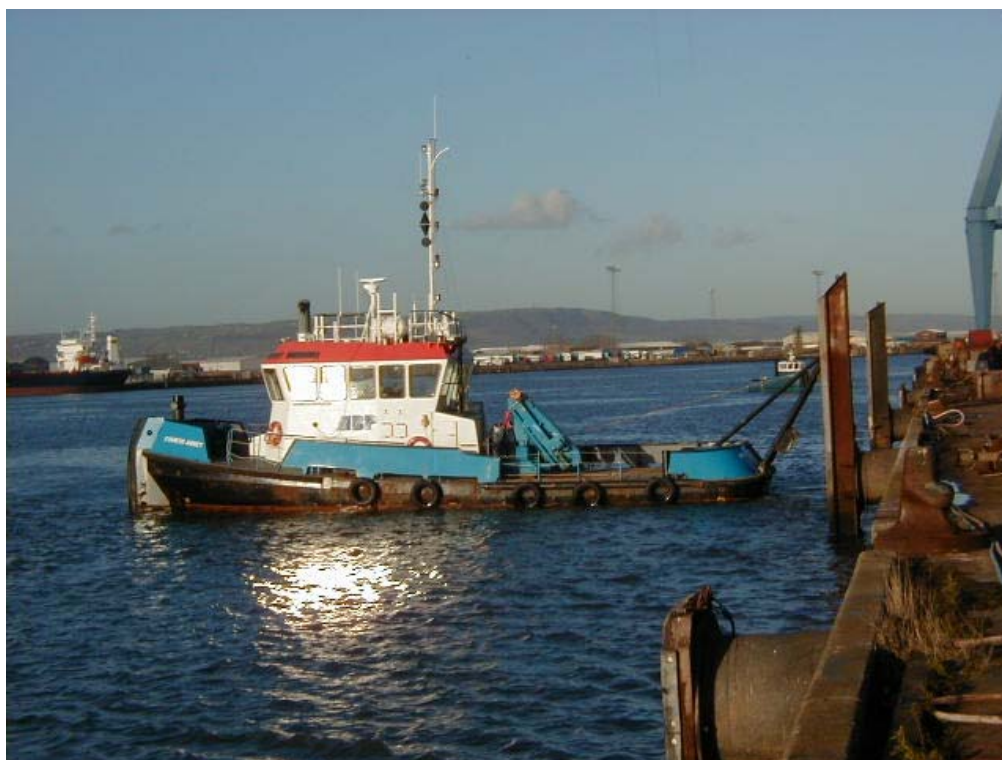
Plate 6. A plough vessel pulling material from the toe line of a berth face to a location where the TSHD can access it.

The above method of plough dredging was used in 2006 to move a small quantity of 'capital' material from the South side of the Channel in the area between the VPOT turning circle and the entrance to Pennar Gut. It is referred to in documentation as the 'Dragon Channel Widening'. This small quantity of material (<500m<sup>3</sup>) had to be removed in order to provide sufficient water to enable the Pembroke-Rosslare ferry to pass the Dragon LNG facility when there is a gas vessel moored alongside the berth. It had originally been intended to remove this material by using a TSHD and disposing of it at sea, but it was decided to attempt to relocate it using a plough first as the material was made up of soft sediments and some gravel/weathered rock. This approach proved successful. The environmental advantage of this method is that the material, and associated benthos is not necessarily lost, it is merely relocated in the same vicinity all be it highly disturbed. There will be a disturbance to the organisms on the seabed in the deeper water where the dredged material falls out of the plough.

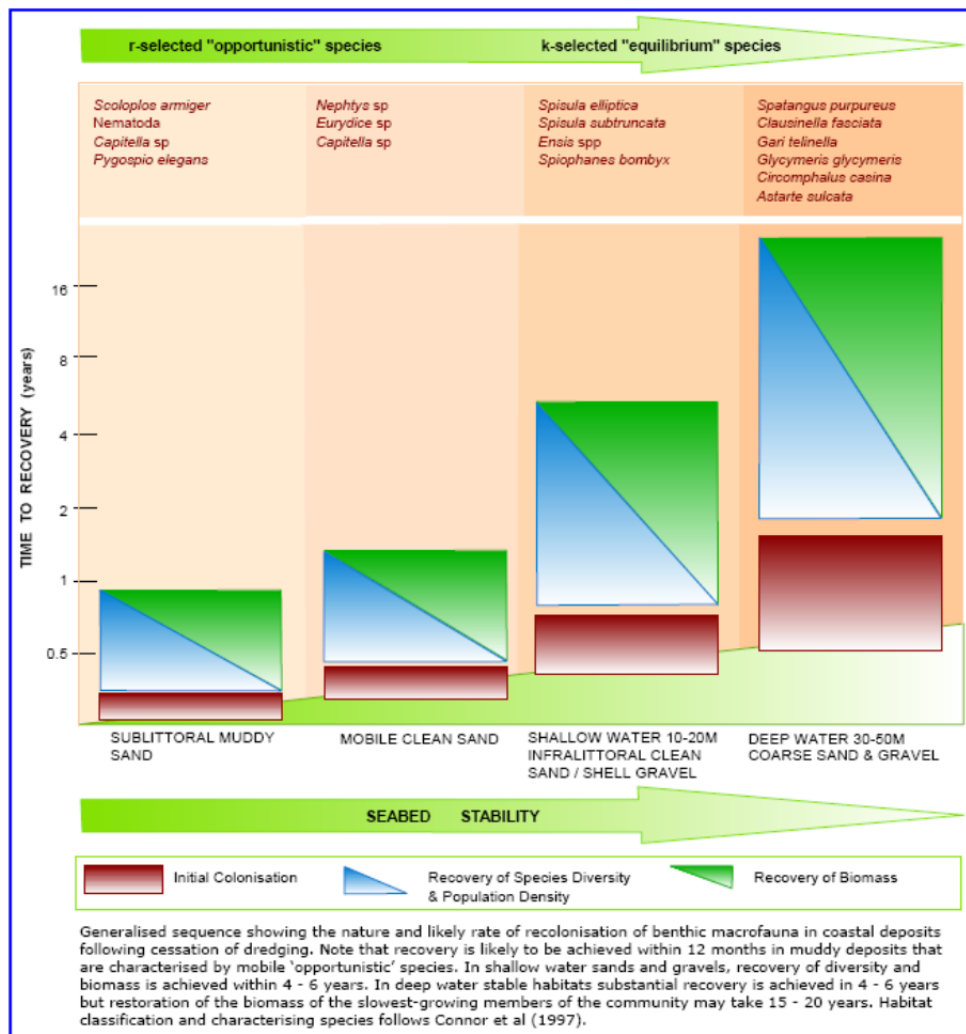
Figure 5 From: IMPACTS OF OVERBOARD SCREENING ON SEABED & ASSOCIATED BENTHIC BIOLOGICAL COMMUNITY STRUCTURE IN RELATION TO MARINE AGGREGATE EXTRACTION Sustainable Land-Won & Marine Dredged Aggregate Minerals Programme. SAMP.1.022, MESL, March 2004

The natural population of benthic organisms that inhabits mobile sands and sandy gravels comprises 'opportunistic' species that are well adapted for rapid recolonisation in deposits that are disturbed. In coarse stable deposits, however, the community is more complex and comprises 'equilibrium' components that have a slow rate of colonisation and growth.

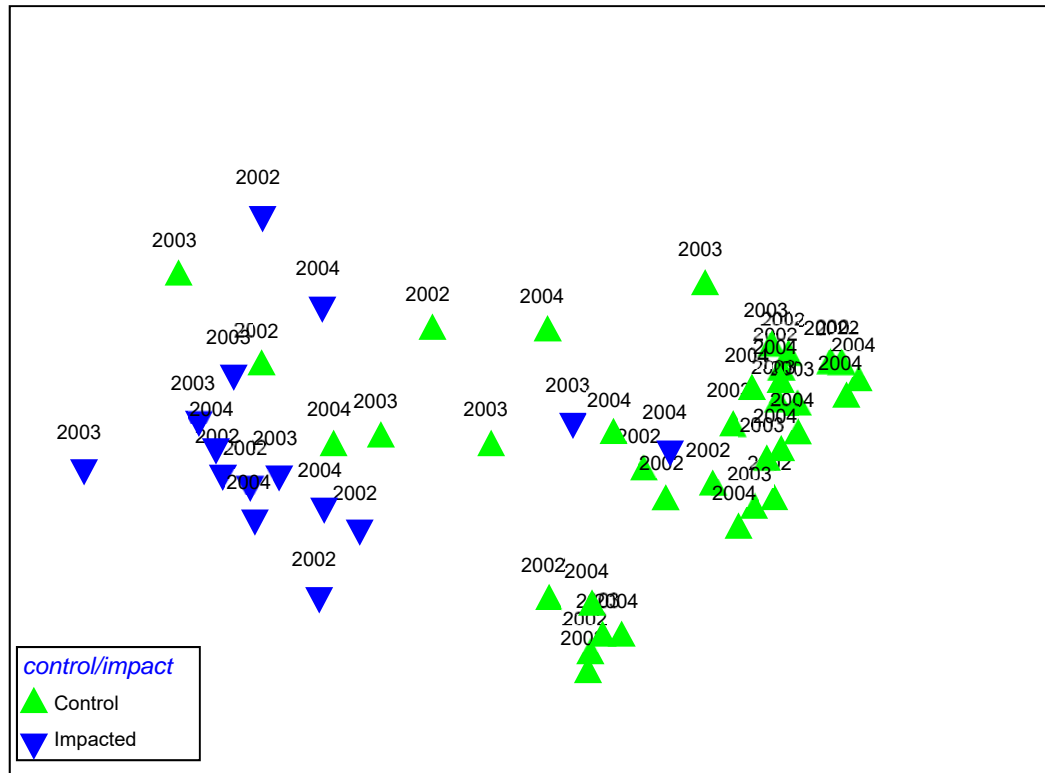
Figure 7. Combined MDS for all years (labels) and control/impacted status (symbols) for the Hebog Environmental survey.

Several multivariate analyses were conducted, the combined Multi-Dimensional Scaling (MDS) for the station mean abundances, within and adjacent to the berthing boxes of the Texaco [*now Valero*] and Petroplus [*now VPOT*] terminal jetties, for the pre-dredge survey in March 2002 and post-dredge surveys in April 2003 and April 2004 shows no obvious difference in the station relationships between years (Fig. 6). However, there are clear differences between impacted (dredged) and control (undredged) sites: Fig. 7 shows the impacted sites (except for station 7 in 2003 and 2004) clustered to the left of the configuration. A two-way crossed ANOSIM (control/impacted and years) reveals a strong and highly significant difference between the impacted and control stations, and no differences between years. This suggests that the differences do not result from the immediate effects of the 2003 dredging activity, but from the historical dredging activity from which the stations have not recovered.
