## Compliance Assessment Report CAR\_NRW0038949

For: Pwllfawatkin Landfill Site EPR/BU8819IV, held by FCC Waste Services (UK) Limited

At: Pwllfawatkin Landfill Site, Pontardawe, SWANSEA, West Glamorgan, SA8 4RX.

**Type of assessment carried out:** Site Inspection, Reason: Routine.

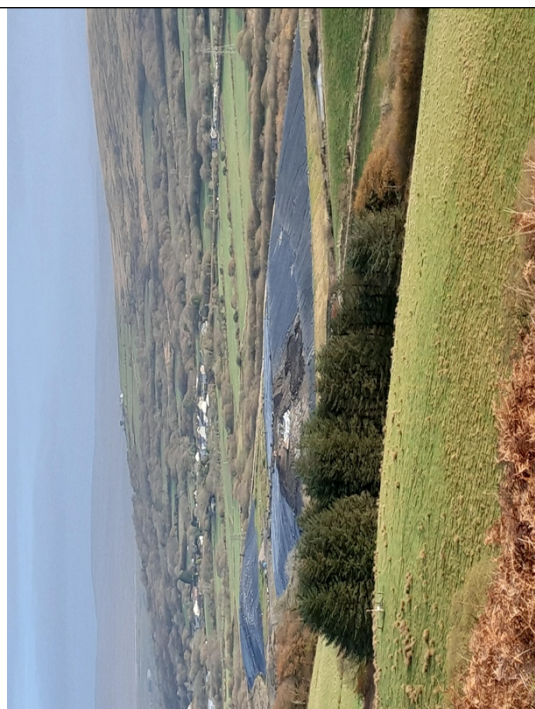
The active tipping face is of a small size.

view looking down onto Pwllfawatkin operational landfill, Photo taken 17/11/21 at 09:35. Illustrates areas recently capped (black) placement of regulation layer (dark brown) and active tipping face (white)

Recognising the works being undertaken, installation of further gas wells and placement of regulation layer in preparations for permanent capping along with a small tipping face illustrated that the operators were using appropriate measure to minimize odours. At the time of this visit and areas assessed no non-compliance with permit condition 3.4.1 was identified.
