# SDI1 - River Neath Swing Bridge Preliminary Ecological Appraisal (PEA)

DOCUMENT INFORMATION			
Project	SDI1 - River Neath Swing Bridge		
Location	River Neath, ELR: SDI1, Mileage: 207mile 63chain, Central Grid Ref: SS 73039 96367		
Title	Preliminary Ecological Appraisal (PEA)		
Document Ref	EV000702/1/PEA-00	Issue / Revision	0.0
File reference	EV000702/1/PEA-00		
Start Date	23/09/2021		
	Name	Signature	Date
Assessment Undertaken by	Owain Waters

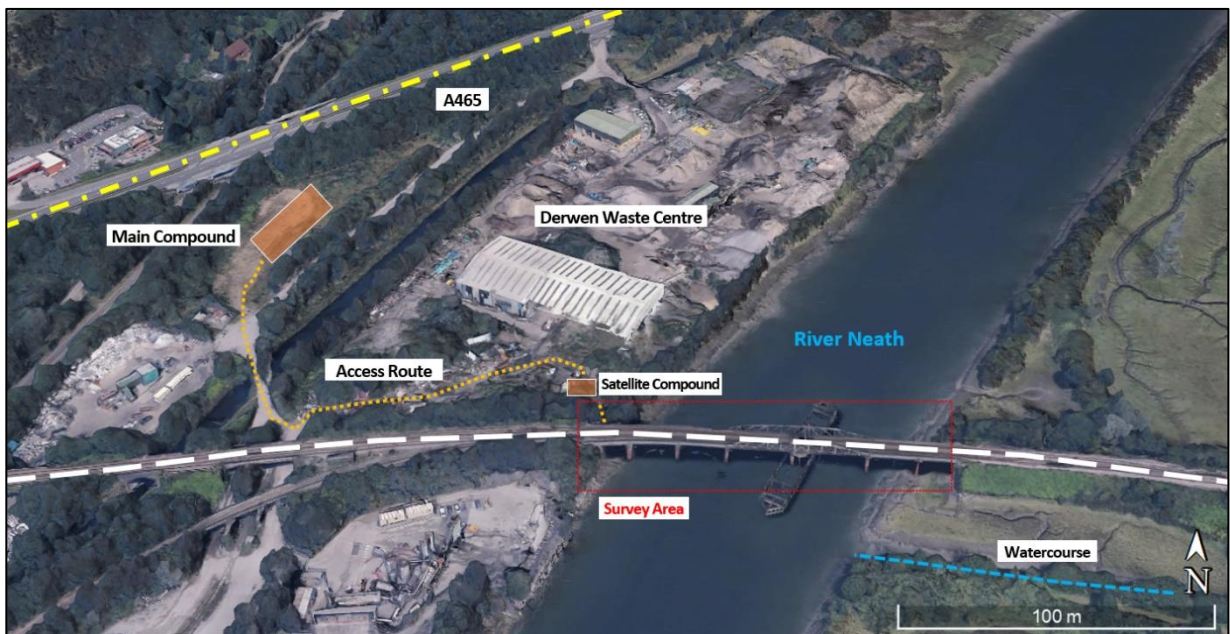
*Figure 1: Project survey areas (red boundaries).*

1.2.4 To the east appears to be a relatively large wetland habitat north of the rail corridor and a larger semi-reclaimed site, which was the Giants Grave Landfill. The approximate survey areas are illustrated below (Figure 1).

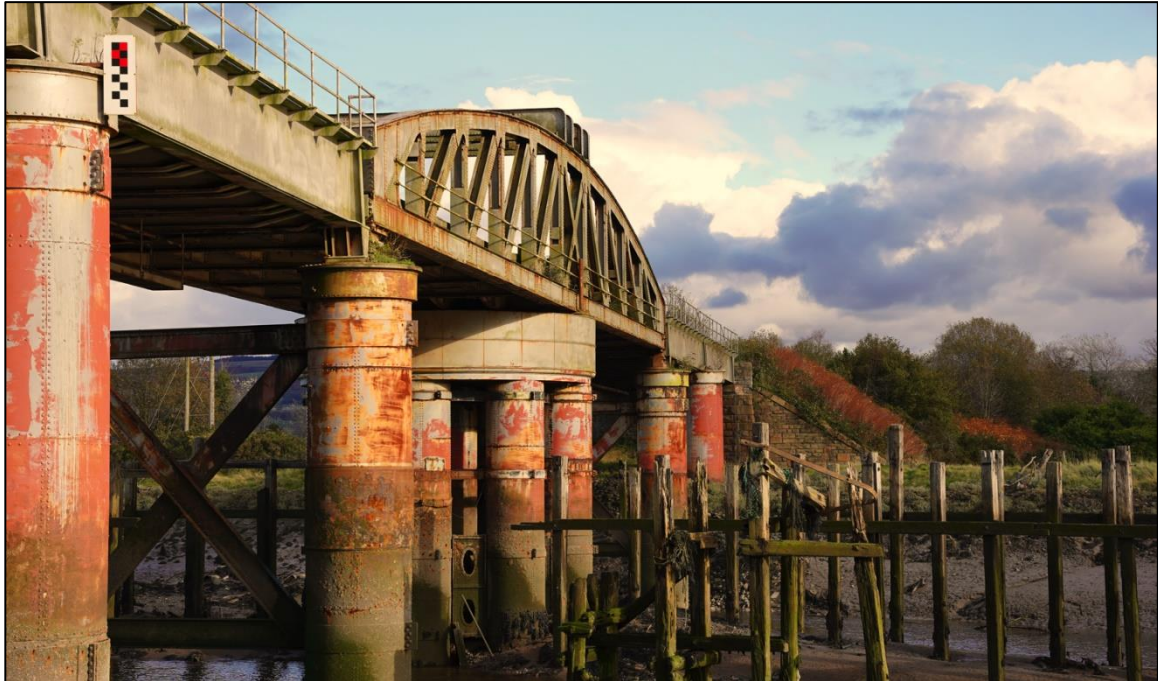
*Figure 5: Overview of Neath Swing Bridge from Western Shore (Facing East).*

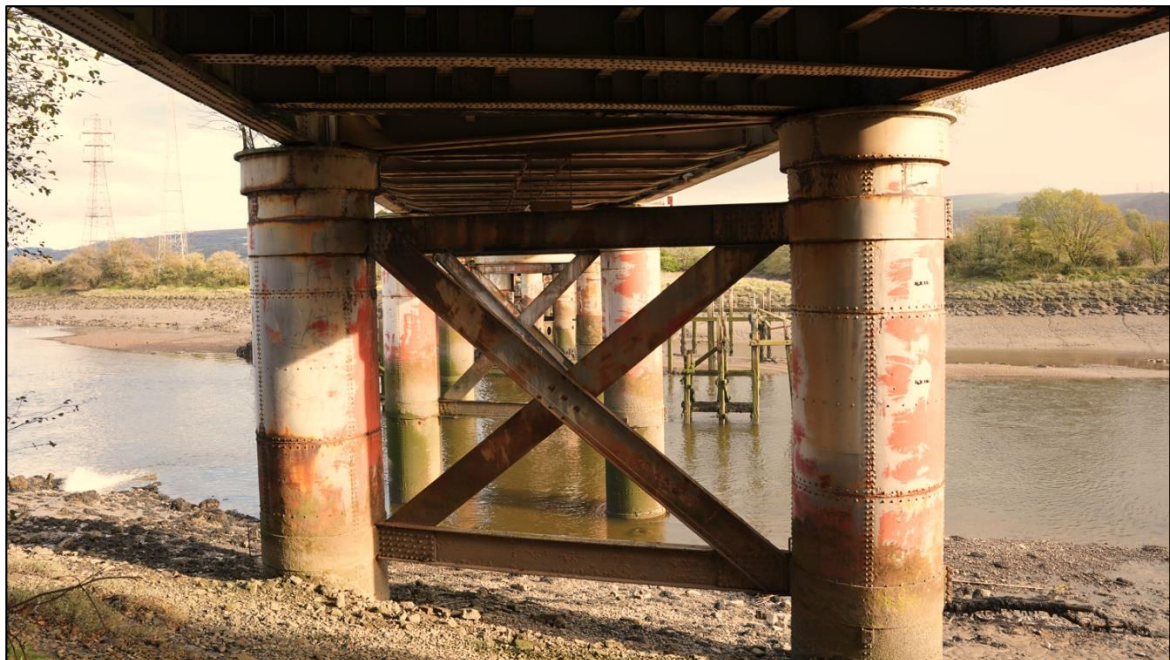
*Figure 6: Below space between first and second set of metallic piers.*

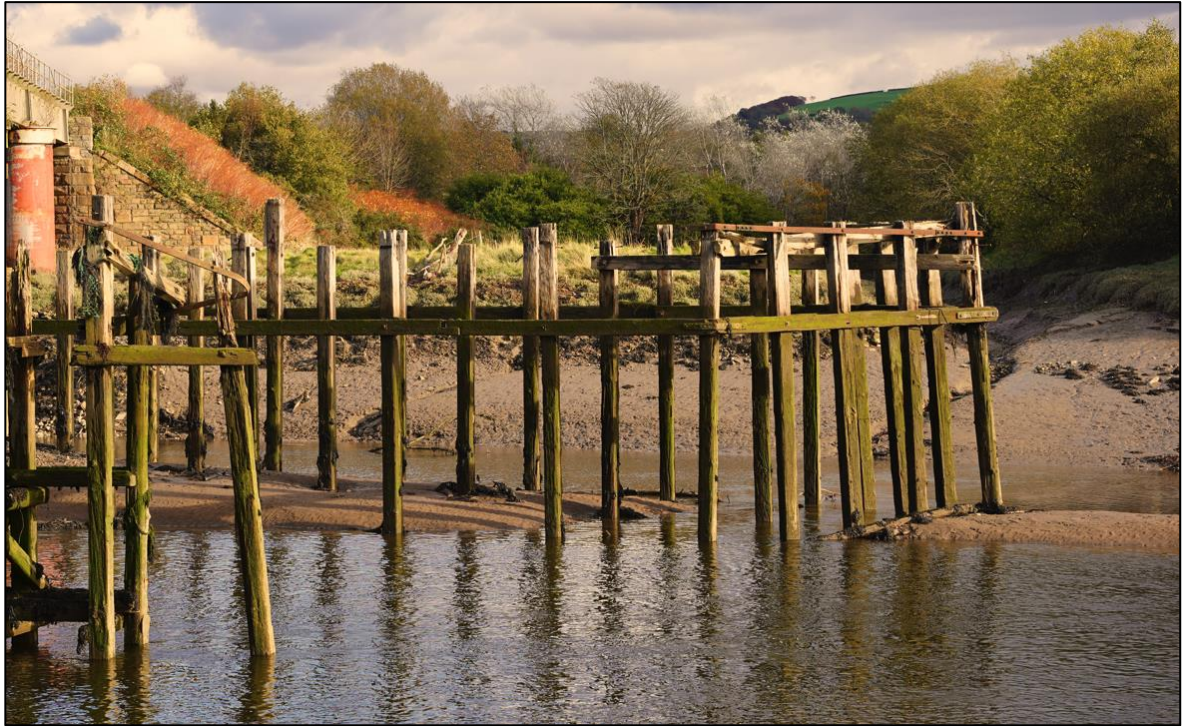
*Figure 7: Remaining timber sections from past operational periods.*

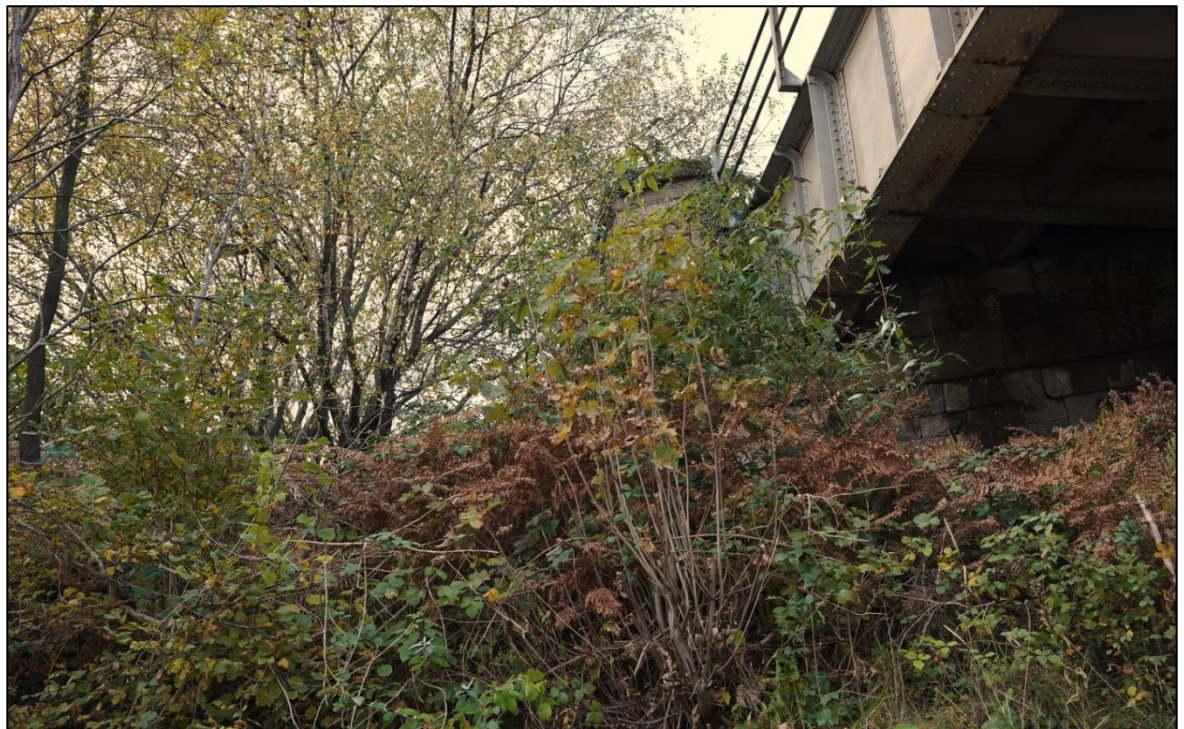
*Figure 8: Mixed dense vegetation below and adjacent to southwest masonry abutment.*

3.6.1 **Habitat:** Habitat within the working footprint is predominately dense bramble, small saplings, and isolated broadleaf trees with Ivy cover of varied densities. Ground vegetation directly below the structure is essentially non-existent. Japanese Knotweed is present to the northwest; however, these stands will not come within the working footprint. The estuary itself and free flowing portion of the river is the defining habitat feature within the project footprint.

- 3.2.1 The required vegetation clearance footprint to allow for the erection of scaffolding is relatively small with a buffer zone of 3-5m required along either side of the rail abutments to ensure safe construction of the scaffolding structure. As indicated above, the small area of the eastern abutment and lower embankment will be assessed once access has been achieved.

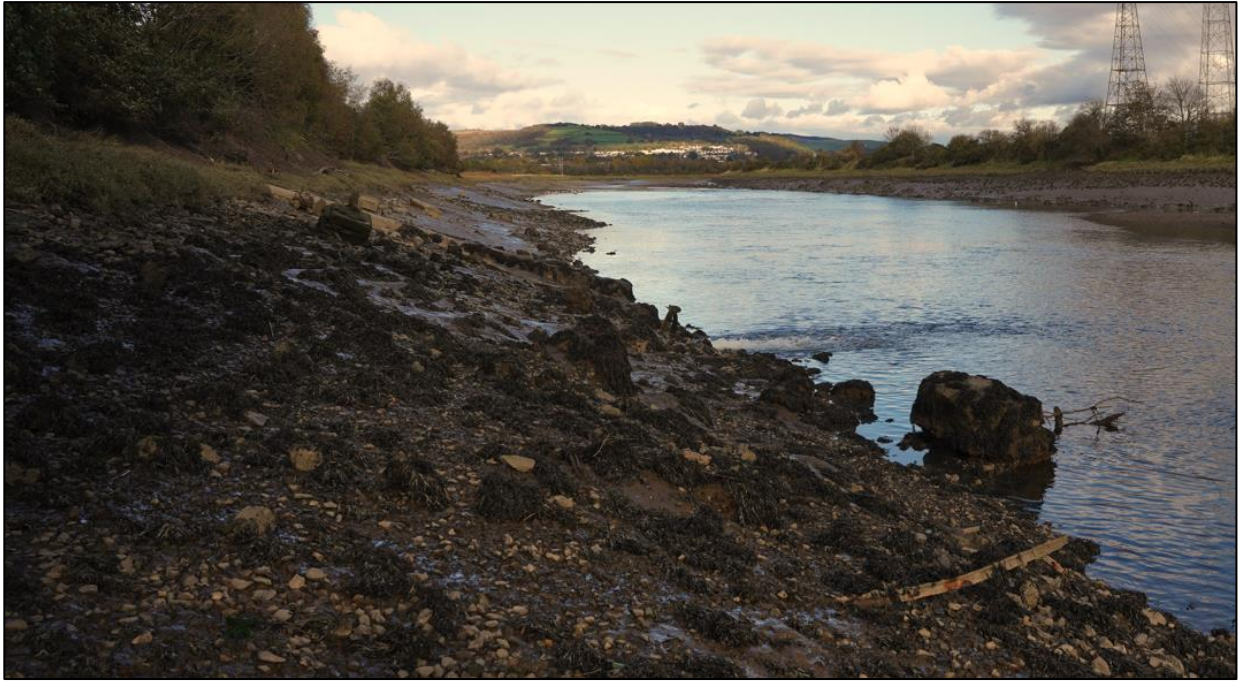
***Figure 9: Exposed riverbed during low tide conditions (facing north).***

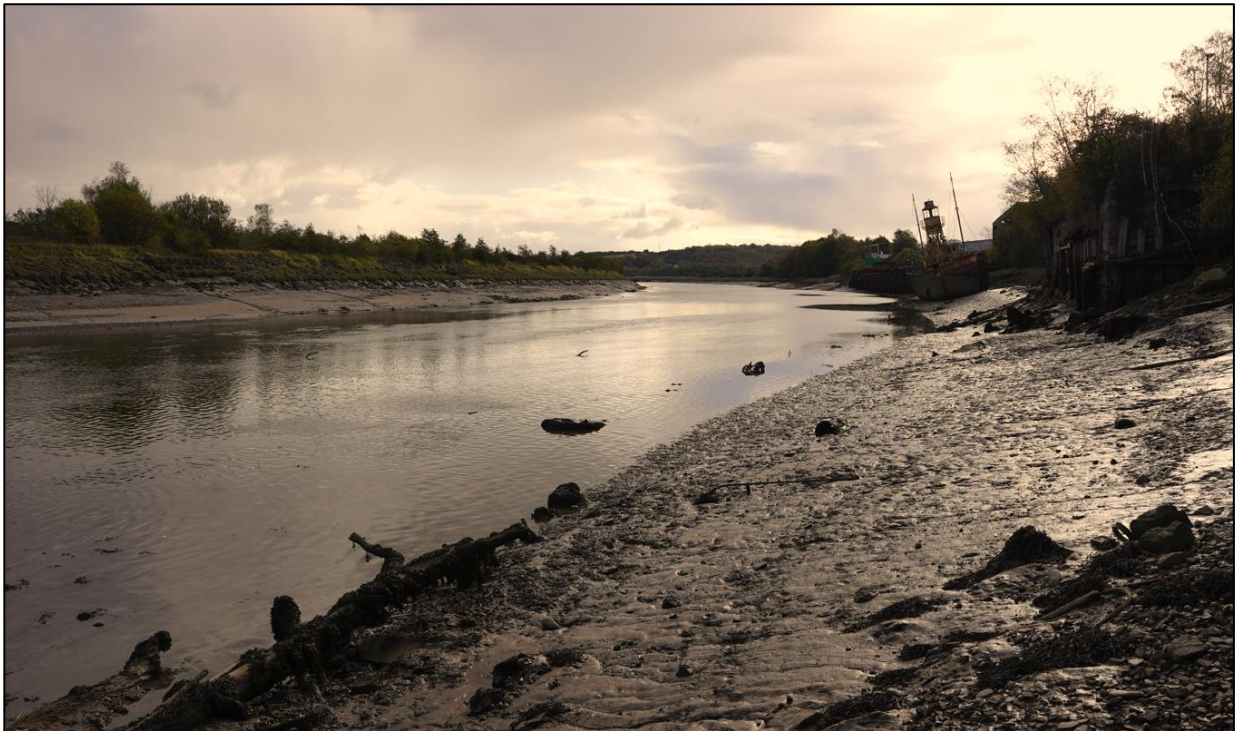
***Figure 10: Exposed riverbed (facing south/downstream).***

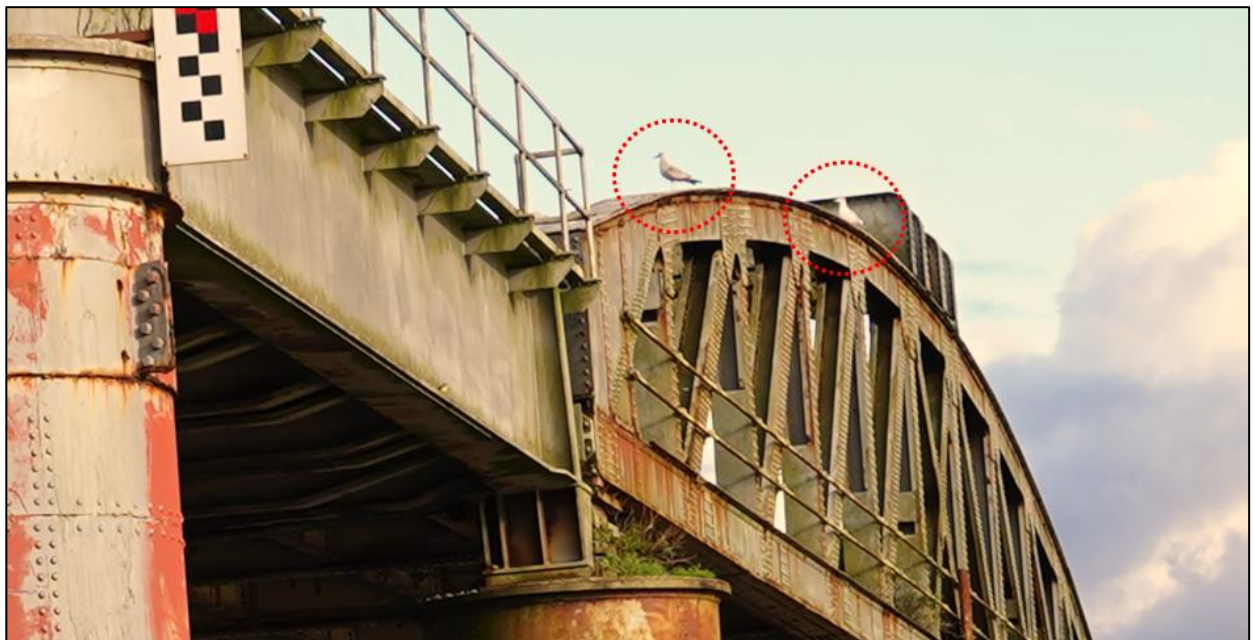
Seagulls were observed perching on the structure's steelwork and metallic piers (see figure 11).

*Figure 11: Gul observed perching on steelwork.*

- 4.4.4 It is highly recommended that a bird activity survey be undertaken at the bridge during early 2022 in relation to Western Osprey, to evaluate whether the structure is of significance to this species e.g. roosting, or whether previous observations are incidental.

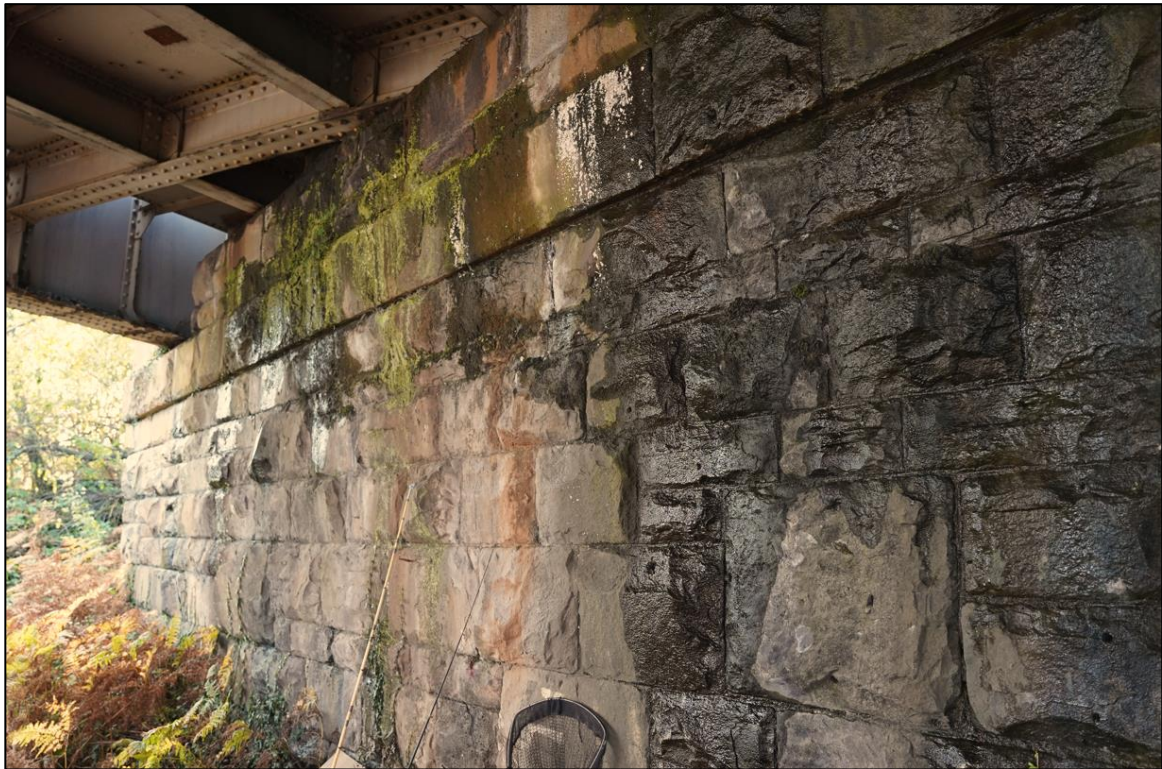
- 3.6.3 **Bat Species:** No trees within the western portion of the structure support bat roosting, beyond potential temporary resting locations, in relatively poor Ivy cover, during optimal conditions. Winter roosting or hibernation potential is negligible, within the trees within 5m of the western rail abutments. It was not possible to assess the entire masonry abutment to the west. Observed minor defects appear to be shallow and offer no viable cavities from initial visual assessments (see figure 12 below). The eastern masonry abutments and vegetation remain un-assessed.

*Figure 12: Lower masonry below steel decking.*

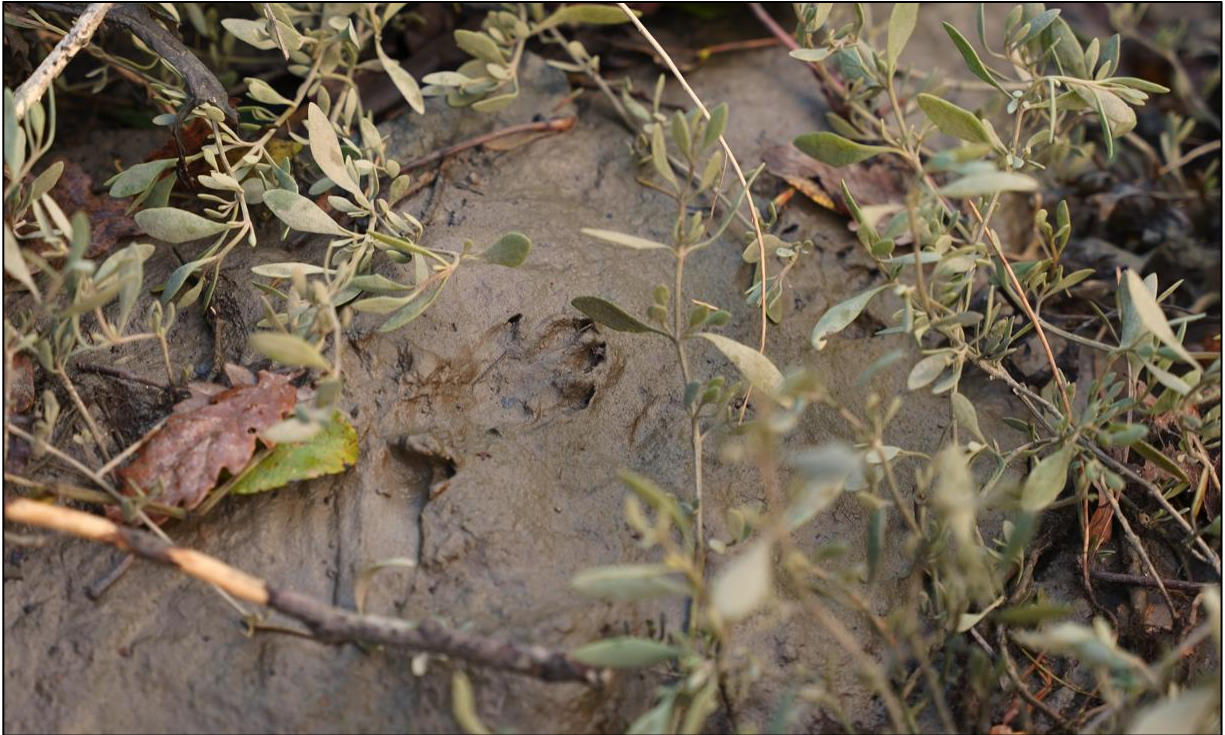
*Figure 13: Potential Otter Paw Print.*

4.9.1 **Otter:** as otter are recorded in the Tannant Canal, which has connections to the Neath and the finding of potential paw prints. It is recommended that a field camera survey is undertaken during the latter months of 2021 and early months of 2022 to quantify the level of otter activity below the structure and as to whether any formal licensing is required beyond best practice measures in limited noise and light pollution, combined with toolbox talks on how to behave in relation to this species.

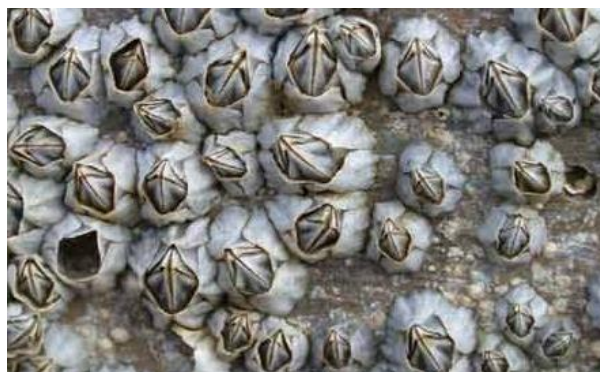
Additionally, Sewbrec data indicates that *Austrominius modestus*, an invasive form of Barnacle which is present near the structure. The data does not directly indicate that this species is found on the structure, however given the nature of this barnacle to thrive on any hard manmade marine structure, it is likely this species will be found on lower sections of metallic piers and timber sections within the tidal reach.

*Figure 14: Austrominius modestus.*

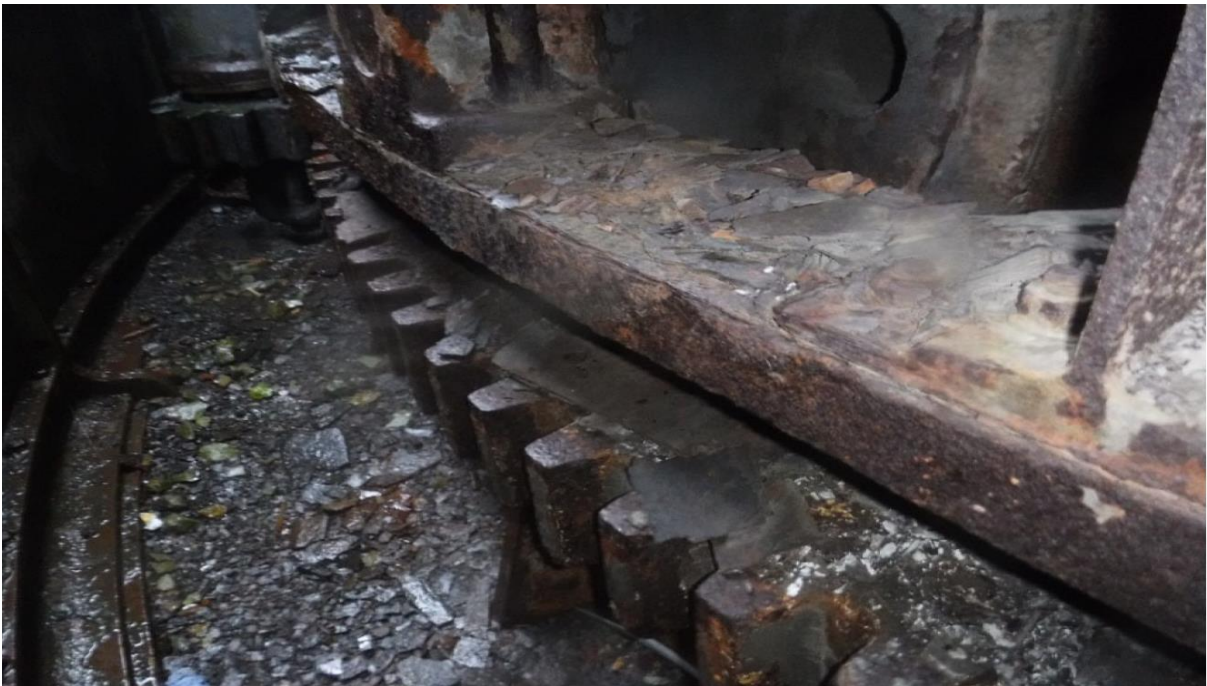
*Figure 15: Internal gearing of Swing Bridge.*

- 4.6.4 Available photos from previous inspections of the gearing house does not suggests highly favorable roosting, however it is not possible to be definitive at this time.
- 4.6.5 Further photos, video or potentially access to the central housing during a line block should be arranged, with a licensed bat ecologist on site to either inspect the housing using endoscope or directly, dependent on safe access restrictions. Or to direct, specially trained technicians on what features to look for or retrieve for further analysis (e.g., whether there are any bat droppings etc).
