**SYSAC MARINA WID DREDGING 2022-2024  
BIOSECURITY RISK ASSESSMENT**

# **SYSAC MARINA WID DREDGING 2022-2024**

## **BIOSECURITY RISK ASSESSMENT**

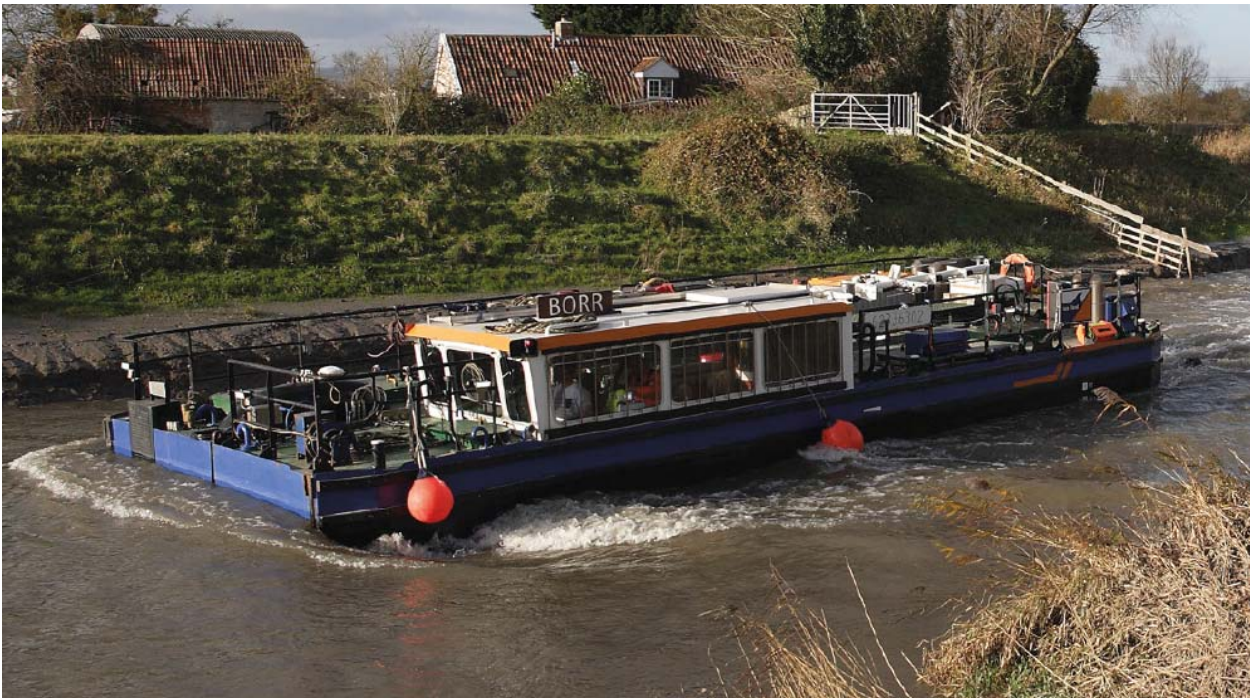
Figure 1. Van Oord UK – WID vessel 'BORR'

| Vessel name | Photo reference<br>(Please insert images in the appendix) | Vessel type | Details, Risk factors & Justification<br>e.g. Pathway, vessel speed, biofouling control, Inspection history, Internal treatment history etc.. | Risk:<br>(High/Medium/Low) |
|---|---|---|---|---|
| <i>Borr</i> | <i>Borr.png</i> | <i>Water Injection Dredger</i> | <i>Antifouling paint and anodes on hull. Ballast tanks cleaned with fresh water</i> | <i>Low</i> |
