Bryn Posteg Landfill Site

Stability Risk Assessment

Addendum No.5

Document Title: Stability Risk Assessment – Addendum 5

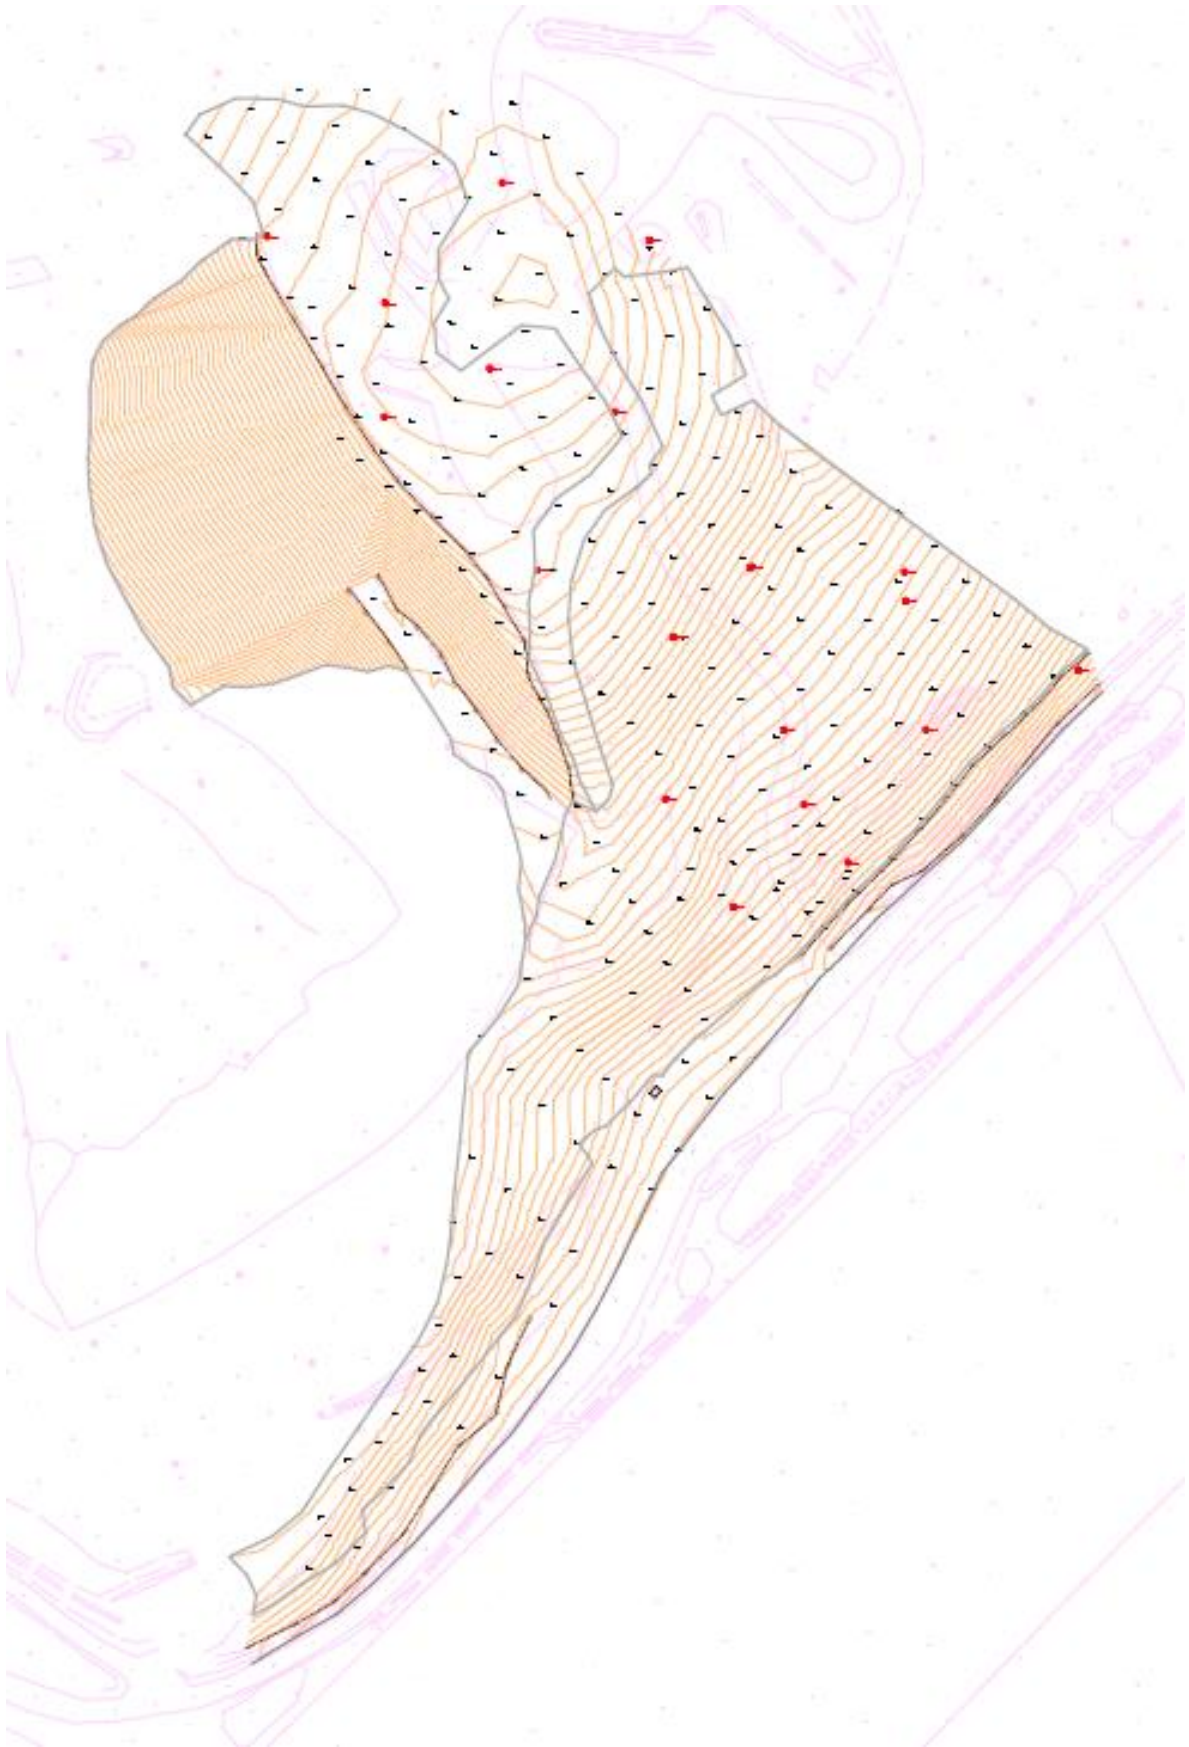
Figure 3: Extent of the 2017 Capping Works

1.4.11 During 2017, further capping works were carried out (part of which was in the over-tip area; these recently capped areas are shown as black on the above photograph (Figure 2). The extent of the 2017 capping works is shown on Figure 3 below.

- 1.4.12 The slope gradients associated with the 2017 capping works are broadly in the range of circa 1 in 3 to 1 in 6 and are the same gradient or shallower than the steepest capped and restored slopes of 1 in 3 associated with the over-tip area pertaining to Phase 3.
- 1.4.13 The long term stability of the northern and western slopes is therefore assessed in this Stability Risk Assessment report below.
- 1.4.14 Settlement of the waste slopes will occur over time resulting in gentler slope gradients as time progresses. It is therefore recognised that the F_s value for the slope will therefore increase over time as settlement occurs. In the longer term shallower, more stable slopes will exist.

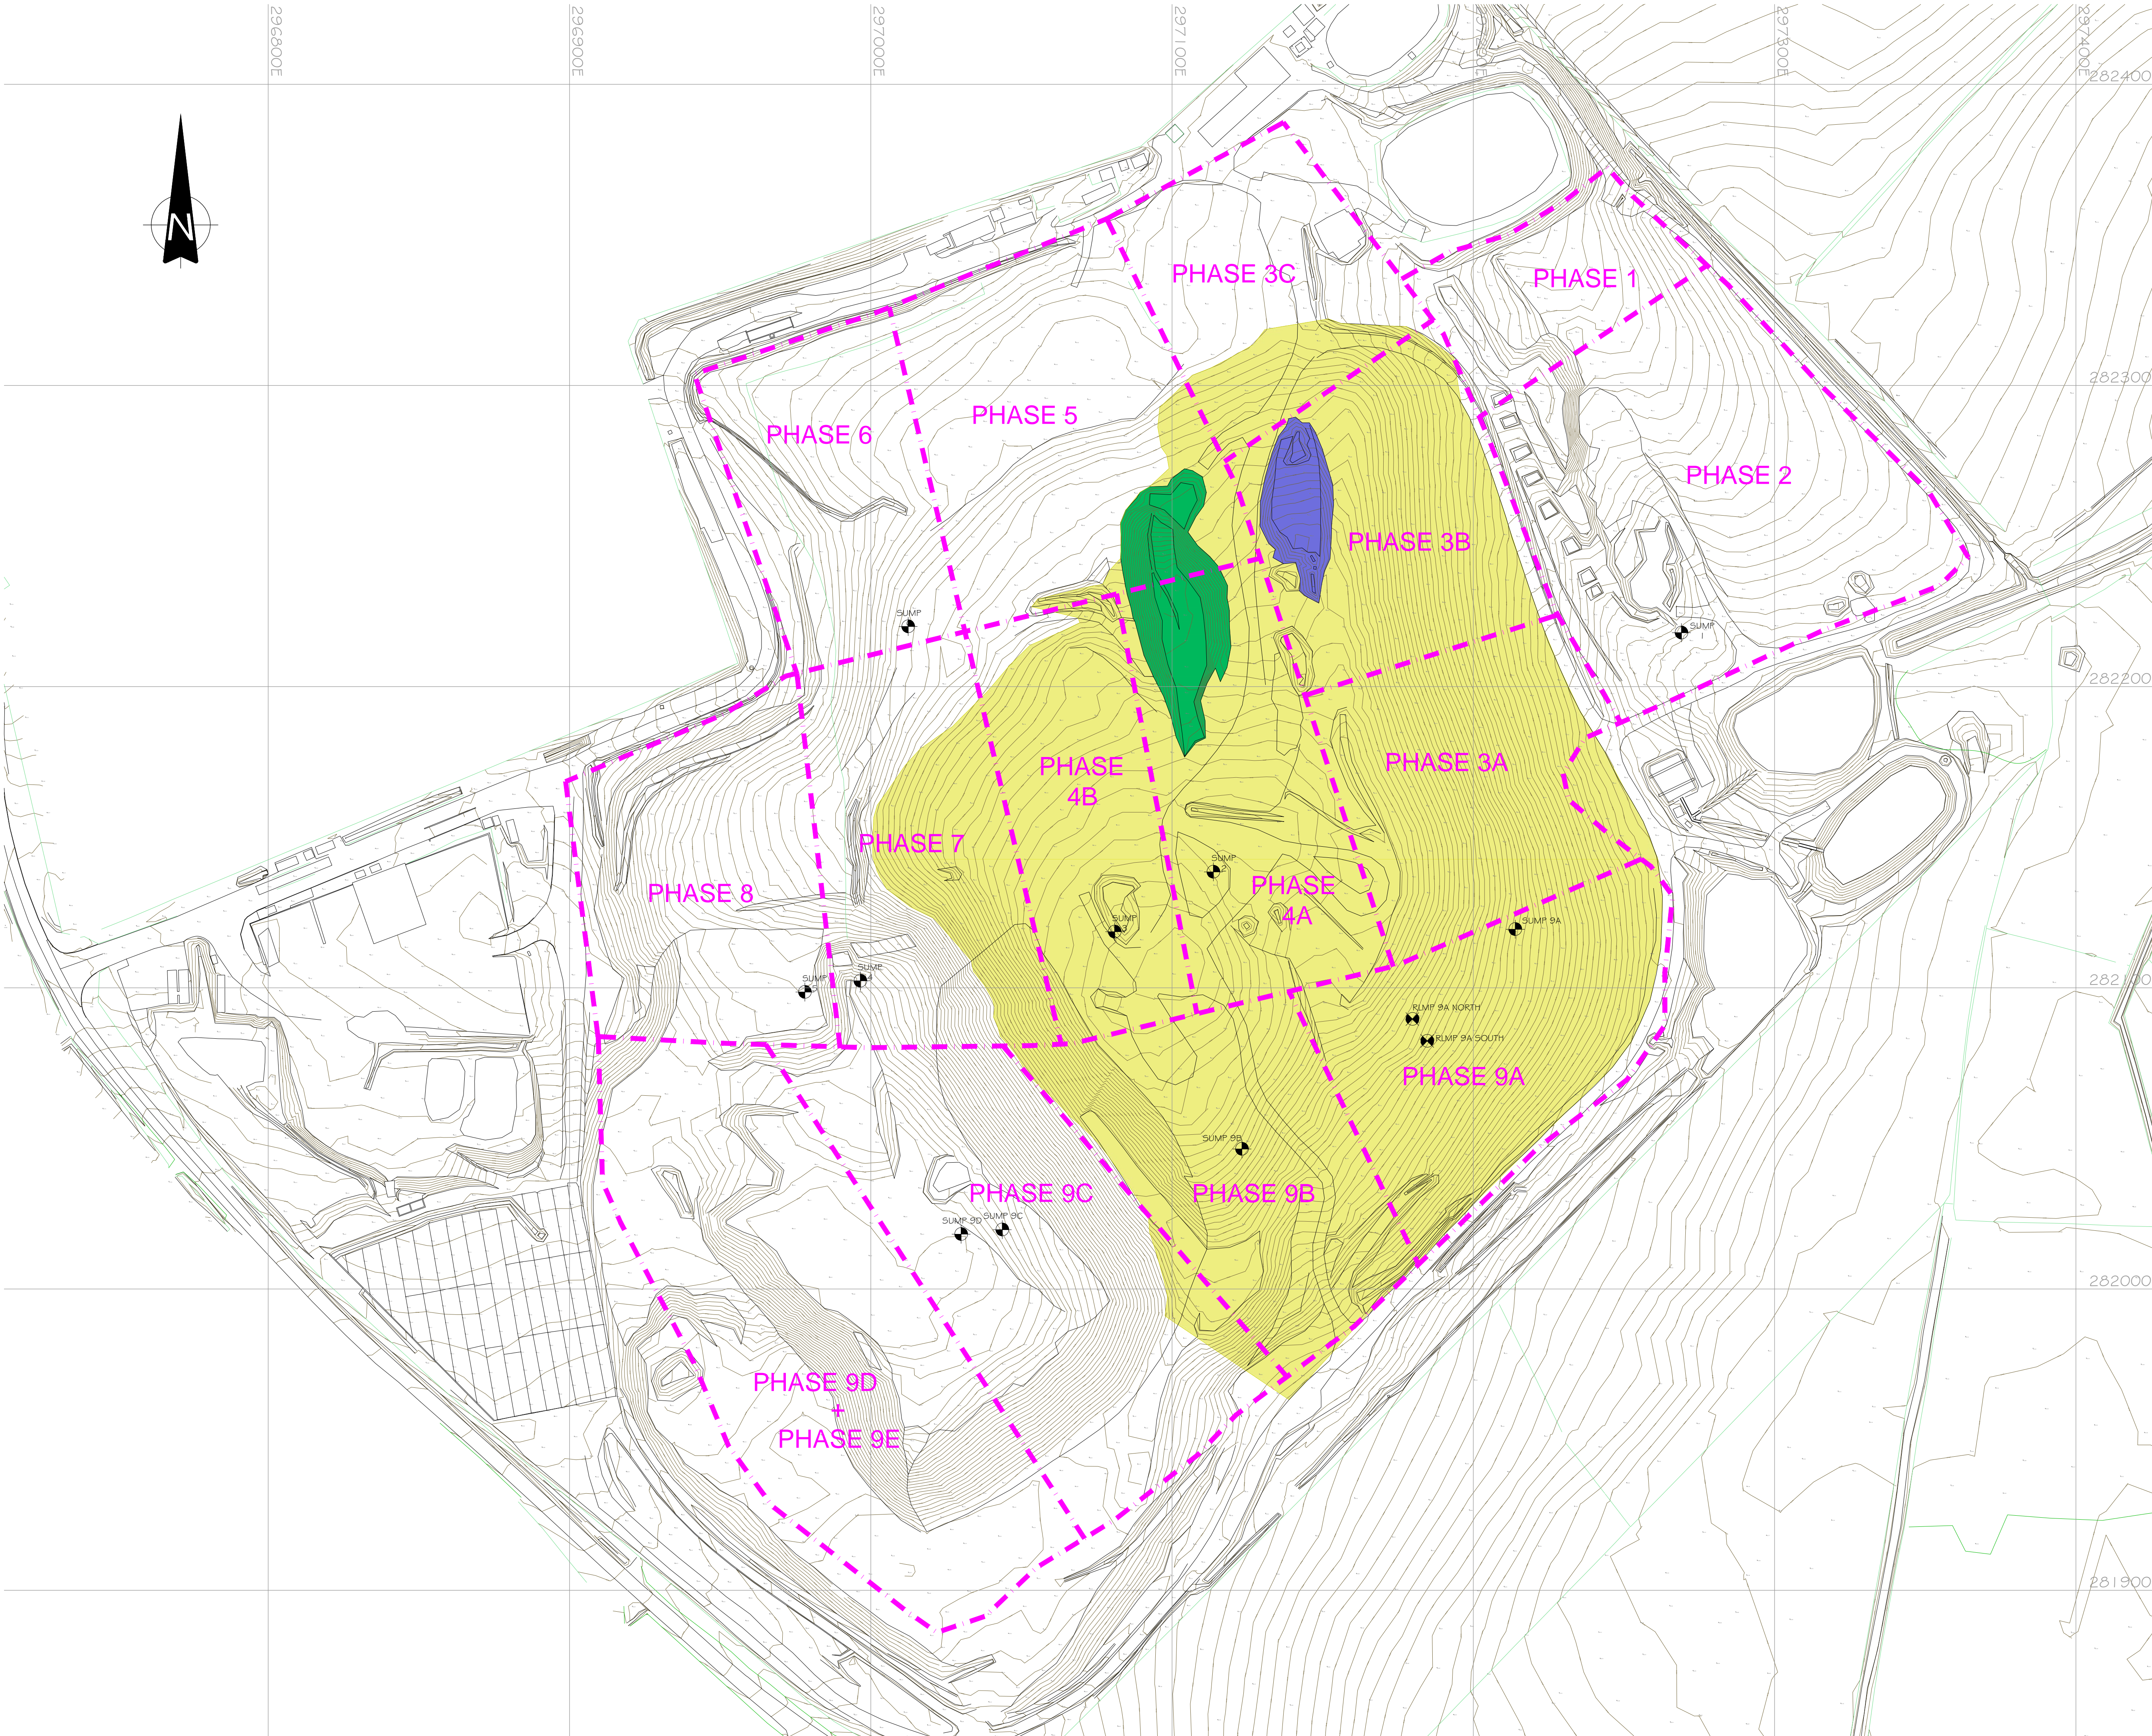
3428.CAU.XX.XX.DR.S.1804 P1 – Area of Overtip Between March 2017 and DRWG9

1.3.4 For ease of reference the area where the levels exceed the pre-settlement profile is shown as yellow on Drawing No. 3428.CAU.XX.XX.DR.S.1804 P1. The over-tip area is located in the central part of the Site and overlays parts of phases 3, 4, 5, 7 and 9.

1.3.5 The extent of the over-tip is shown on Drawing No. 3428.CAU.XX.XX.DR.S.1804 P1. The over-tip at its highest exceeds the pre-settlement profile of Drawing No. DRWG9 by circa 12.5m in the central part of the site.
