Application Site Condition Report EPR/GB3490HG/A001

Nine Mile Point Waste Processing Facility
for:

Hazrem Environmental Limited

Project:	Nine Mile Point Waste Processing Facility
For:	Hazrem Environmental Limited
Status:	FINAL
Date:	September 2015
Author:	Jane Hall, Principal Consultant
Reviewer:	Peter Cumberlidge, Director

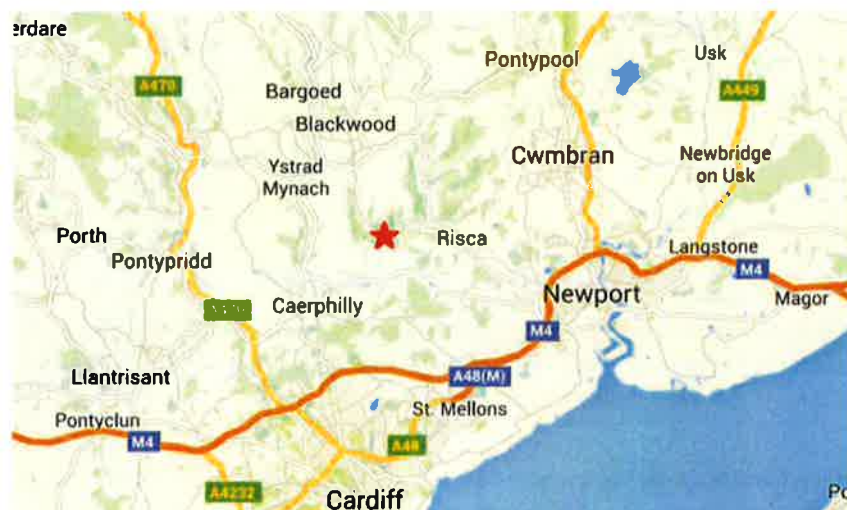
Figure 1.3.1: Site Location

- 1.3.2. The site is located on currently undeveloped land comprising open mown grass and some trees on the Nine Mile Point Industrial Estate. The size of the application site is approximately 1.09 ha and is located at NGR ST 19235 91305.

- 1.3.3. The site is bordered by an industrial unit and car park to the East, roads to the South and West and woodland to the North. The western boundary is planted with trees with a road beyond and a number of further industrial units and car park. There is more woodland beyond the road to the South of the site and the Sirhowy River runs parallel to the Southern boundary of the site in the woodland.

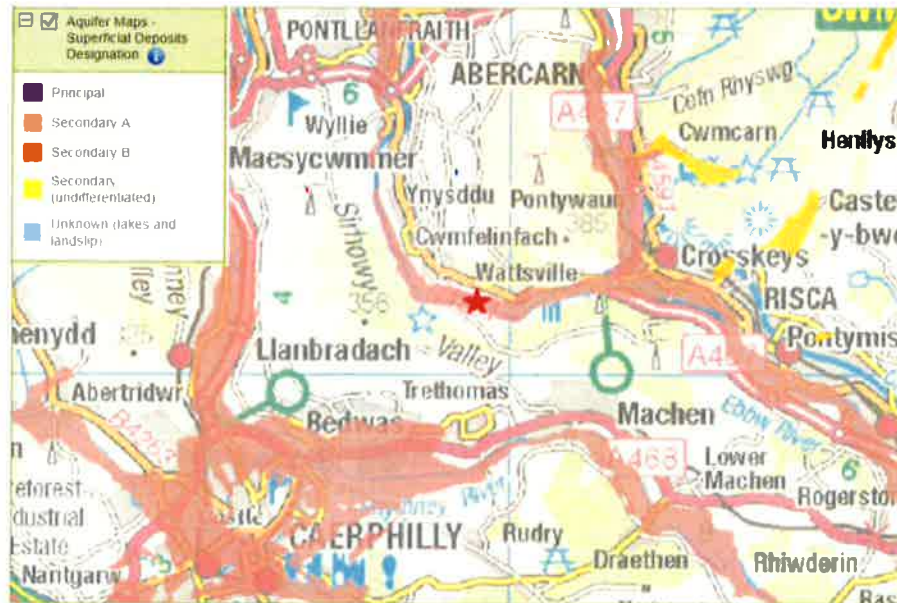
Figure 4.3.1A: Superficial Deposits Aquifer Map

4.3.1 The Groundsure EnviroInsight report confirms that the superficial layers and the bedrock beneath the application site are designated as a 'Secondary 'A' Aquifer', permeable layers capable of supporting water supplies at a local rather than strategic scale, and in some cases forming an important source of base flow to rivers. This is illustrated in Figures 4.4.1A and B below.

Image obtained from EA's 'What's in your backyard?' database
The site location is indicated with a red star.

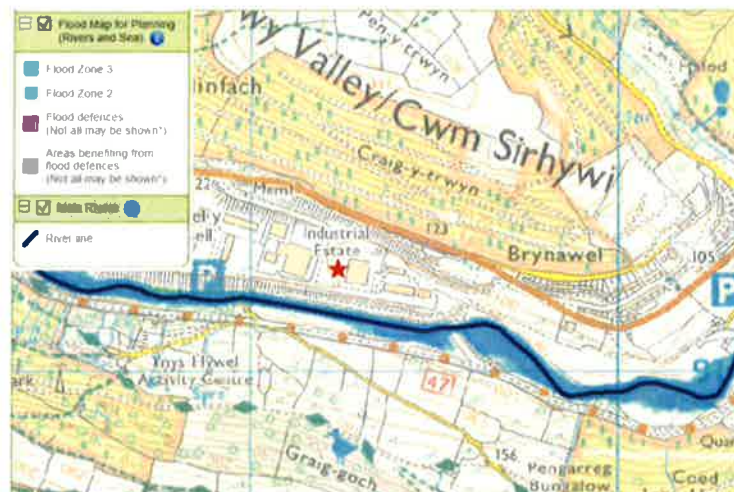
Figure 4.4.1: Flood Map

- 4.4.1 A review of the flood maps indicate that the application site is not within any designated flood zone. However, there are Zone 2 (annual probability of flooding occurring from rivers between 0.1% and 1%) and Zone 3 (a 1% or greater annual probability of flooding occurring from rivers) flood zones associated with the Sirhowy river approximately 50m South of the site, as illustrated in Figure 4.5.1 below.
- 4.4.2 There are no flood defences, no areas benefitting from flood defences or areas used for flood storage within 250m of the application site.

Image obtained from EA's 'What's in your backyard?' database.
The site location is indicated with a red star.

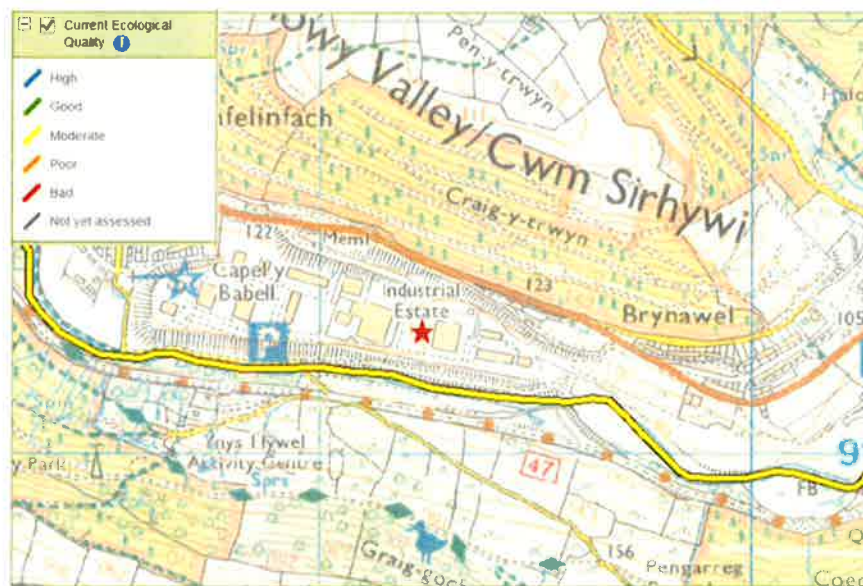
Figure 4.4.4: Ecological Quality

- 4.4.3 British Geological Survey data shows an area with limited potential to be susceptible to groundwater flooding associated with the unconfined aquifer, i.e. Clearwater Flooding, within 50m of the site, as reported in the GroundSure EnviroInsight Report. This area could be susceptible to groundwater flooding at the ground surface (rated with a 'Low' confidence by BGS).
- 4.4.4 The river Sirhowy to the south of the site is currently on Natural Resources Wales's monitored network for Ecological quality. It is currently designated as 'Moderate' Ecological quality, as illustrated in Figure 4.5.4 below, and is not currently monitored for chemical quality.

Image obtained from EA's 'What's in your backyard?' database.
Site location is indicated with a red star
