**This form will report compliance with your permit as determined by an NRW officer**

Site	Docksway Landfill EPR/DP3733BK	Permit Ref	DP3733BK		
Operator/Permit holder	Newport City Council				
Regime	Installations				
Date of assessment	23/06/2016	Time in	10:30	Out	15:00
Assessment type	Report/Data Review				
Parts of the permit assessed	Fugitive emissions				
Lead officer's name	Willey, David				
Accompanied by	Ward, Tyrone				
Recipient's name/position	Jonathan Davey/ Site Manager	Date issued	13/07/2016

### Docksway site visit – 23<sup>rd</sup> June 2016

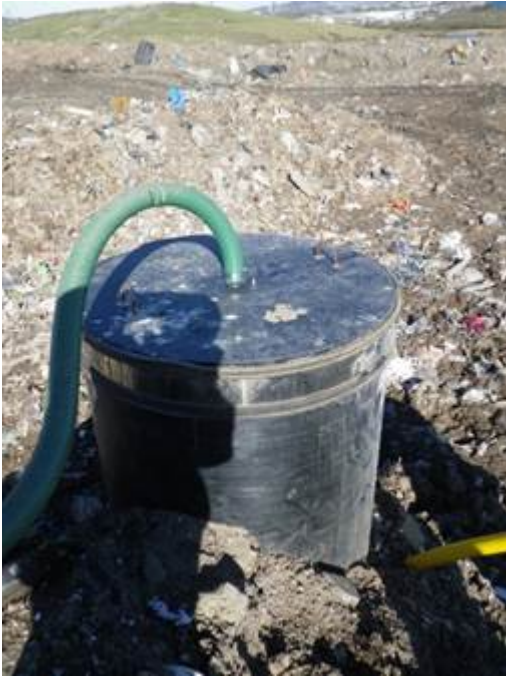
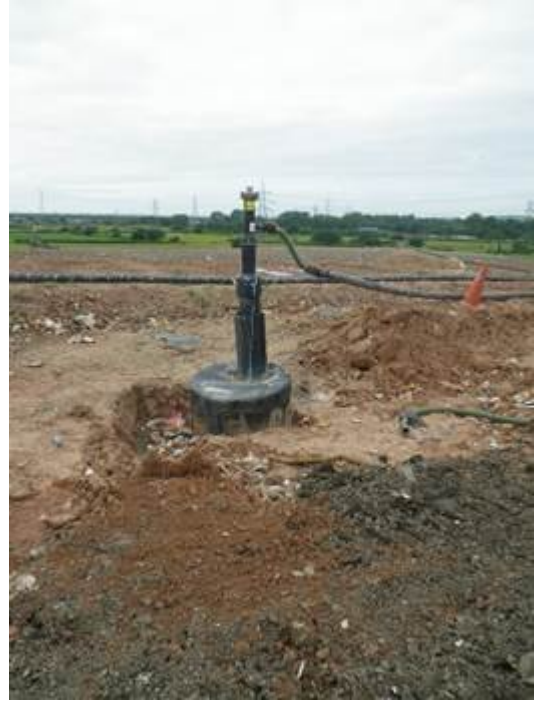
**Figure one**

The leachate well chambers have had work undertaken on them to limit the amount of LFG released as well as improving health and safety when leachate samples are taken. Photos below are some examples of the wells before and after the work.
