Docksway Disposal Site

Annual Environmental Review for Area 2 - 2017

On behalf of **Newport City Council**

Project Ref: 14739/3528/A2/PJ/VKR | Rev: 00 | Date: April 2018

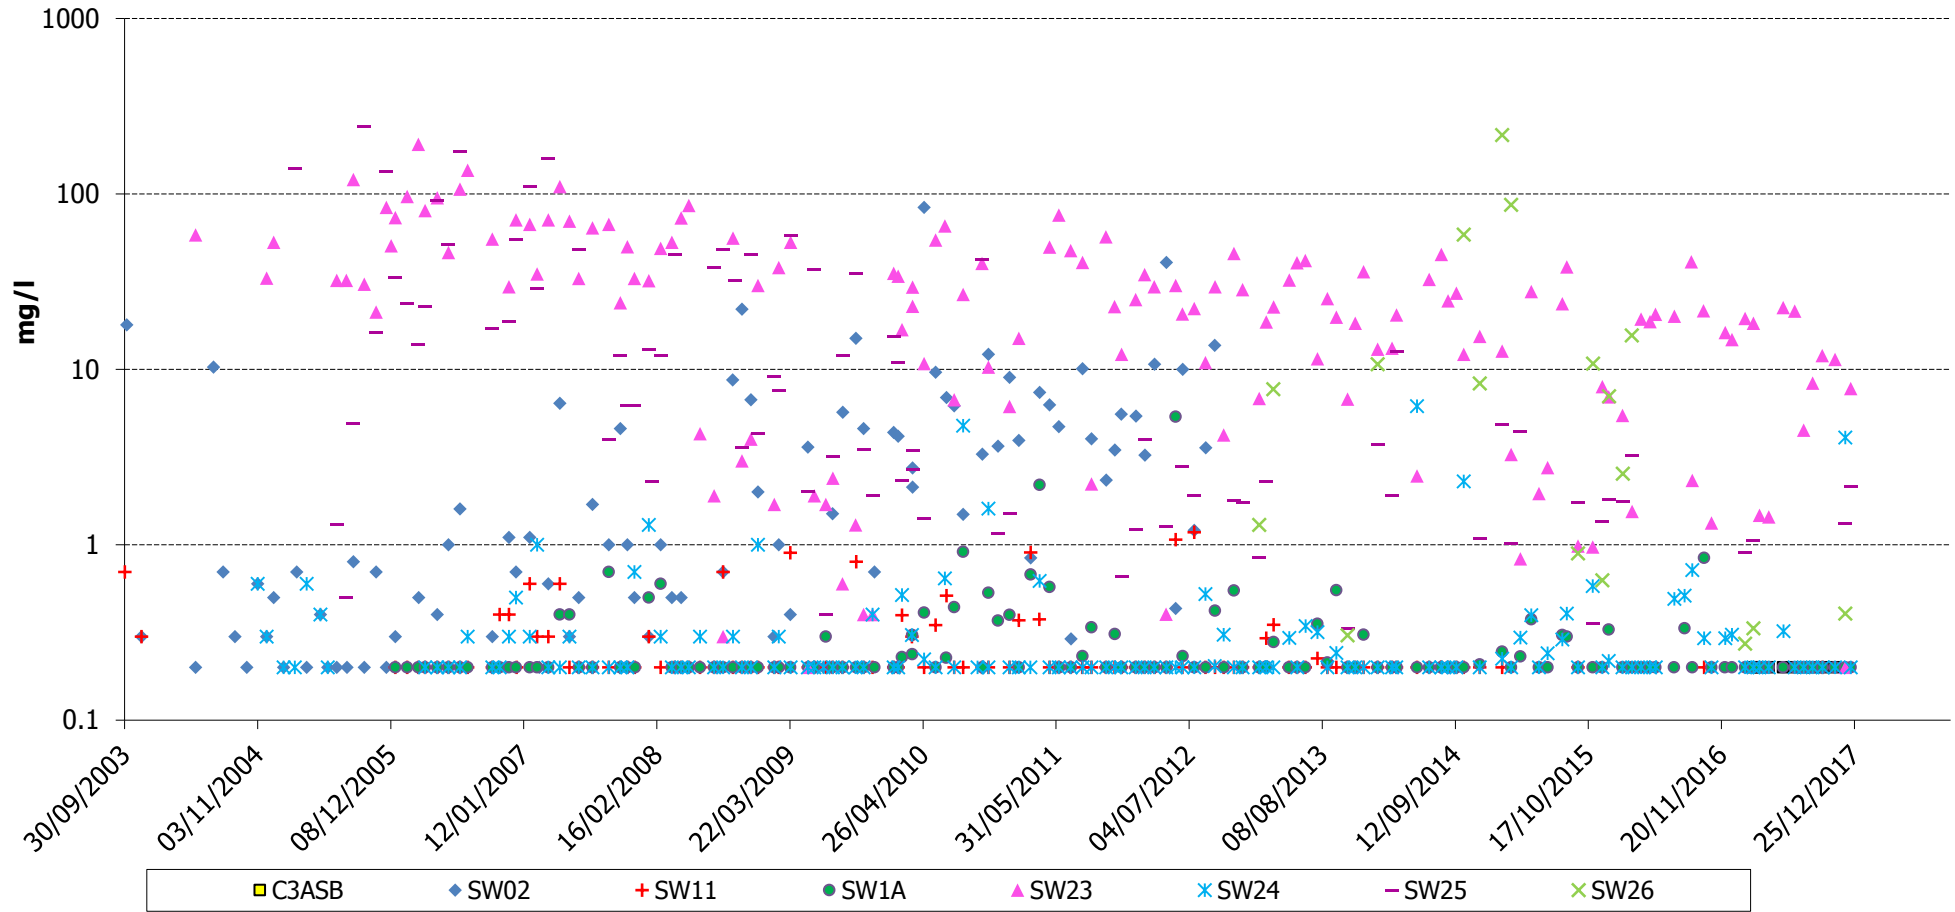
Date	February 2018
A4 Scale	nts
Drawn	CB
Checked	VKR
Appendix 1-1

**Appendix 1/1
Docksway Disposal Site - Ammoniacal Nitrogen in Surface Water**

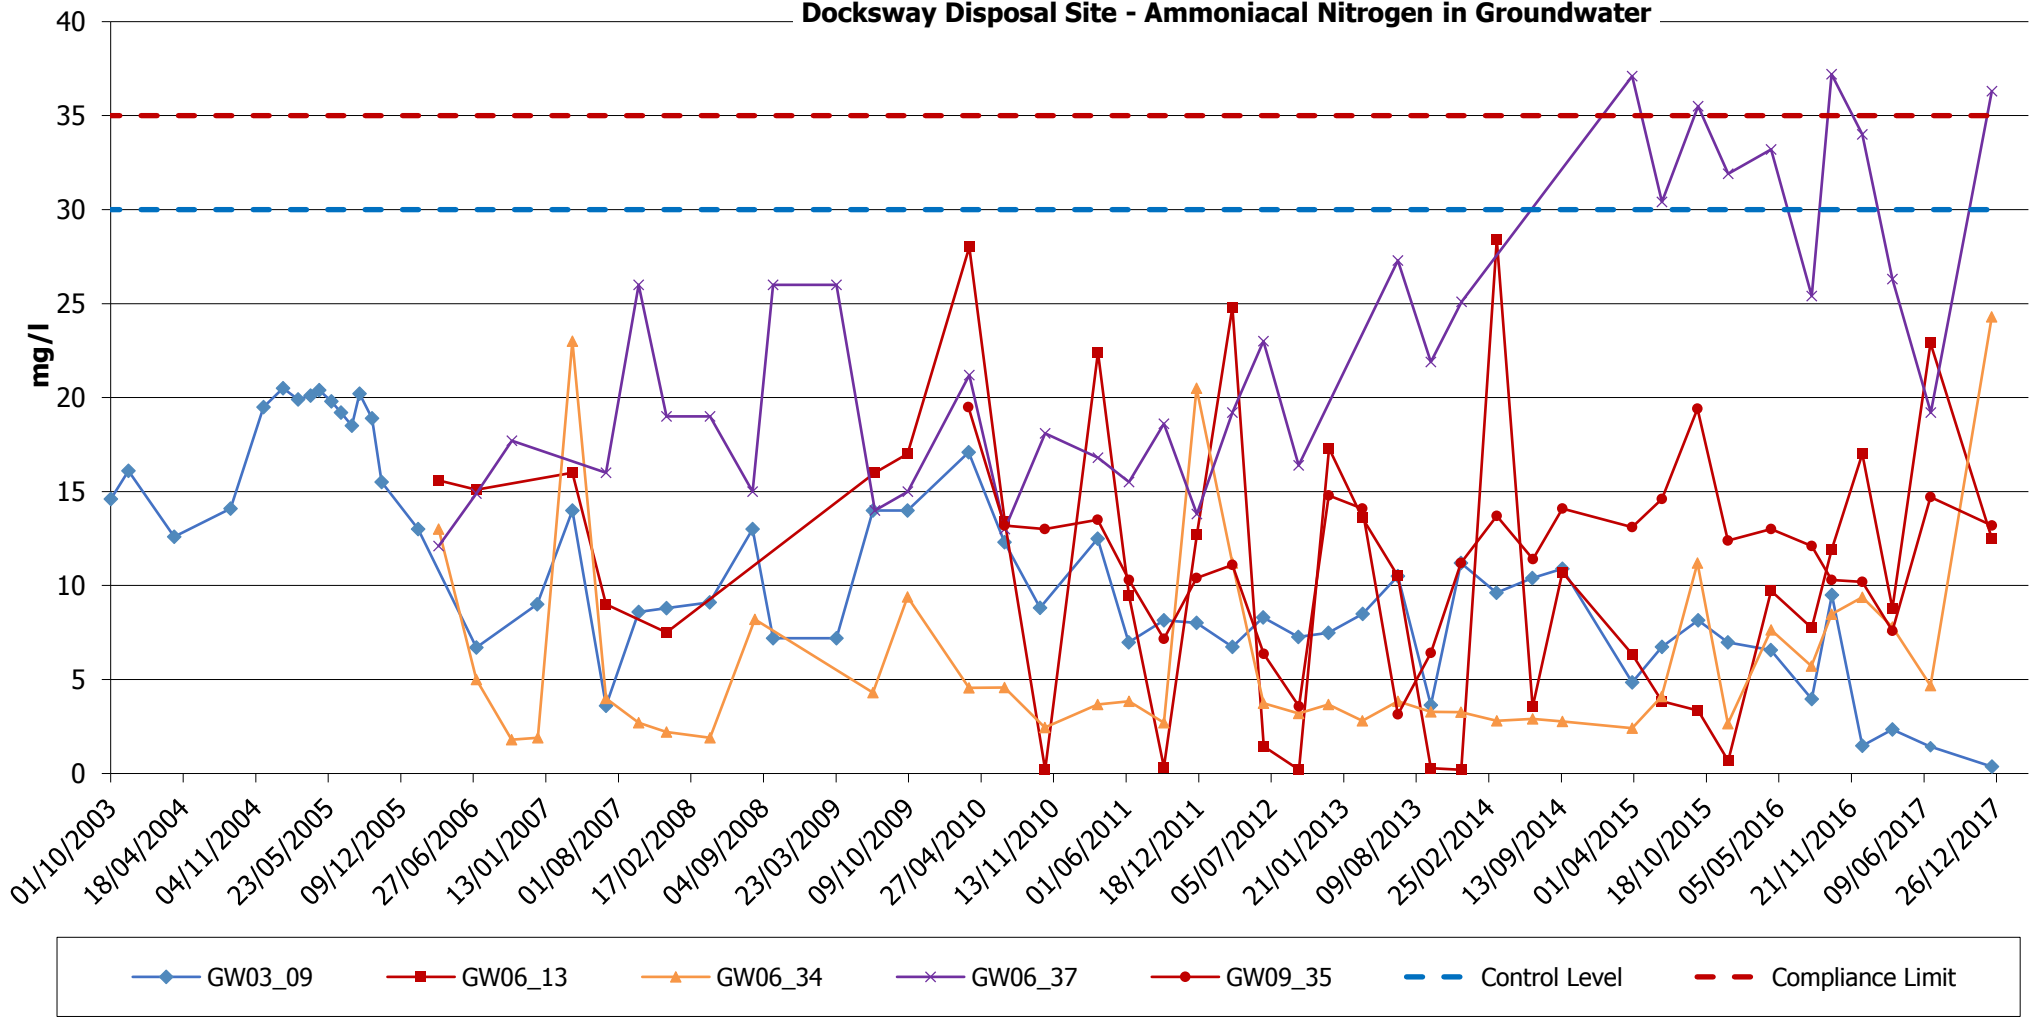
Appendix 2-1

**Appendix 2/1
Docksway Disposal Site - Ammoniacal Nitrogen in Groundwater**

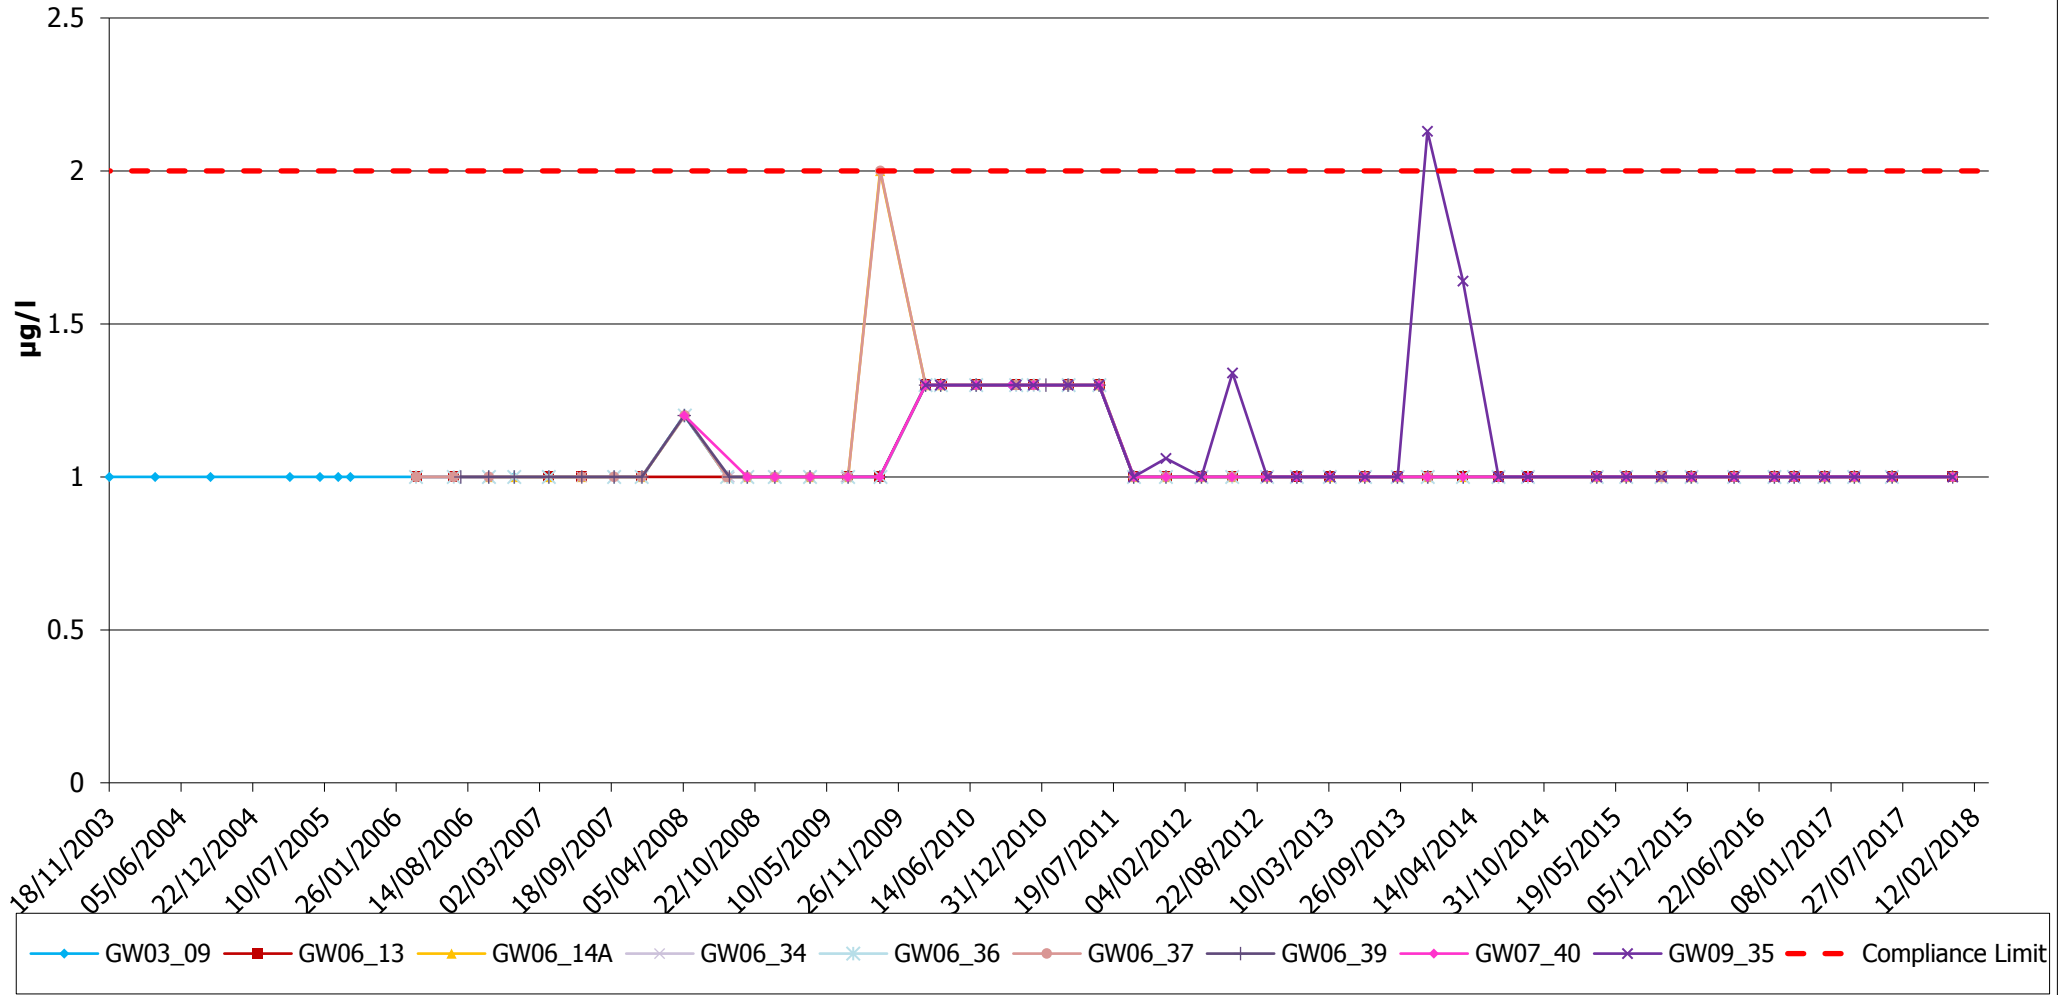
**Appendix 2/13
Docksway Disposal Site - Benzene in Groundwater**

It should be noted that the laboratory MDL has changed a number of times since 2004 for Benzene, Naphthalene and o-Xylene which gives a false impression that some of the results have occasionally exceeded the compliance limit, because the compliance limit tracks the MDL.

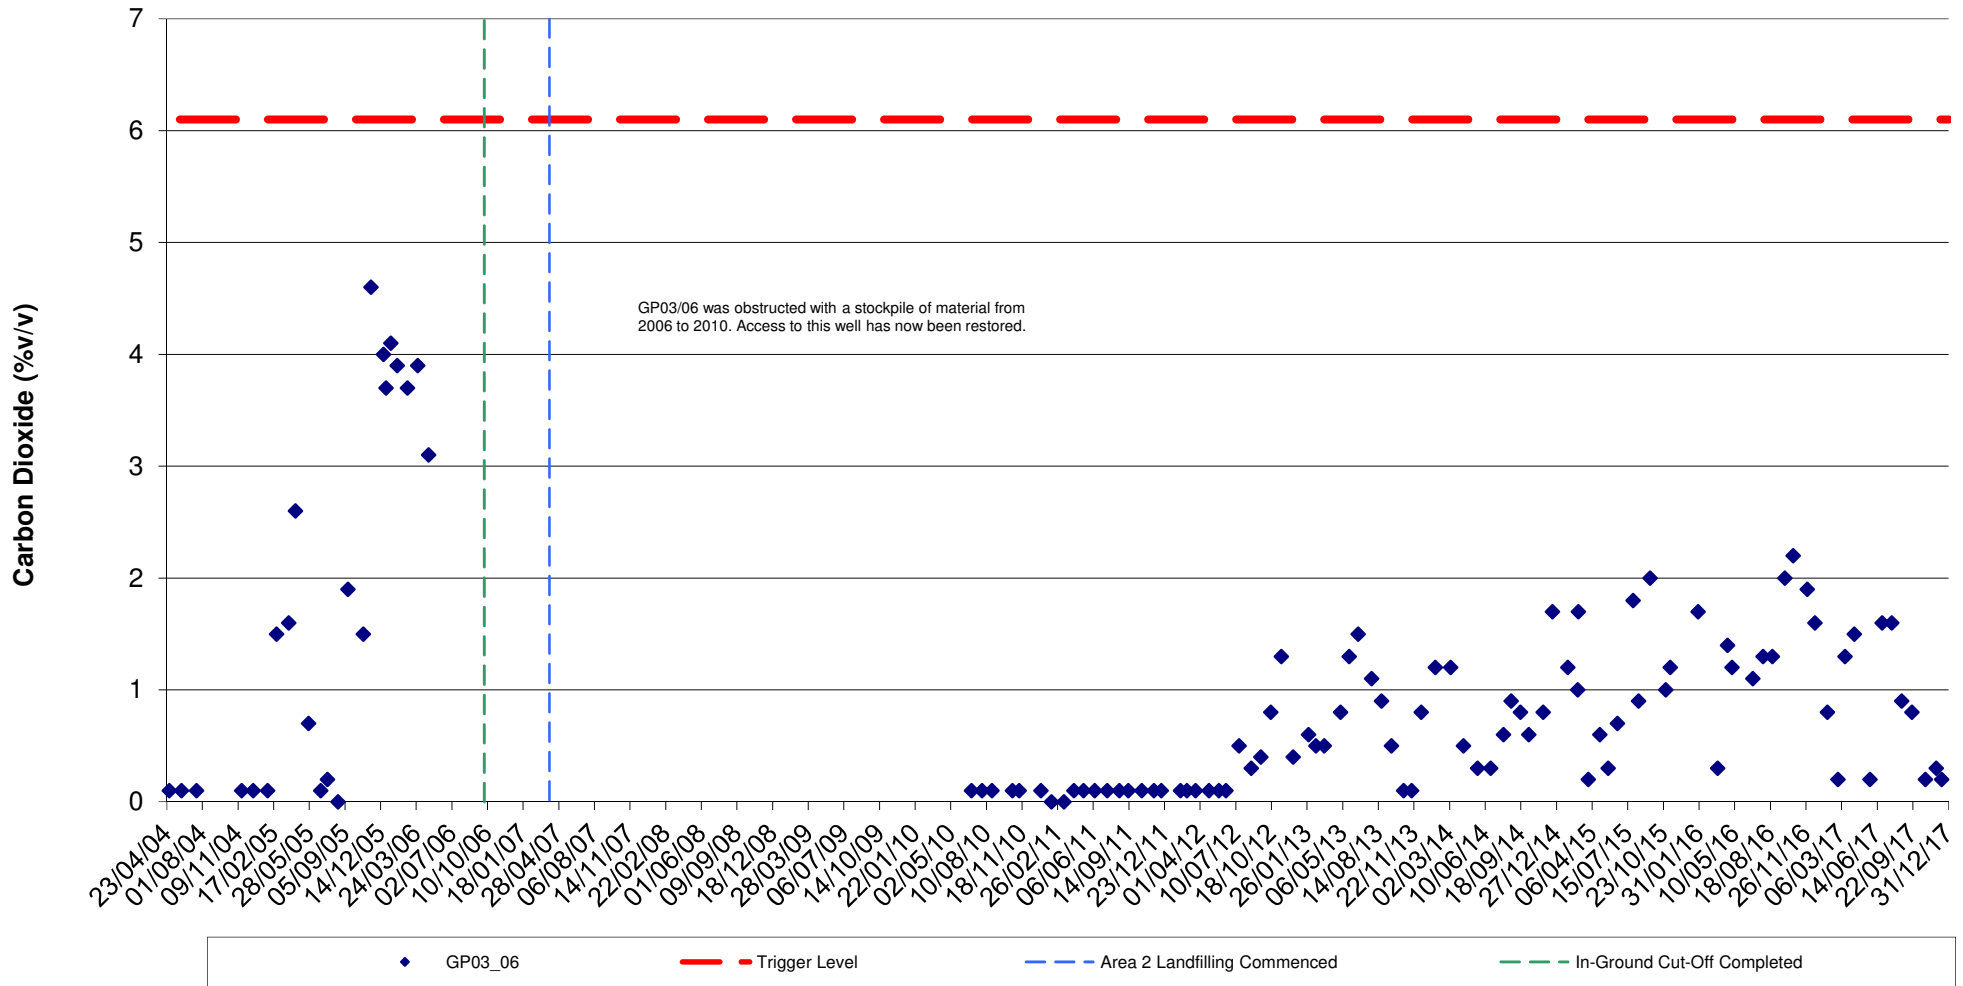
Appendix 4/4 Docksway Disposal Site Recorded Carbon Dioxide Concentrations in GP03_06

Concentrations of Carbon Dioxide recorded within GP03_06 have shown an overall decreasing trend throughout 2017, compared with increasing concentrations observed in the previous five years.

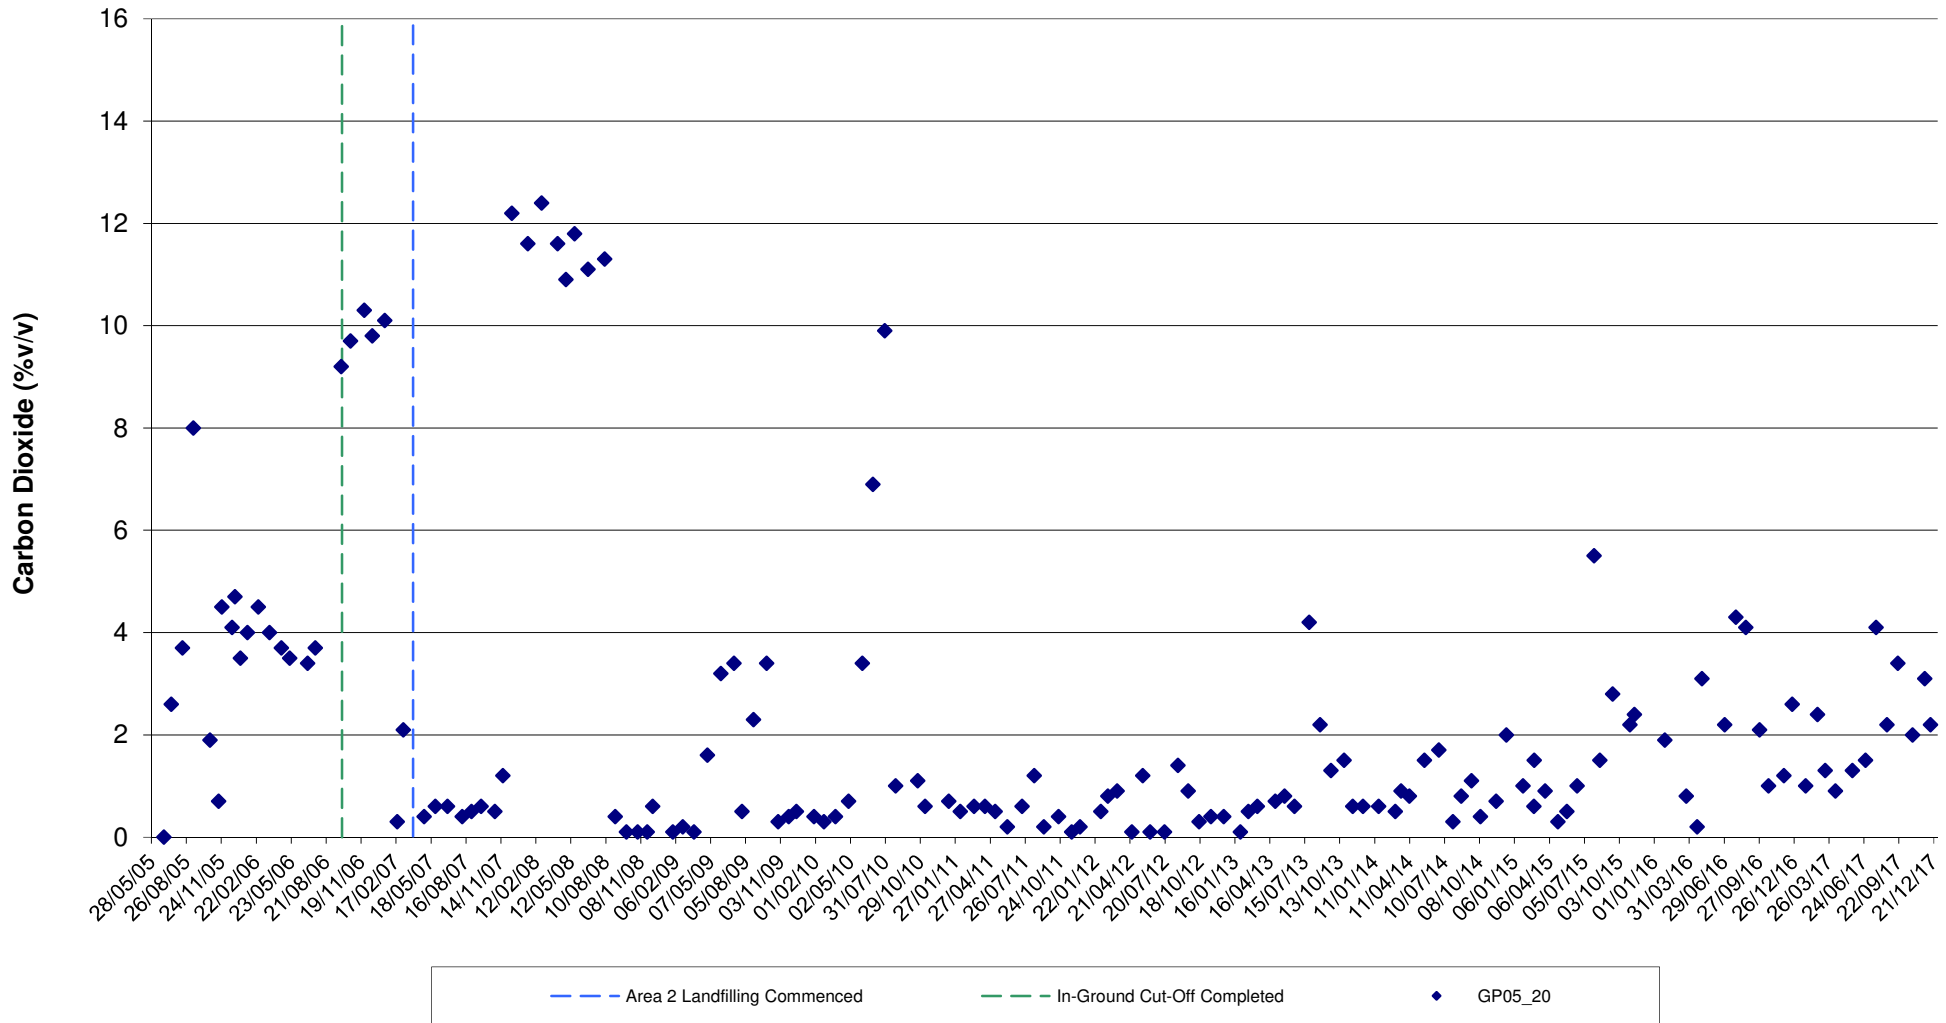
Appendix 4/11
Docksway Disposal Site
Recorded Carbon Dioxide Concentrations in GP05_20

Adverse trends (rising or uncommonly fluctuating concentrations) have been observed in GP09_18 (Methane and Carbon Dioxide), and GP05_20 (Carbon Dioxide) in the last 12 months. No other adverse trends in landfill gas concentrations have been observed. It is considered that ground gas concentrations in GP05_20 should continue to be monitored closely to determine whether the potential trend of rising concentrations continues and whether further investigative or remedial action is required. It is proposed that additional ground gas monitoring wells will be installed around the existing GP09_18, and that following an initial 6 month monitoring period, the data will be reviewed to determine if any remedial action is required.

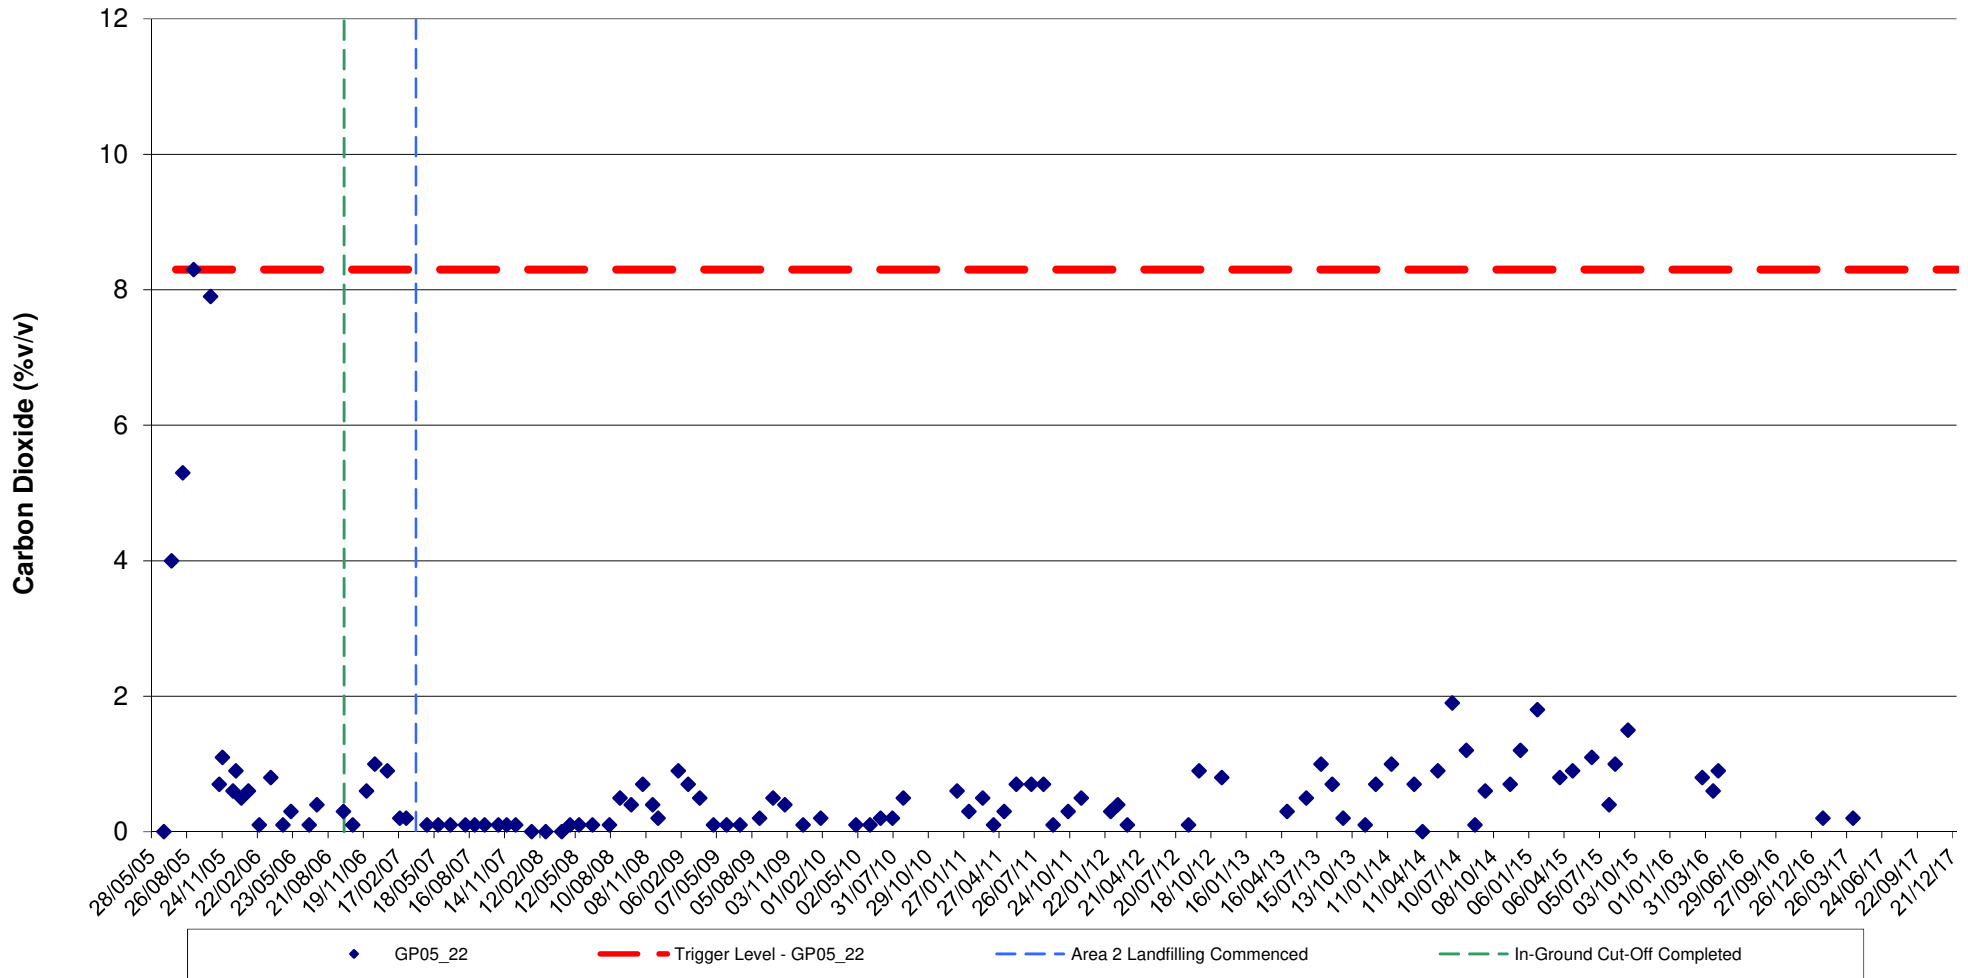
Appendix 4/13
Docksway Disposal Site
Recorded Carbon Dioxide Concentrations in GP05_22

It should be noted that GP05_22 was flooded during the majority of monitoring rounds in 2017, and was therefore only monitored on two occasions (January and April) when concentrations were recorded below the well-specific trigger levels on both occasions.

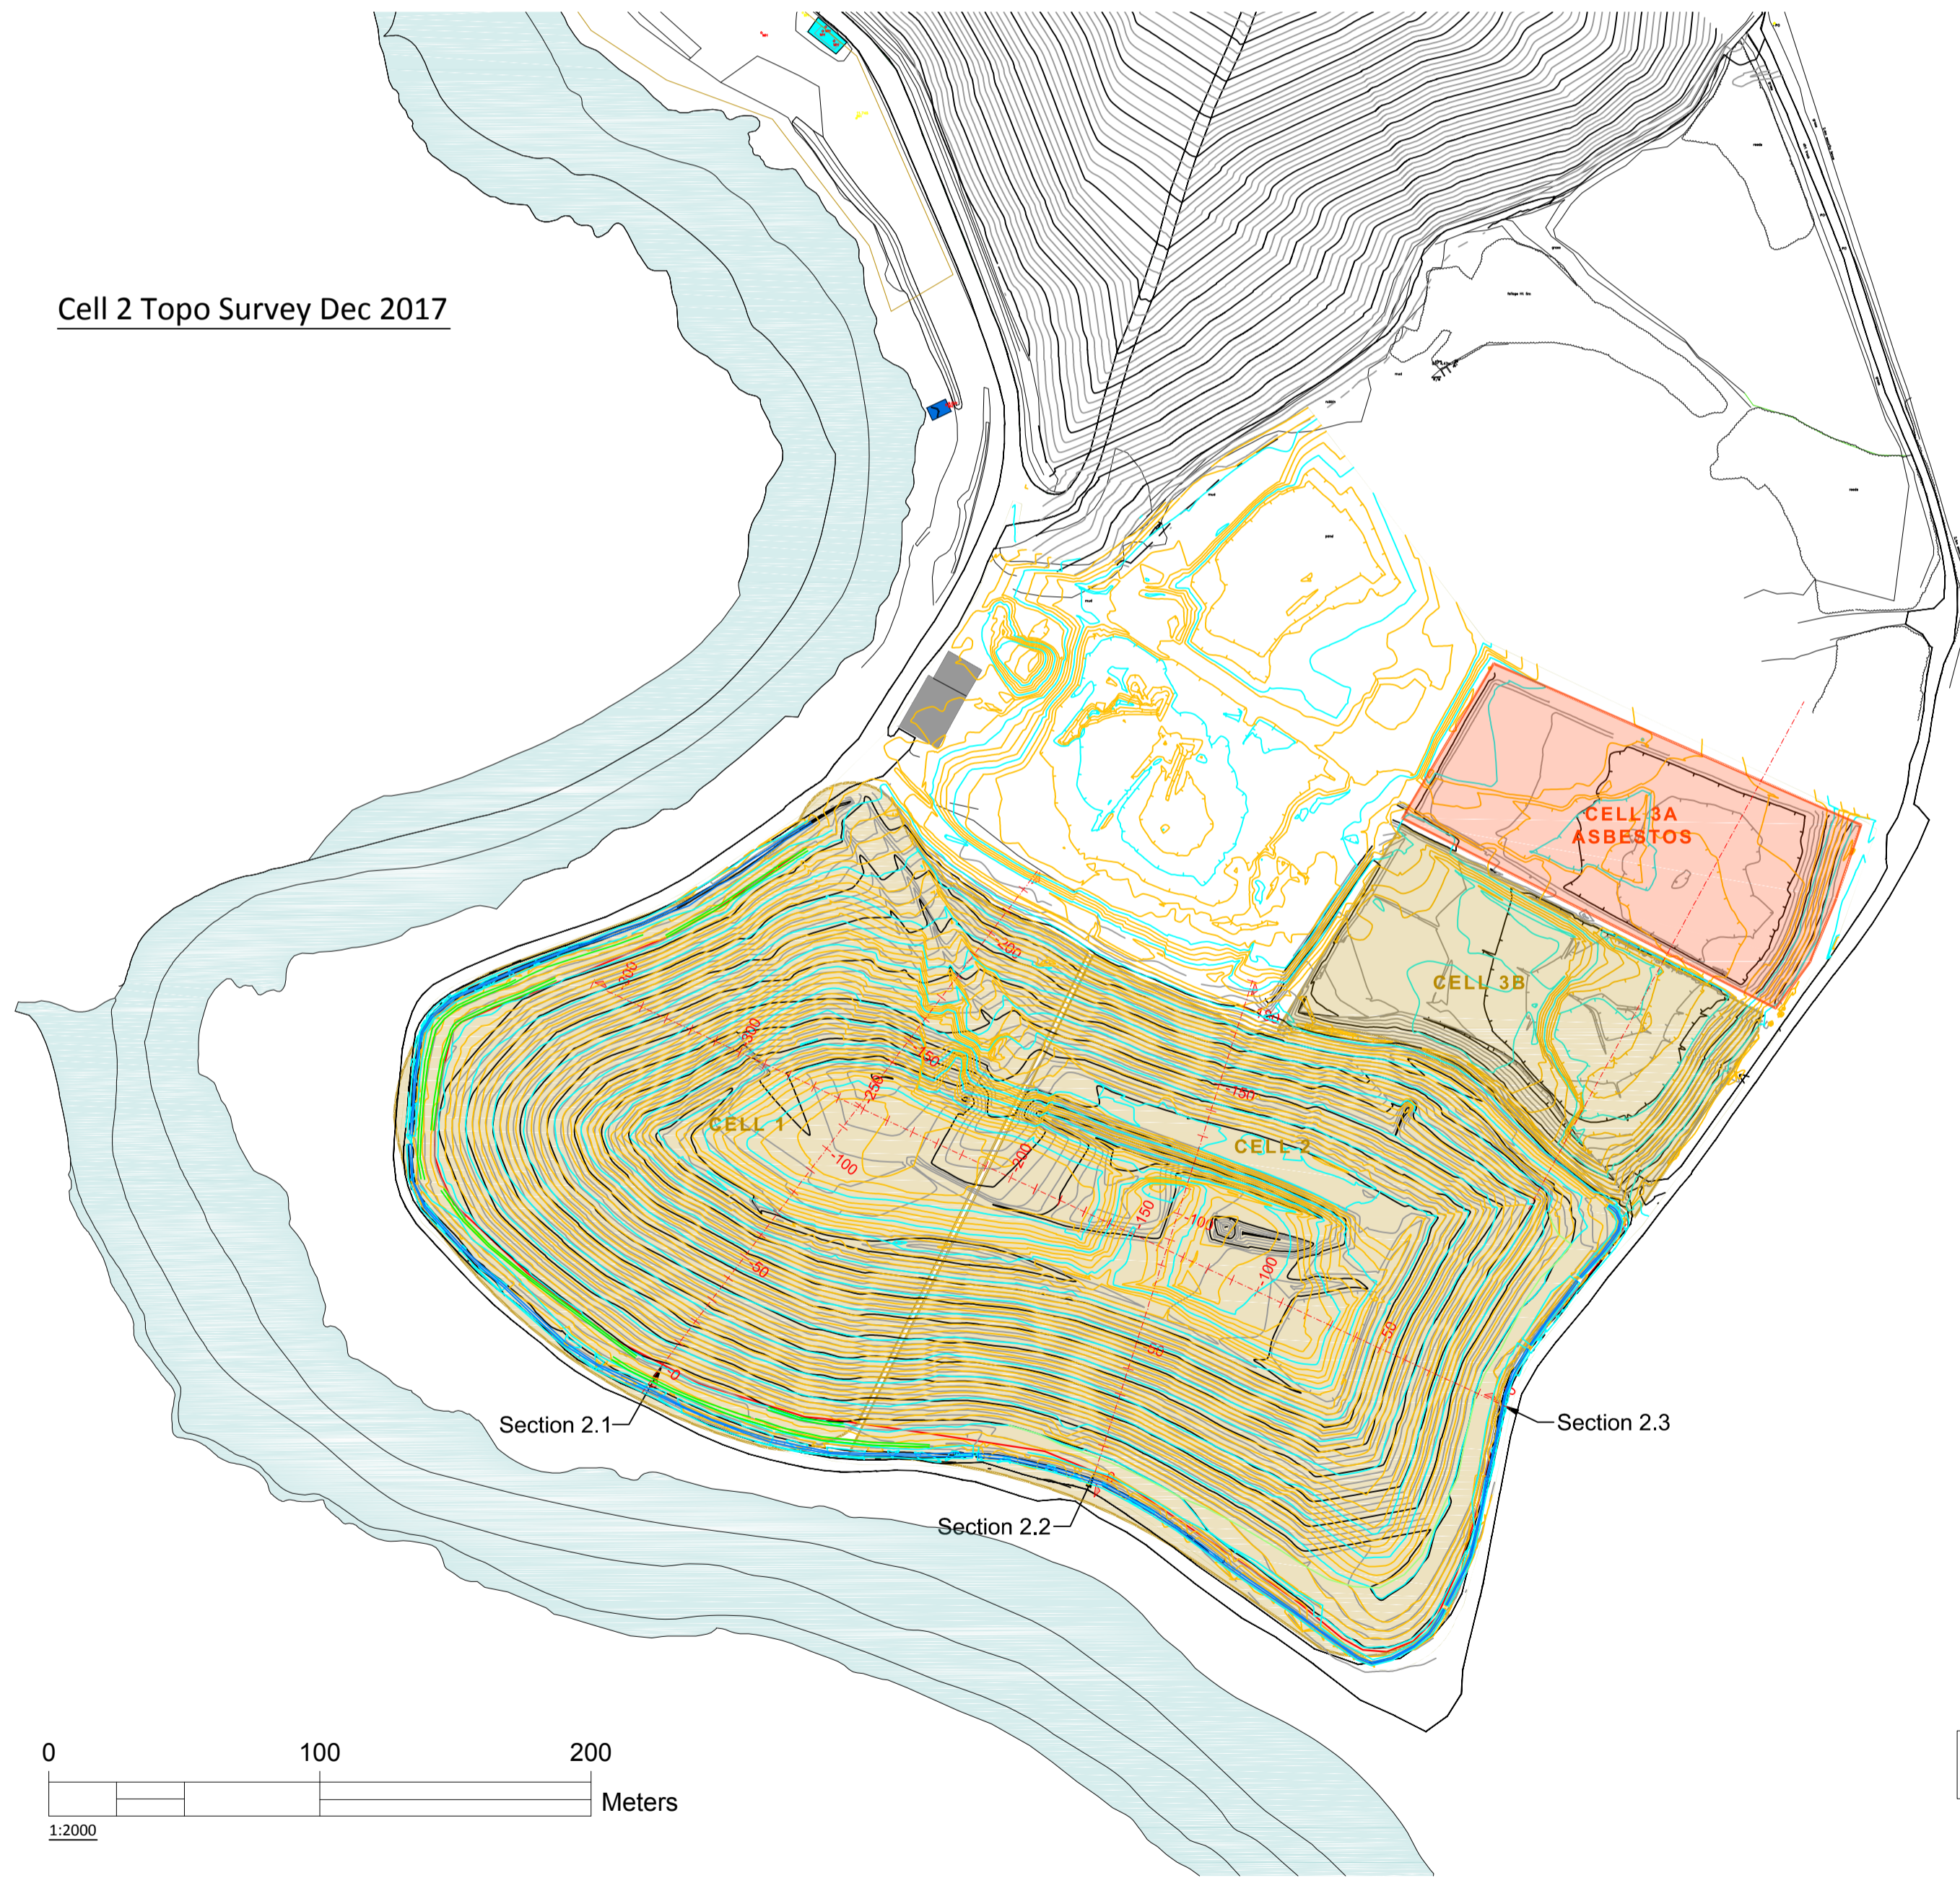
Cell 2 Topo Survey Dec 2017

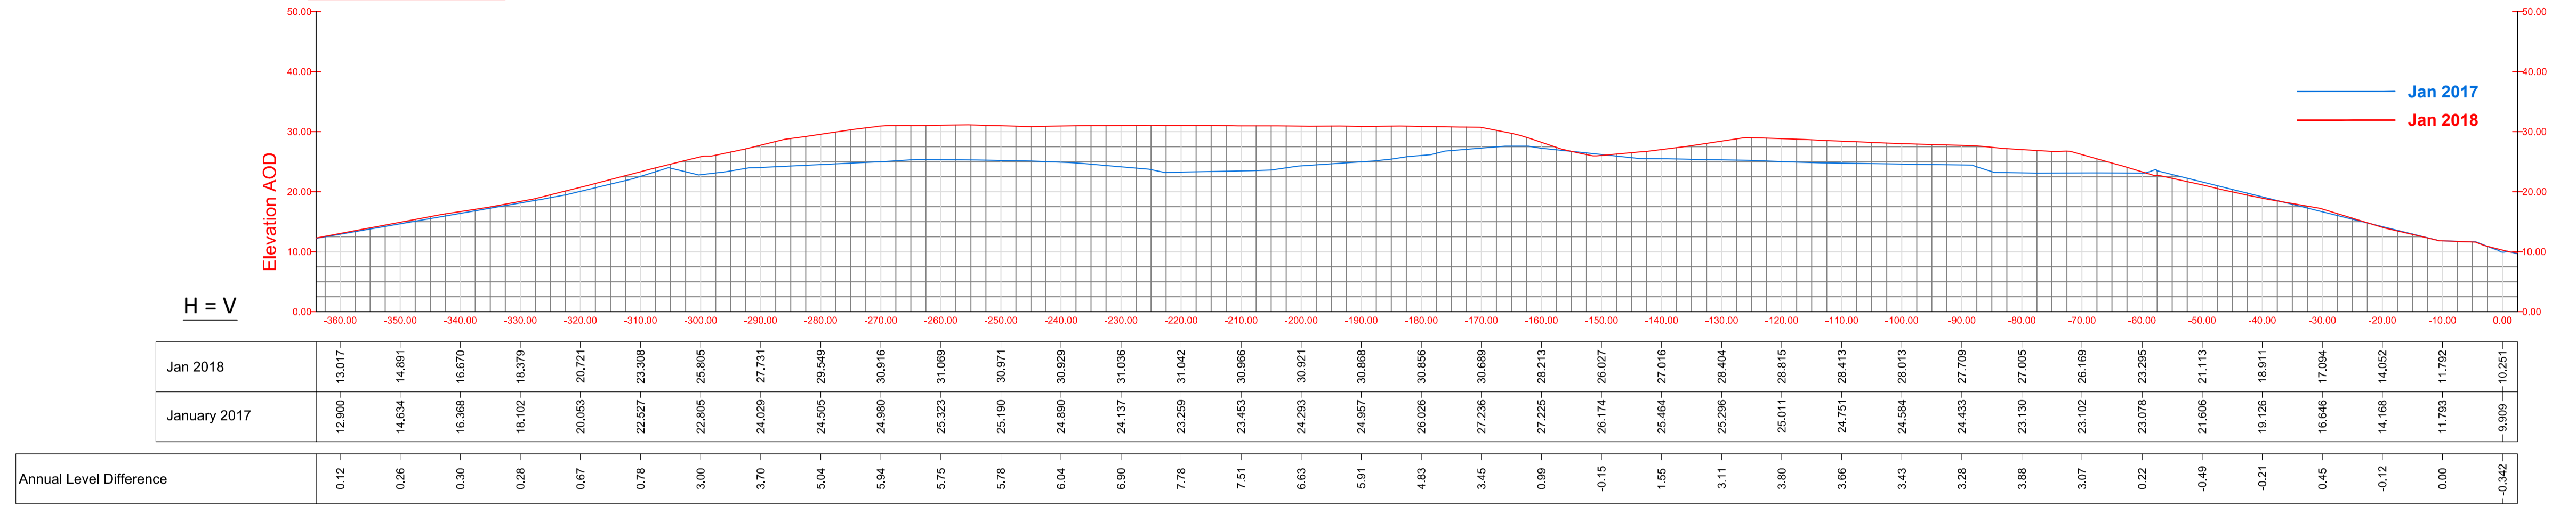
Section 2.3 @ 710 m
