# **Cilyrychen Quarry – Dewatering Abstraction Licence Application**

## **Final Report**

**December 2021**

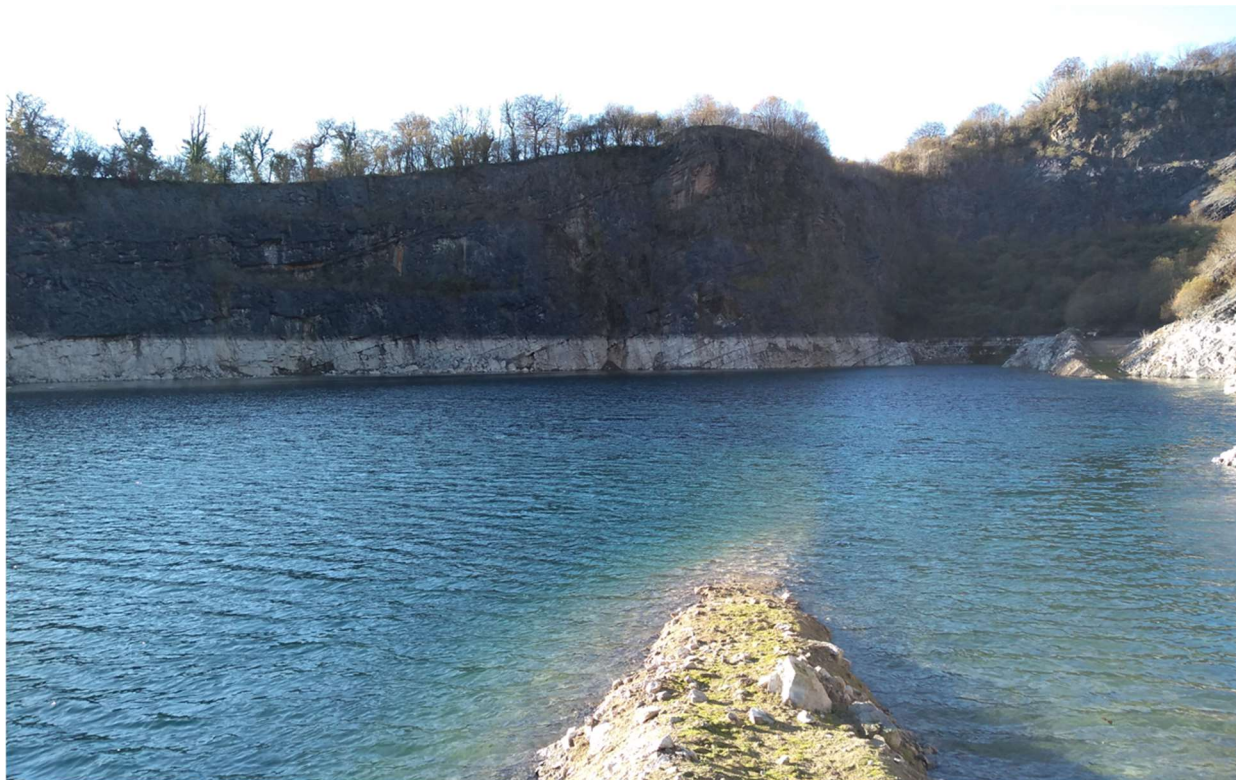
**Figure 3-5: Quarry level Nov 2021**

By the time of the cessation of pumping, the water level in the void had fallen an estimated 10 m (as illustrated by the 'tide line' in Figure 3-5. By late November 2021, the water level had only risen back ~1 m, demonstrating a slow response to recharge, runoff and/or infiltration. On this basis, it is considered that once the quarry void has been initially dewatered, it would not require ongoing pumping at such sustained levels thereafter in order to maintain a dry working area for the quarry activities.

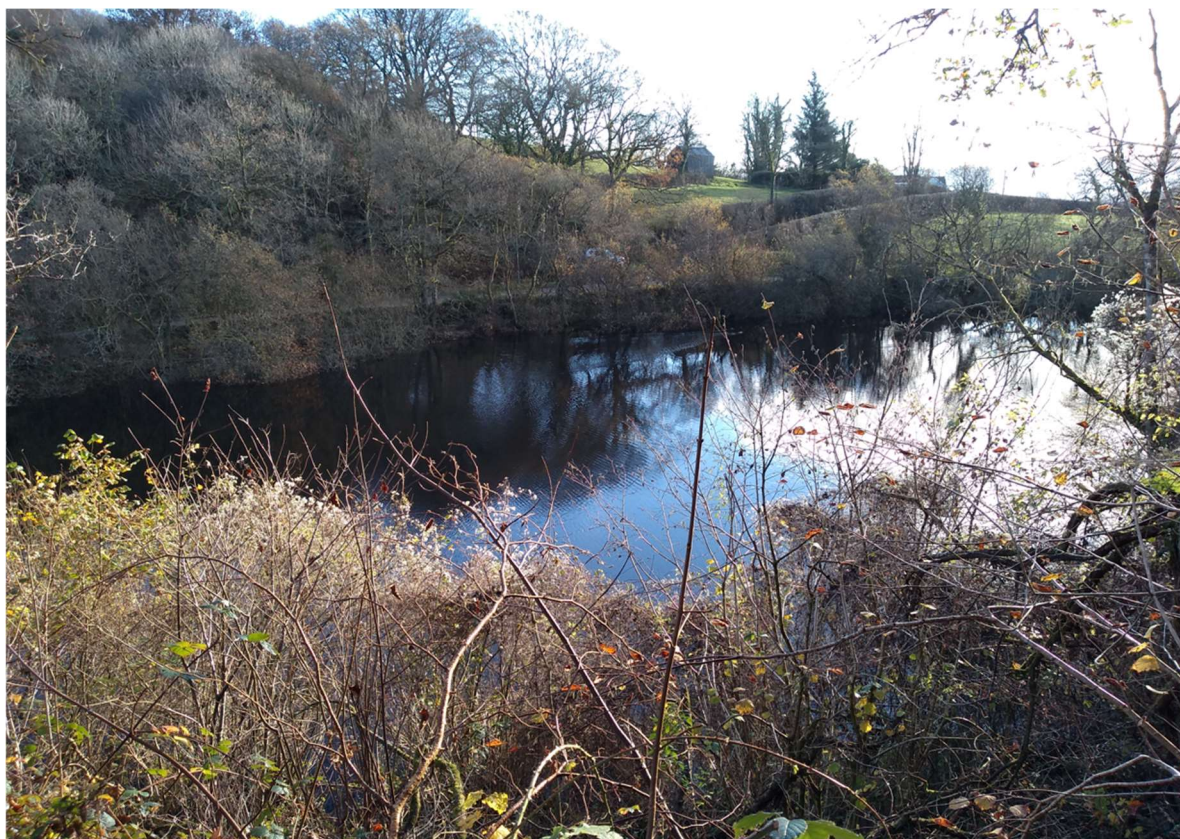
**Figure 3-6 – Turlough water level, Nov 2021**

No turlough water level data are available during or after the time of pumping at Cilyrychen quarry in the summer of 2021. Nonetheless, visual inspection of the turlough in late November 2021 showed the turlough to be full and indicative of winter water levels ). There was no evidence to suggest that the turlough's ability to achieve its winter water levels had been impaired as a result of the pumping at Cilyrychen quarry during the summer.

Lidar (2020) data illustrates the water level elevation within the turlough is 160.5 mAOD, some 82.1 m higher than that observed within Cilyrychen quarry (water level 78.4 mAOD). Water levels were also recorded (and also modelled) for a two-year period by BGS (2012) and indicate highs of ~160.5 mAOD from typically November to April. The base of the turlough when empty is at ~157.5 mAOD and revealed a discrete estavelle in the bed which both fills and empties the feature.

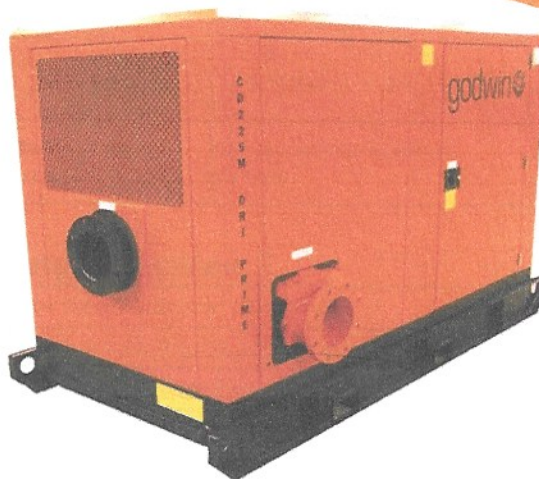
The Godwin Dri-Prime CD225M pump is an extremely powerful yet compact pump with flow capabilities to 735 m<sup>3</sup>/hr and discharge heads to 49 metres.

The CD225M features the unique Godwin high pressure oil bath mechanical seal design. This allows for dry running for prolonged periods while automatically priming and repriming. Able to perform in the toughest conditions, the CD225M can handle solids up to 75 mm in diameter. This makes it an extremely effective pump, suitable for both slurry and clean water applications. The powerful CD225M has proven itself a pump of choice for mines, quarries and many other high capacity applications.
