## Compliance Assessment Report

Report ID:  
CAR\_NRW0034163

| Site | Twyn Dismantlers Ltd | Permit Ref | WP3395FT | | | |
| Date of assessment | 19/10/2018 | Time in | 11:30 | Out | 13:00 | |

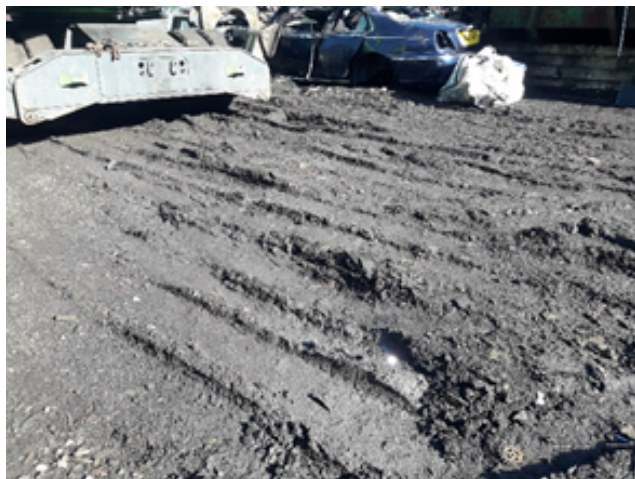
- In areas of hardstanding which had not been remediated, widespread contamination of the ground with oil and end of life vehicle waste remained (see photo 1).

- Approximately half of the area of hardstanding had not been remediated as required within the enforcement notice, this area had significant ground contamination with oil and residual end of life vehicle wastes (see photo 1).

**Photo One** - Rutting of hardstanding surface

- Rutting of the area of hardstanding was evident (see photo 1 and 2).
- There were several cracks in the parts of the site which had an impermeable surface.

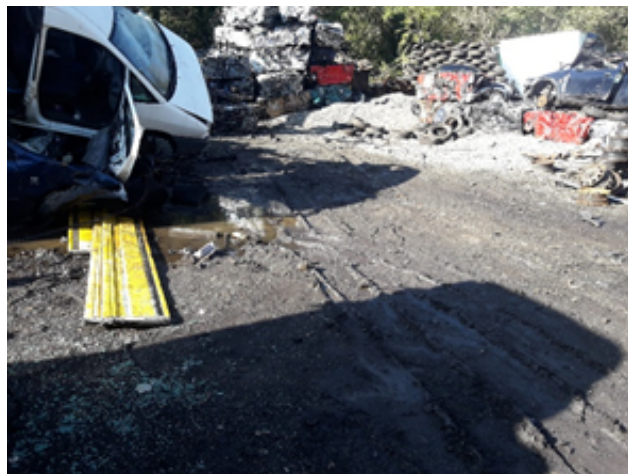
- Settling of water was present, puddles were contaminated and had a film of oil on the surface. Rutting of the contaminated surface was evident (see photos 1,2 and 4).

**Photo Two** - Rutting of hardstanding surface

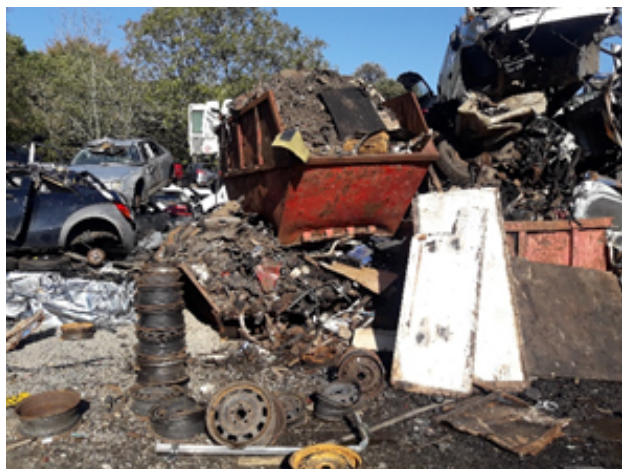
- The residual waste and contaminated ground had not been removed from site (see photo 3). Some waste had been placed within skips, but some was also stockpiled in the South-East corner of the site (see photo 7). Given that the waste had not be removed from site, no transfer/consignment notes could be provided. Mr Ashley Griffiths stated that he was seeking quotes for the removal of the contaminated waste. Officers reminded him that this waste would need to go to an appropriate facility given its hazardous nature, and that evidence would need to be provided when the waste is removed from site.

**Photo Three** - Contaminated ground and waste

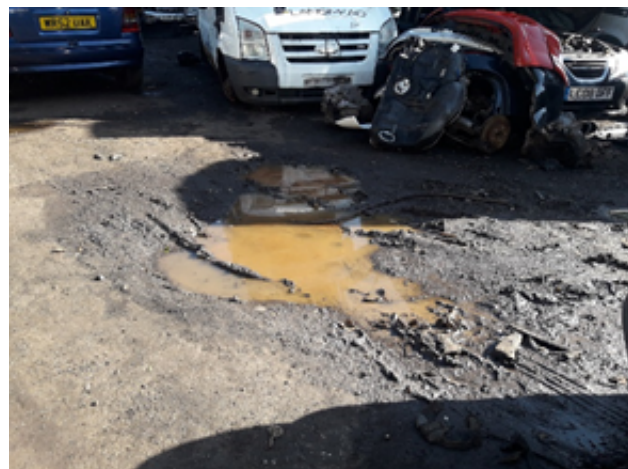
- Settling of water was present, both on the area of hardstanding and on the impermeable surface. These puddles were contaminated and had an oil film on the surface.

**Photo Four** - Pooling of water

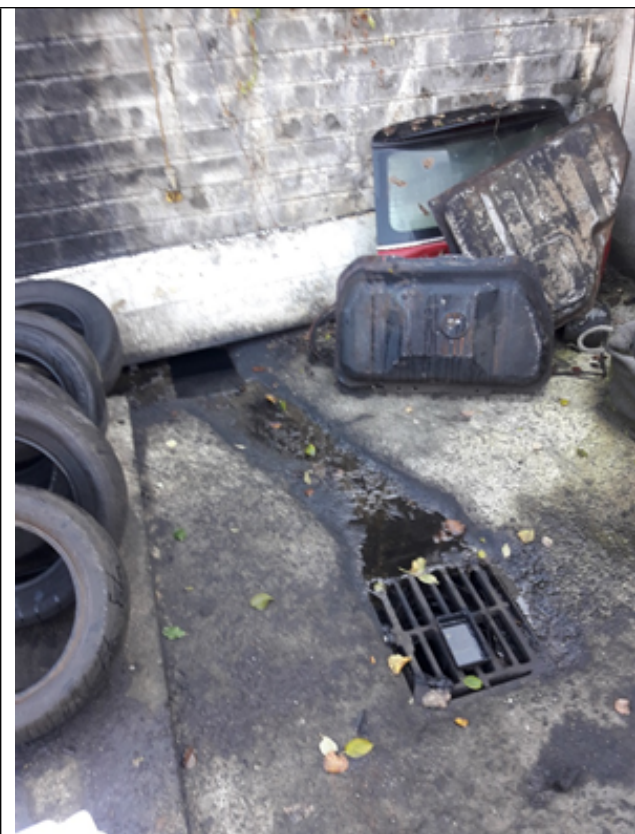
- Parts of the interceptor system had a distinct odour of oil and fuel. There was visible oil contamination within all of the tanks (see photo 6). The contamination of the system suggests that spillages are not being cleaned before oils can enter the sealed drainage system. This was confirmed in that oil staining could be clearly seen on the entrance gully (see photo 5).

**Photo Five** - Oil staining on entrance gully

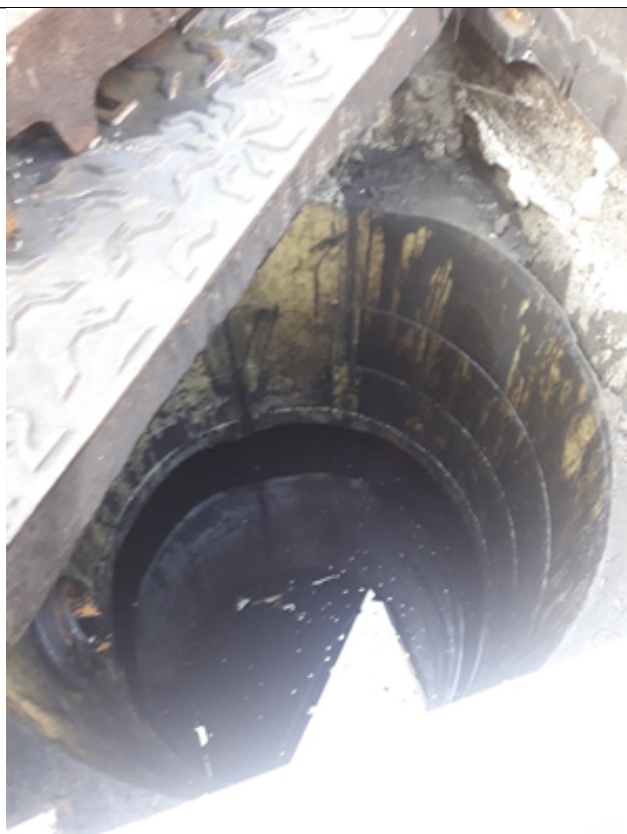
**Photo Six** - Oil staining of interceptor tank

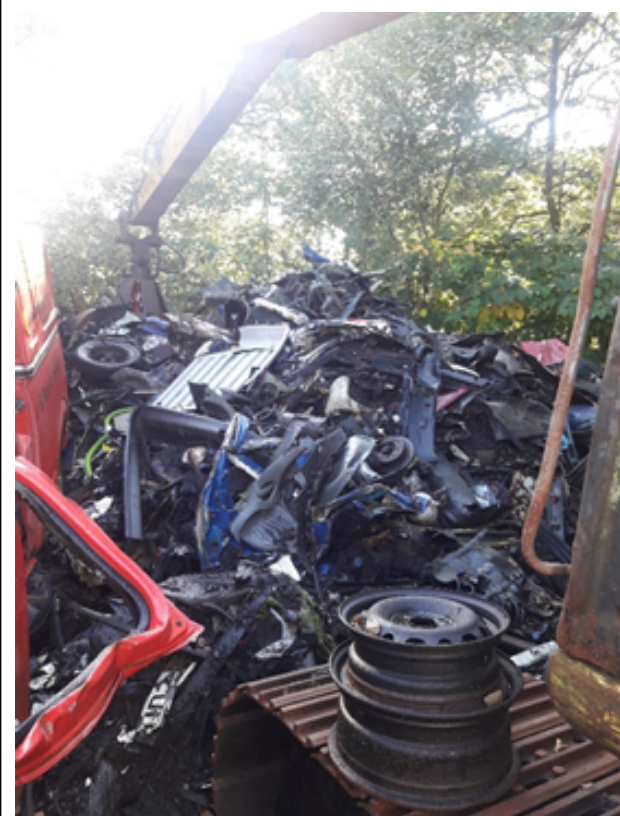
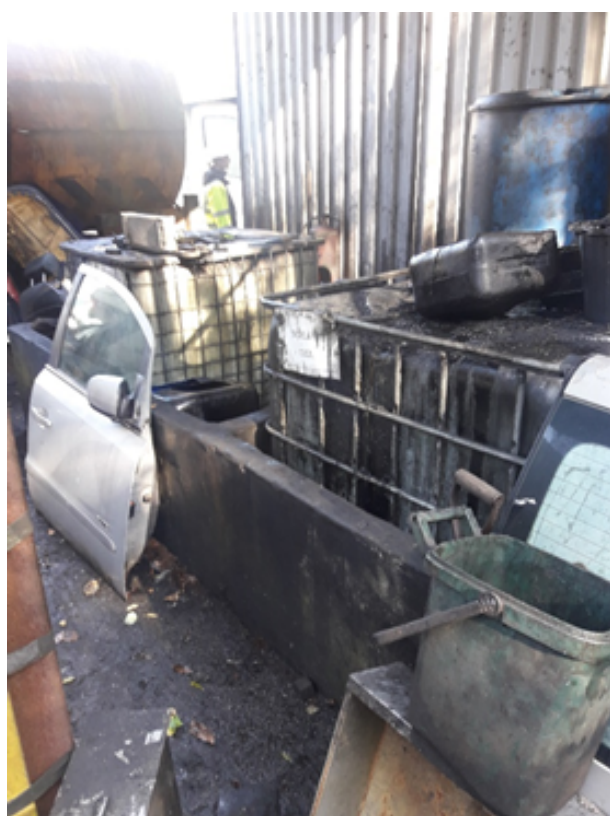
**Photo Seven** - Stockpile of metals
