# Barmouth Viaduct Metallic Works Habitat Regulations Assessment (HRA)

| DOCUMENT INFORMATION | | | |
|---|---|---|---|
| Project | Barmouth Viaduct Metallic Works | | |
| Title | Habitat Regulations Assessment | | |
| Document Ref | EV000652/HRA-002 | Issue / Revision | 0.1 |

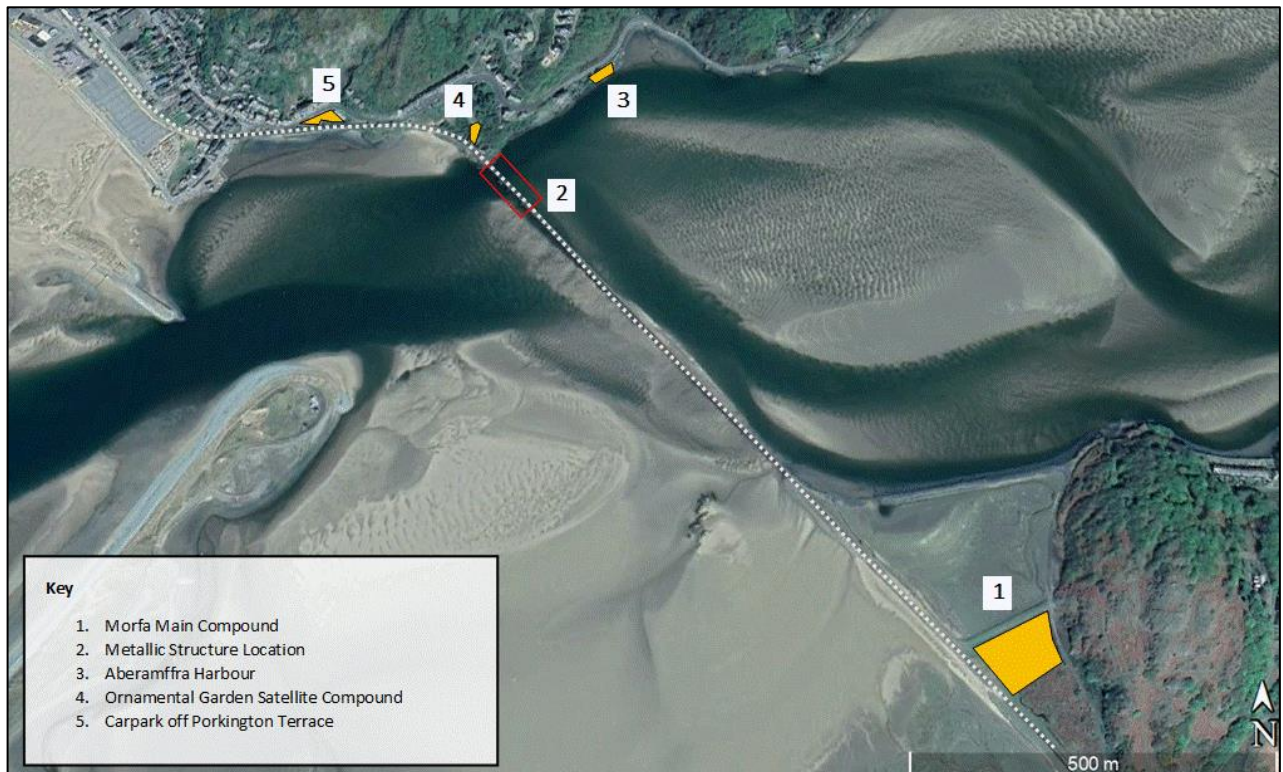
**Figure 3: Project Compounds.**

- 4.3.1 The compounds to be used are the same as those used under Marine License CML2016. With the addition of Aberamffra Harbour (location 3, figure 3).

- 4.3.2 The compound at Ornamental Gardens (location 4) has been chosen to be as close to the structure as possible whilst minimising disruption to Barmouth. The additional parking (location 5) has been chosen to avoid having cars parked within the compound area due to lack of available space and the reduced sighting distance when leaving the compound onto the main road.

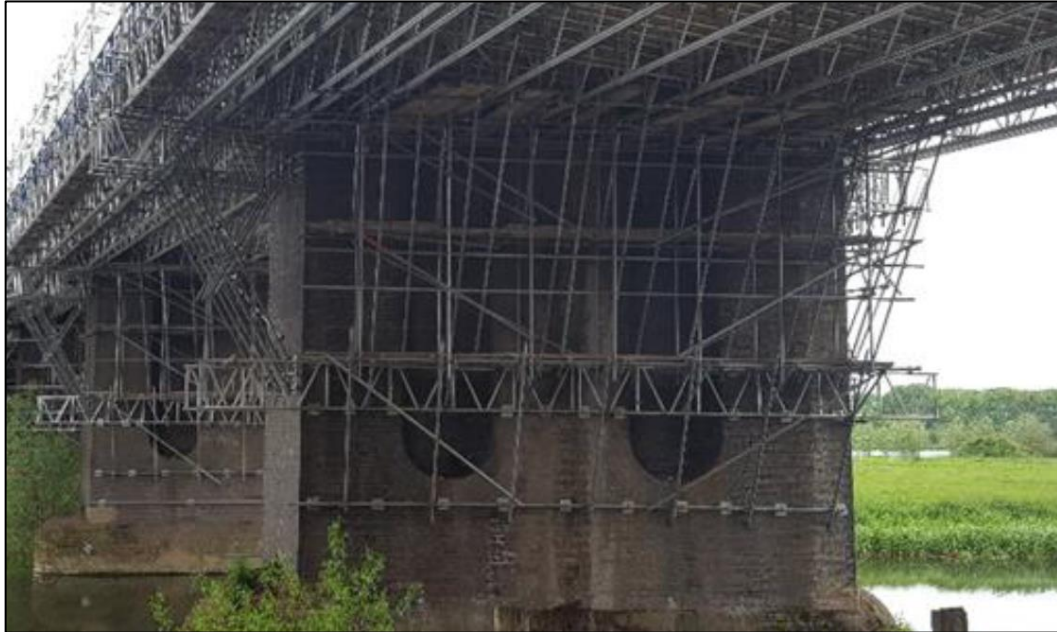
*Figure 5: Example of scaffolding above high waterlines.*

- 4.5.1 During the summer of 2022 the substructure will be painted and repaired. The painting will consist of grit blasting (please refer to Appendix C for grid blasting technical information) above the tidal splash zones i.e., above MHWS with access gained via scaffolding fixed to the cylinders using shear plates.

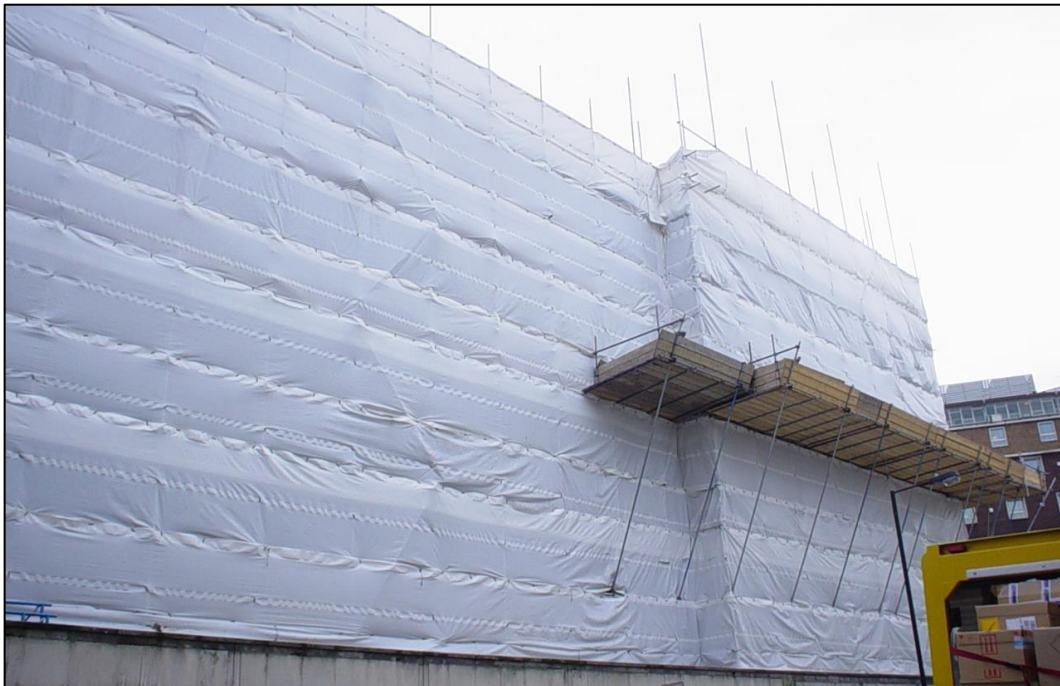
*Figure 6: Example of Monarflex sheeting used in an urban setting.*

- 4.5.2 The upper section of this scaffolding will include encapsulation and ply boarding to catch spent grit. The encapsulation will likely be of a Monarflex design or equivalent (see figure below for example)

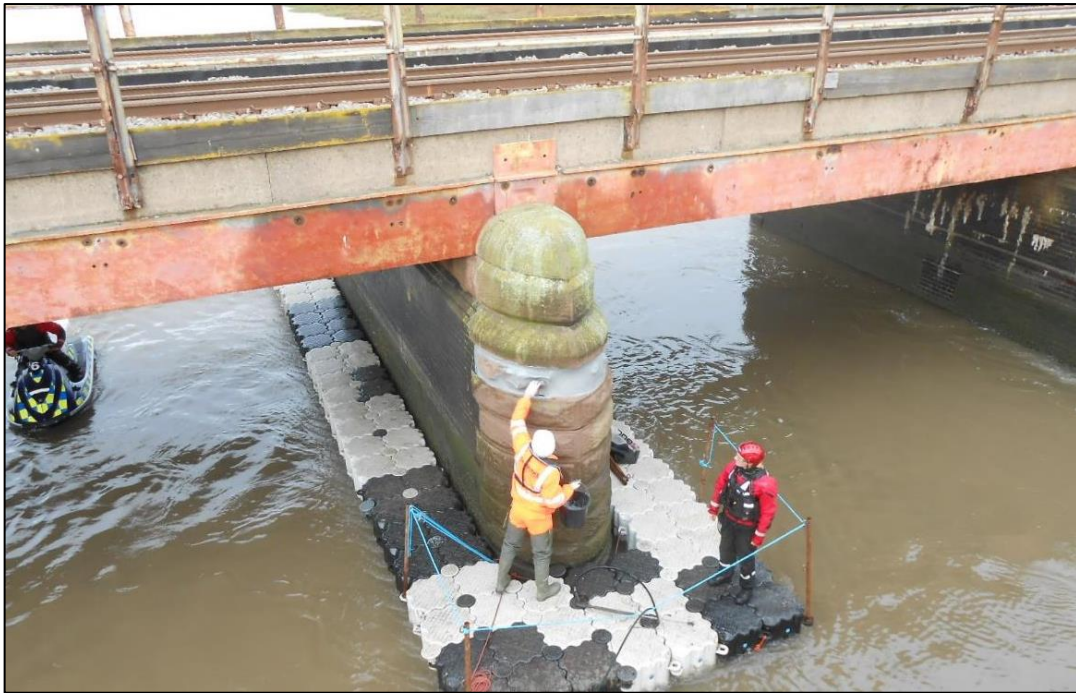
**Figure 7: Example of pontoon wrapped around pier.**

- 4.5.3 The lower scaffold will not be encapsulated and will be specifically designed to allow tide to pass over and through and will include steel 'haki' boards. The pontoons will be 'wrapped' around the piers. Blasting will utilise either a mechanical removal of degraded paint or vacuum blasting techniques.

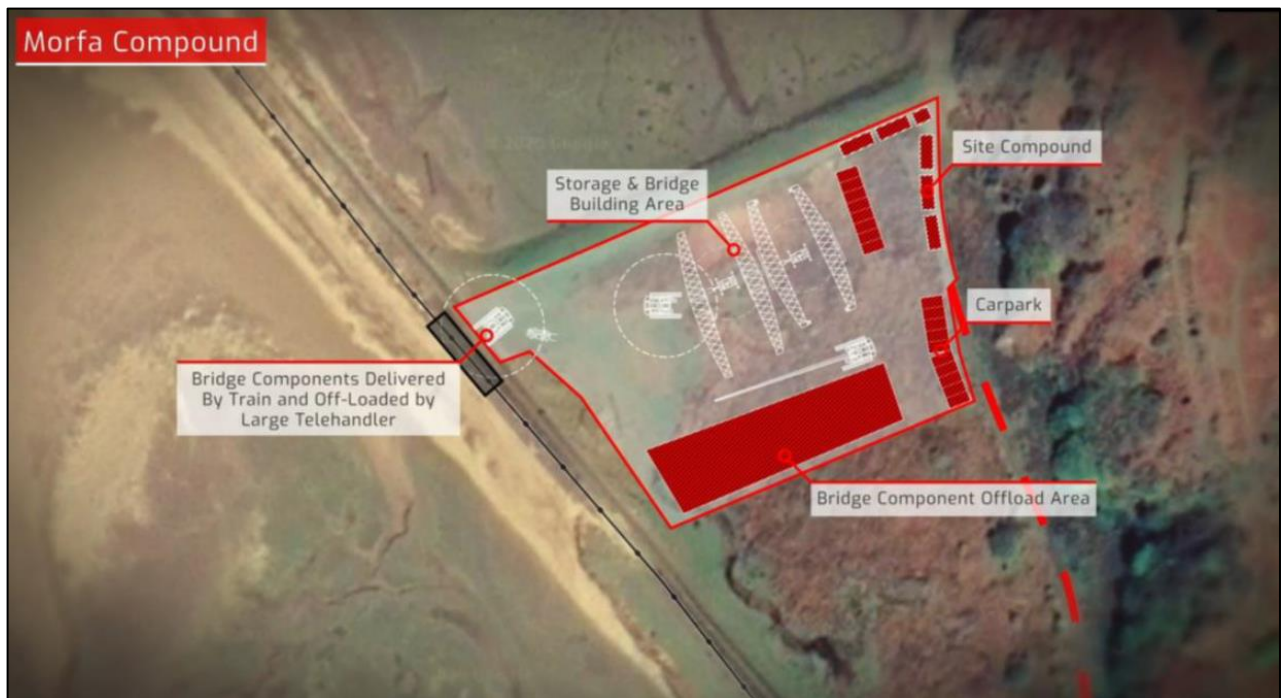
**Figure 8: Upgraded compound to support new metallic sections.**

- 4.6.1 Following the fabrication, the bridge components will be transported from Darlington via Rail and delivered to Morfa within a Saturday night possession by DB Schenker. The train will be unloaded using an all-terrain crane positioned in the Morfa compound. This will be carried out early summer 2022,

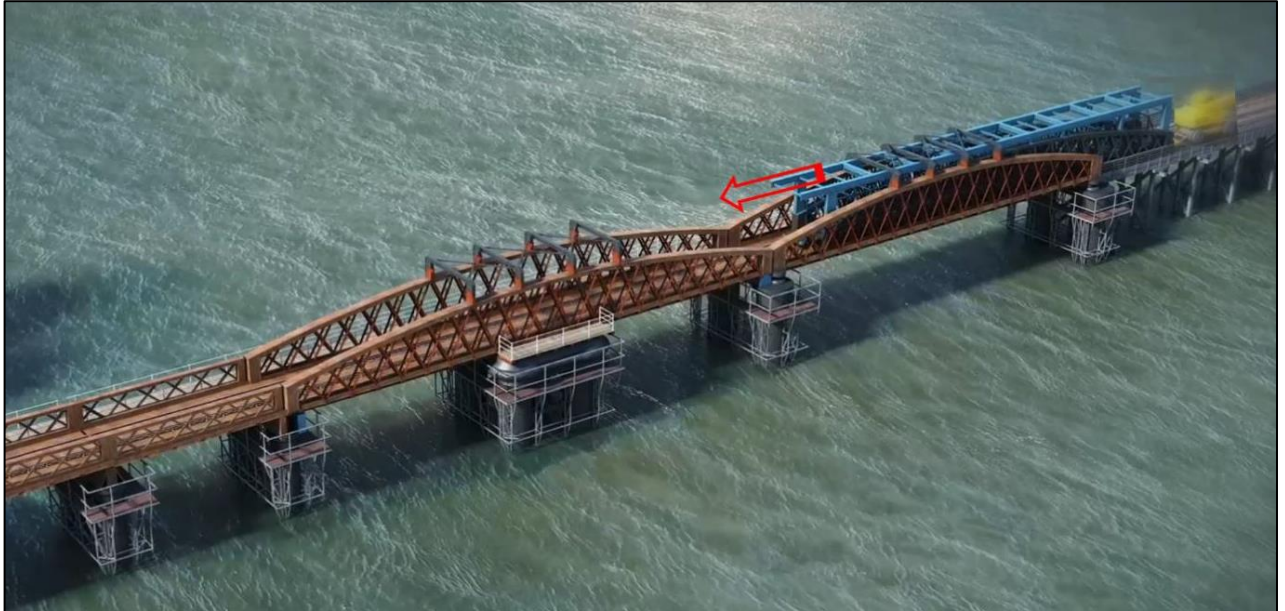
*Figure 10: New bridge sections and loading beams driven into space between existing outer frames.*

- 4.7.9 The existing spans will then be cut into pre-determined sections (generally 3-4m depending on nodal positions). As the sections are fully supported all cutting can be carried out from the deck without the need for open edge working.

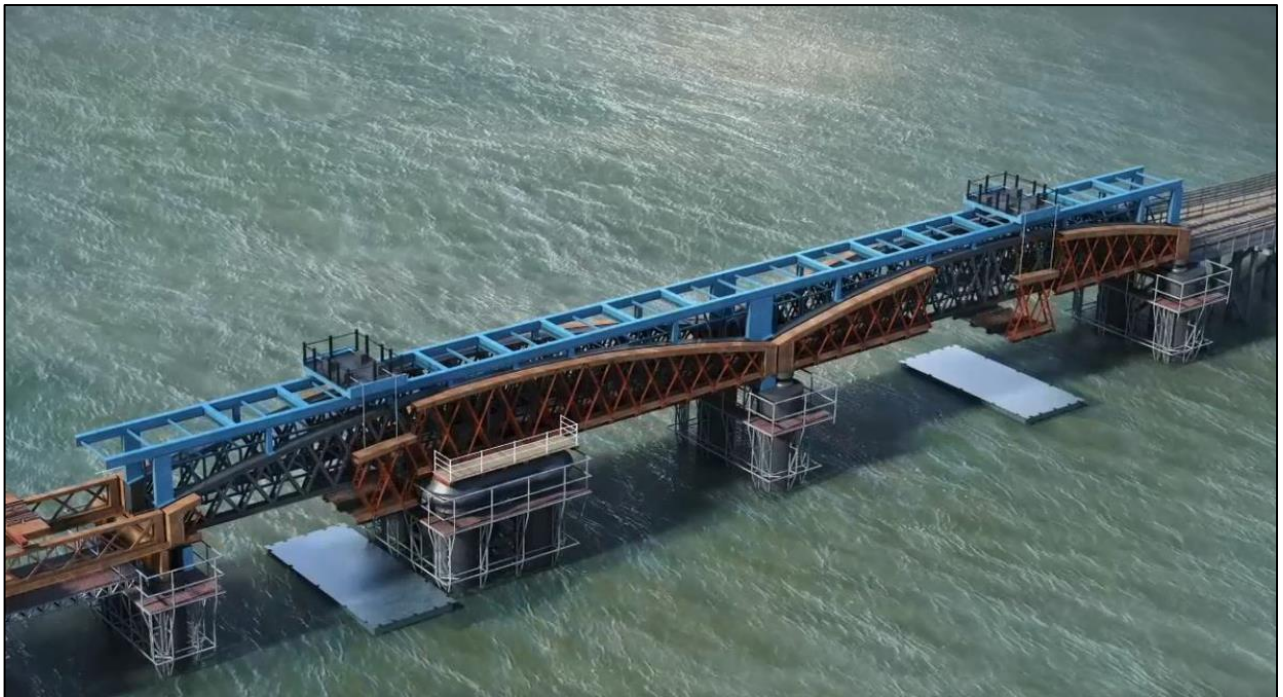
*Figure 11: Removal of outer steel work and existing decking.*

- 4.7.12 There is an allowance for 4No steel pontoons in order to ensure that sections can be lowered without waiting for removal of a loaded pontoon. Both spans will be dismantled simultaneously in a predetermined sequence as to ensure a balanced transfer of loading onto the new girders.

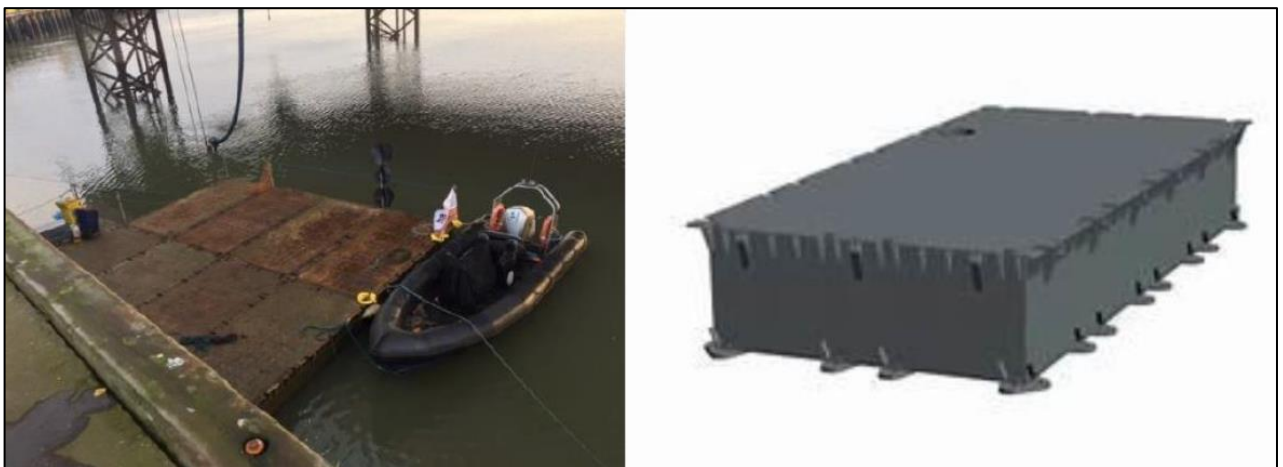
*Figure 12: Example of metal pontoon platforms.*

- 4.7.15 The pontoons will consist of 9 No (4.2m x 2.1m) NATO pontoons bolted together to form a 12.6m x 6.3m stable pontoon with solid handrail capable of holding 25 tonnes. This will then be moved to the old harbour using two small vessels each acting as redundancy to the other should any issues occur. Using these methods will provide the benefit that work can continue at almost all states of tide due to the low draft.

- 4.7.17 It should be noted that the pontoons are road deliverable and will be constructed off the old harbour ahead of the blockade. They have a maximum height of 770mm with a draft of 570mm fully loaded ensuring that they can work at all locations of the structure even at low tide. The proposed support craft have drafts of 0.45 and 0.6m again ensuring that work can continue on all but the lowest of tides.

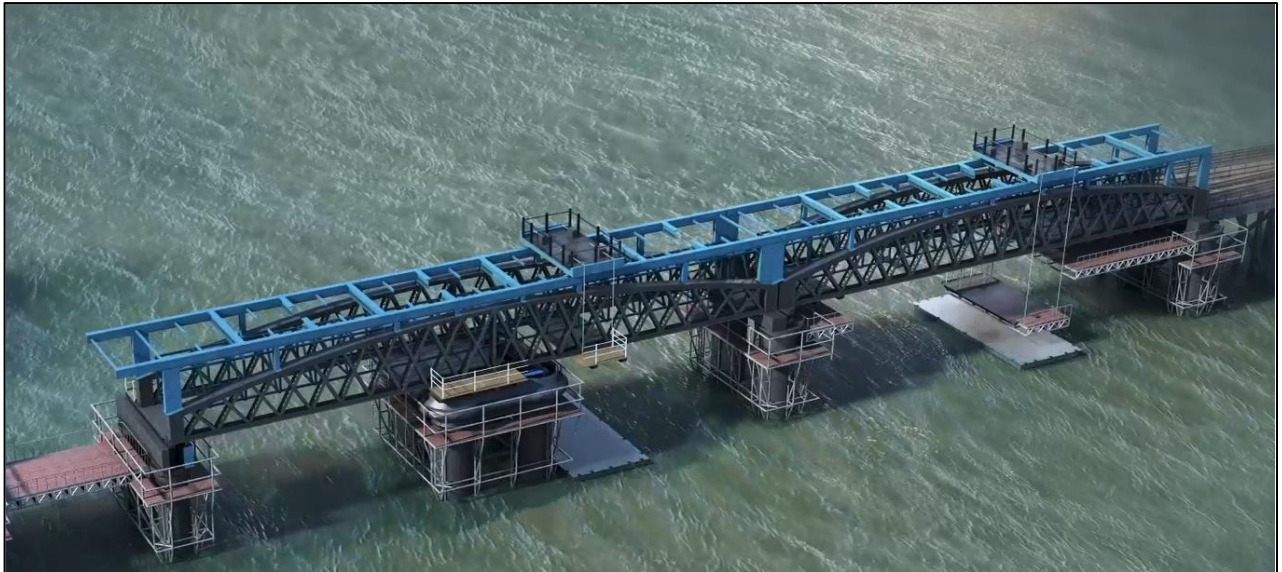
*Figure 13: New outer structure supports, and frame widened, and new decking raised and fixed into place.*

- 4.7.39 Once the main beams are secured into their final position the extended gantries will be reinstalled, using the TXM monster crane at the south end of the fixed span. Once in position the new deck panels complete with viper base plates and slave rail will be lifted from pontoons and secured to the deck.

- 4.7.40 The new deck panels will include a suspended scaffold deck below as they are lifted which will connect to the scaffold in place at pier heads. This gives the benefit of continuous access for bolting up and touch up paintwork.

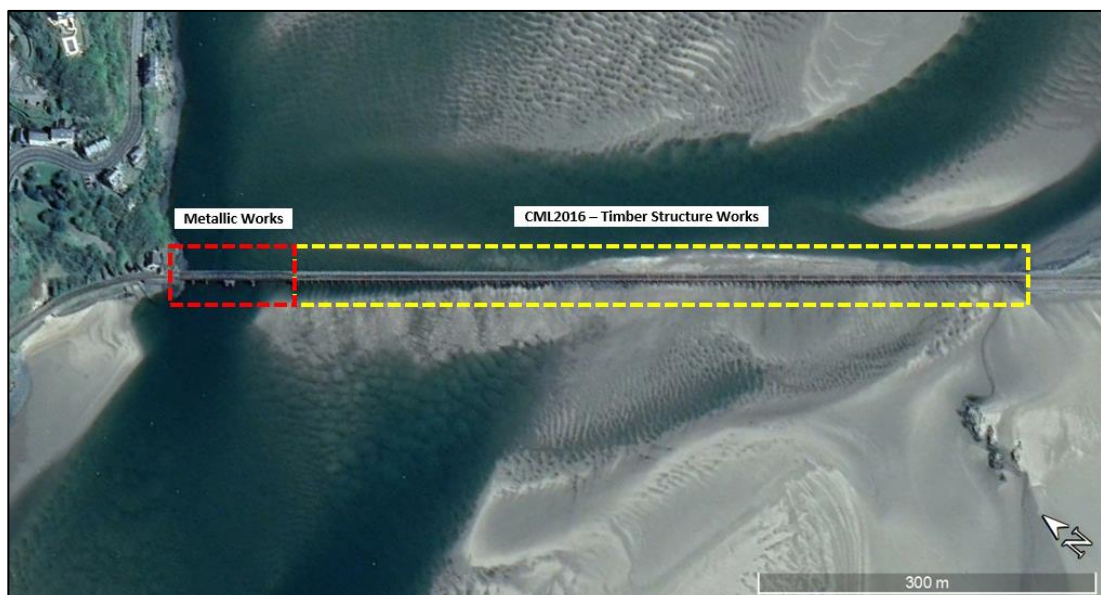
**Figure 24: Marine License Areas**

- 15.1.3 The figure above illustrates how boundaries of the licenses once impended. Both licenses will be supported by the same project compounds. The only addition is the use of Aberamffra harbour for the metallic works.

- 15.1.1 The metallic works are a portion of the overall Barmouth Viaduct refurbishment project. The majority of works in relation to CML2016 Timber works has been completed. However, due to project complications and adverse weather conditions, there are remaining concrete shrouds and timber components yet to be replaced. Consequently, CML2016v1 original license period will be extended to from 01/02/2021 to 28/03/23 to match that of the metallic works application.
- 15.1.2 This is to ensure that the final portion of the CML2016 agreements (e.g., demobilisation and reinstatement) coincide at the same time between both licenses, which share the same compounds.
