**Report No: AC2015/ENV/01**  
**March 2014**

**REVIEW OF ENVIRONMENTAL MONITORING  
RESULTS AT THE  
BRYN PICA LANDFILL SITE DURING THE PERIOD  
JAN 14 – DEC 14**

**Amgen Cymru  
Bryn Pica Landfill Site  
Llwydcoed  
Aberdare  
CF44 0BX**

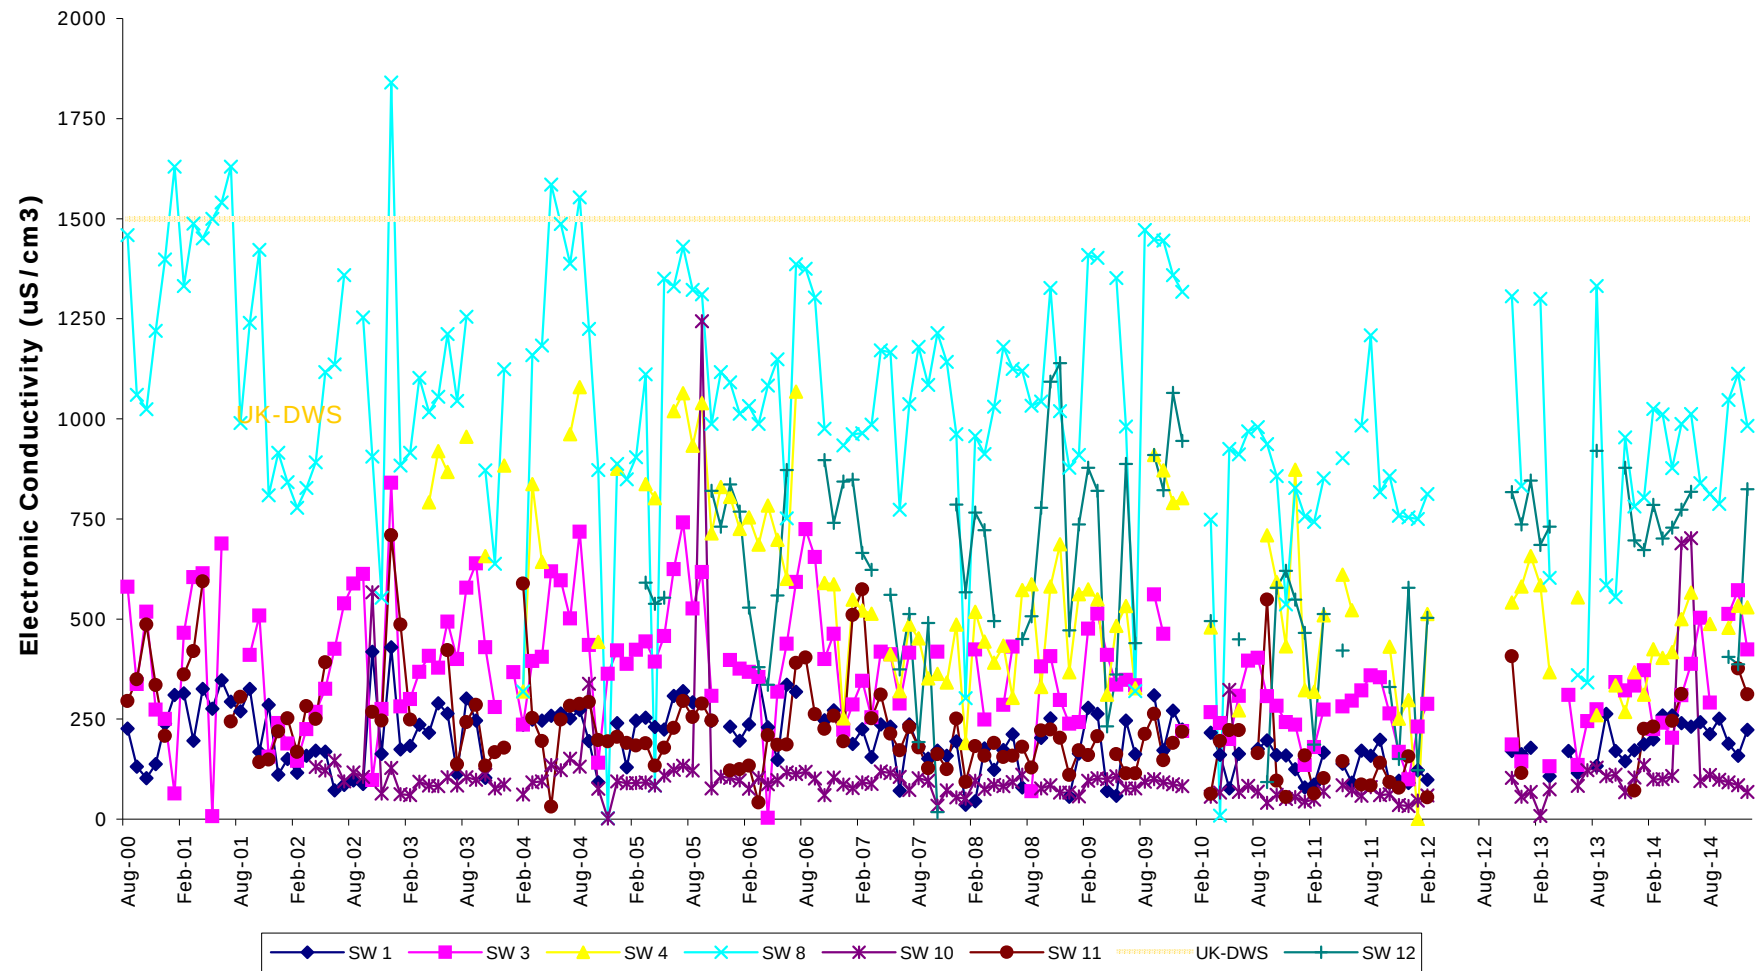
**In-Situ analysis of Electronic Conductivity levels in surface water sampled by Amgen Cymru at the Bryn Pica Landfill Site during the period August 2000 - Dec 2014.**
