Report No: AC2017/ENV/01  
Apr-17

REVIEW OF ENVIRONMENTAL MONITORING  
UNDERTAKEN AT THE  
BRYN PICA LANDFILL SITE DURING THE PERIOD  
JAN 16 – DEC 16

Amgen Cymru  
Bryn Pica Landfill Site  
Llwydcoed  
Aberdare  
CF44 0BX

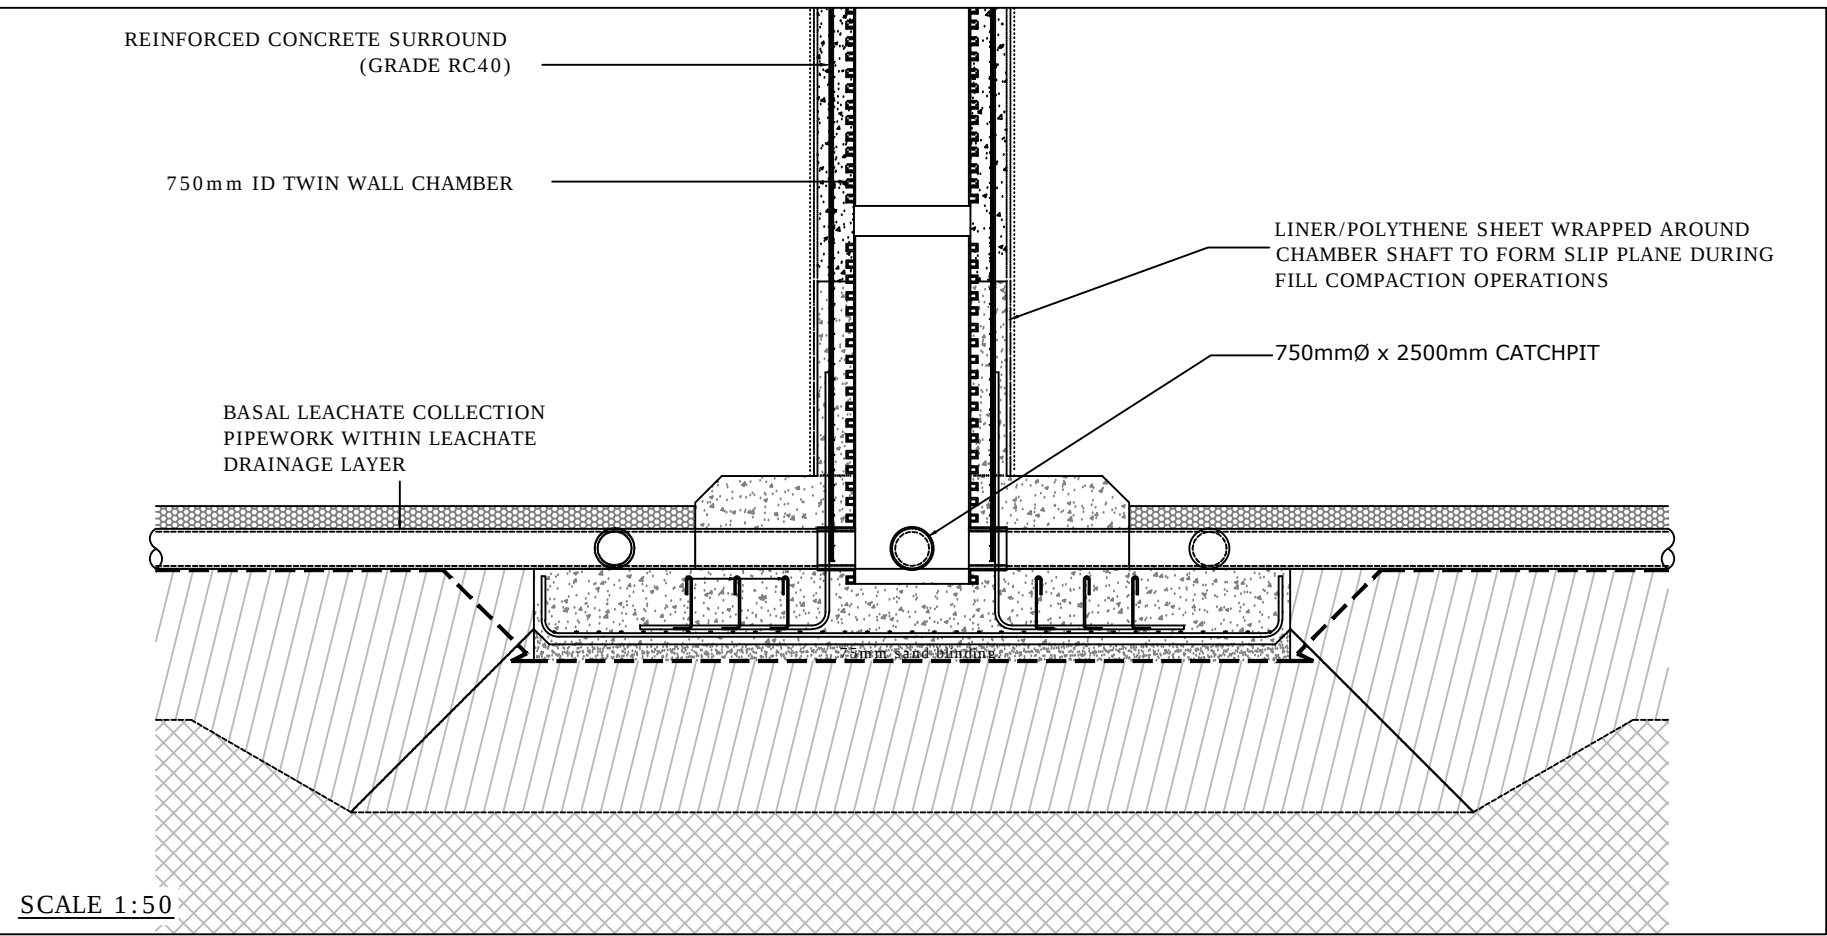
TYPICAL SECTION THROUGH LEACHATE COLLECTION WELL

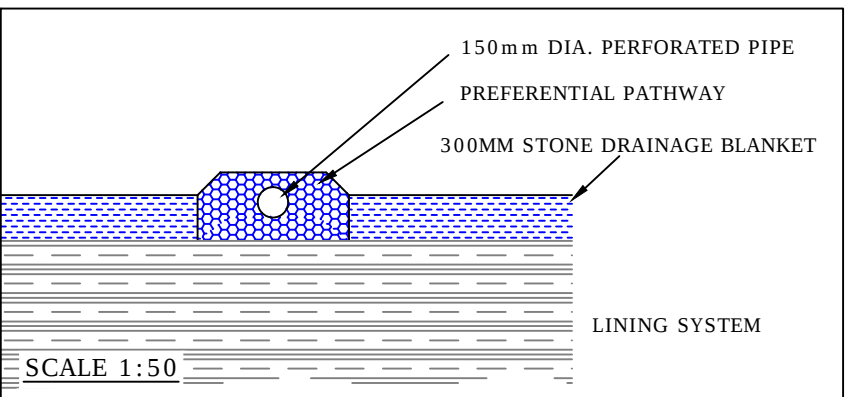
TYPICAL DETAIL THROUGH STONE DRAINAGE LAYER

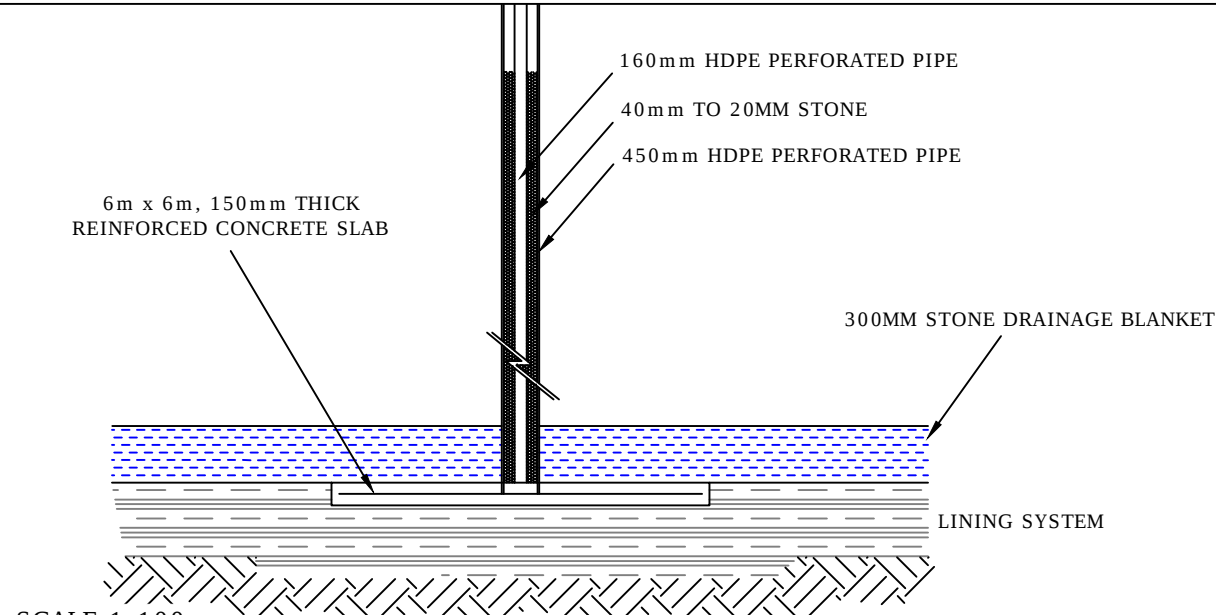
TYPICAL LEACHATE MONITORING POINT

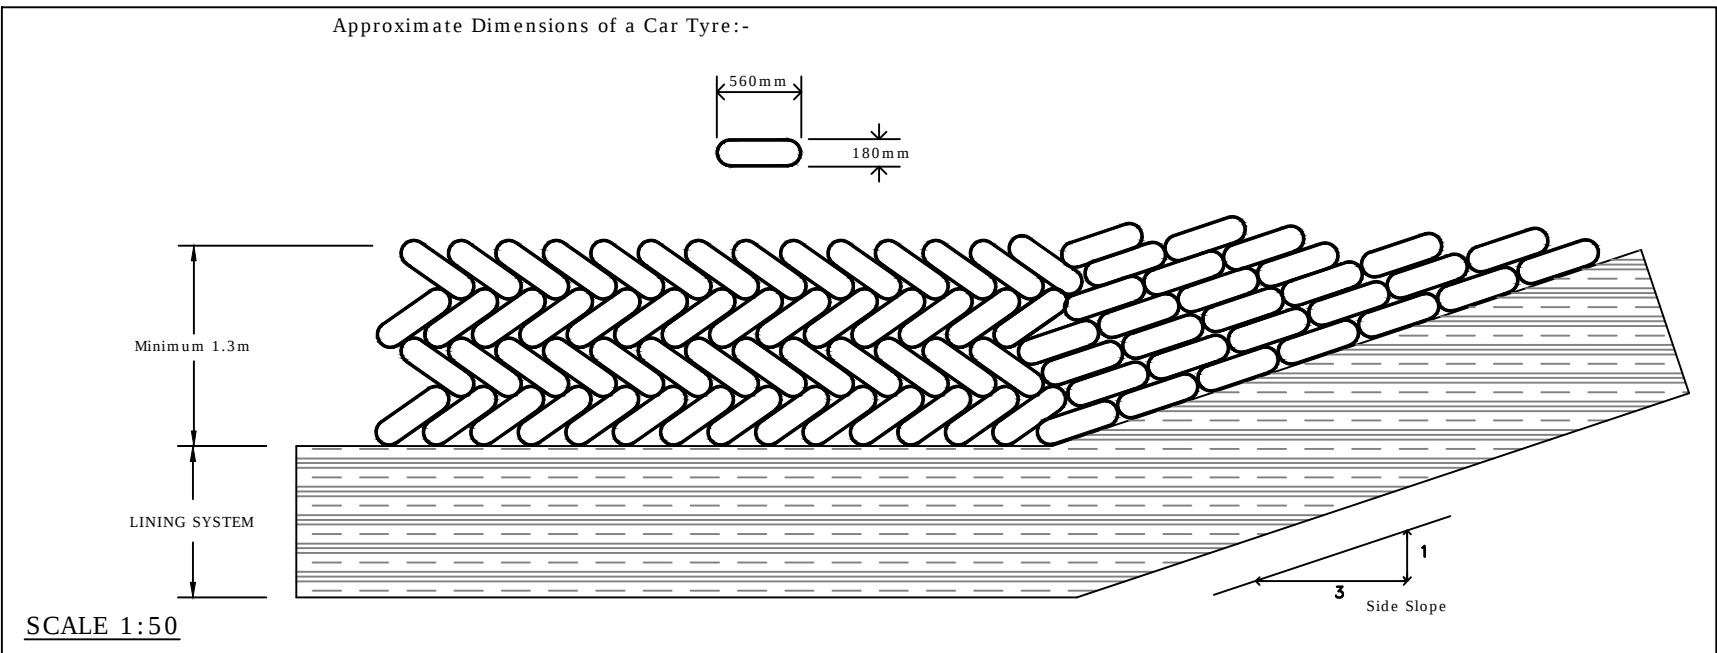
TYPICAL DETAIL THROUGH WHOLE TYRE LEACHATE DRAINAGE LAYER

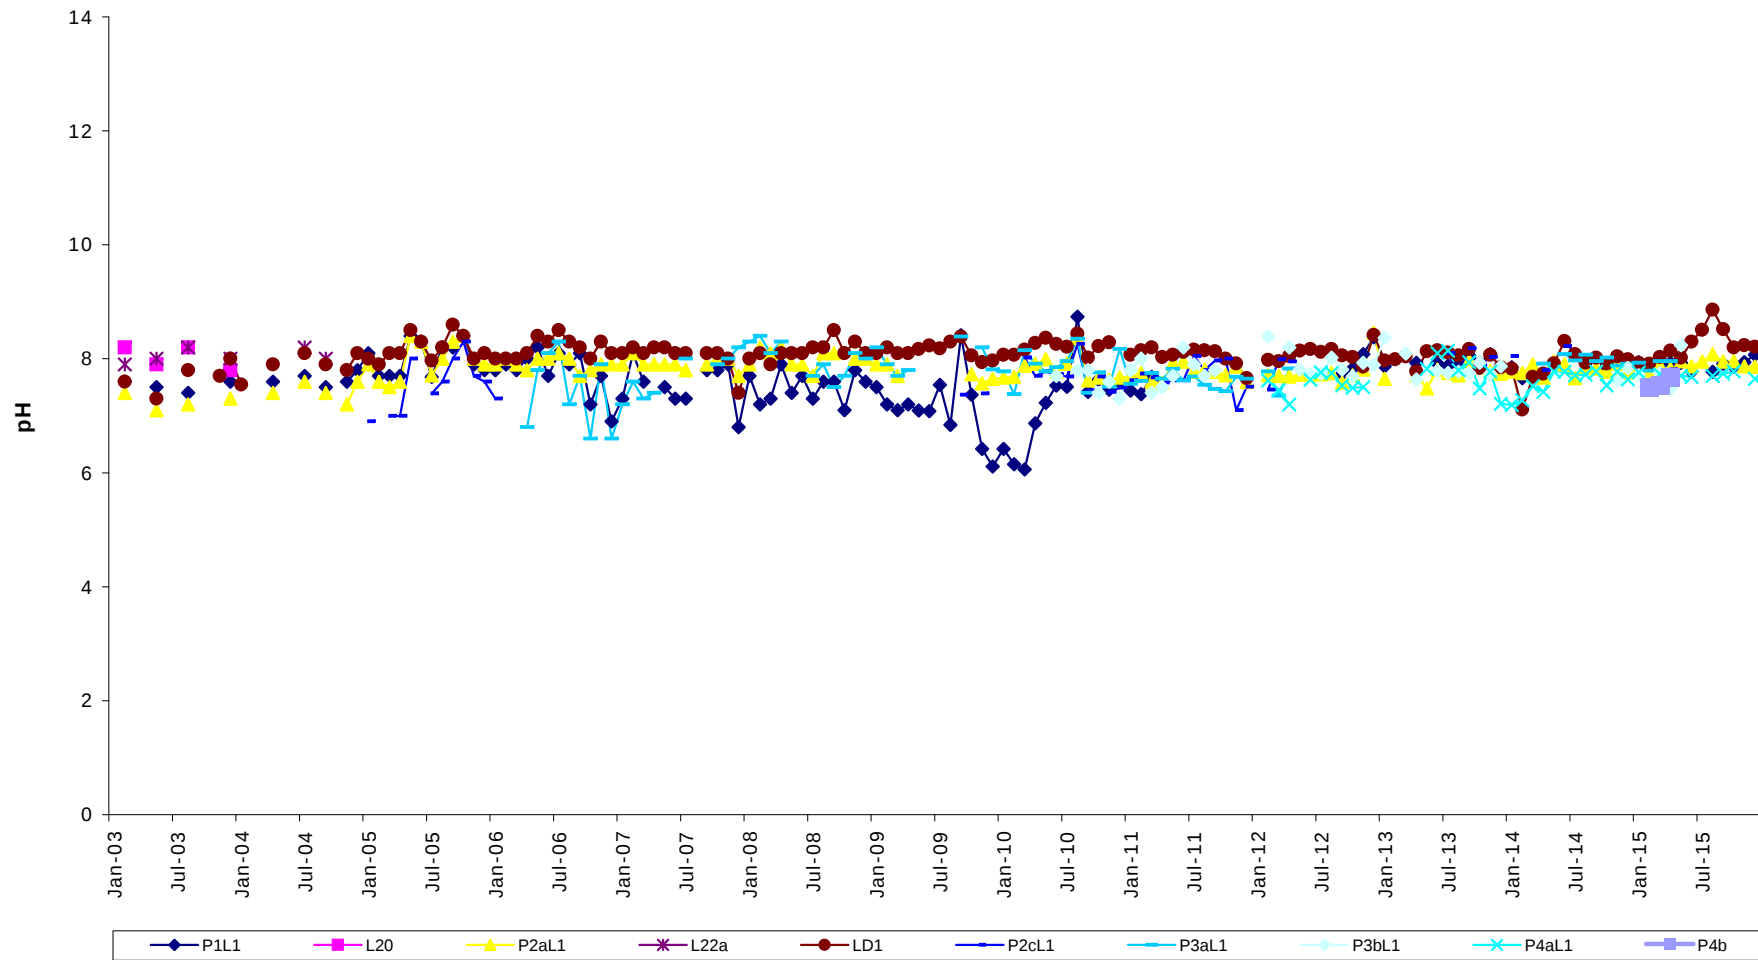
**Lab analysis of pH levels in leachate sampled by Amgen Cymru at the Bryn Pica Landfill Site during the period Jan 2003 - Dec 2016.**

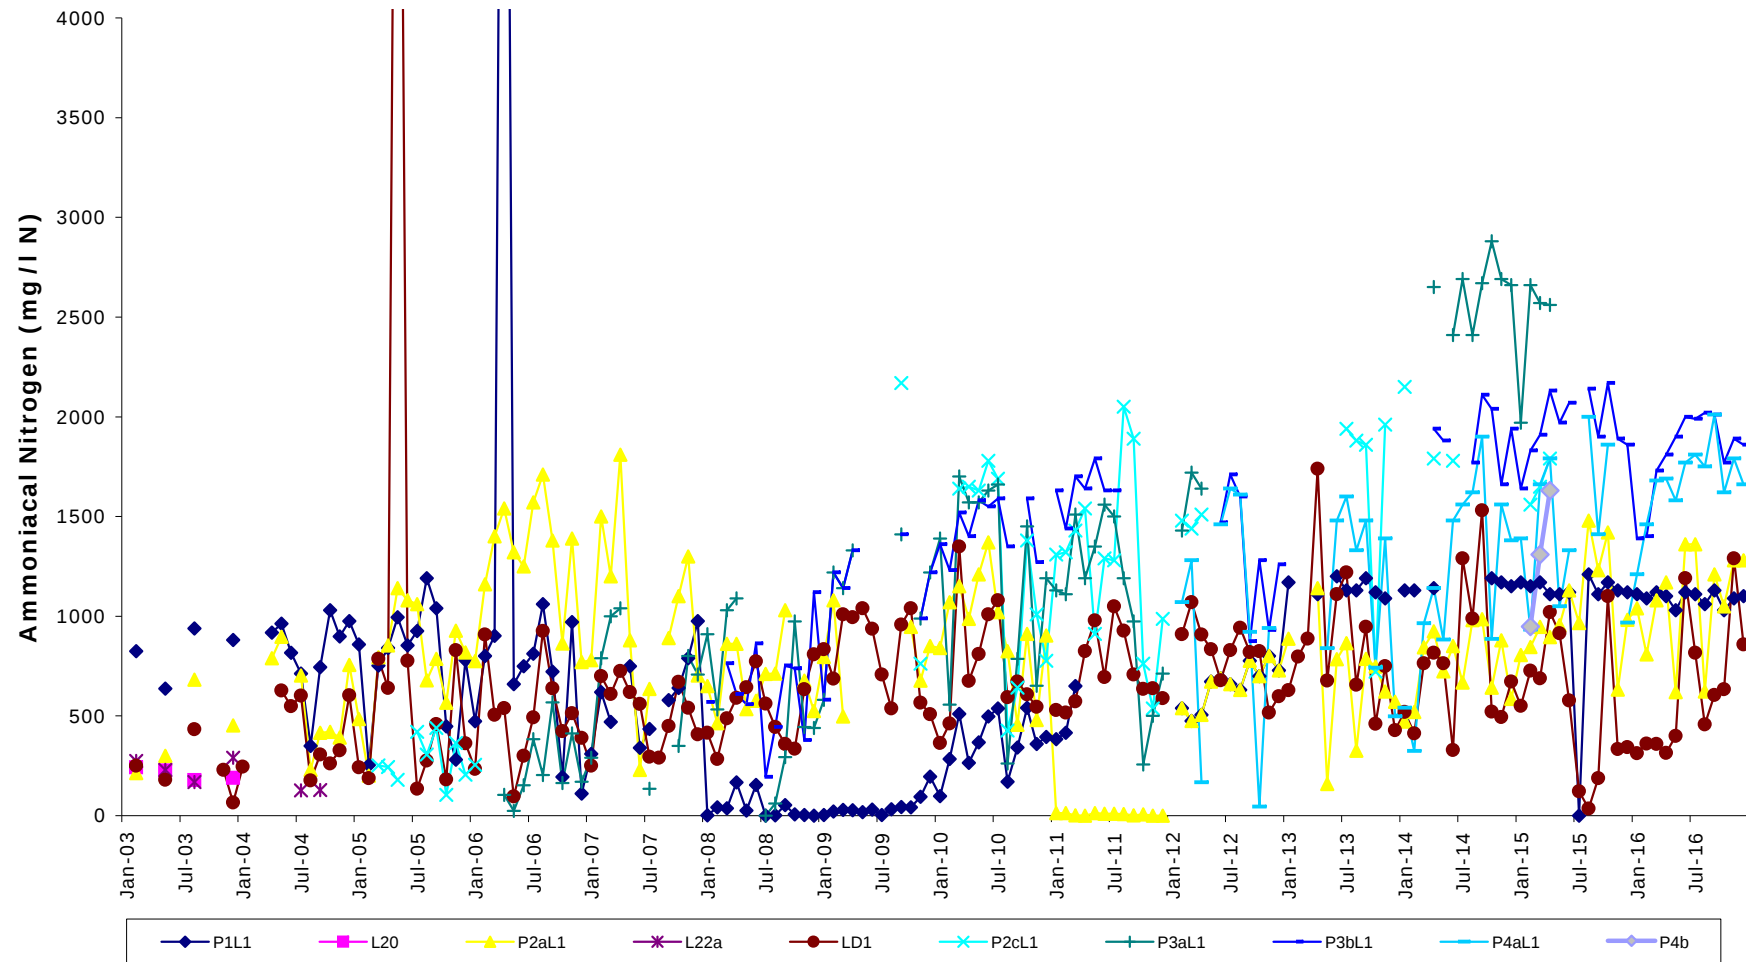
**Lab analysis of Ammoniacal Nitrogen (as N) concentrations in leachate sampled by Amgen Cymru at the Bryn Pica Landfill Site during the period Jan 2003 - Dec 2016.**

- 3.4.4 The average value of ammonia in leachate sampled from Phase 1 throughout 2016 is calculated as being 1,091 mg/l NH<sub>4</sub> as N. This is slight reduction when compared with the value calculated for 2015 (1,143 mg/l NH<sub>4</sub> as N). These values are slightly above the DoE 1995 published average for non-hazardous landfill leachate (DoE, 1995 Average of 889 mg/l NH<sub>4</sub> as N). No significance has been drawn in relation to this observation. Concentrations of ammonia in leachate sampled from Phase 1 are similar in magnitude to those identified in leachate samples taken from other landfill cells at the site.

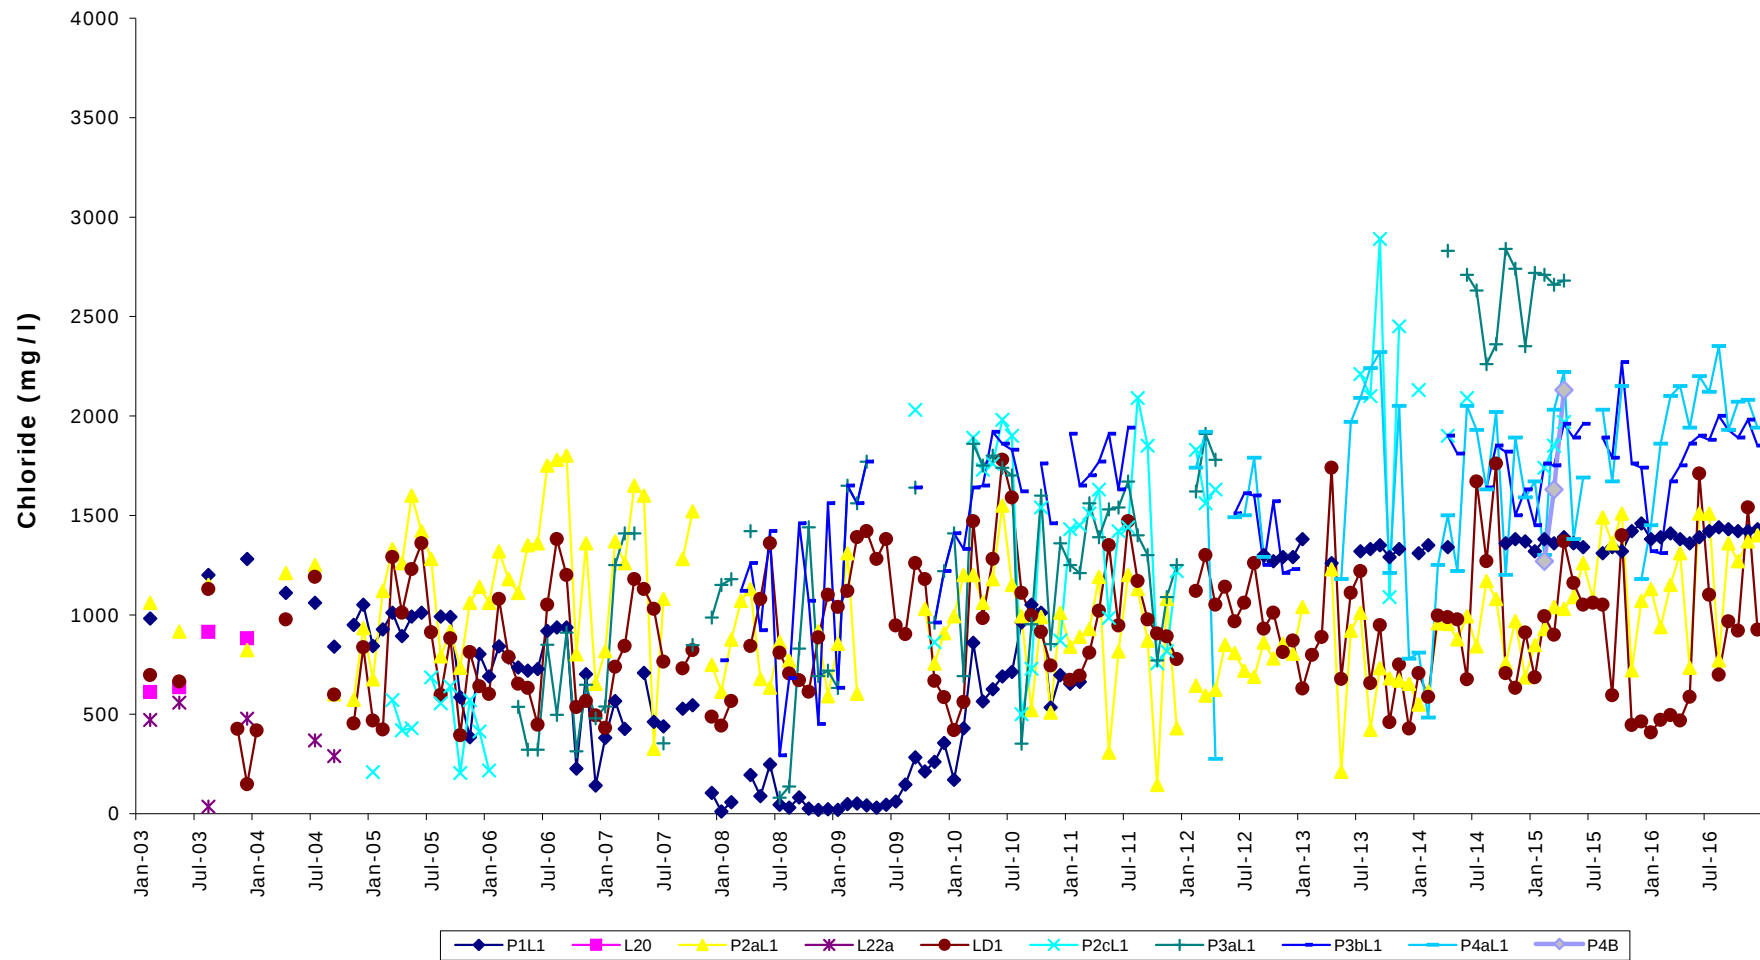
**Lab analysis of Chloride concentrations in leachate sampled by Amgen Cymru at the Bryn Pica Landfill Site during the period Jan 2003 - Dec 2016.**

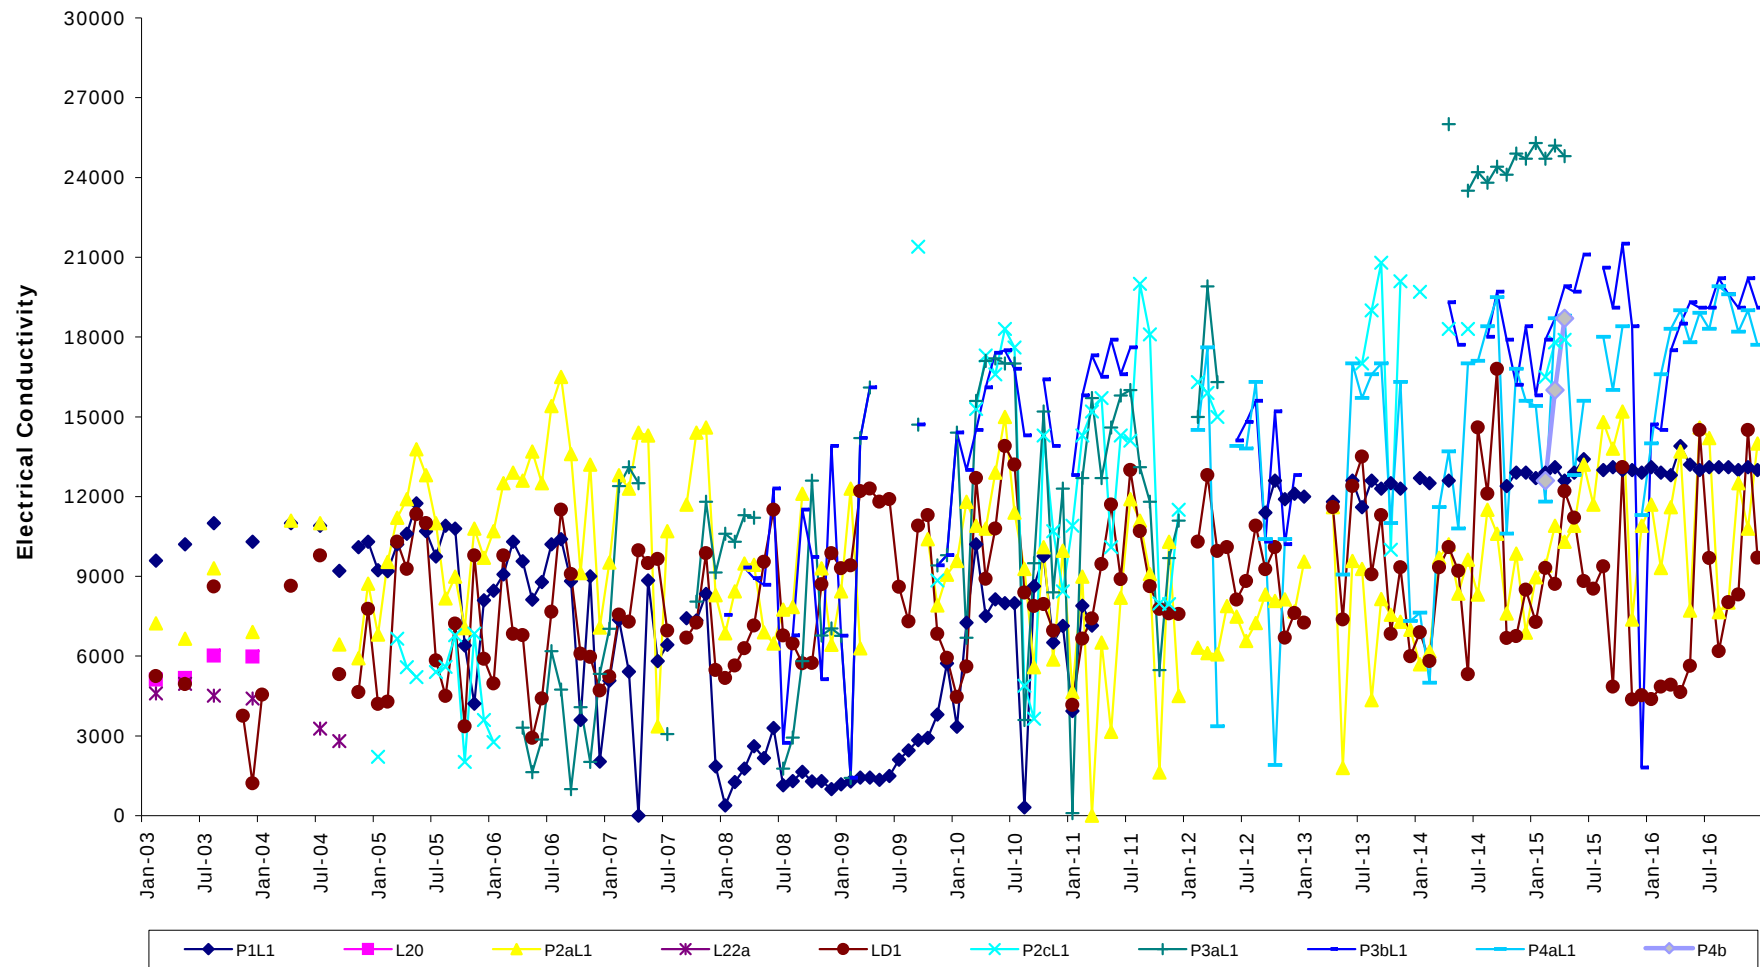
**Lab analysis of Electrical Conductivity levels in leachate sampled by Amgen Cymru at the Bryn Pica Landfill Site during the period Jan 2003 - Dec 2016.**

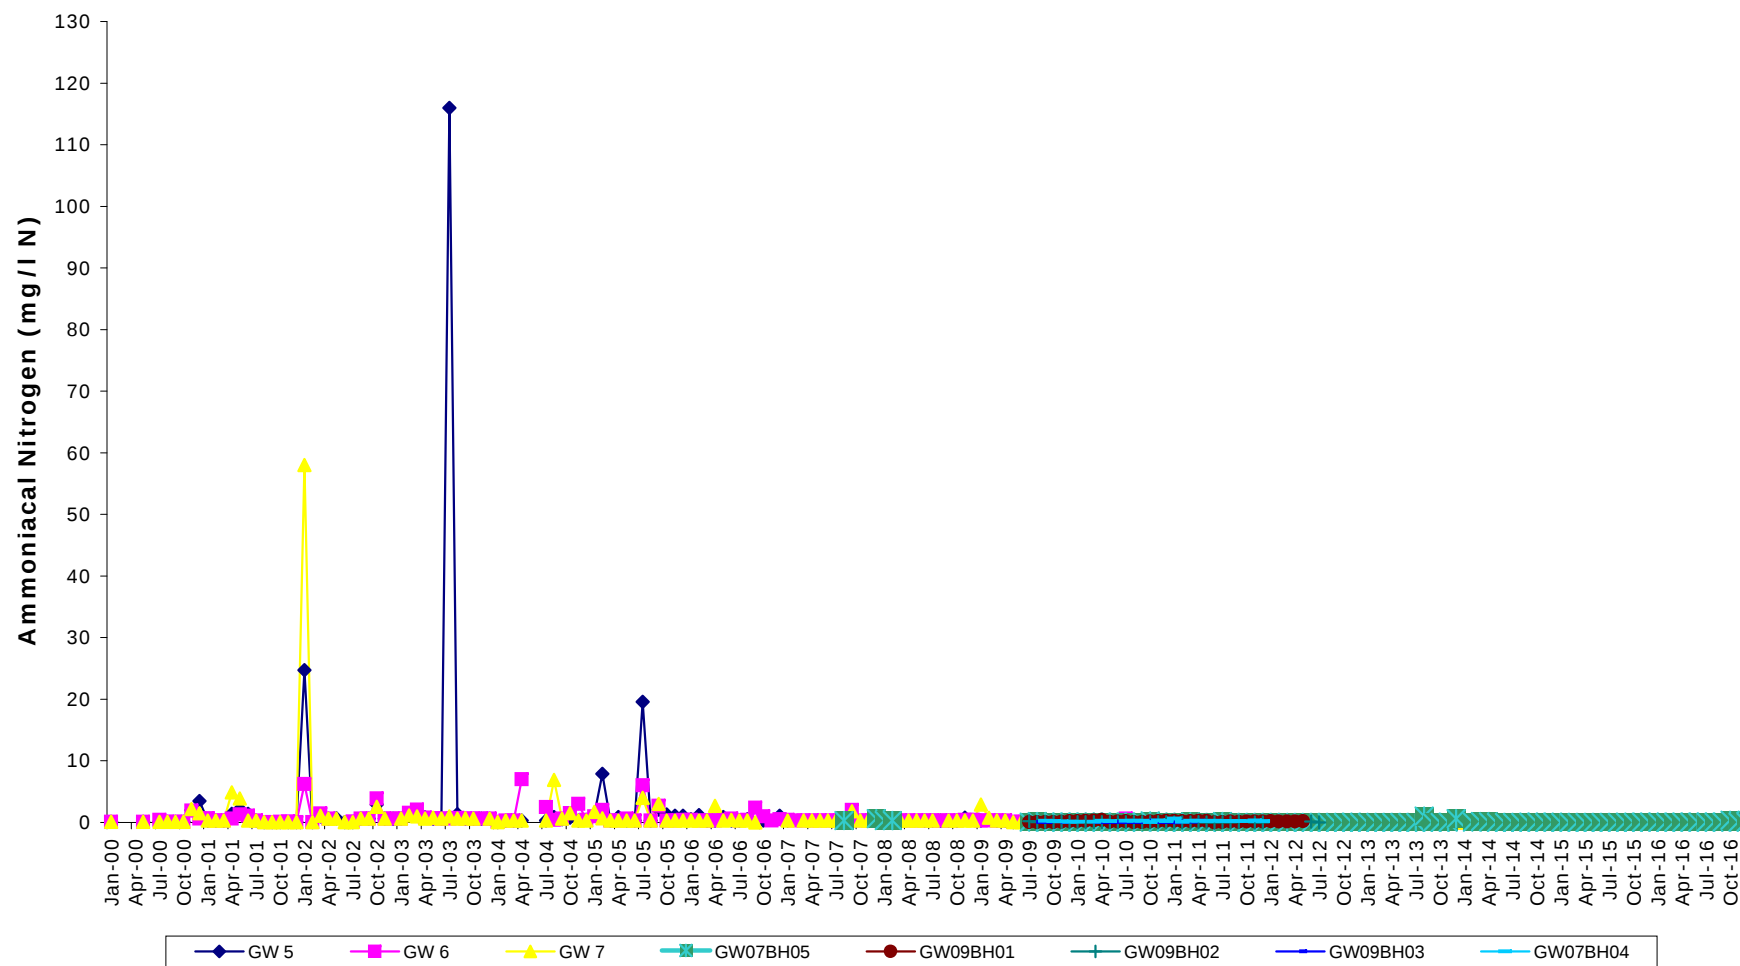
**Lab analysis of Ammoniacal Nitrogen (as N) concentrations in groundwater sampled by Amgen Cymru at the Bryn Pica Landfill Site during the period Jan 2000 - Dec 2016 (Scale 1).**

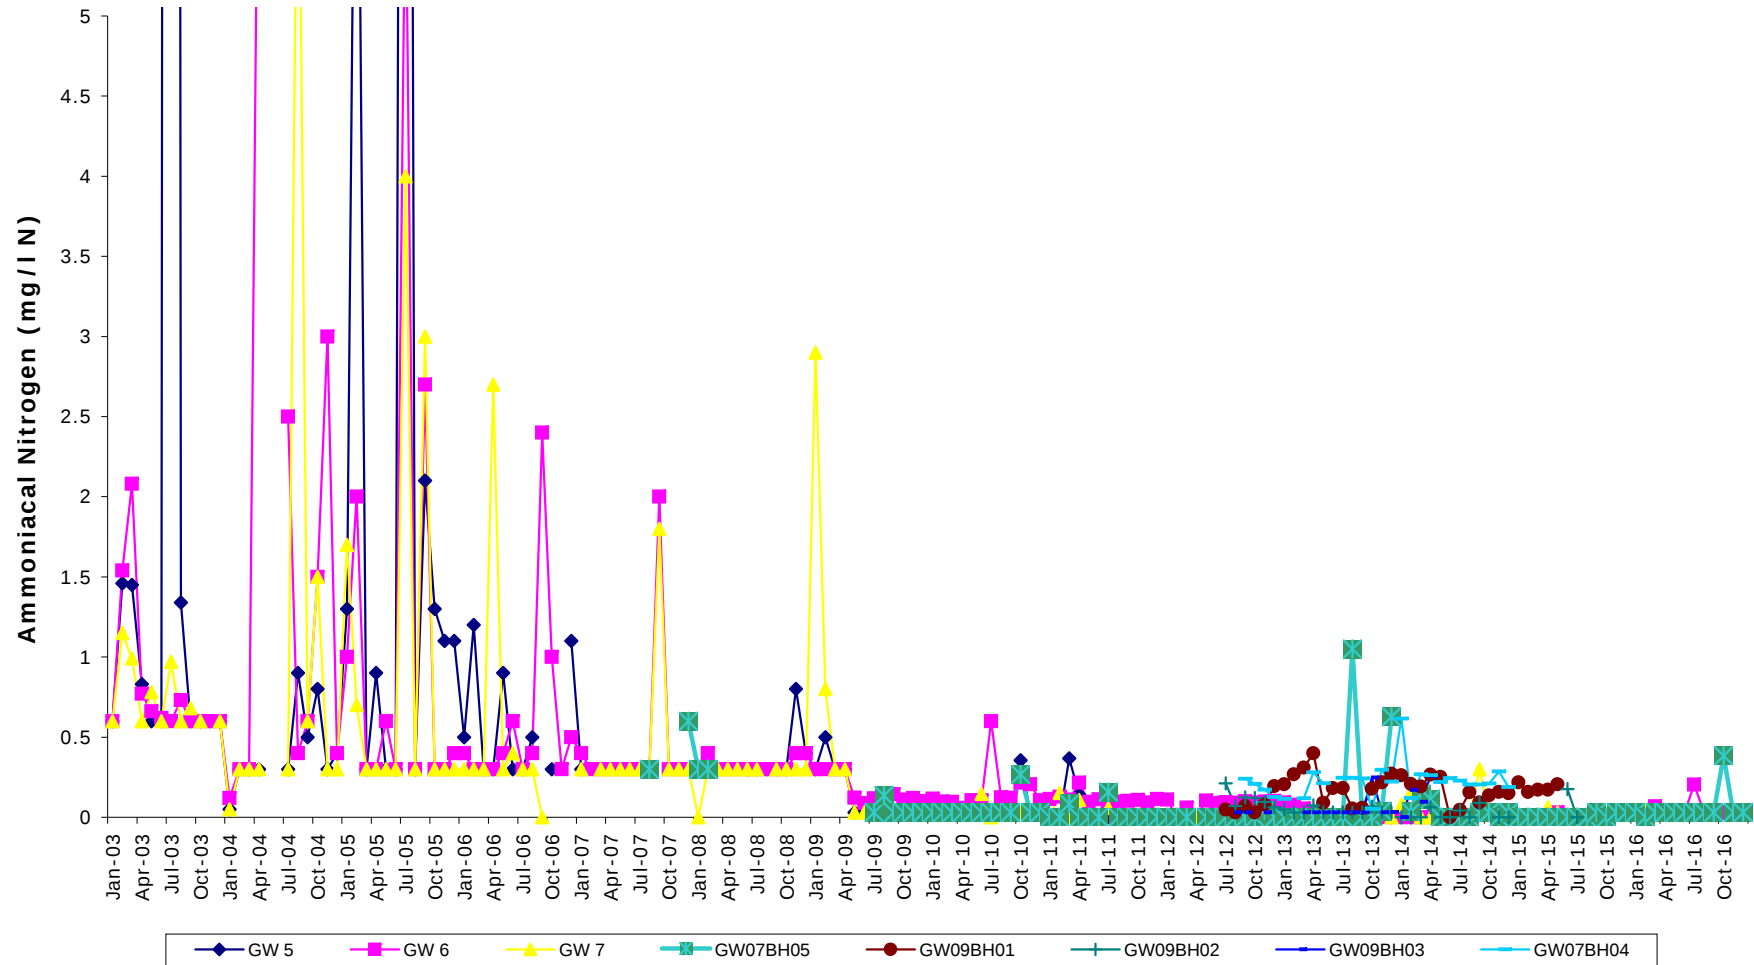
**Lab analysis of Ammoniacal Nitrogen (as N) concentrations in groundwater sampled by Amgen Cymru at the Bryn Pica Landfill Site during the period Jan 2003 - Dec 2016 (Scale 2).**

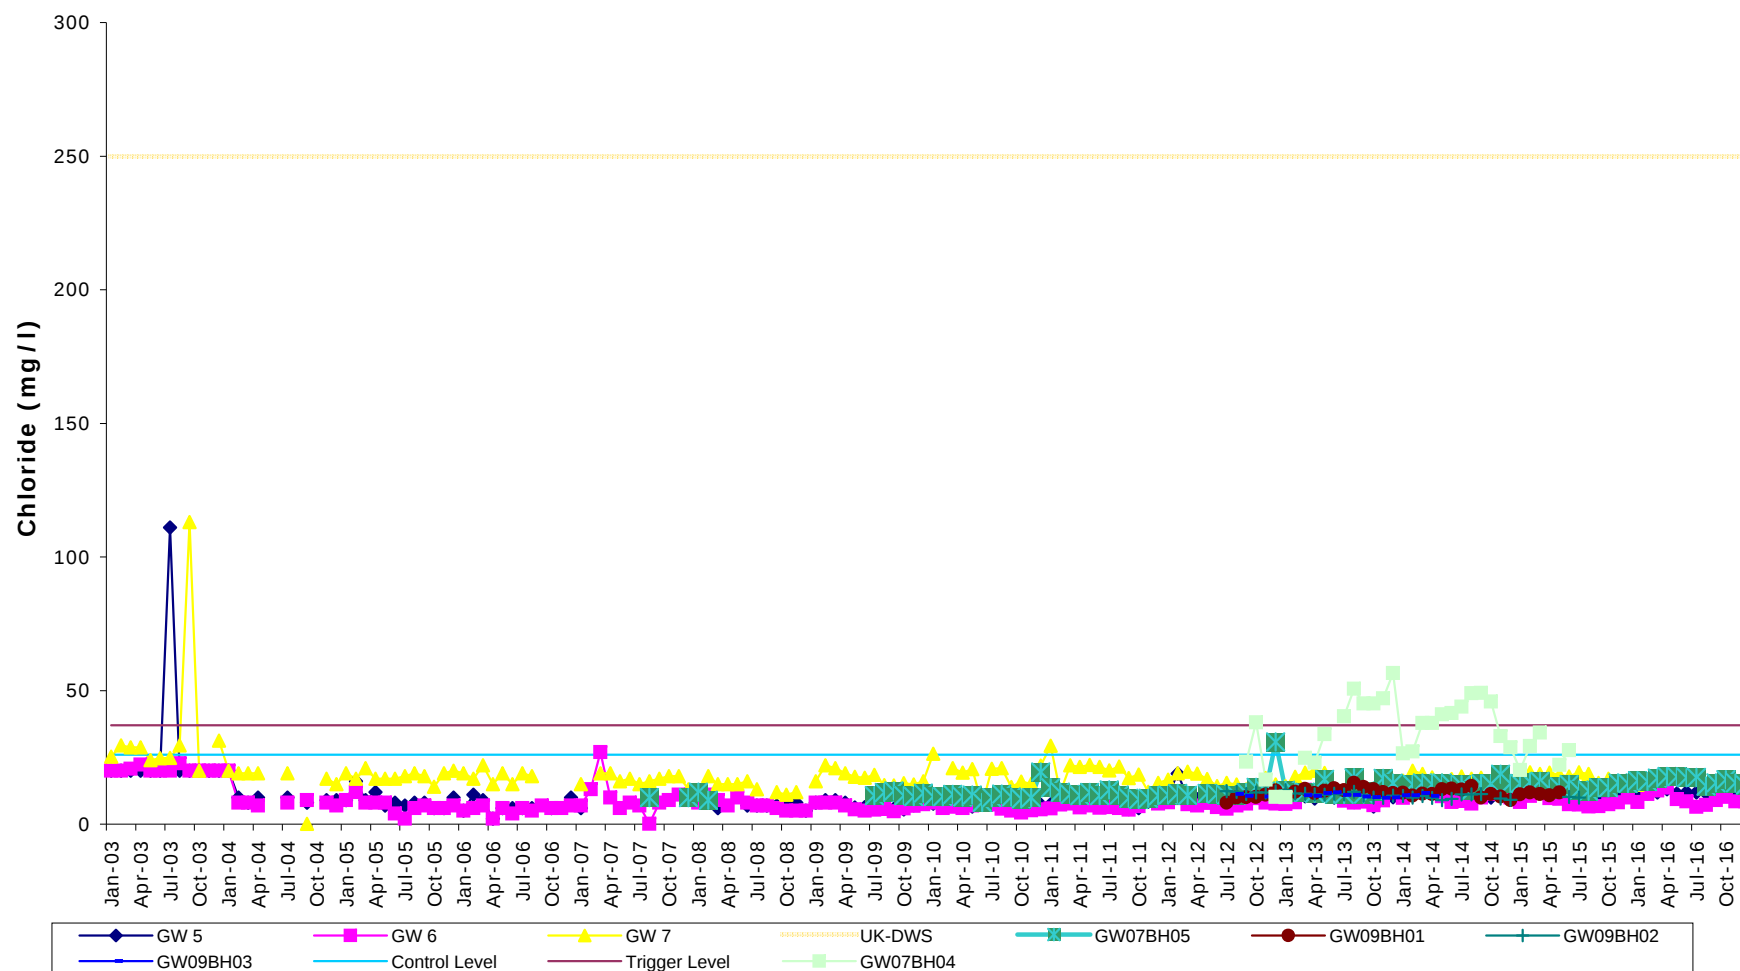
**Lab analysis of Chloride concentrations in groundwater sampled by Amgen Cymru at the Bryn Pica  
Landfill Site during the period Jan 2003 - Dec 2016.**

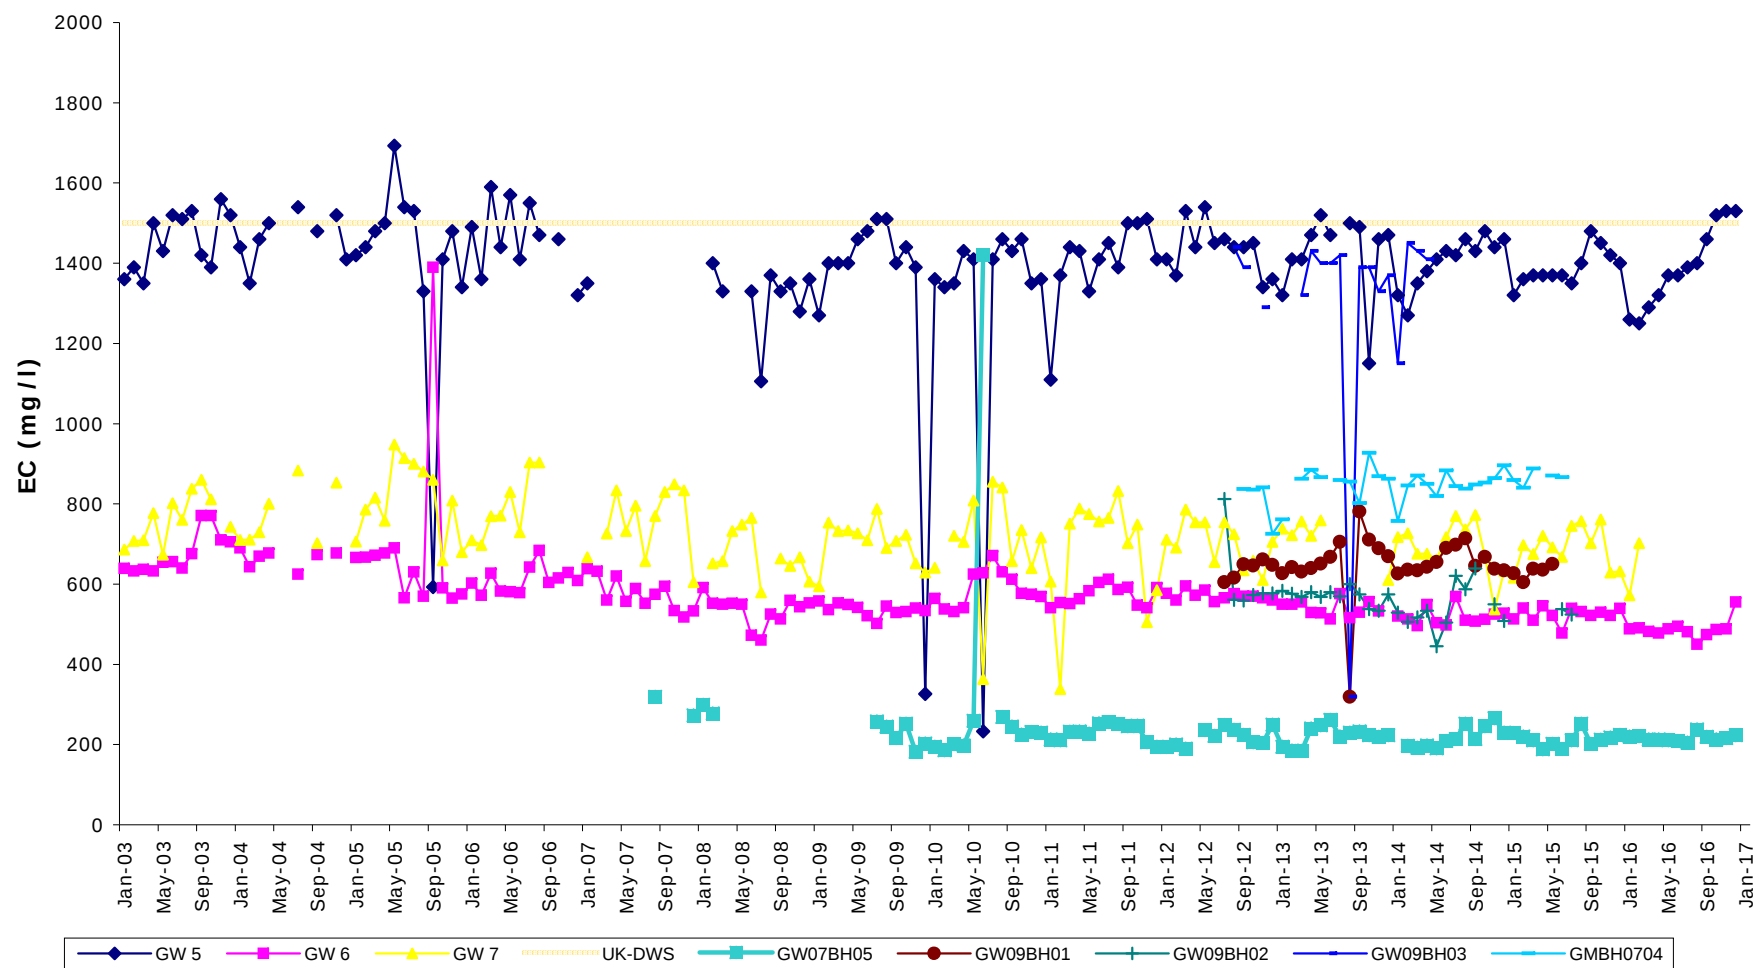
**Lab analysis of Electric Conductivity levels in groundwater sampled by Amgen Cymru at the Bryn Pica Landfill Site during the period Jan 2003 - Dec 2016.**

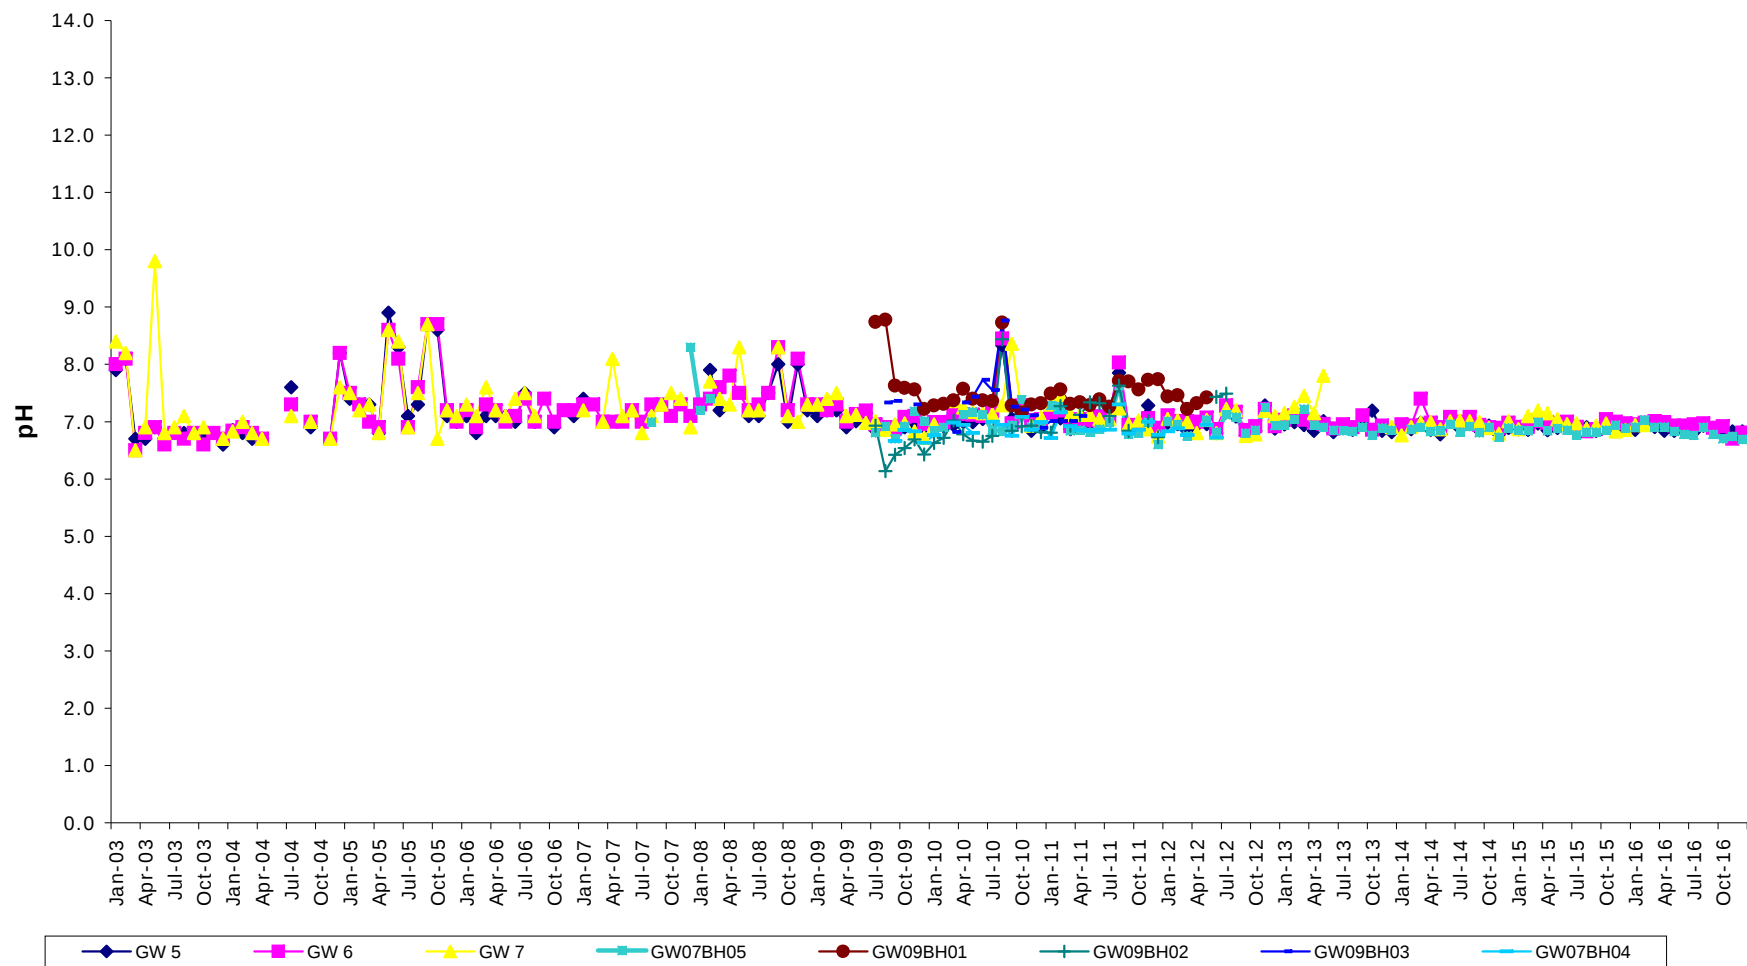
**Lab analysis of pH levels in groundwater sampled by Amgen Cymru at the Bryn Pica Landfill Site during the period Jan 2003 - Dec 2016.**

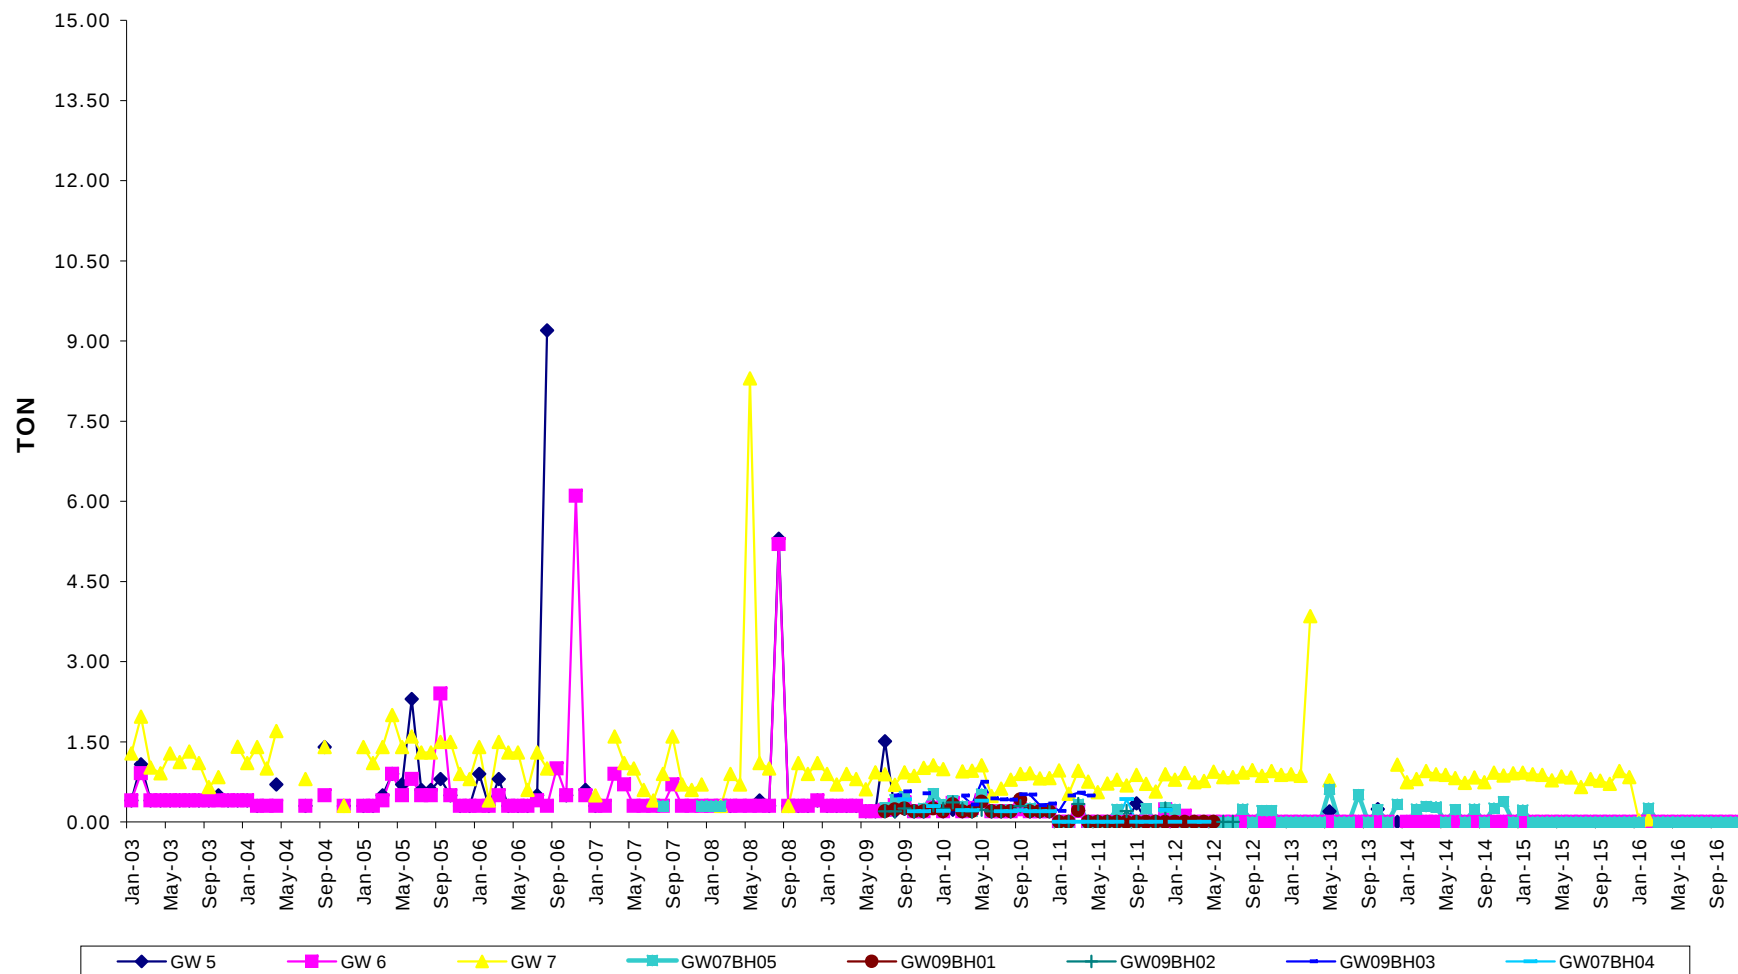
**Lab analysis of Total Oxidisable Nitrogen (TON) concentrations in groundwater sampled by Amgen  
Cymru at the Bryn Pica Landfill Site during the period Jan 2003 - Dec 2016.**

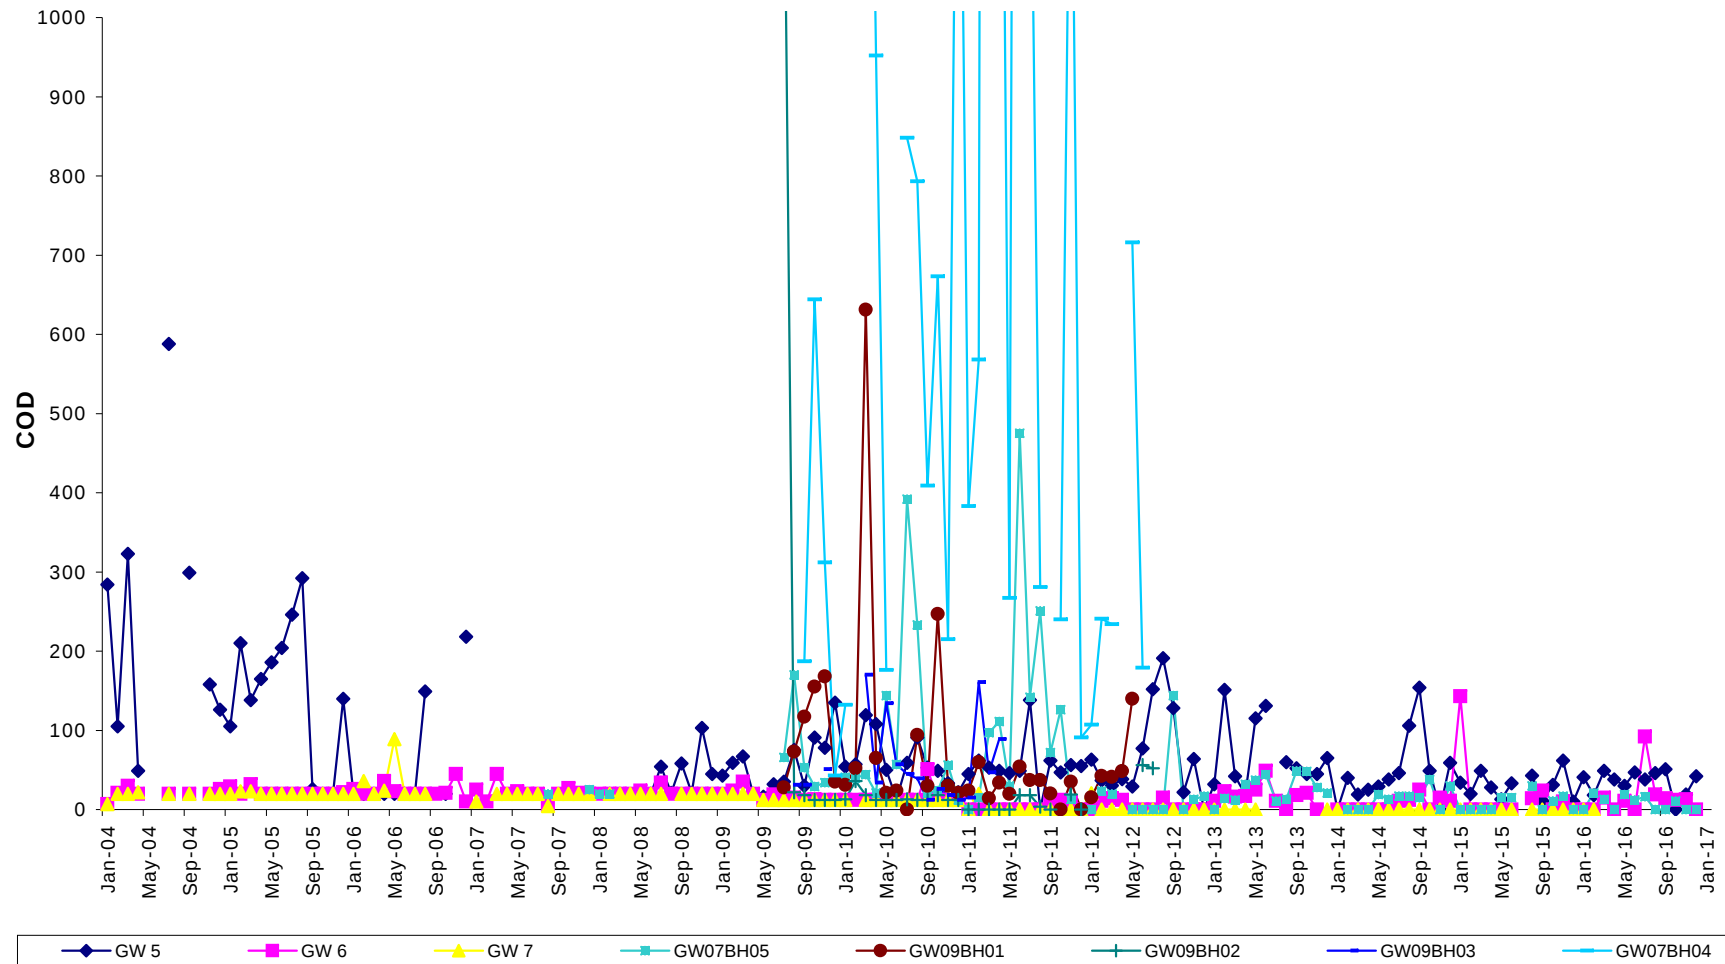
**Lab analysis of Chemical Oxygen Demand (COD) concentrations in groundwater sampled by Amgen Cymru at the Bryn Pica Landfill Site during the period Jan 2004 - Dec 2016.**
