Report No: AC2017/ENV/01  
Apr-17

REVIEW OF ENVIRONMENTAL MONITORING  
UNDERTAKEN AT THE  
BRYN PICA LANDFILL SITE DURING THE PERIOD  
JAN 16 – DEC 16

Amgen Cymru  
Bryn Pica Landfill Site  
Llwydcoed  
Aberdare  
CF44 0BX

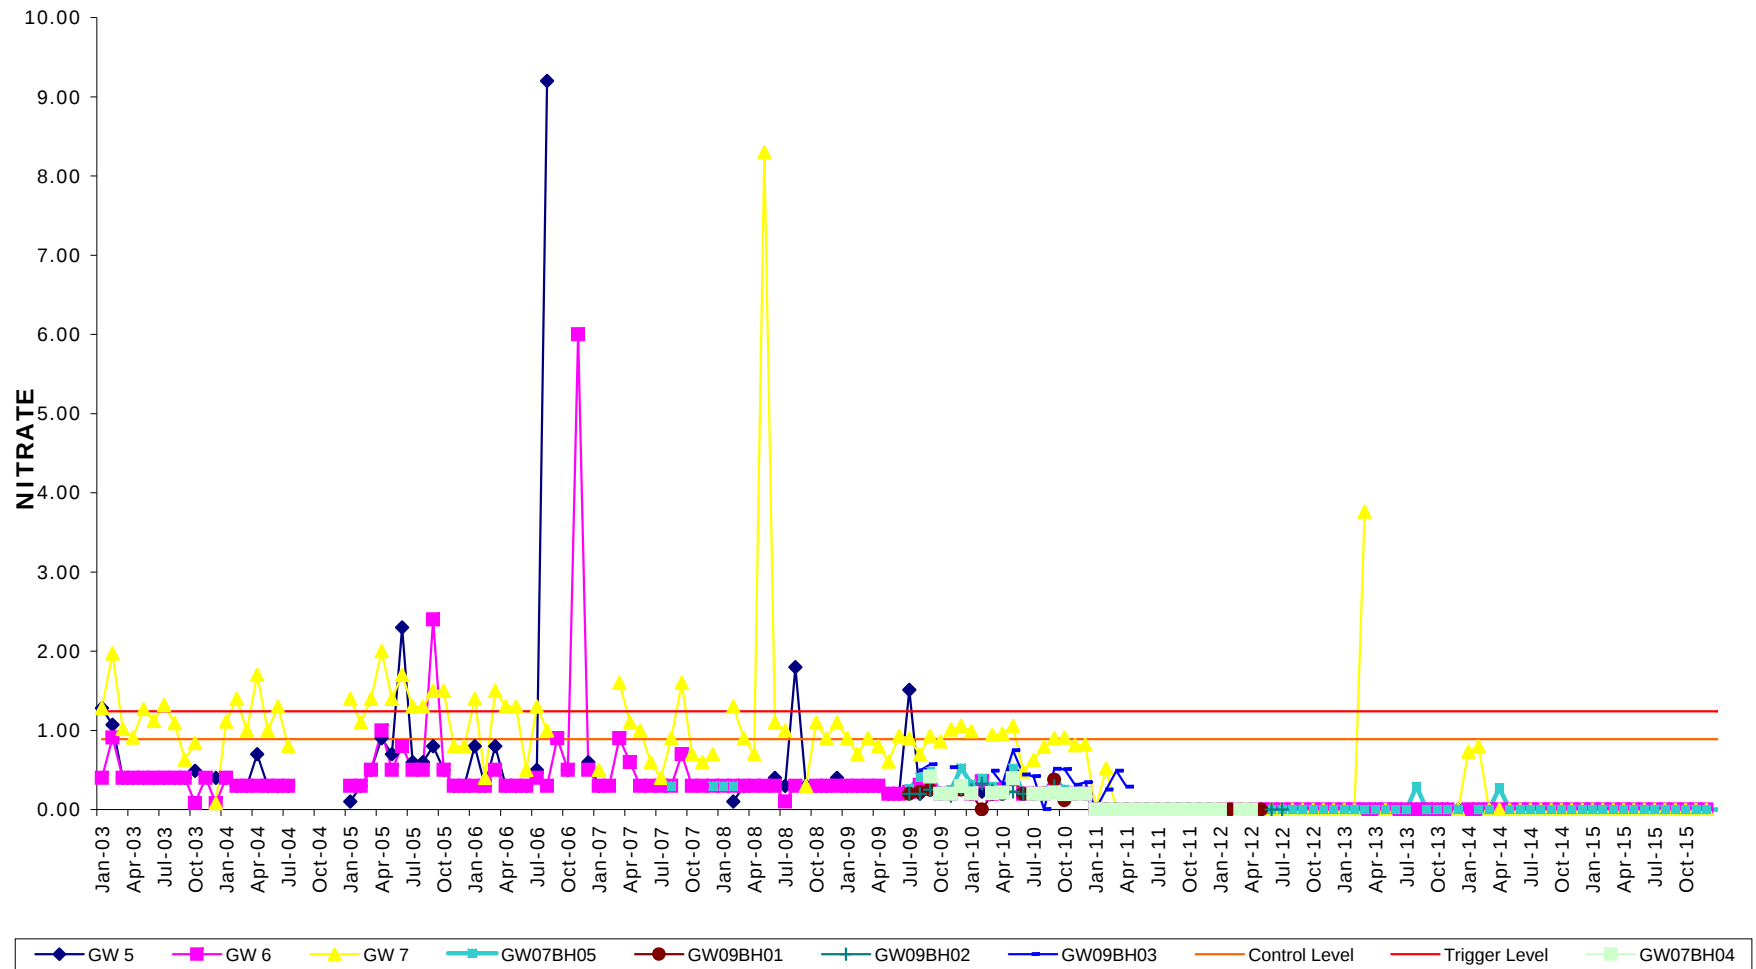
**Lab analysis of Nitrate concentrations in groundwater sampled by Amgen Cymru at the Bryn Pica Landfill Site during the period Jan 2003 - Dec 2016.**

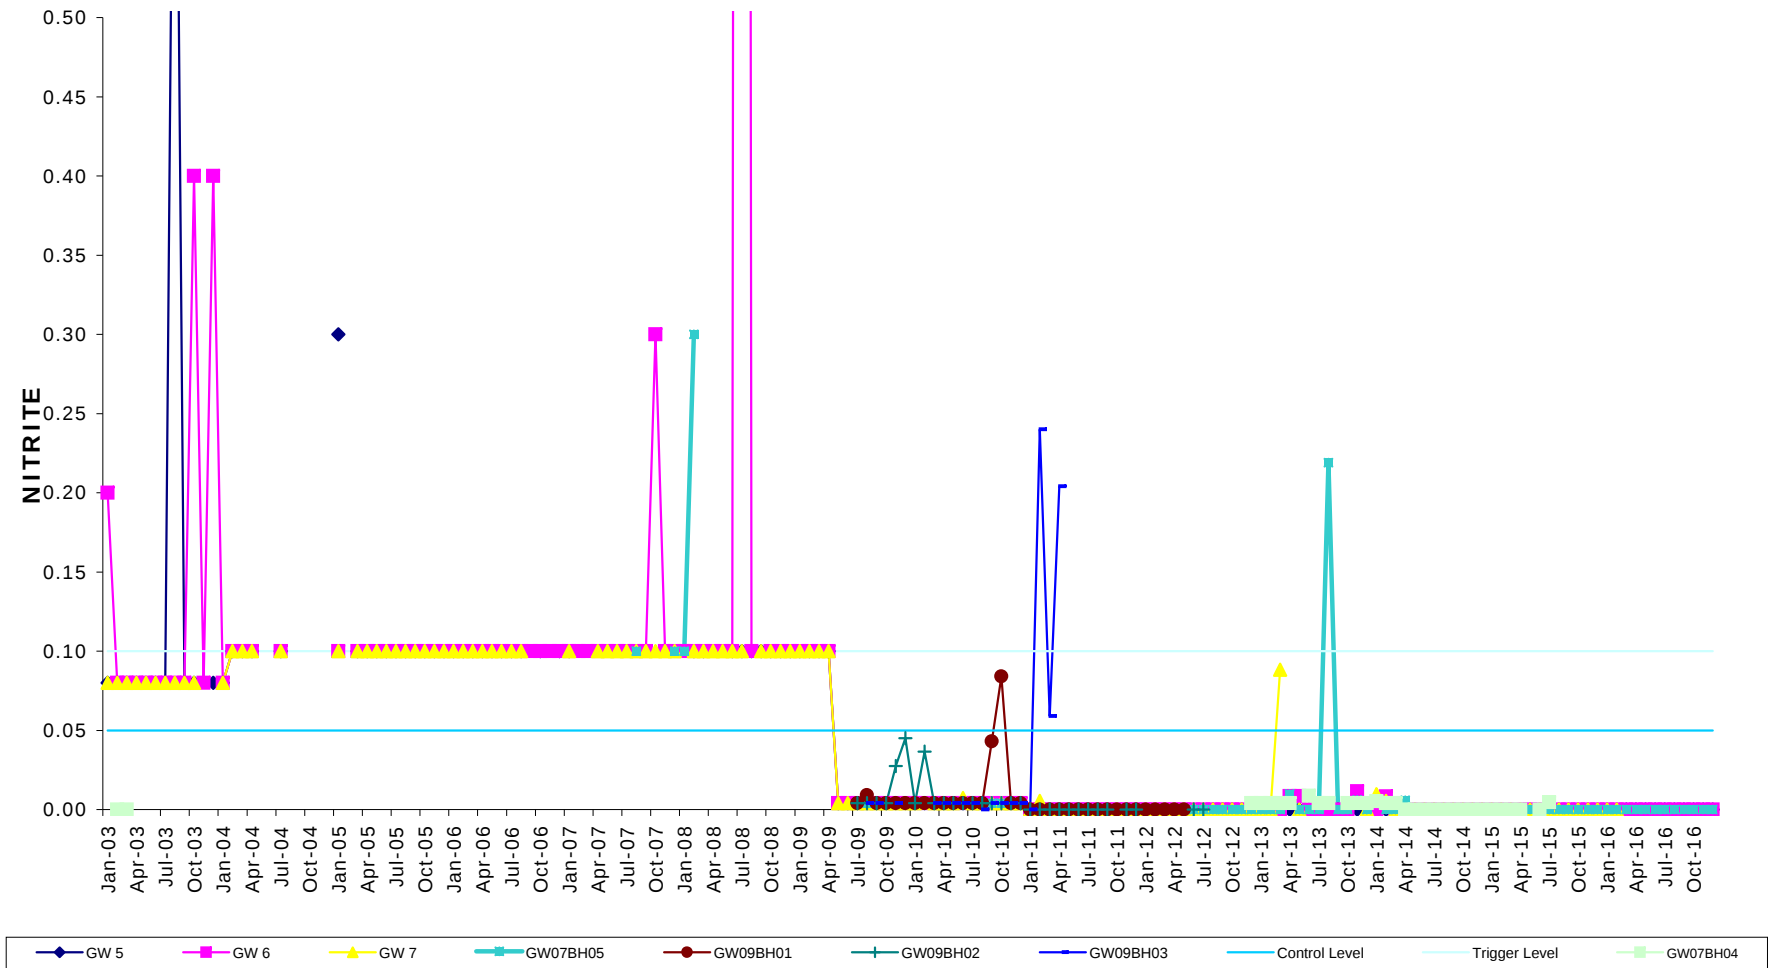
**Lab analysis of Nitrite concentrations in groundwater sampled by Amgen Cymru at the Bryn Pica  
Landfill Site during the period Jan 2003 - Dec 2016.**

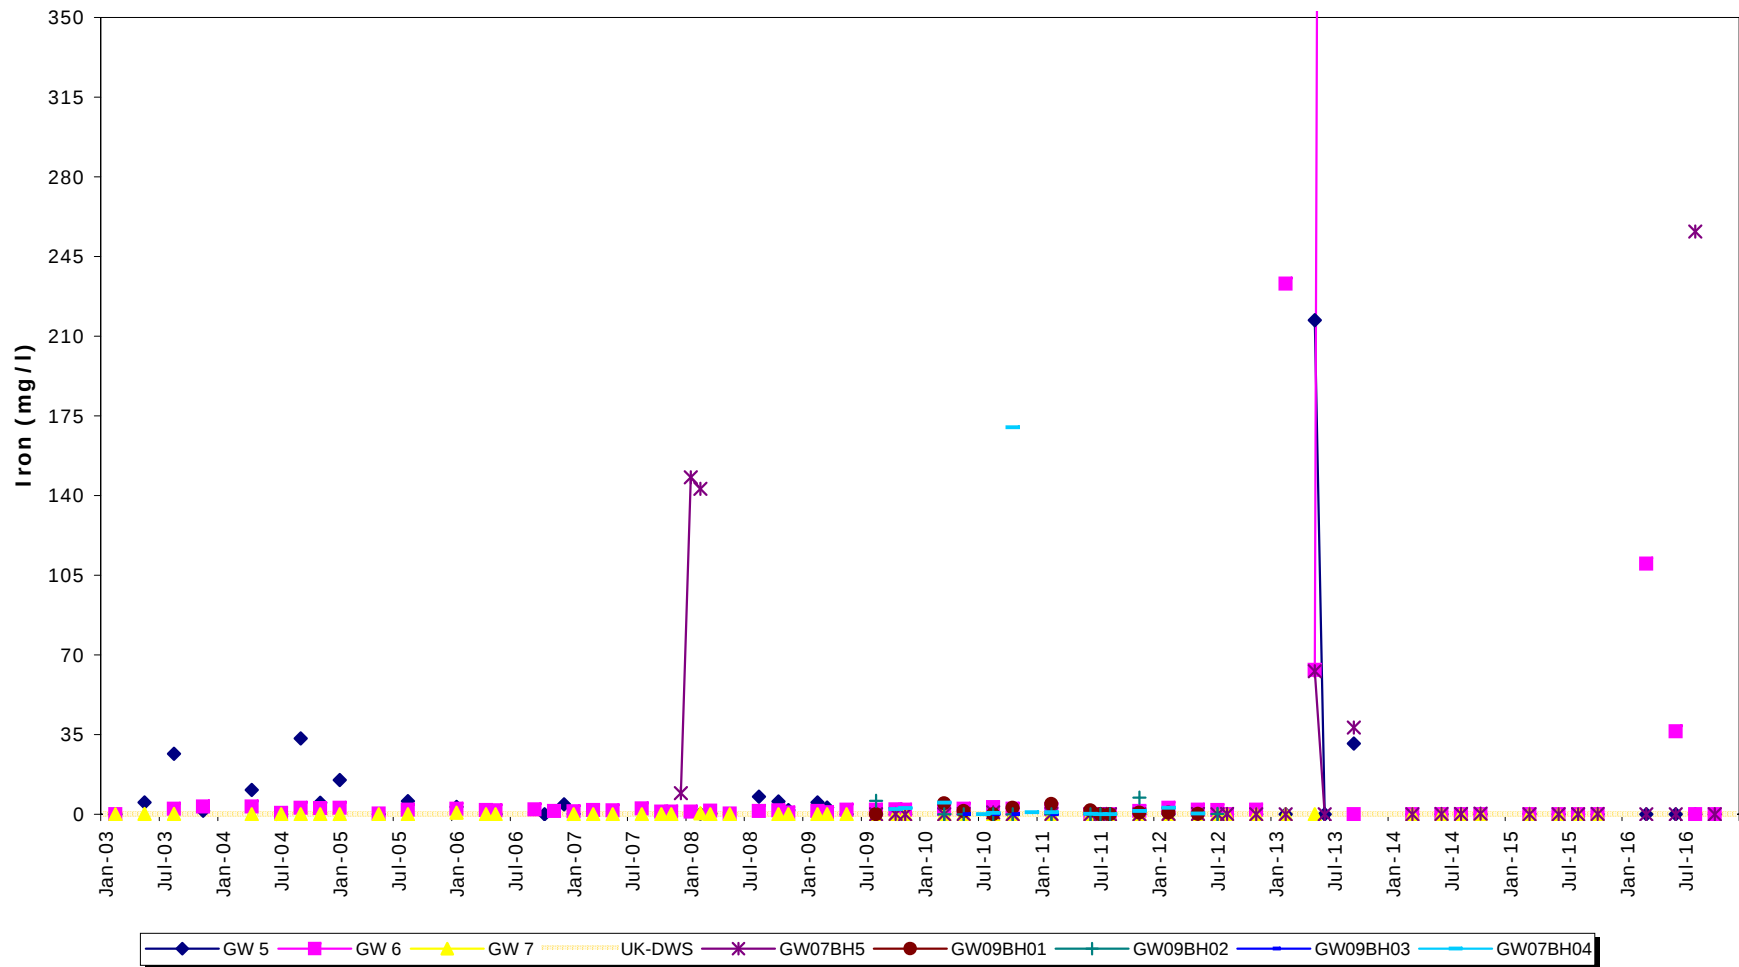
**Lab analysis of Iron concentration in groundwater sampled by Amgen Cymru at the Bryn Pica Landfill Site during the period Jan 2003 - Dec 2016.**

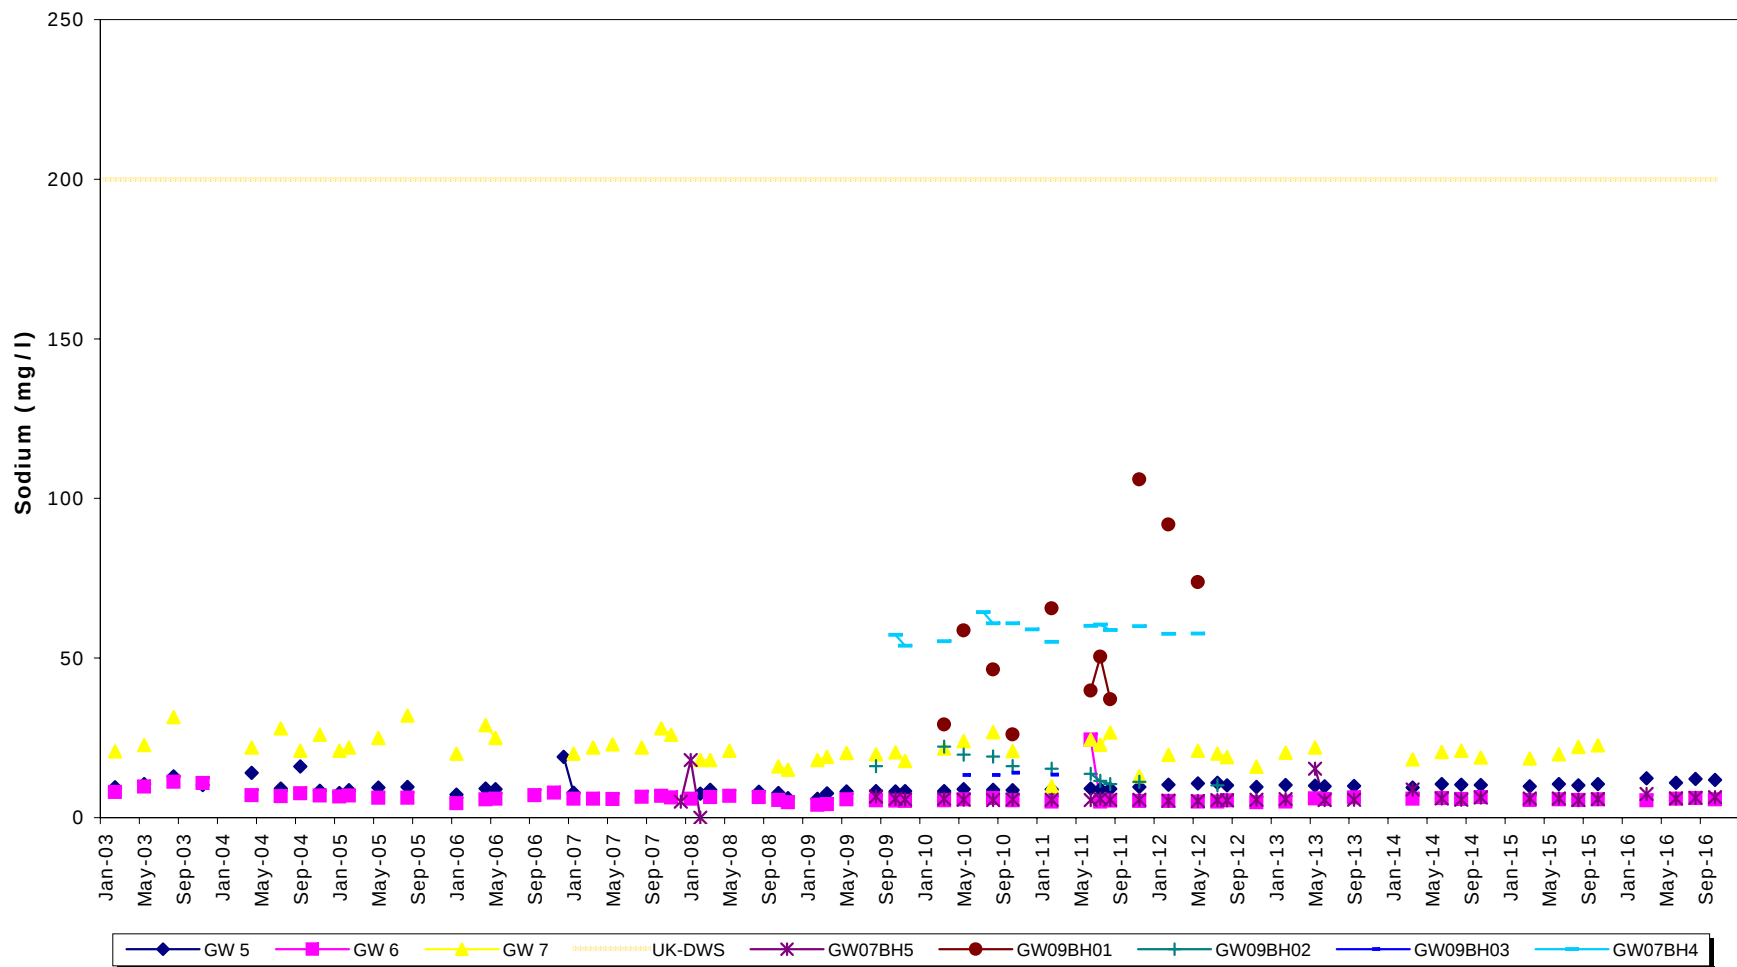
**Lab analysis of Sodium concentration in groundwater sampled by Amgen Cymru at the Bryn Pica  
Landfill Site during the period Jan 2003 - Dec 2016.**

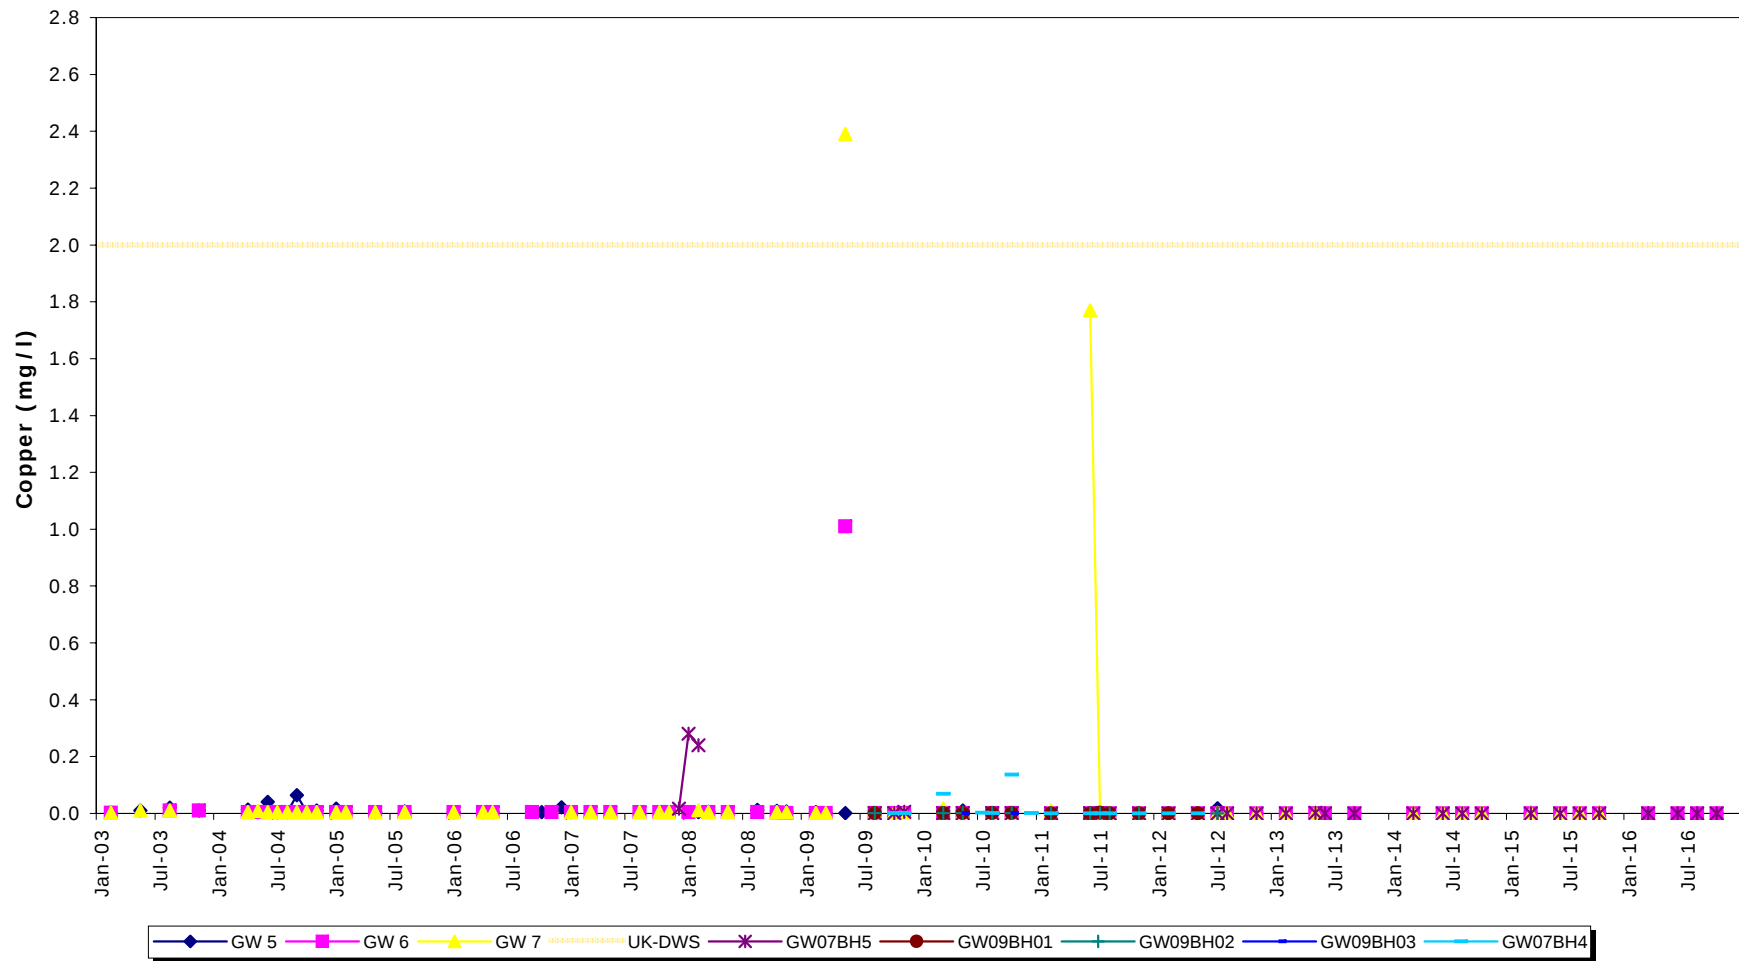
**Lab analysis of Copper concentration in groundwater sampled by Amgen Cymru at the Bryn Pica  
Landfill Site during the period Jan 2003 - Dec 2016.**

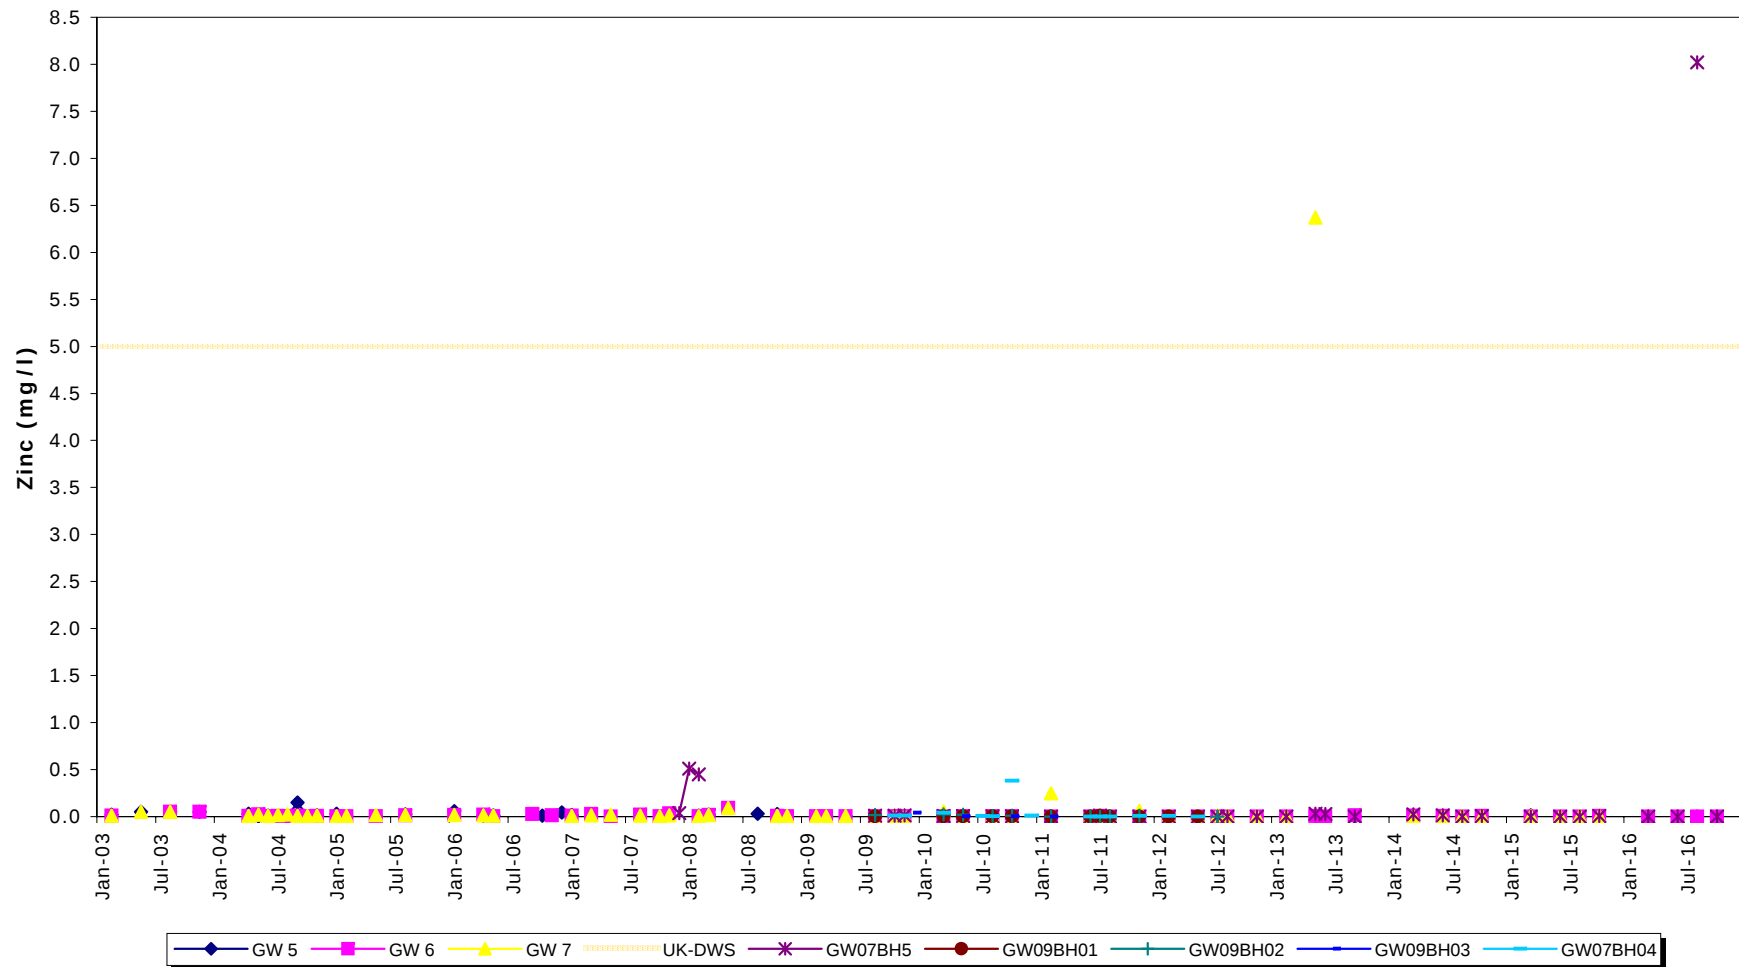
**Lab analysis of Zinc concentration in groundwater sampled by Amgen Cymru at the Bryn Pica Landfill**  
**Site during the period Jan 2003 - Dec 2016.**

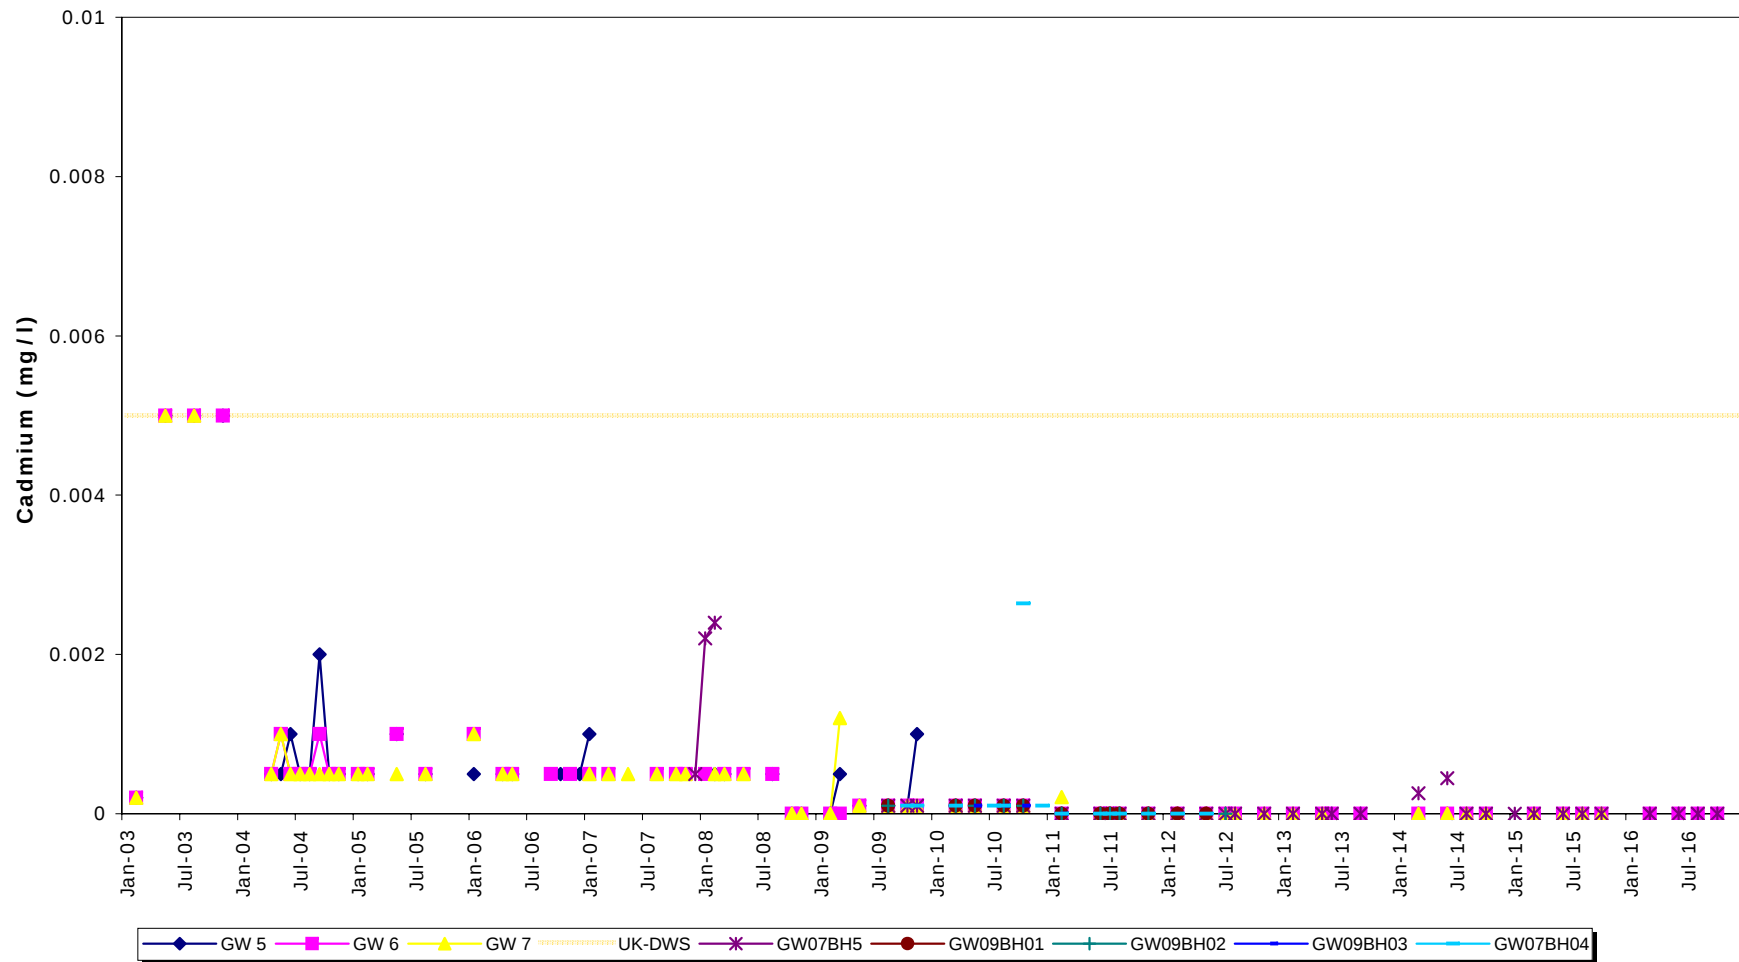
**Lab analysis of Cadmium concentration in groundwater sampled by Amgen Cymru at the Bryn Pica  
Landfill Site during the period Jan 2003 - Dec 2016.**

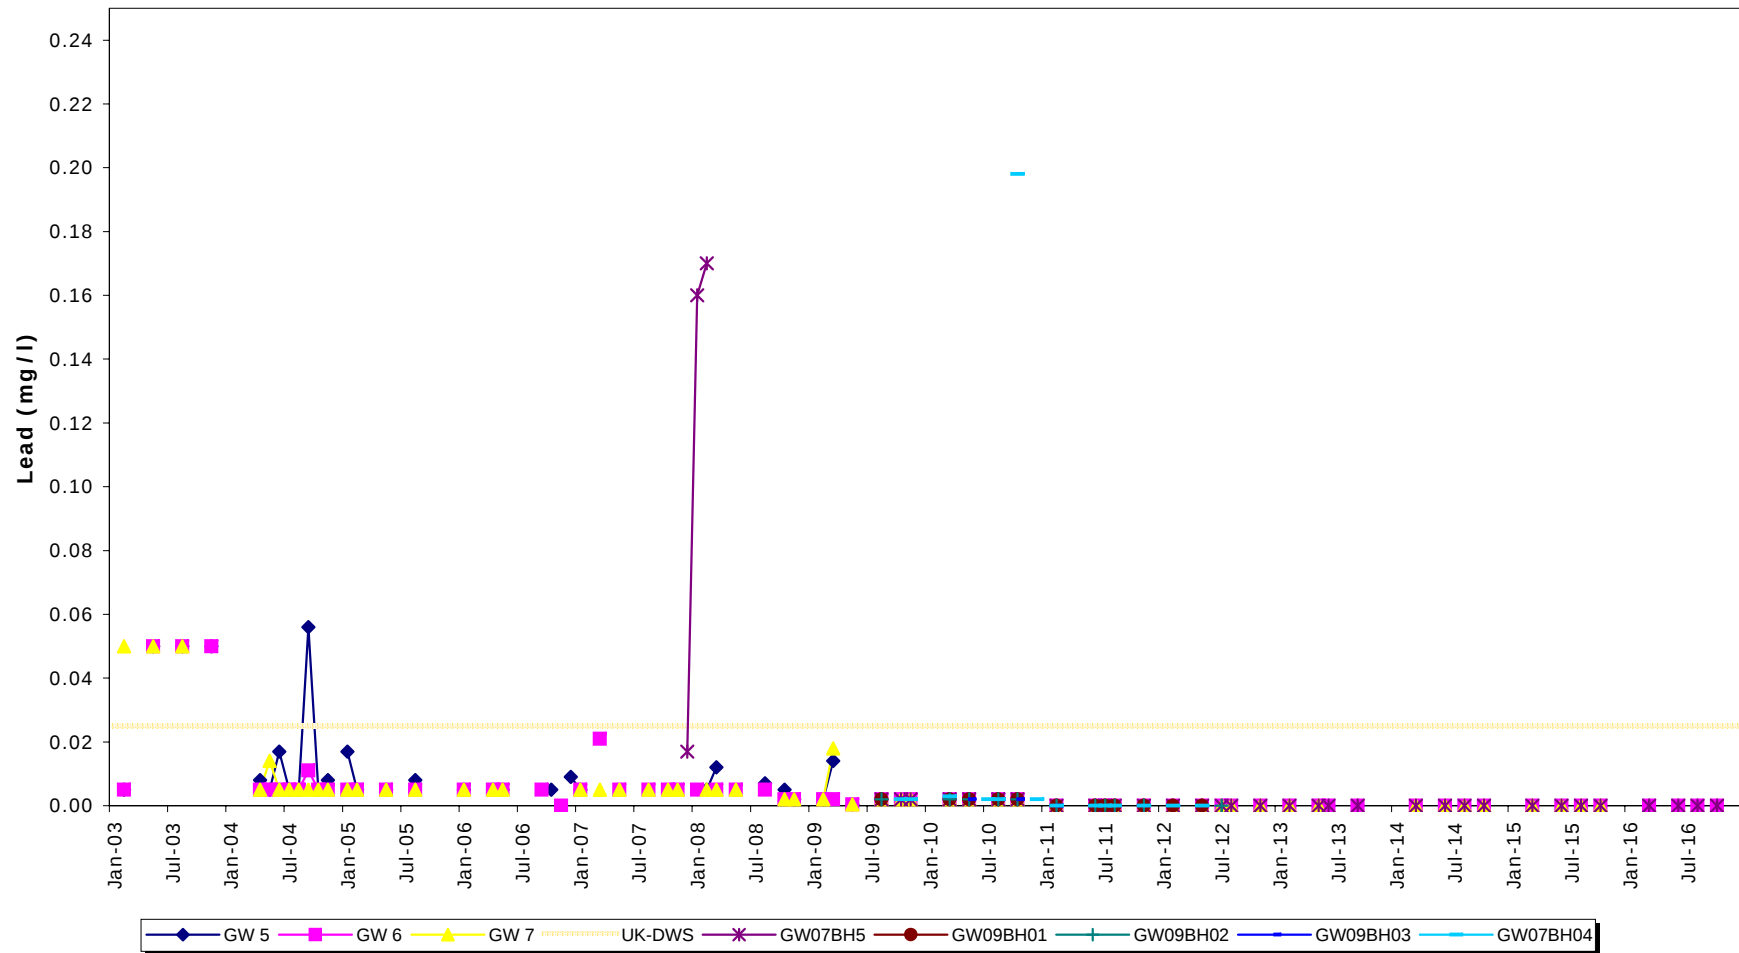
**Lab analysis of Lead concentration in groundwater sampled by Amgen Cymru at the Bryn Pica Landfill**  
**Site during the period Jan 2003 - Dec 2016.**

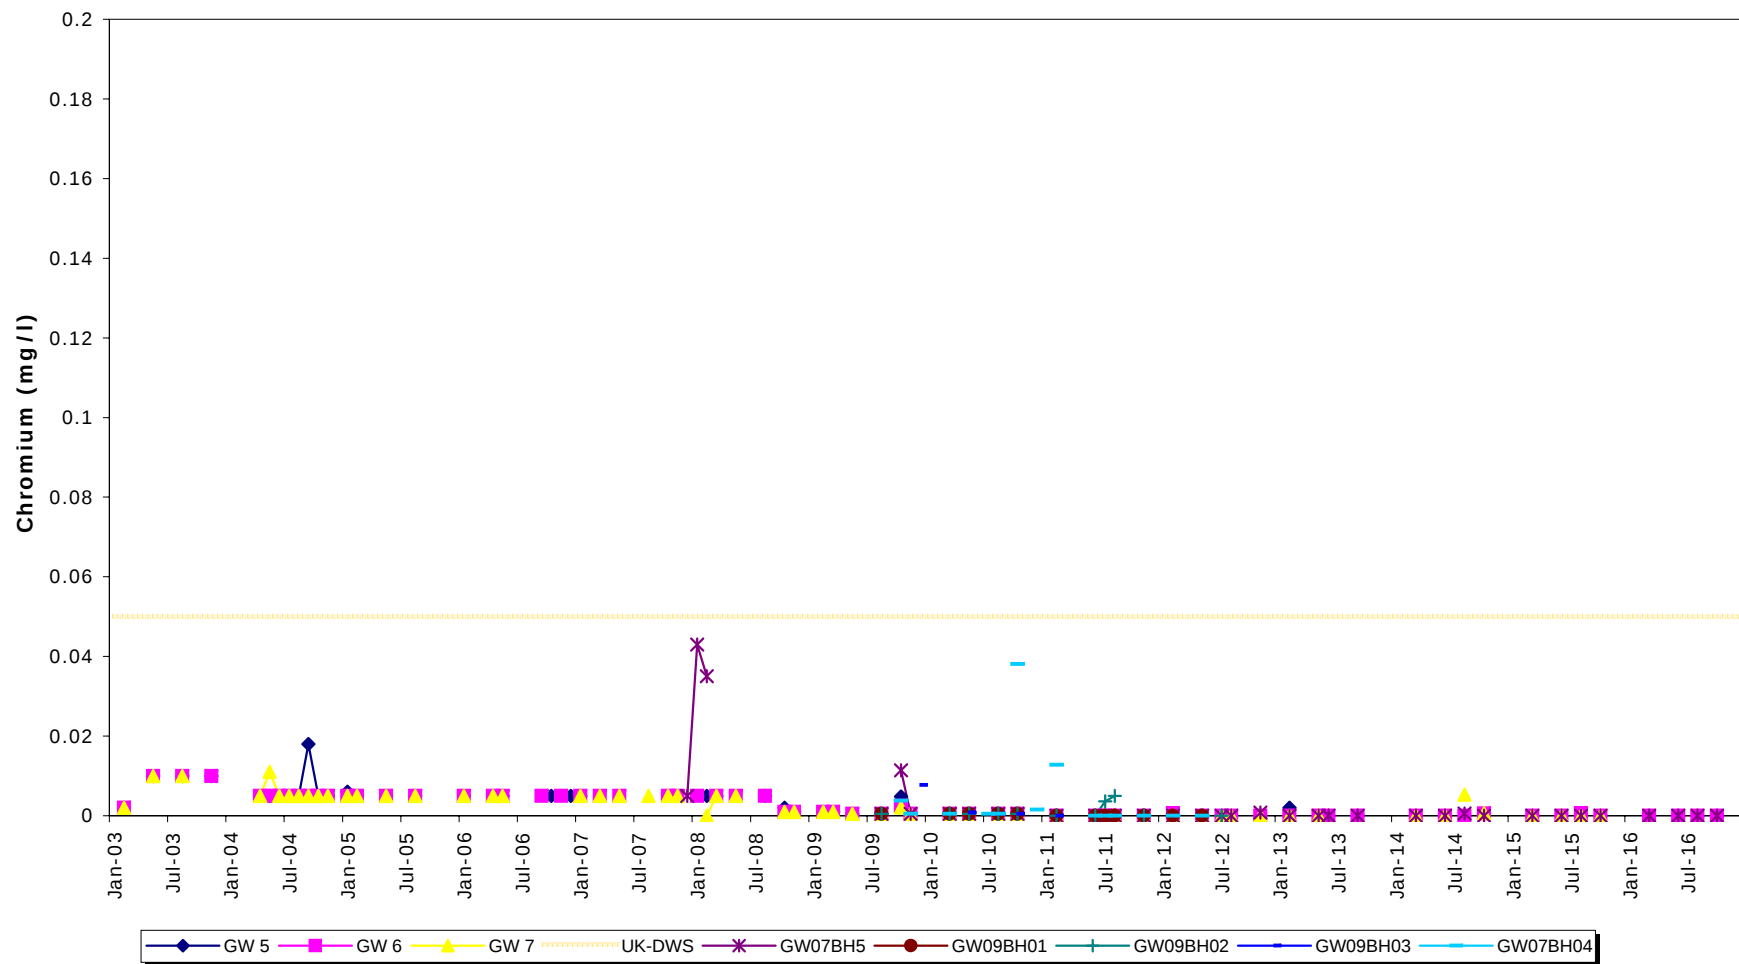
**Lab analysis of Chromium concentration in groundwater sampled by Amgen Cymru at the Bryn Pica  
Landfill Site during the period Jan 2003 - Dec 2016.**

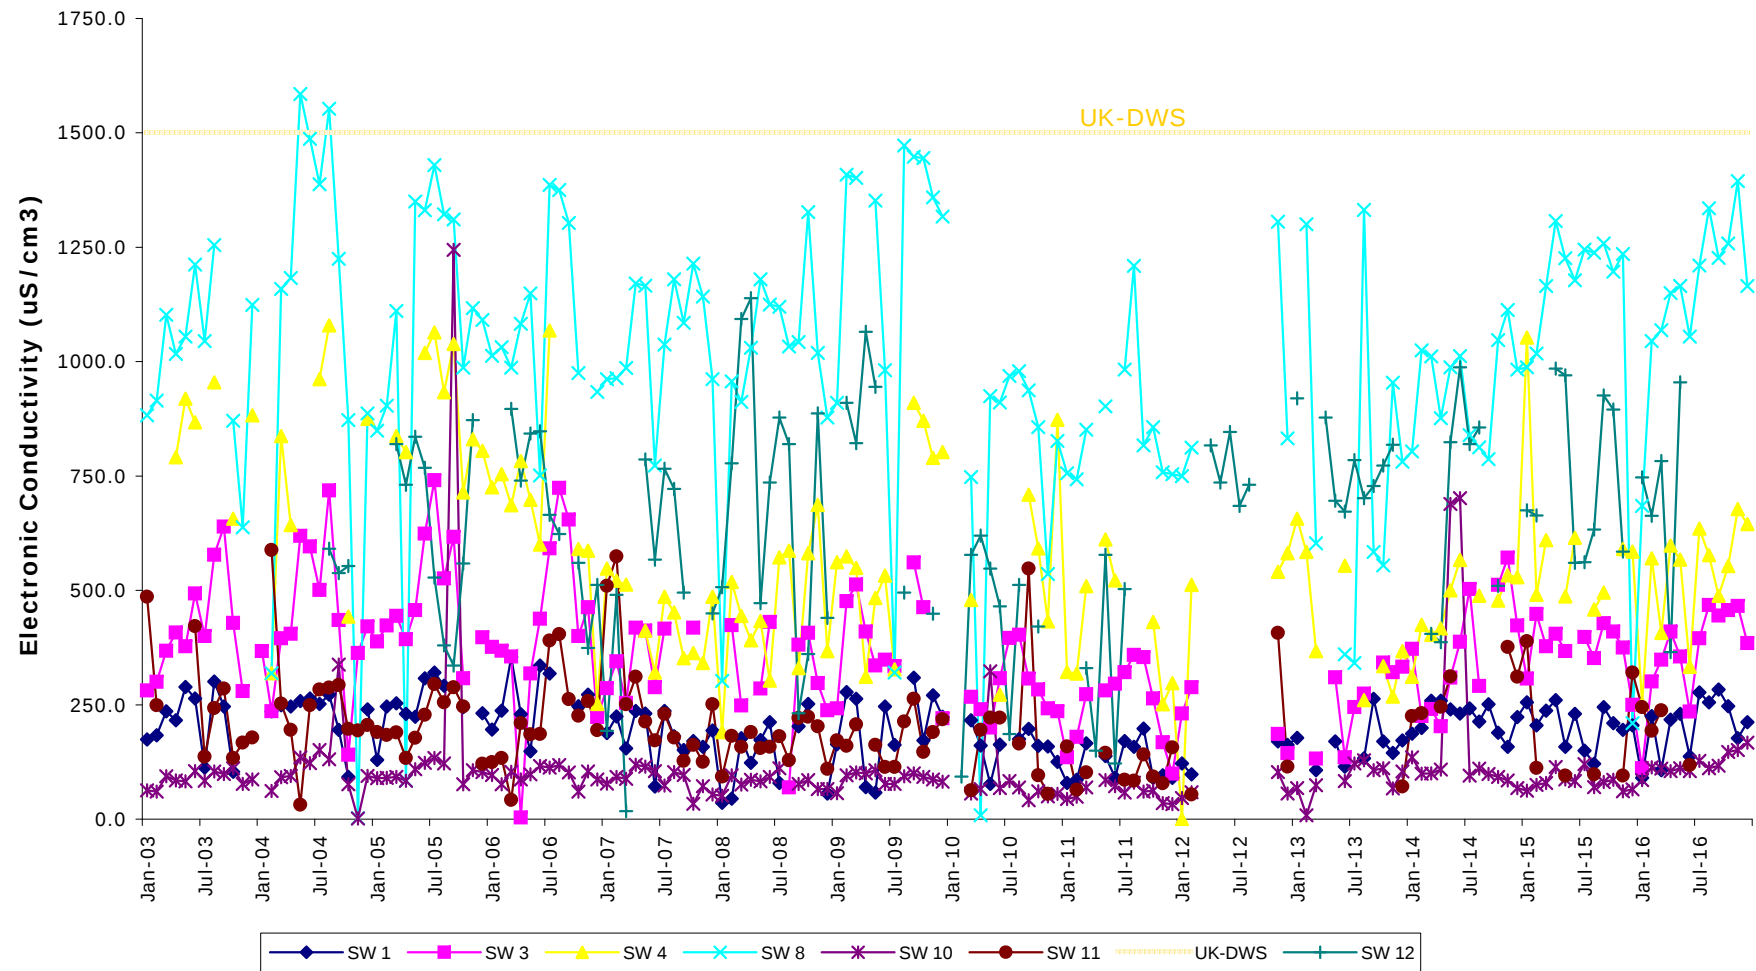
**In-Situ analysis of Electronic Conductivity levels in surface water sampled by Amgen Cymru at the Bryn Pica Landfill Site during the period August 2003 - Dec 2016.**

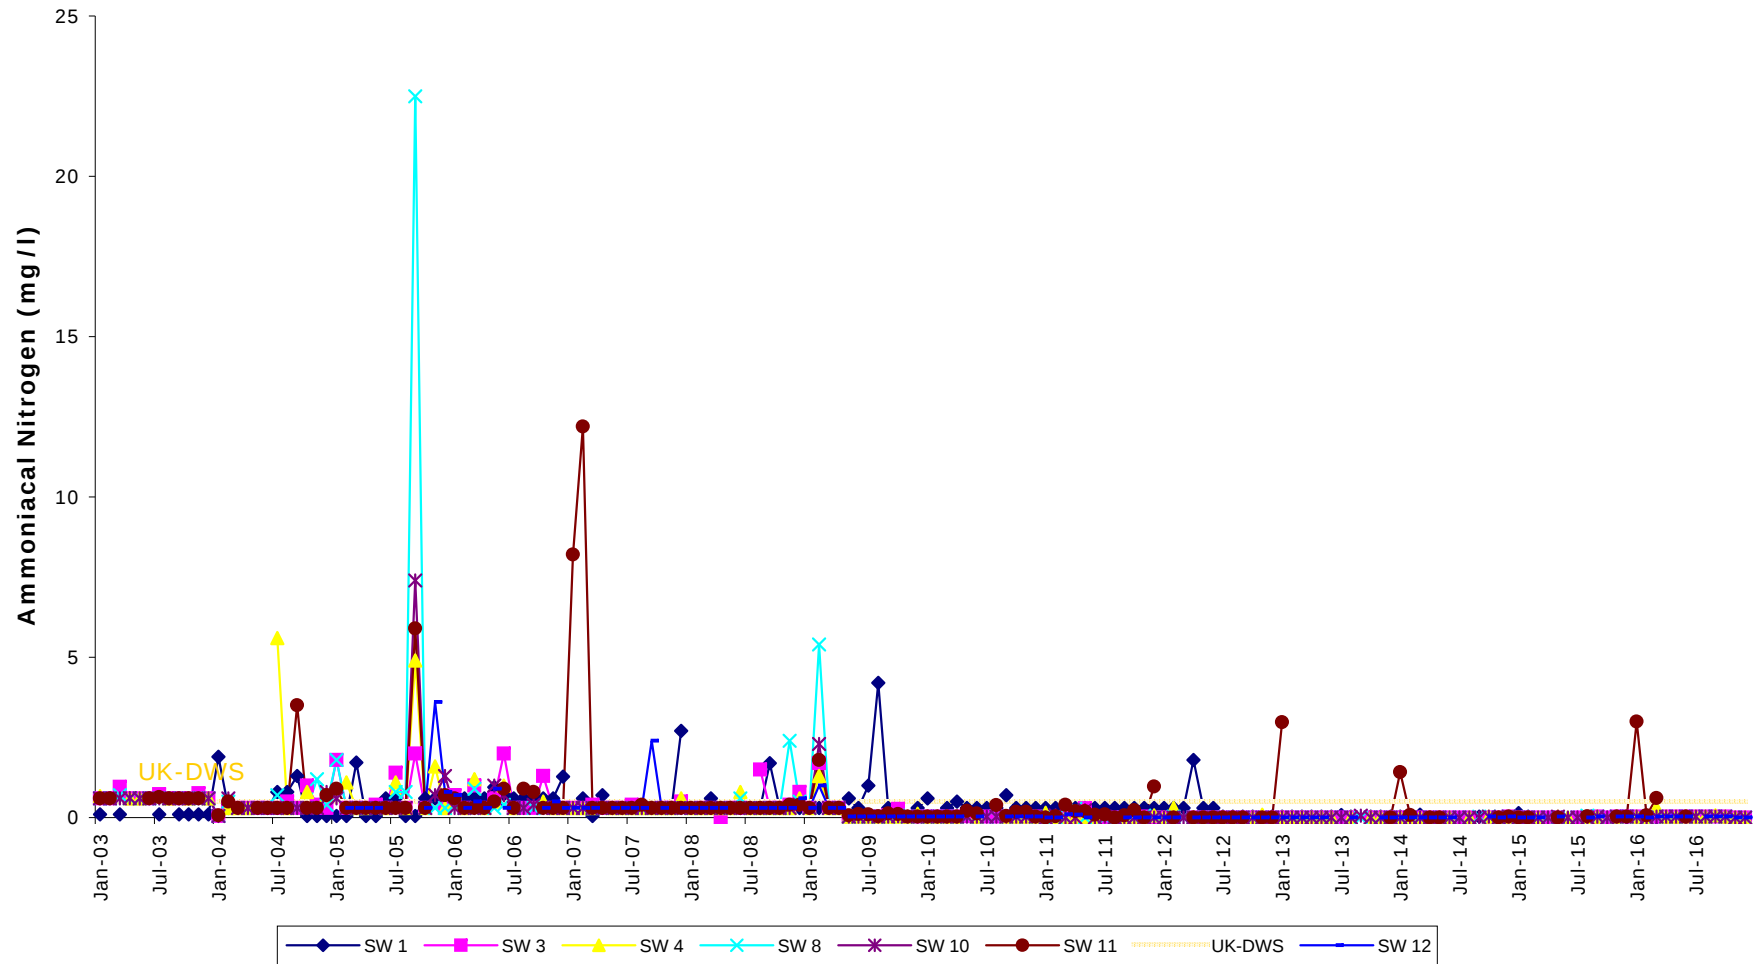
**Lab analysis of Ammoniacal Nitrogen (as N) concentrations in surface water sampled by Amgen Cymru at the Bryn Pica Landfill Site during the period Jan 2013 - Dec 2016.**

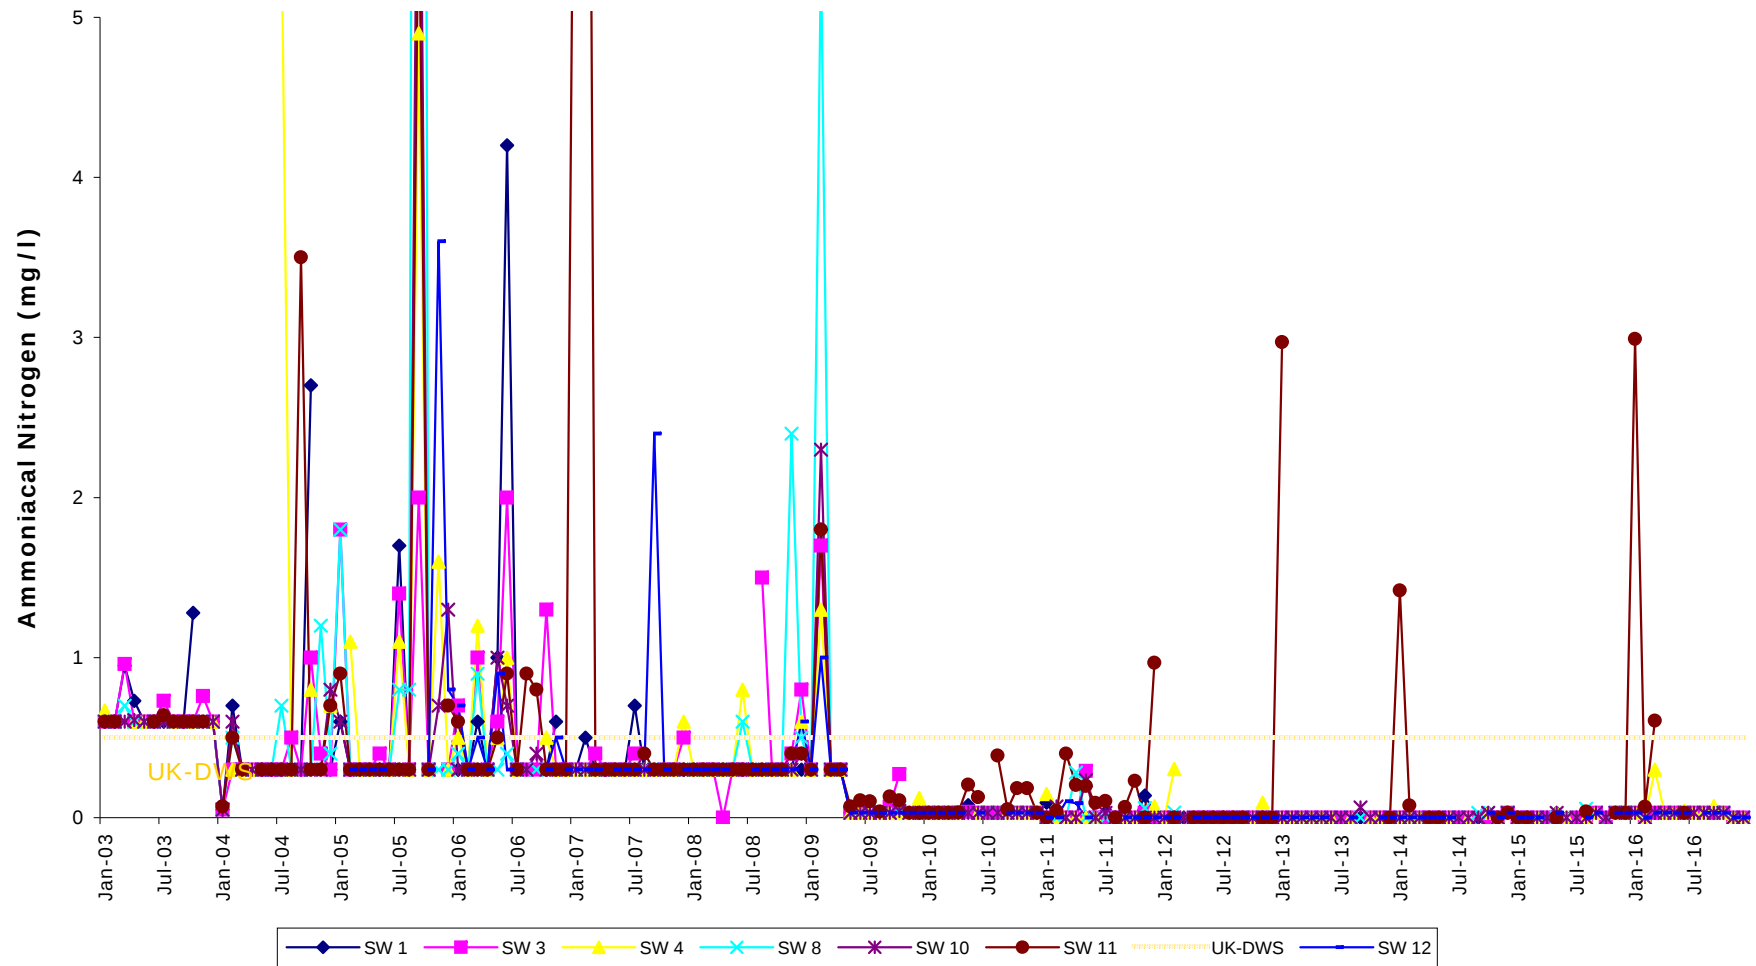
**Lab analysis of Ammoniacal Nitrogen (as N) concentrations in surface water sampled by Amgen Cymru at the Bryn Pica Landfill Site during the period Jan 2013- Dec 2016 (Alternative Scale).**

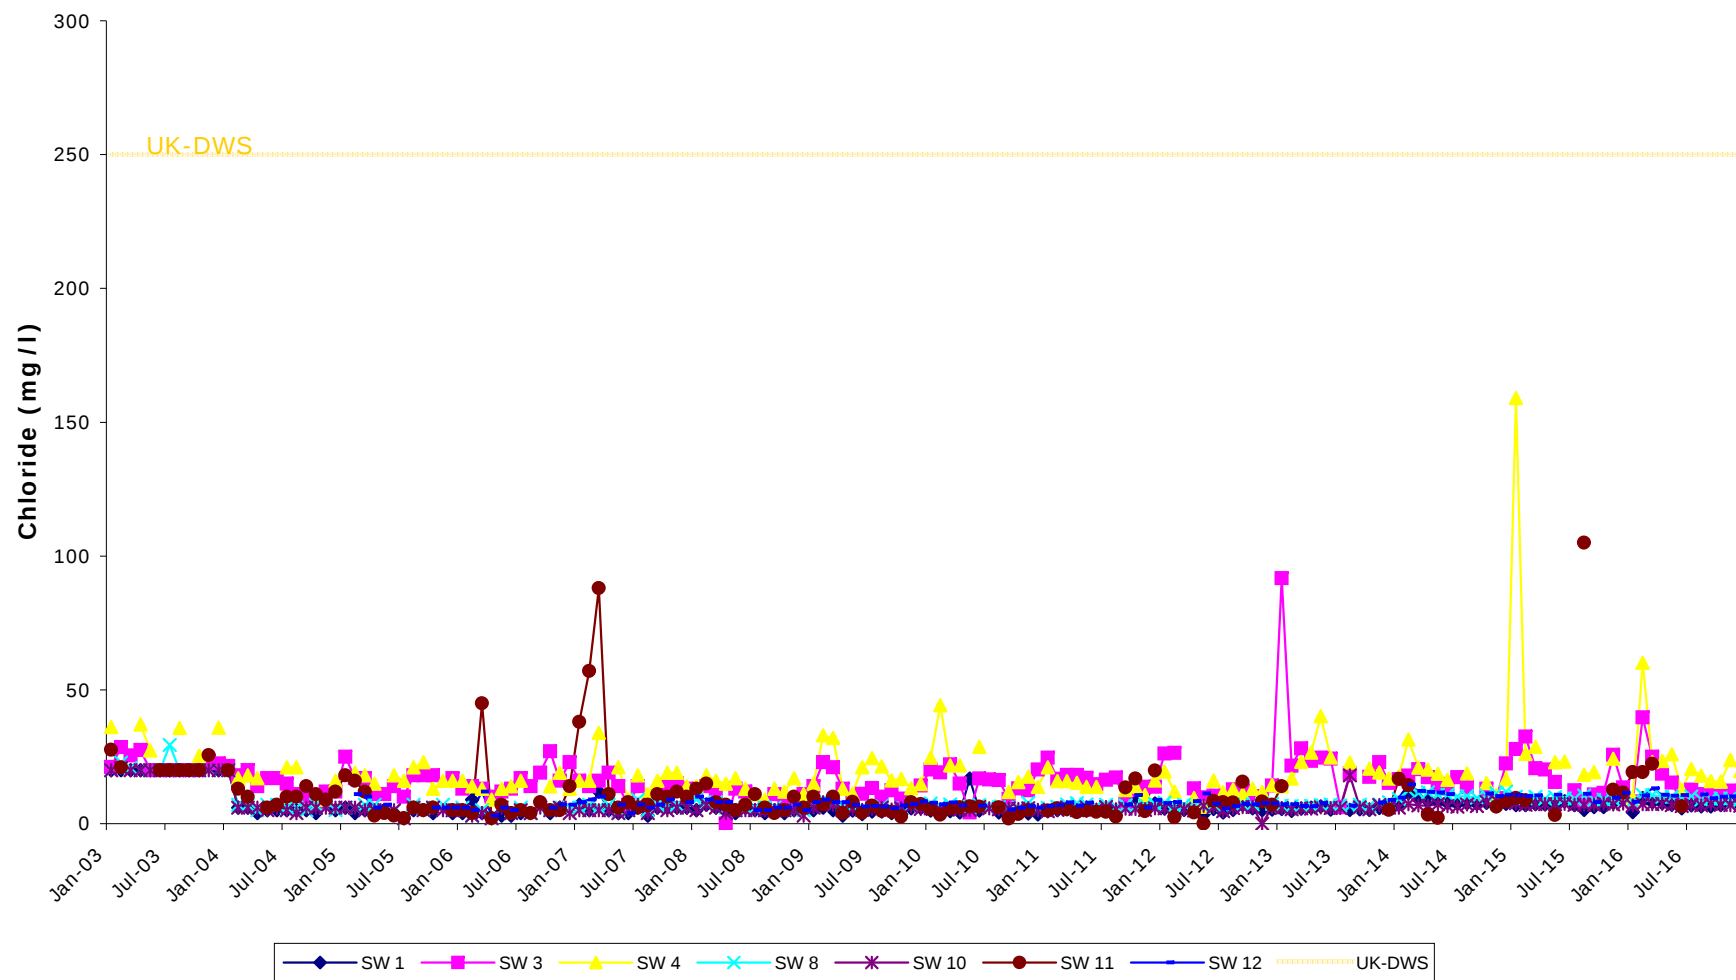
**Lab analysis of Chloride concentrations in surface water sampled by Amgen Cymru at the Bryn Pica Landfill Site during the period Jan 2003- Dec 2016.**
