Report No: AC2017/ENV/01  
Apr-17

REVIEW OF ENVIRONMENTAL MONITORING  
UNDERTAKEN AT THE  
BRYN PICA LANDFILL SITE DURING THE PERIOD  
JAN 16 – DEC 16

Amgen Cymru  
Bryn Pica Landfill Site  
Llwydcoed  
Aberdare  
CF44 0BX

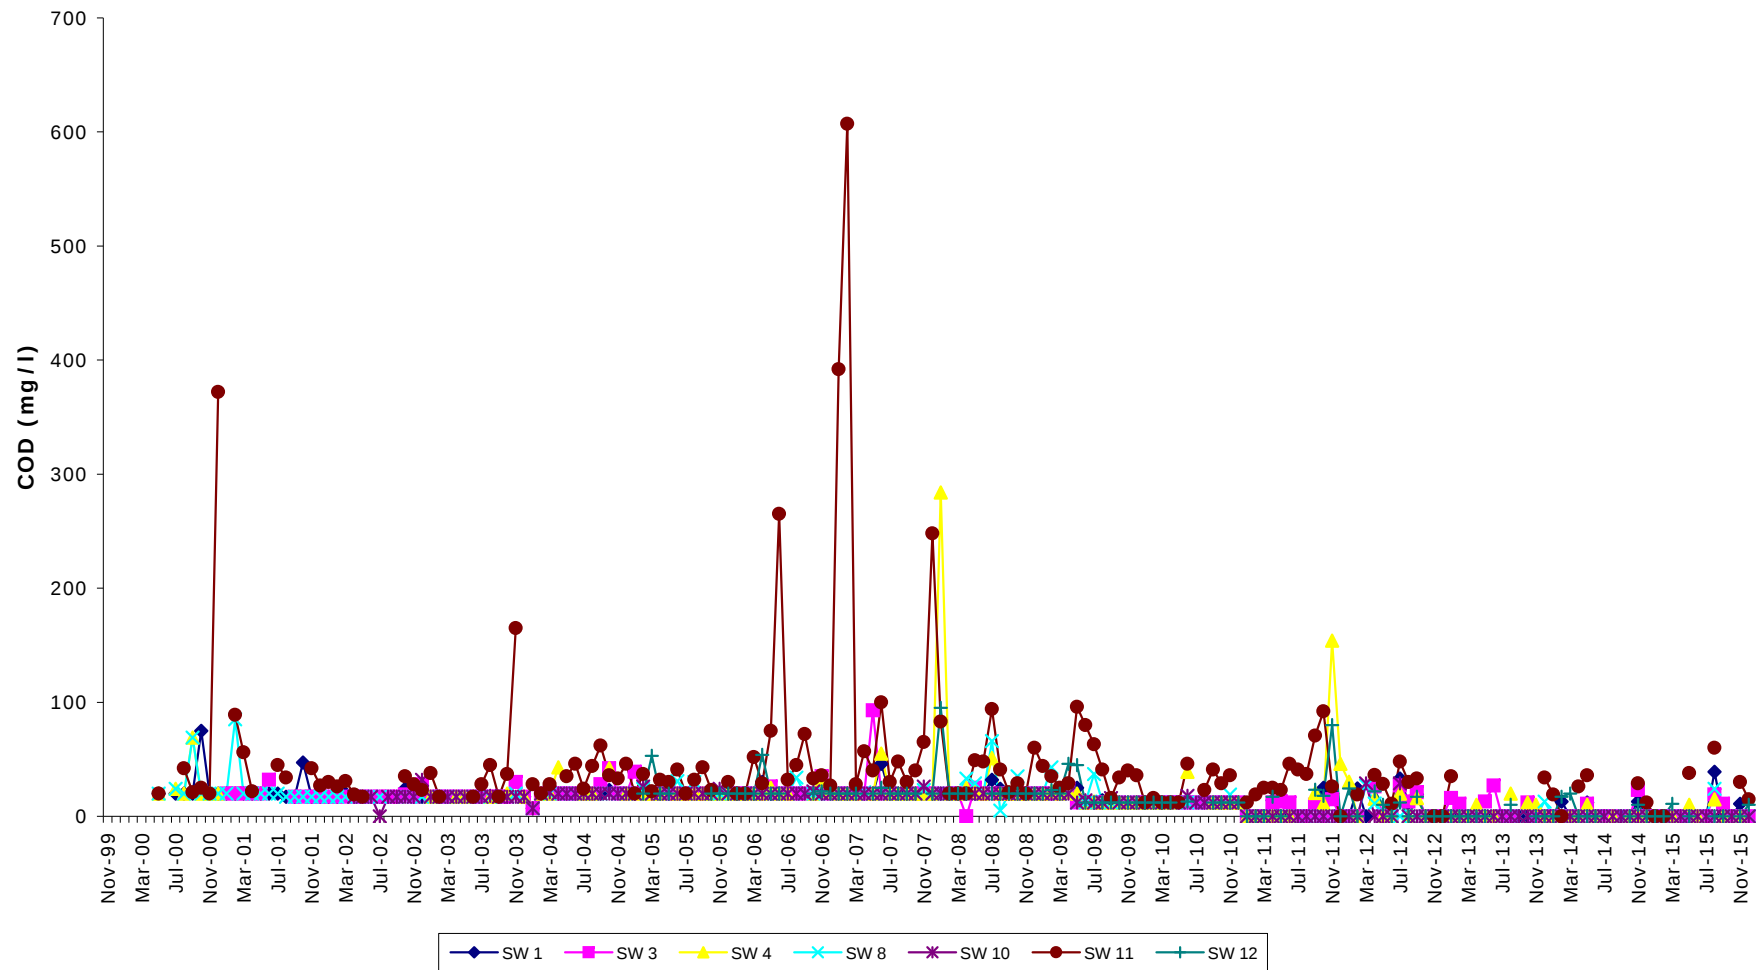
**Lab analysis of Chemical Oxygen Demand (COD) concentrations in surface water sampled by Amgen  
Cymru at the Bryn Pica Landfill Site during the period Jan 2000 - Dec 2015.**

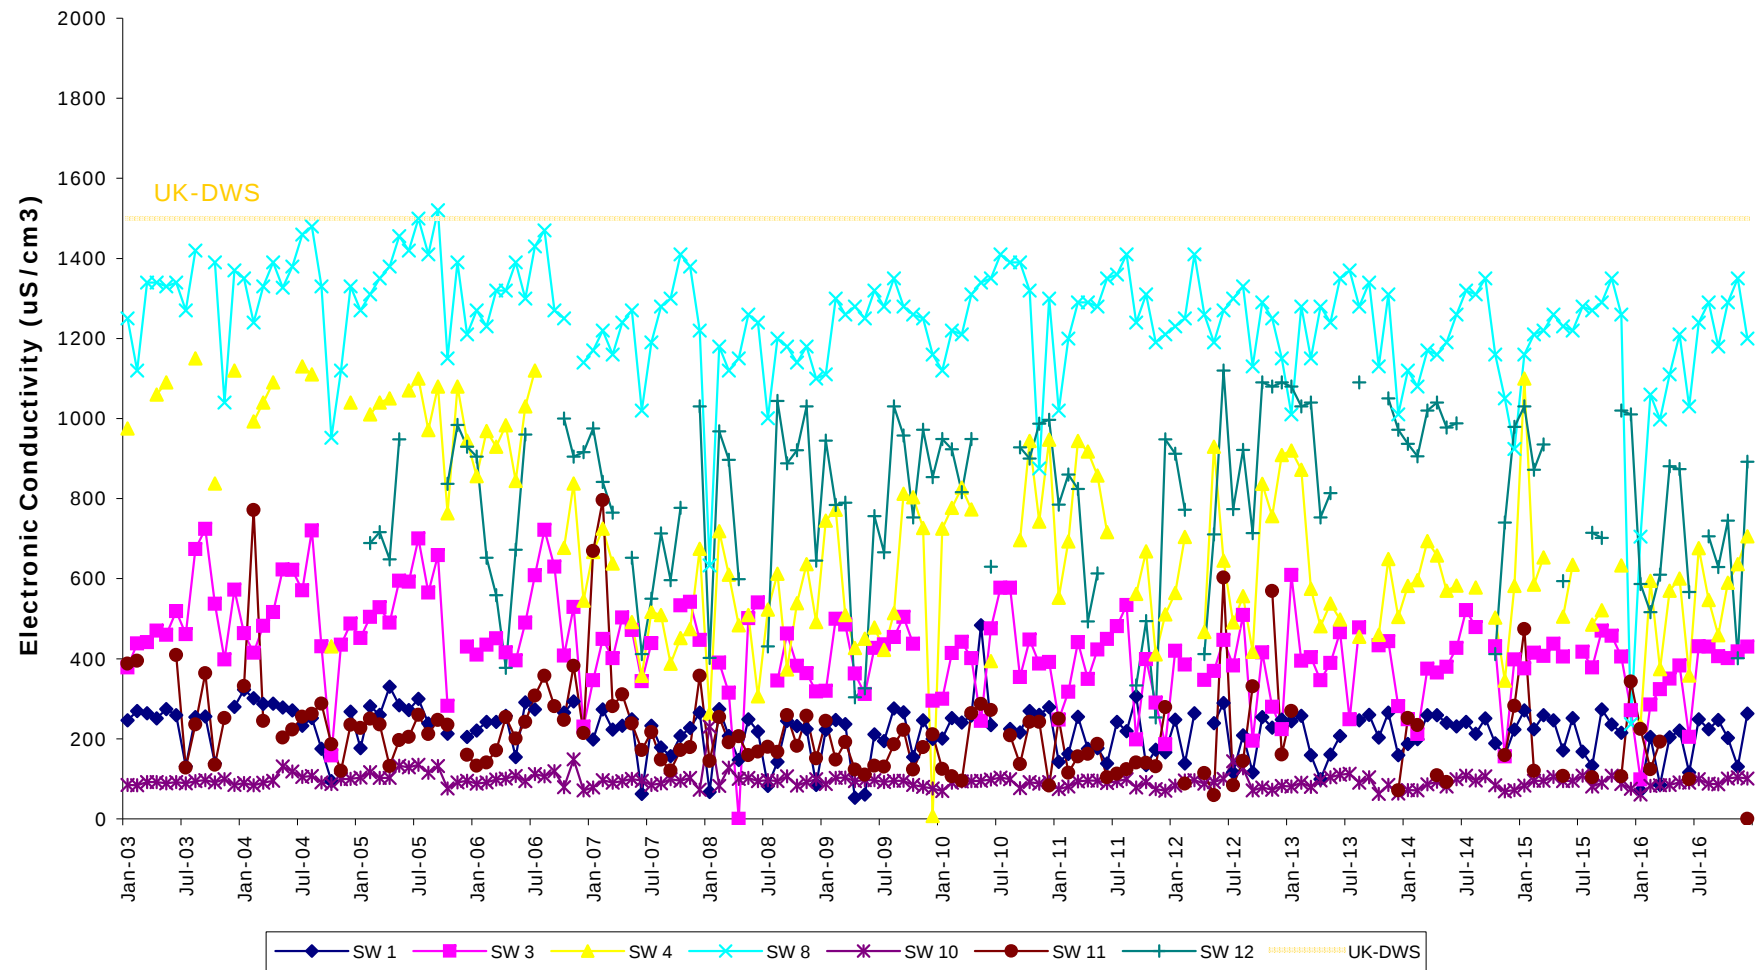
**Lab analysis of Electronic Conductivity levels in surface water sampled by Amgen Cymru at the Bryn Pica Landfill Site during the period Jan 2003 - Dec 2016.**

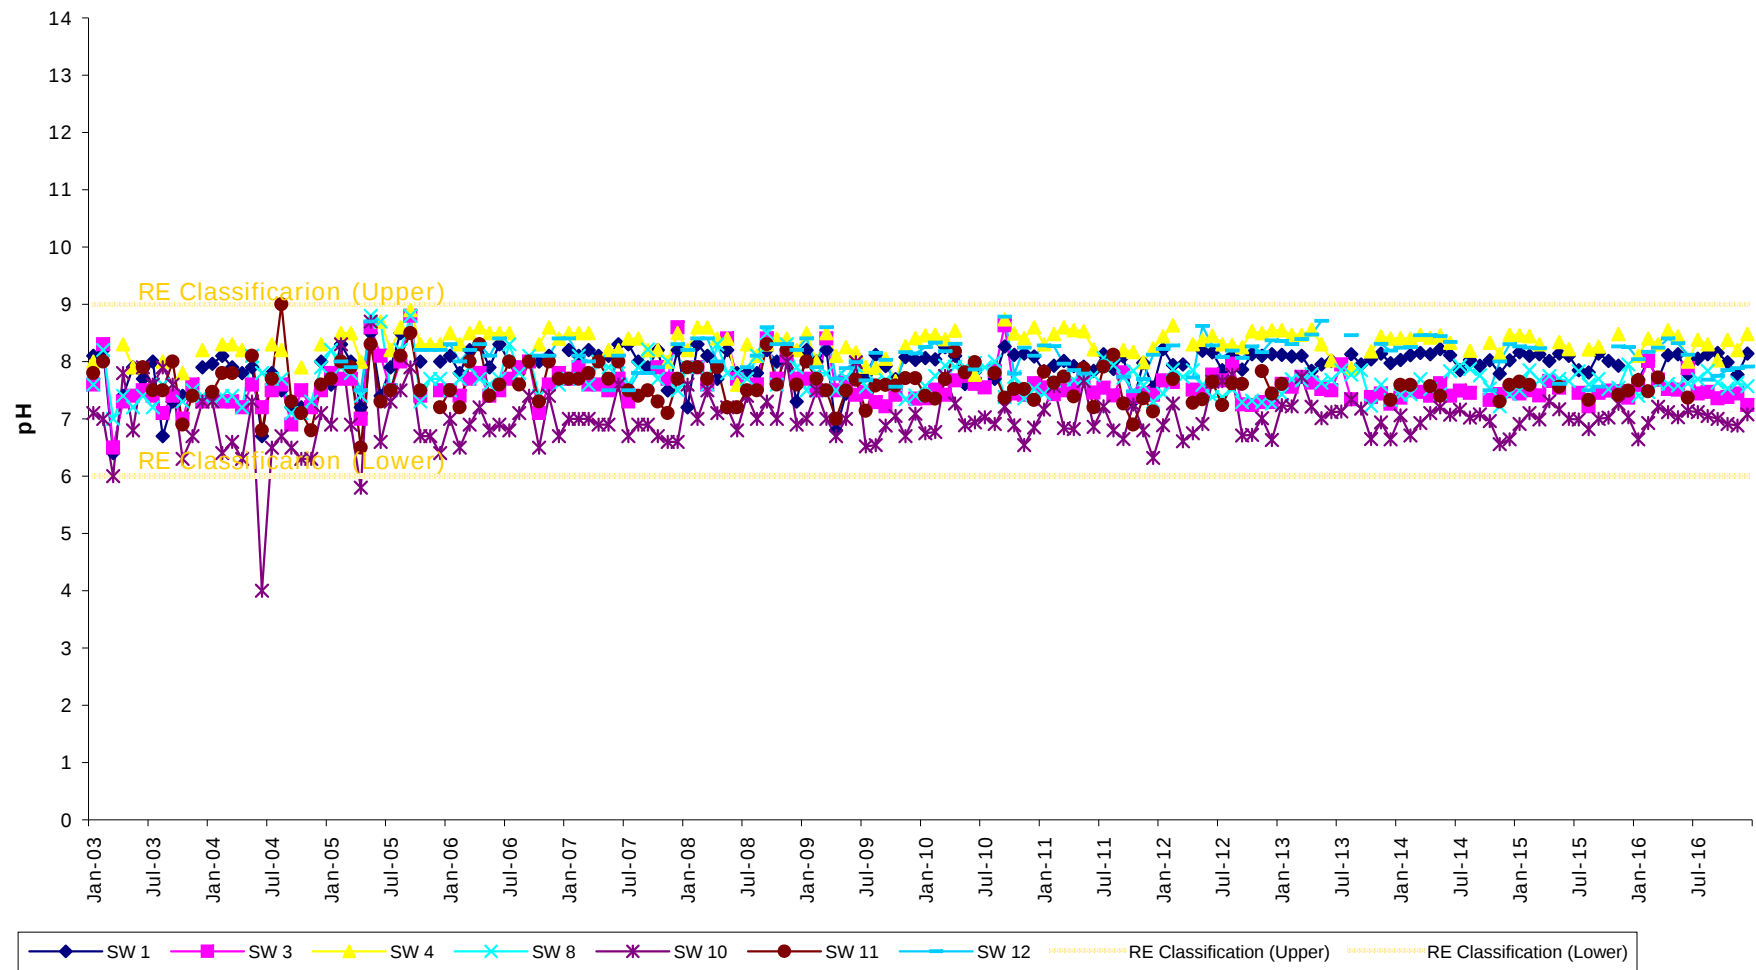
**Lab analysis of pH in surface water sampled by Amgen Cymru at the Bryn Pica Landfill Site during the period Jan 2003 - Dec 2016.**

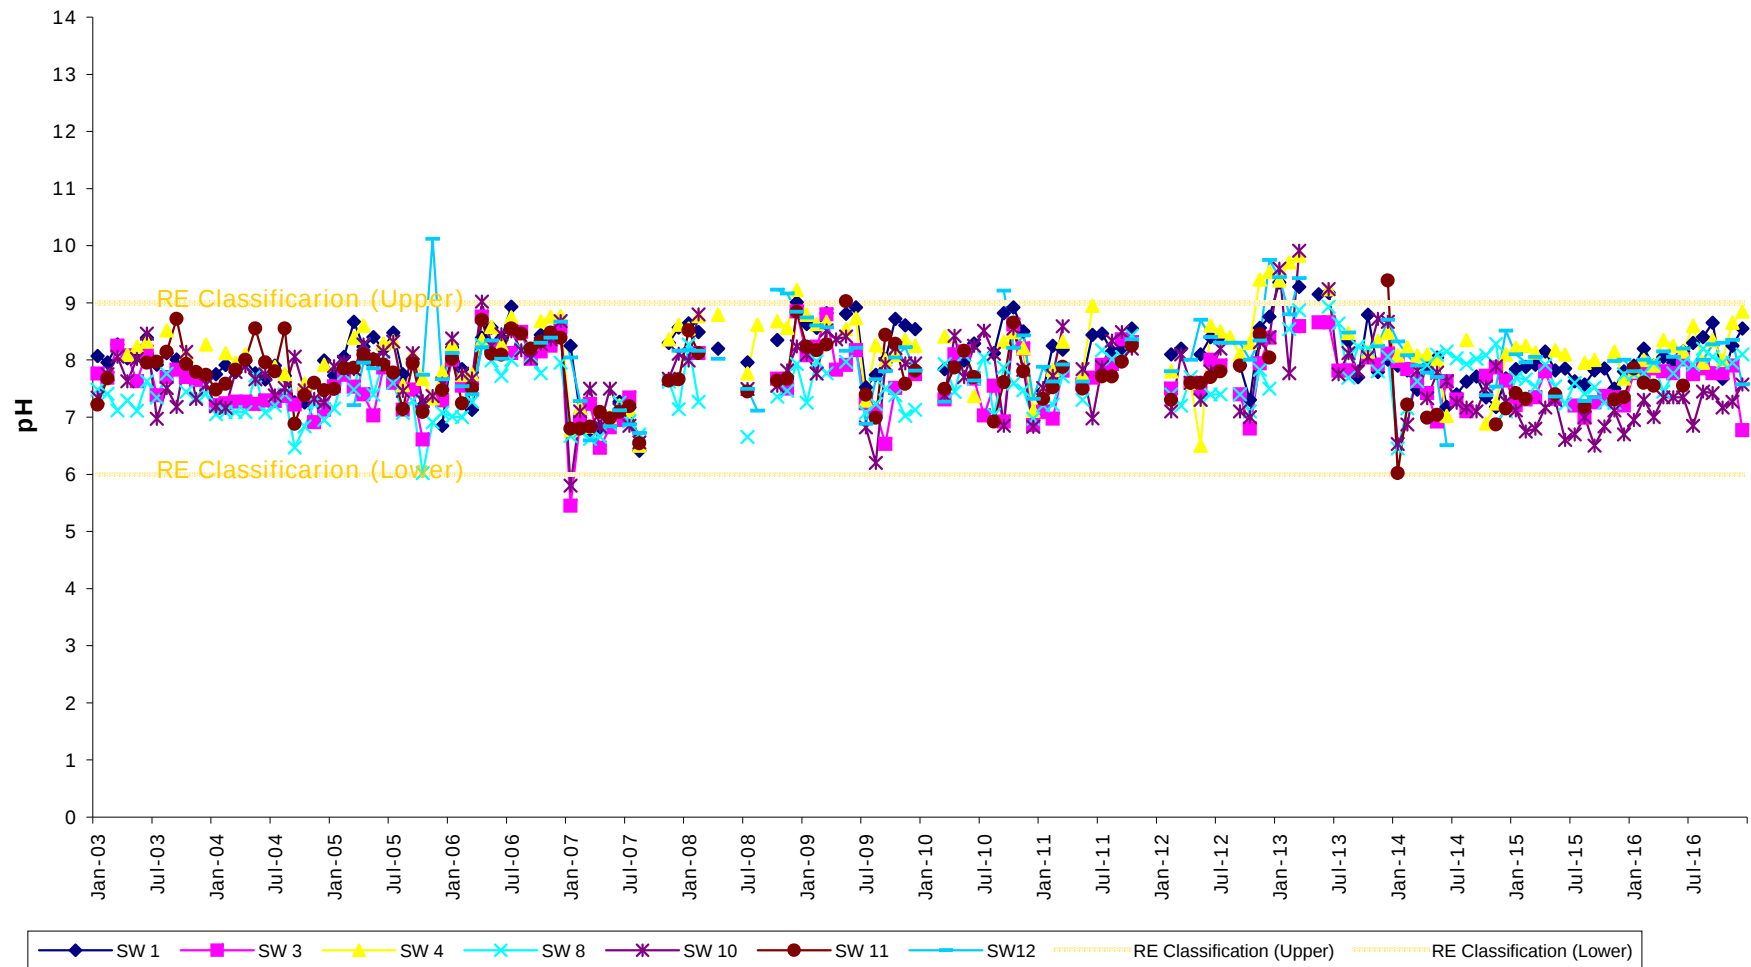
**In-Situ analysis of pH in surface water sampled by Amgen Cymru at the Bryn Pica Landfill Site during the period August 2003 - Dec 2016.**

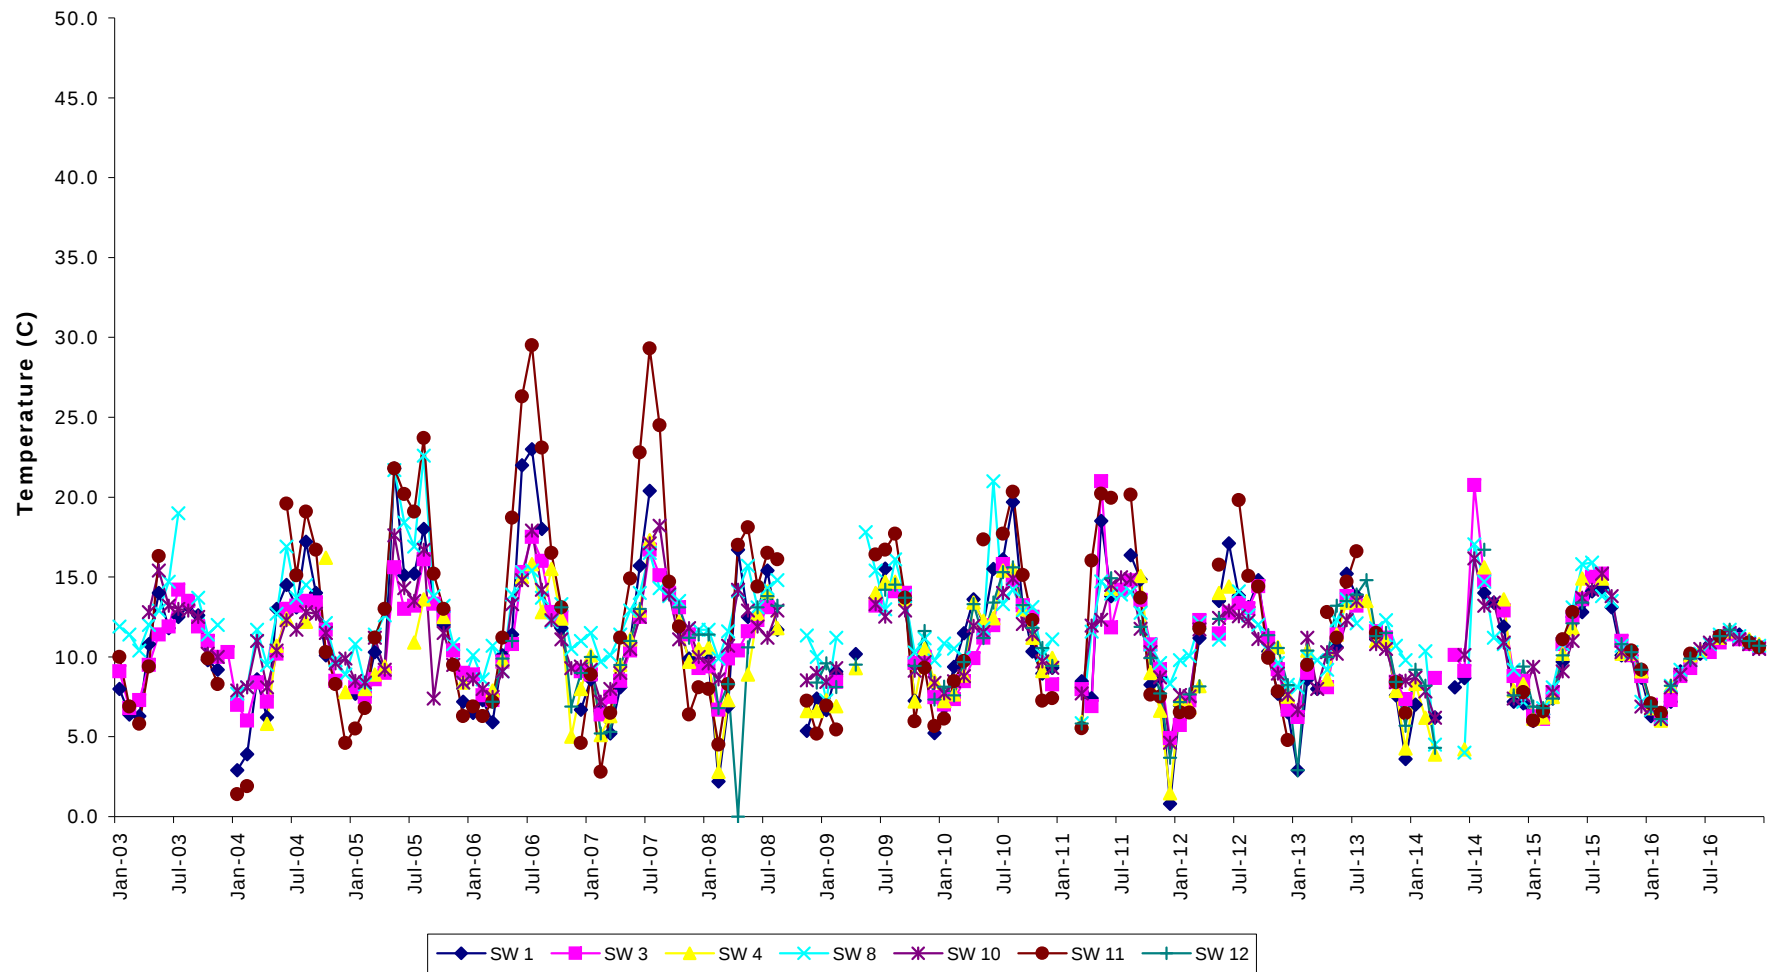
**In-Situ analysis of Temperature in surface water sampled by Amgen Cymru at the Bryn Pica Landfill**  
**Site during the period August 2003 - Dec 2016.**
