Report No: AC2018/ENV/01  
January 2018

REVIEW OF ENVIRONMENTAL MONITORING  
UNDERTAKEN AT THE  
BRYN PICA LANDFILL SITE DURING THE PERIOD  
JAN 17 – DEC 17

Amgen Cymru  
Bryn Pica Landfill Site  
Llwydcoed  
Aberdare  
CF44 0BX

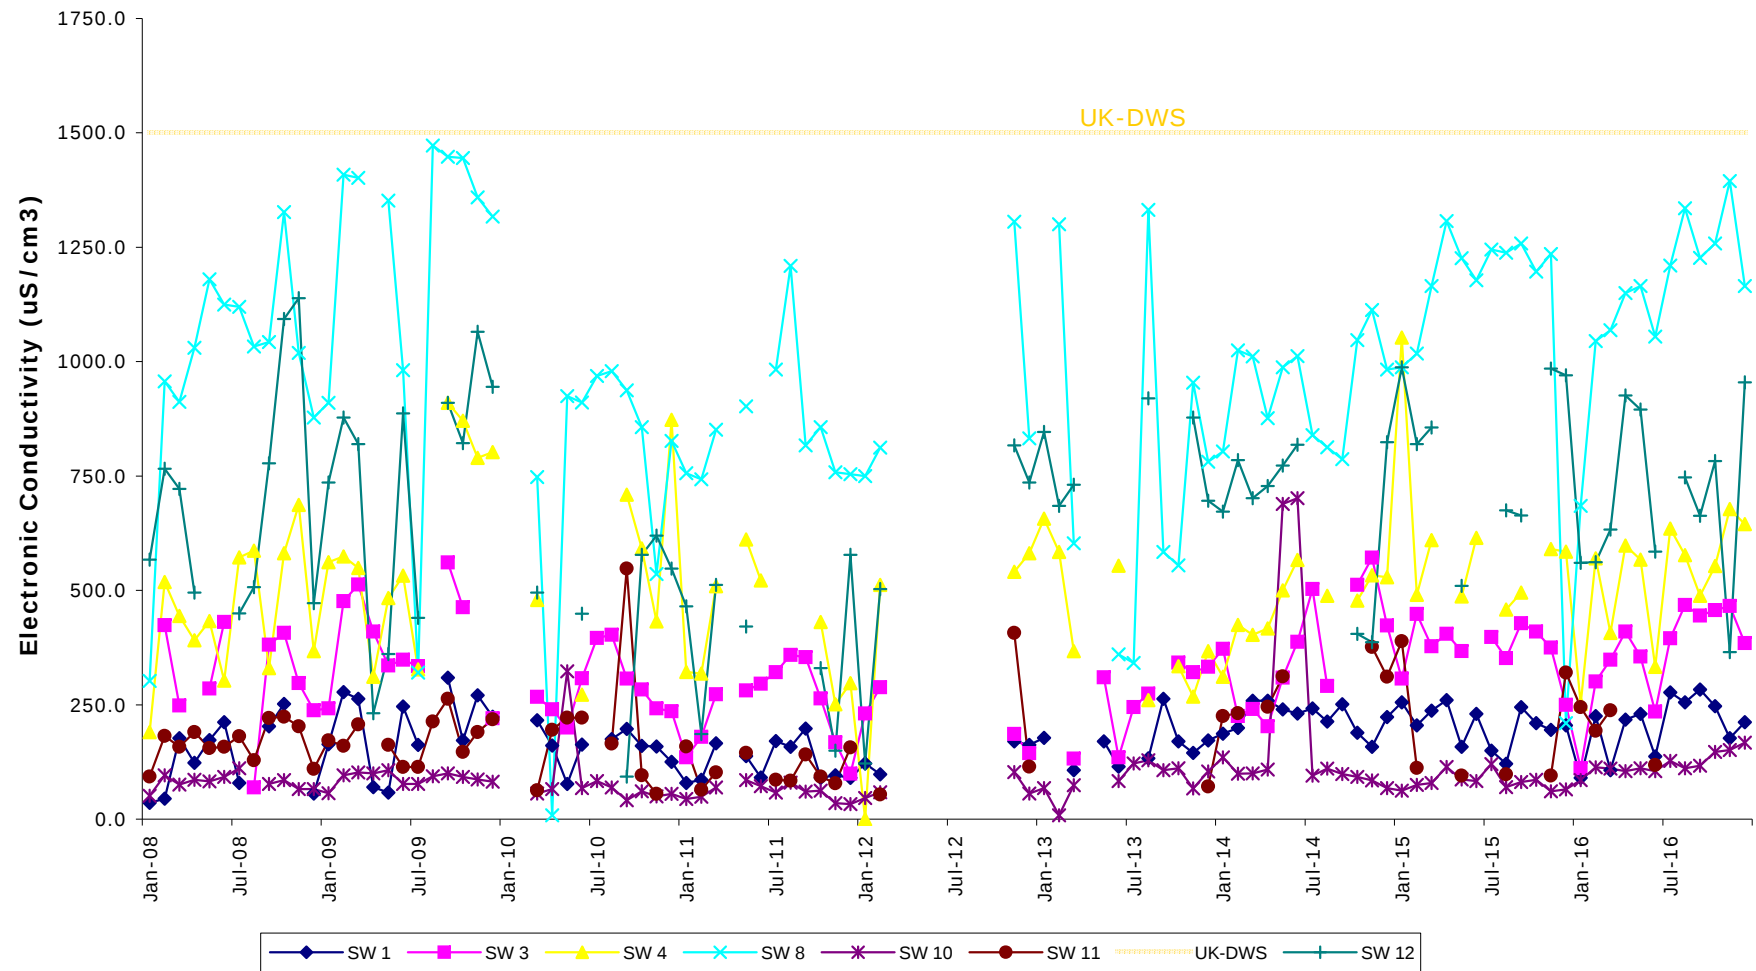
**In-Situ analysis of Electronic Conductivity levels in surface water sampled by Amgen Cymru at the Bryn Pica Landfill Site during the period August 2003 - Dec 2016.**
