Trecatti Landfill Site

Improvement conditions 2 and 3 as required in Table S1.3 Permit RP3733PC  
V008

## 1. Introduction

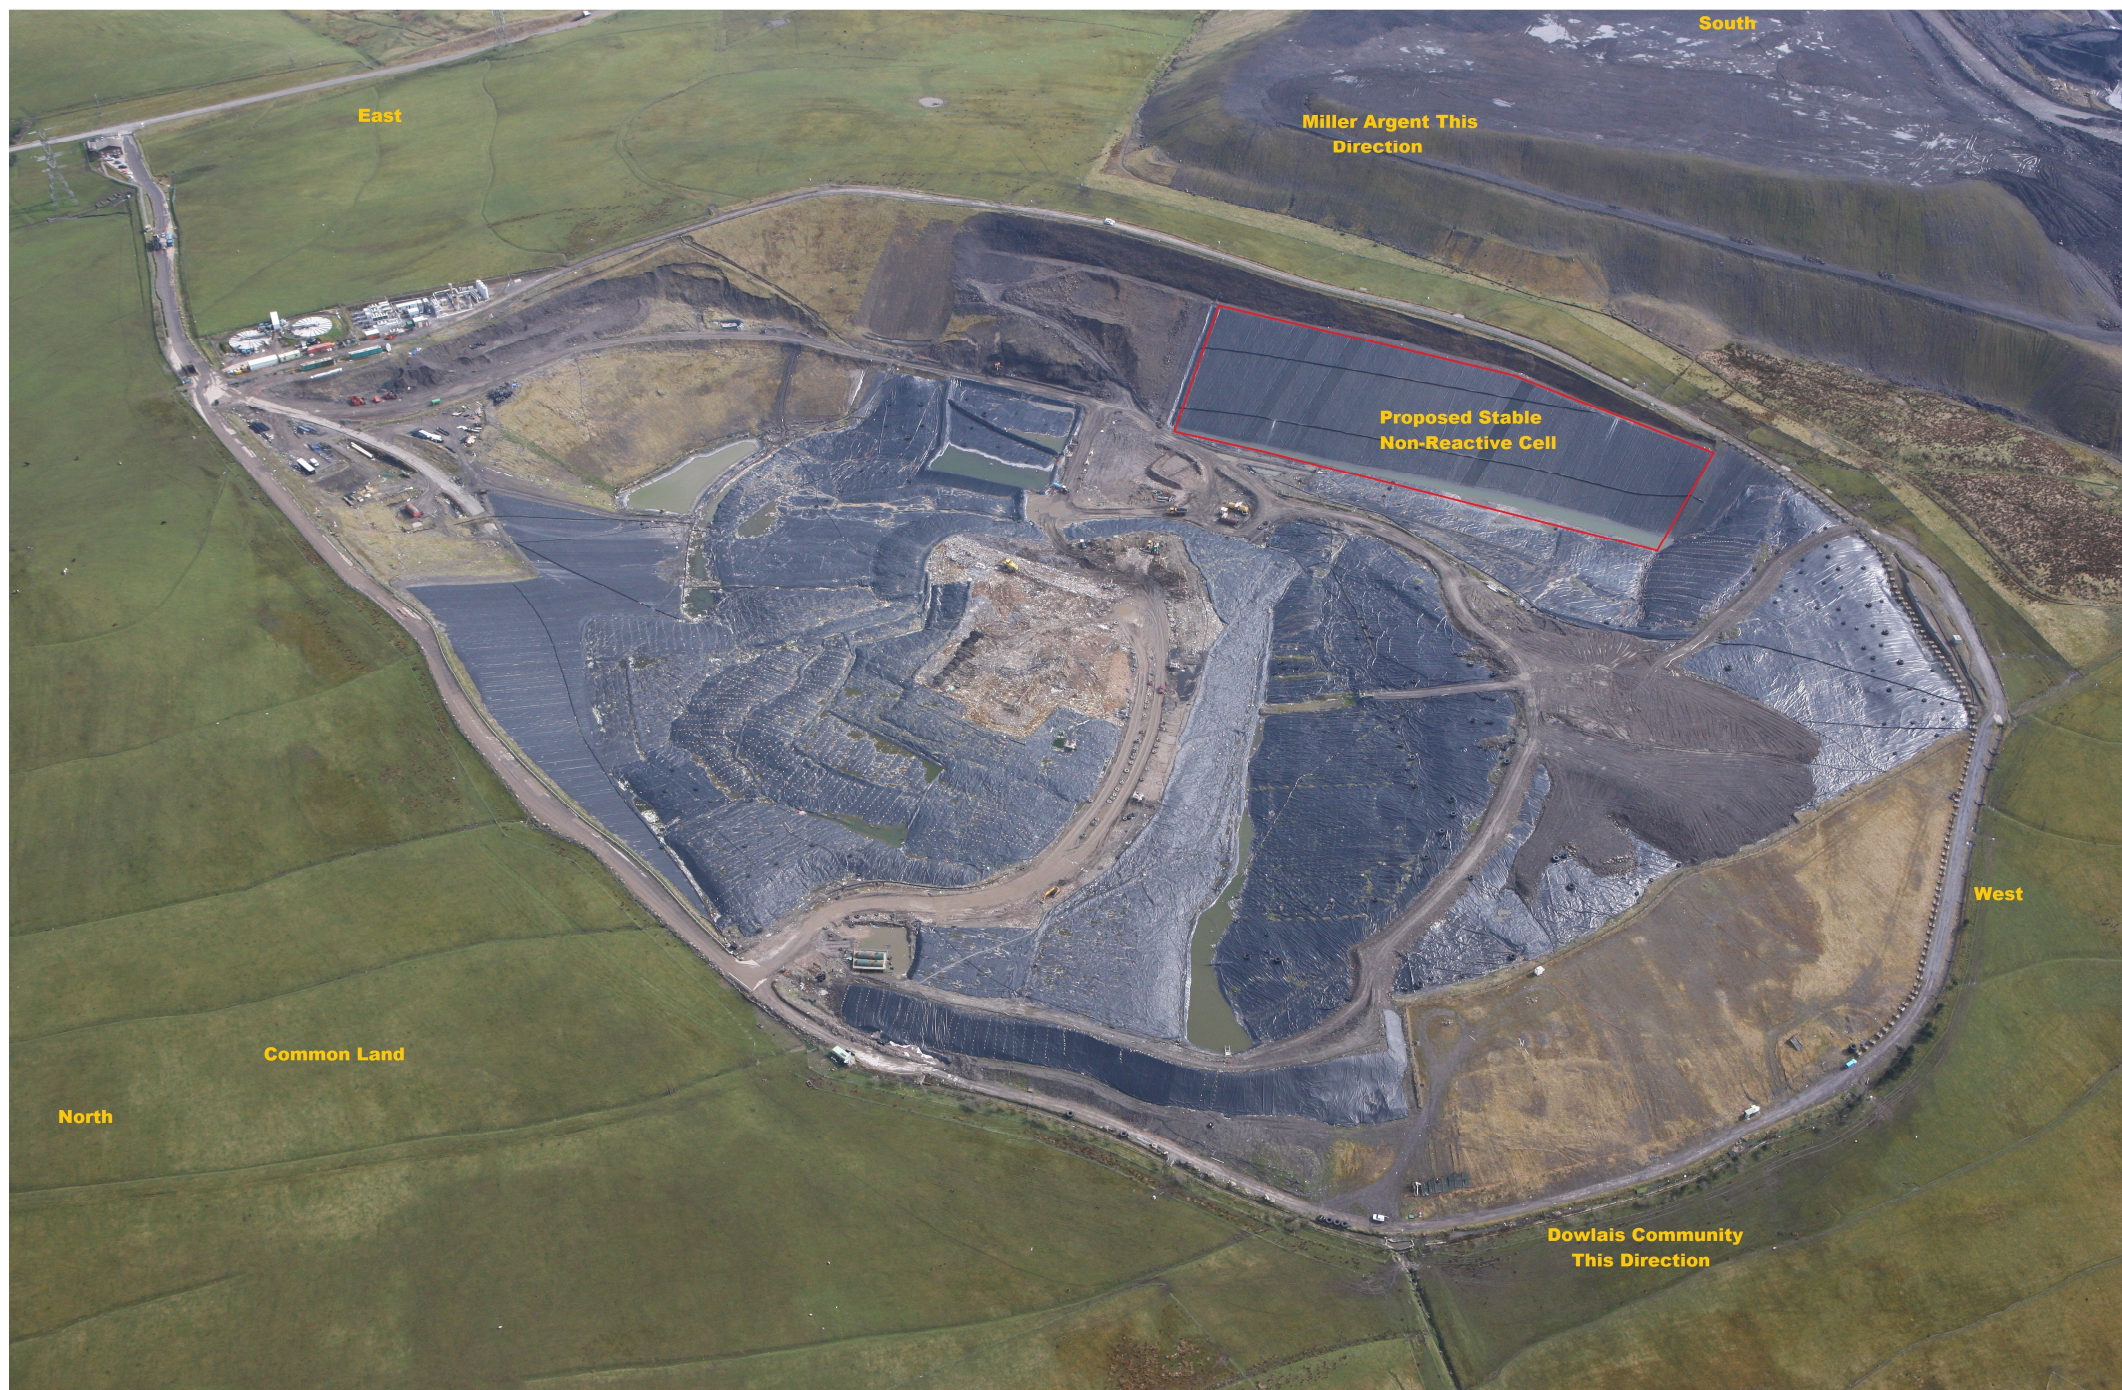
A stable non-reactive waste cell located in the southern area of the Trecatti site (see figure 2) opened in April 2015, accepting all forms of asbestos waste and asbestos contaminated soils.

**Figure 2.** Aerial view of Trecatti Landfill Site showing the location of the stable non-reactive cell for asbestos. Please note that this image was used in the permit application, the asbestos cell has since been built.

To reduce the likelihood of airborne fibres, the stable non-reactive cell has been surrounded by a dust suppression system that will be operational during the period of asbestos acceptance. The asbestos waste will then be immediately covered with fines following placement.
