NOISE IMPACT ASSESSMENT AT PLATTS AGRICULTURE LIMITED, WREXHAM

**Platts Agriculture Limited,
Miners Park,
Llay Industrial Estate,
Wrexham,
LL12 0PJ**

**ECL Ref: PLAT.01.02/NIA
January 2022
Version: Issue 1**

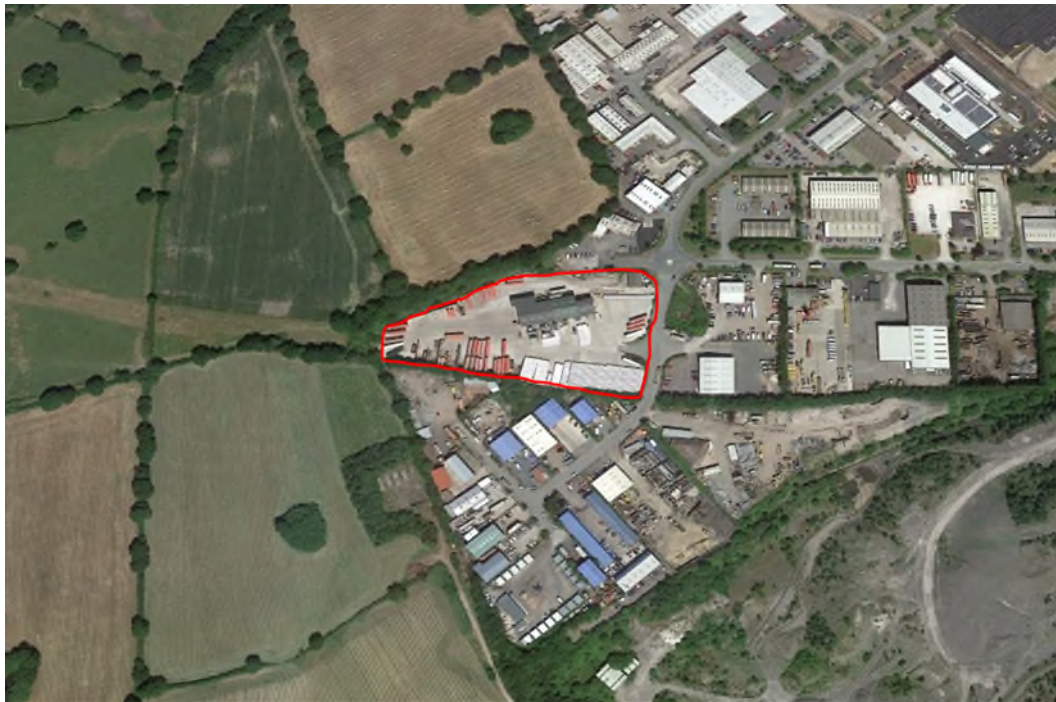
Figure 1: Site Location and Approximate Site Boundary

- 3.1.1. The Site is located at Miners Park within the Llay Industrial Estate and is centred on Ordinance Survey (“OS”) National Grid Reference (“NGR”) 332077 356370. The Site will occupy an area of approximately 1.56 Hectares (“Ha”).
- 3.1.2. The location of the Site and the approximate site boundary which is also the proposed Permit boundary (outlined in red) is provided in Figure 1.

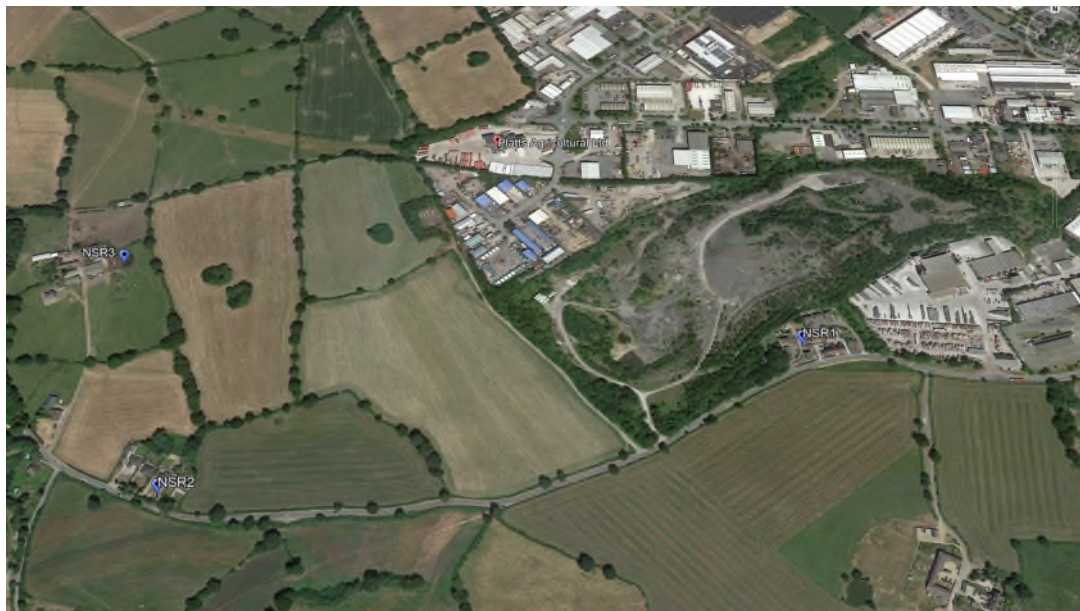
Figure 2: Originally Proposed Potential Noise Sensitive Receptor Locations

- 3.1.3. During the planning phase of the project, three potential NSR locations were identified as being residential areas within 500m of the Site boundary. However, upon attending site to determine the suitability of the monitoring locations, it was found that the originally proposed locations NSR1 and NSR2 were unduly influenced by traffic noise from the B5102 Llay Road immediately to the south of the locations.

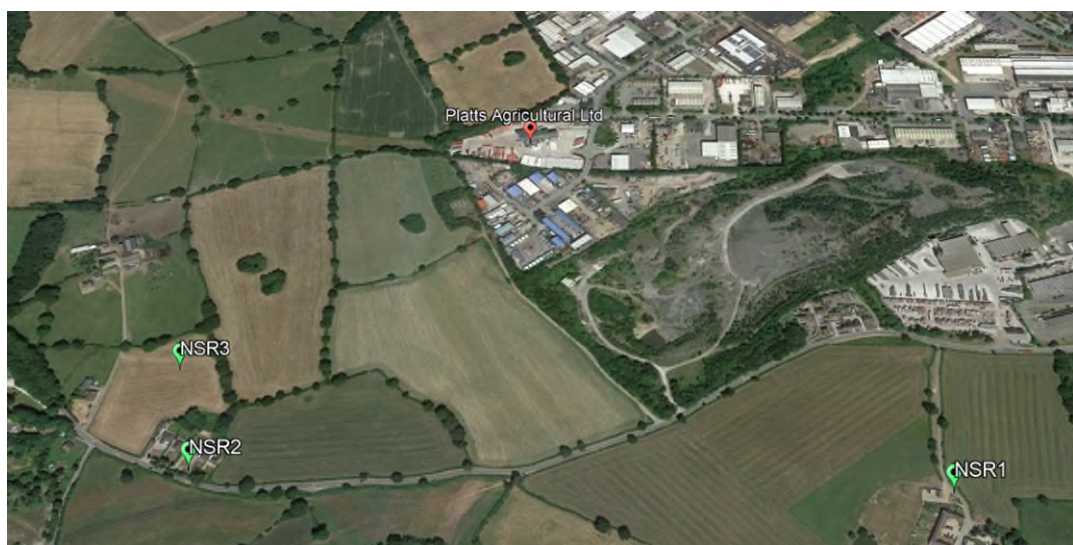
Figure 3: Measured Potential Noise Sensitive Receptors Locations

- 3.1.4. It was therefore decided that NSR1 should be moved to a location approximately 300m to the south of the originally proposed location to ensure a more representative measurement of noise emanating from the Site. Measurements were taken from location NSR2 as no alternative location was identified. Details of the specific NSR's where measurements were taken are provided in Table 1. A visual representation of the originally proposed NSR locations is provided in Figure 2 and the actual NSR locations where measurements were taken provided in Figure 3.
