Taylor Wimpey Limited

Environmental Permit Application – Supporting Notes

Cwrt Sirhowy, Blackwood, NP12 1DA

Project No. 314974 R2 (00)

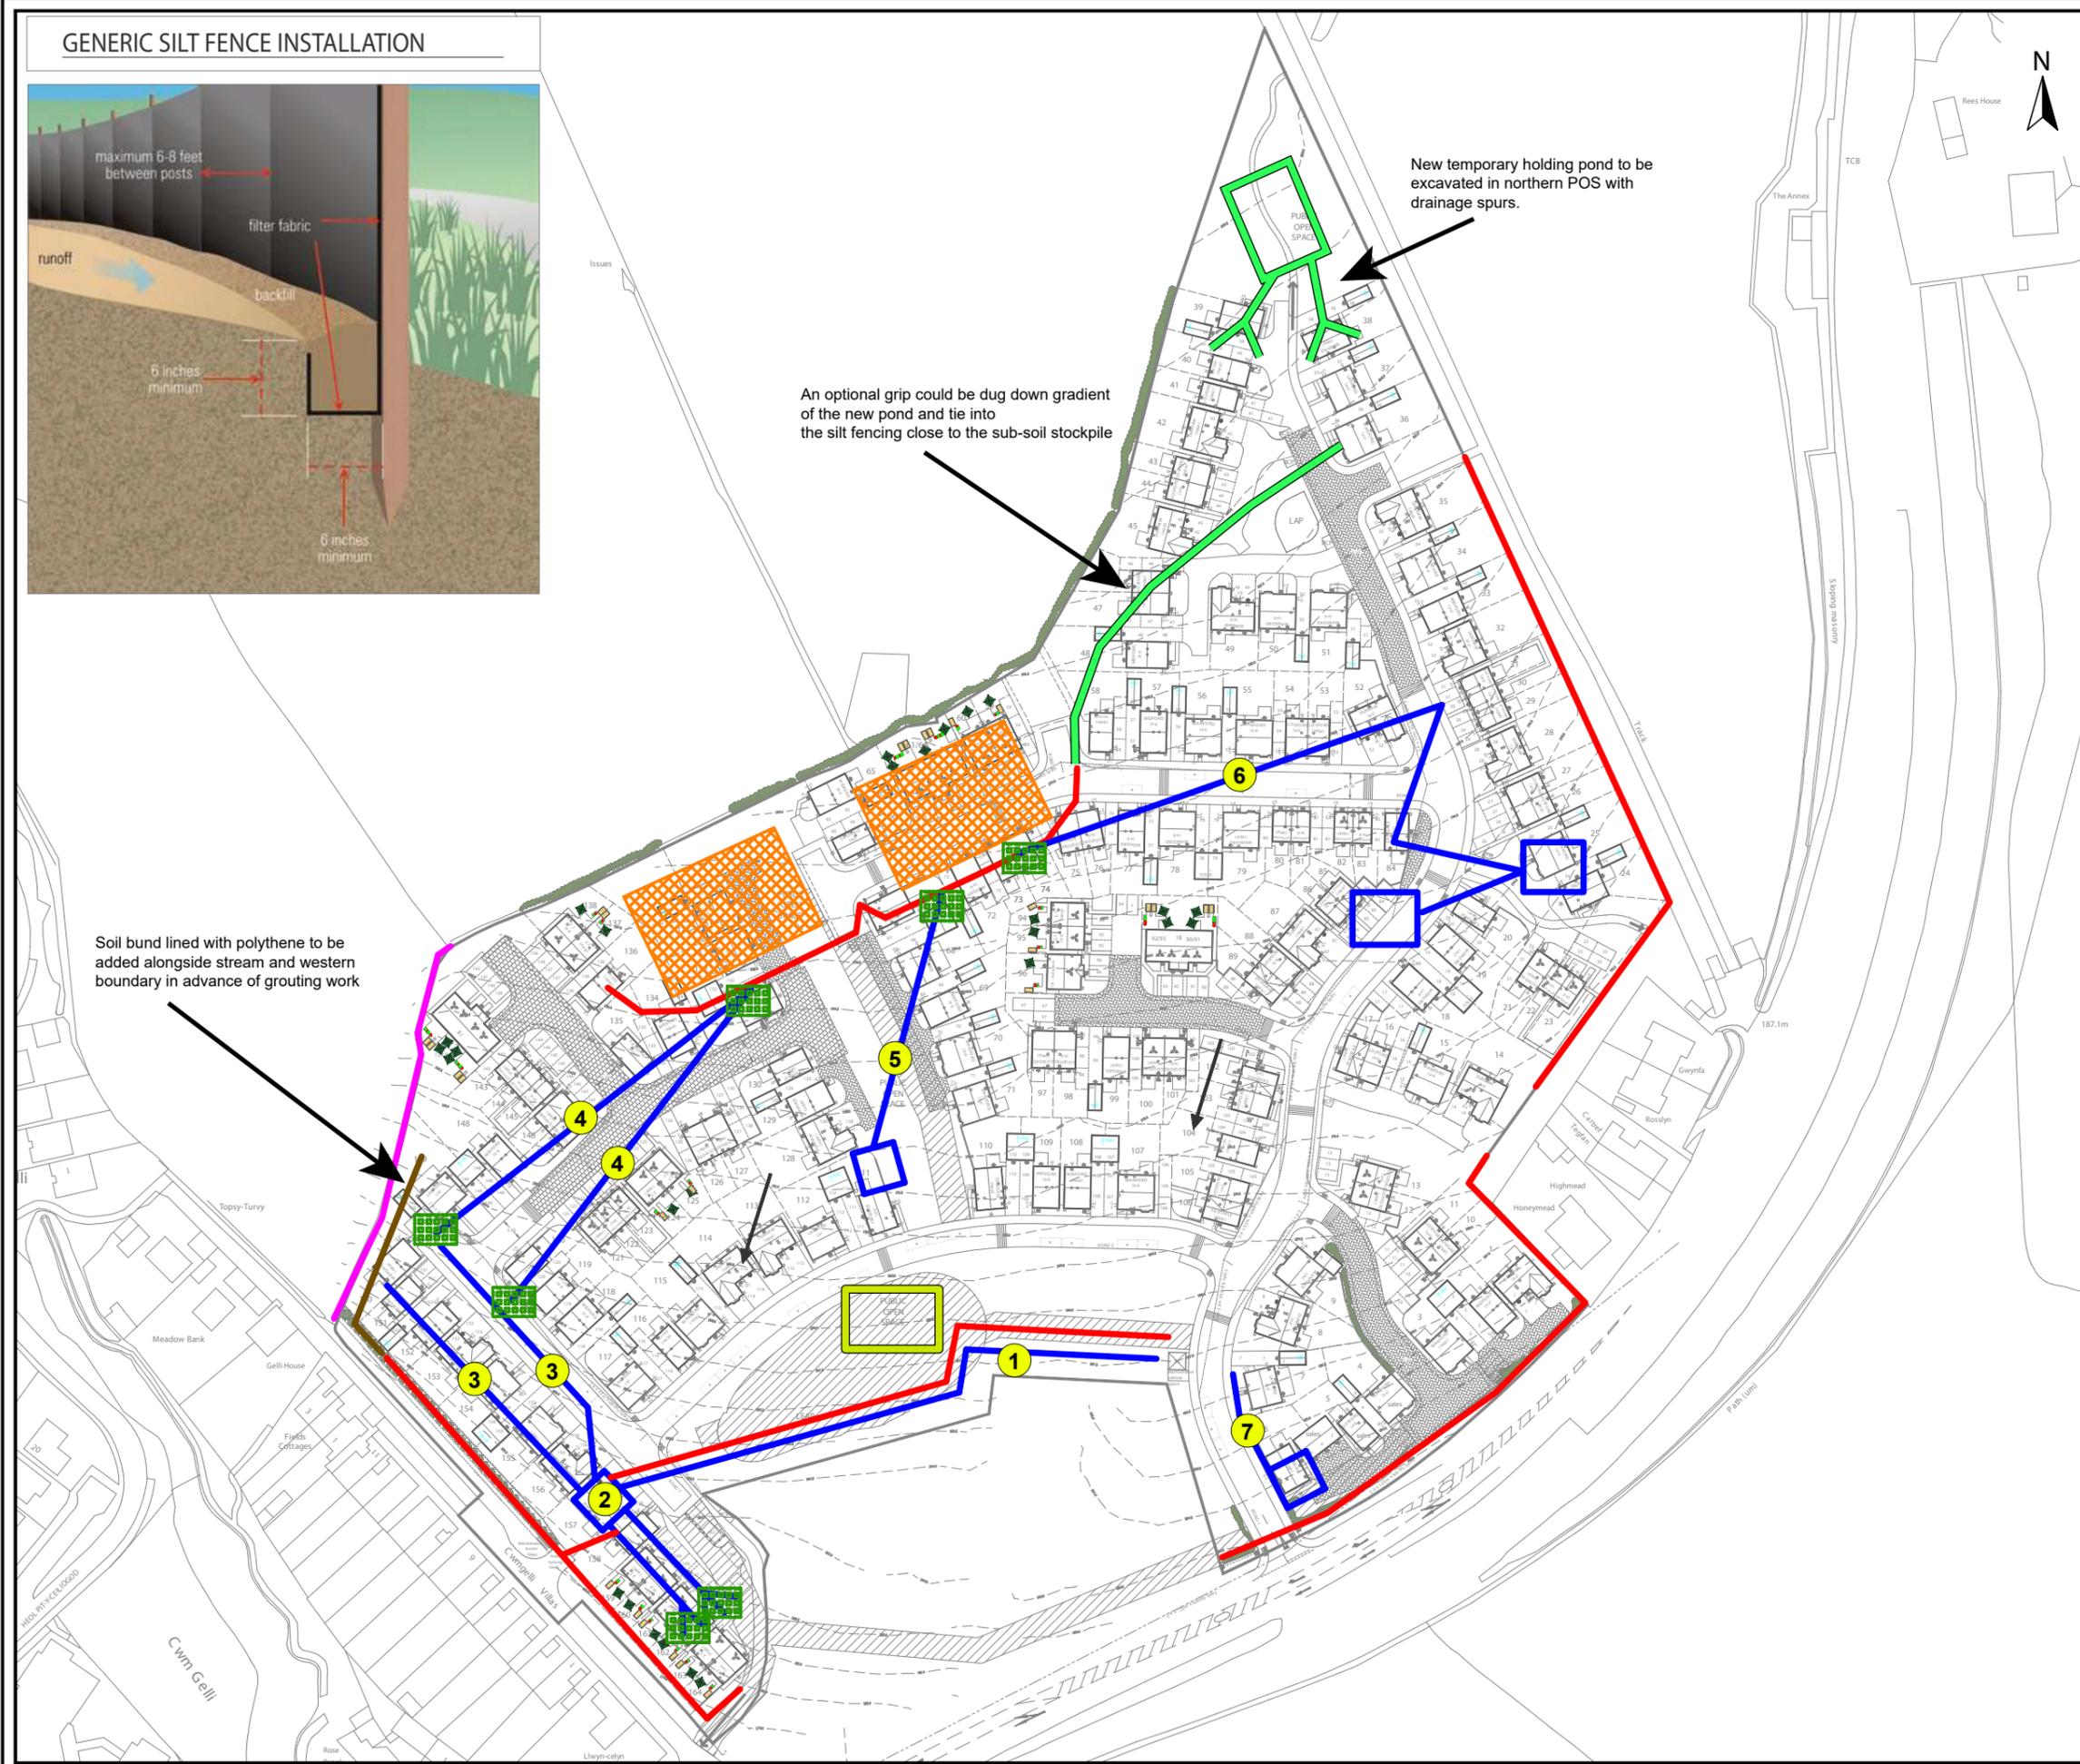
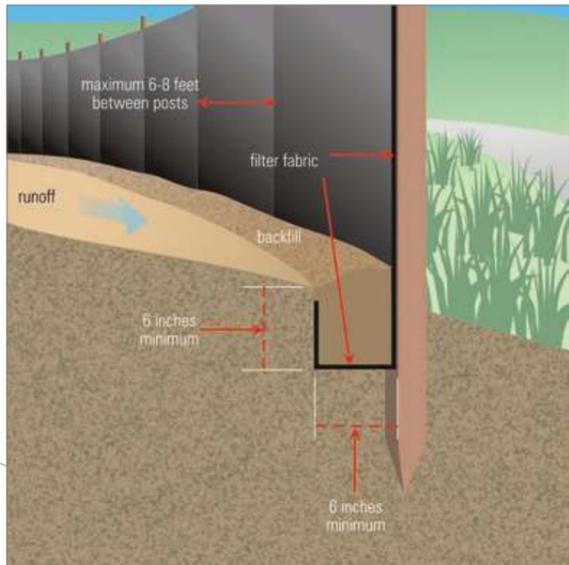
Enclosed: Figure 1: Surface water and silt mitigation measures

GENERIC SILT FENCE INSTALLATION

New temporary holding pond to be excavated in northern POS with drainage spurs.

An optional grip could be dug down gradient of the new pond and tie into the silt fencing close to the sub-soil stockpile

In advance of September 2021 and in accordance with recommendations set out within the SWSMP (April 2021), silt fencing was installed as a mitigation measure along the site's topographically down-gradient peripheral boundaries. This included the south-western, southern and south-eastern boundaries as protection for the off-site residential properties. At present, there is no surface water outfall location for the site and therefore mitigation measures specified by RSK have been aimed to slow, divert and attenuate rainfall and surface water runoff to prevent flooding of hydraulically down-gradient properties. However, it is noted that given the lack of natural infiltration; owing to the steep topography and in the absence of a surface water outfall, it is not possible to fully retain and attenuate all surface waters migrating across the site.

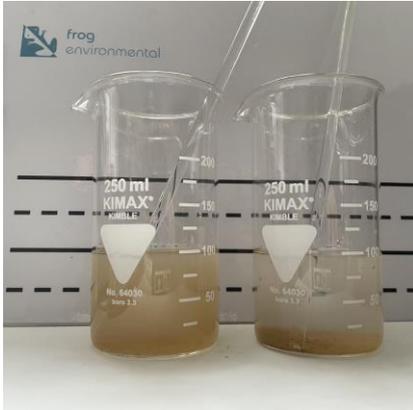
A. Control vs 30 min Settlement

Turbidity
315 NTU to 24.83 NTU

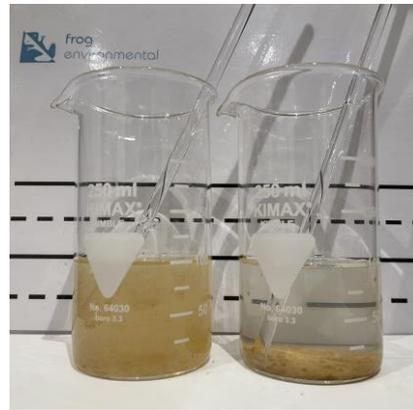
B. Control vs 12h Settlement

Turbidity
315 NTU to 19.59 NTU

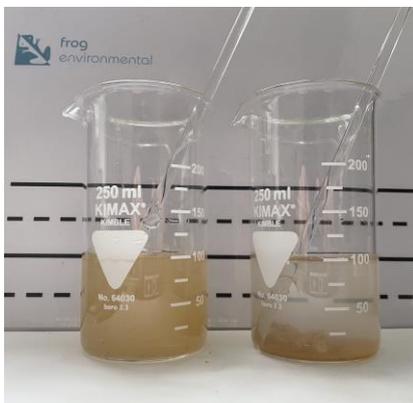
A. **Test 1** Control vs WL 494 / 360
(15 seconds agitation plus 15 seconds settlement)

Turbidity
315 to 48.99 NTU

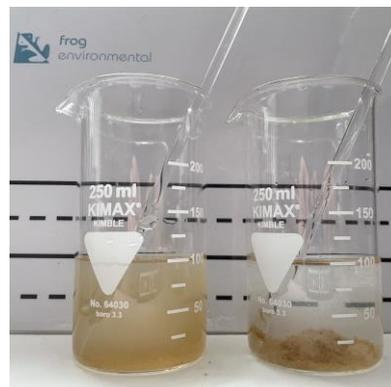
B. **Test 2** Control vs WL 494 / 360
(further 15 second agitation from Test 1 plus 30 seconds settlement)

Turbidity
315 to 24.83 NTU

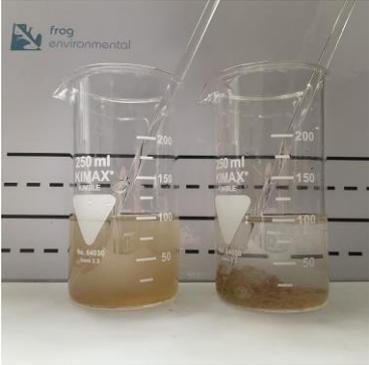
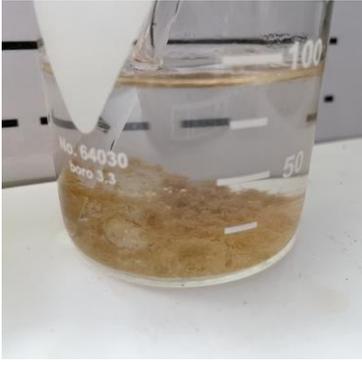
<p>C. Test 3 Control vs WL 494 / 360 (further 15 second agitation from Test 2 plus 60 second settlement)</p>	
<p>Turbidity 315 to 19.13 NTU</p>	<p>Test 3 Close Up</p>

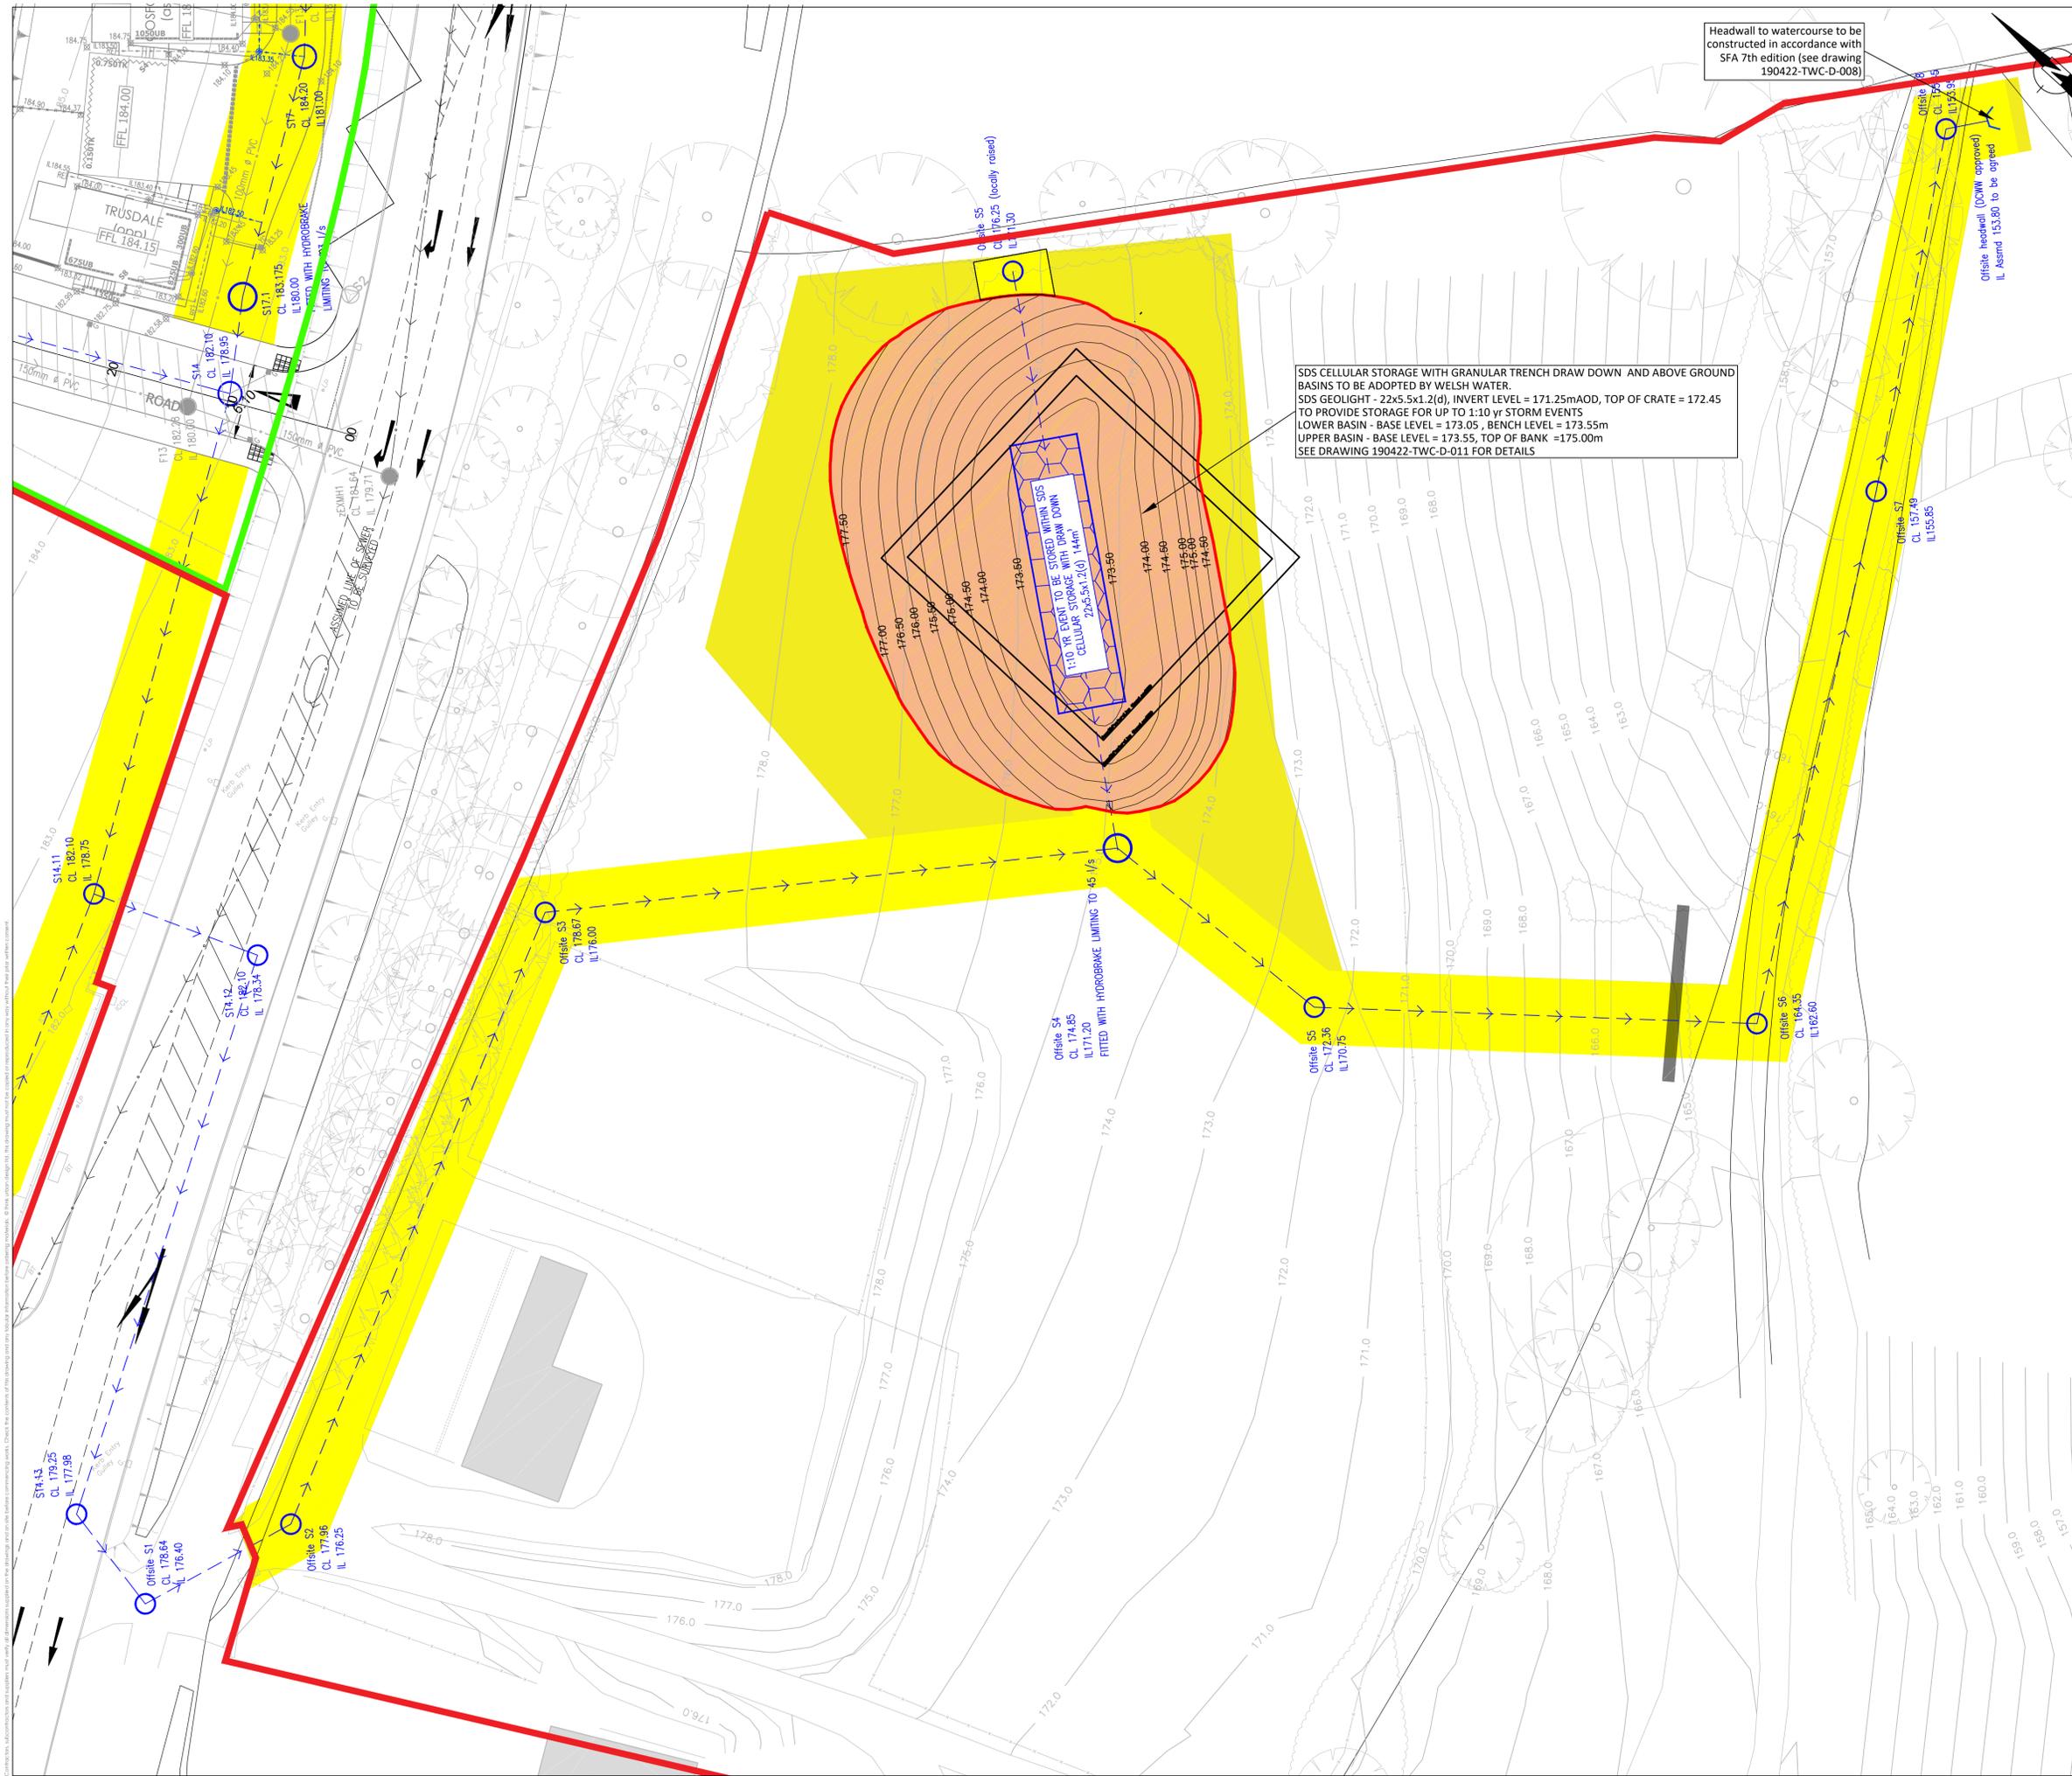
Headwall to watercourse to be constructed in accordance with SFA 7th edition (see drawing 190422-TWC-D-008)

SDS CELLULAR STORAGE WITH GRANULAR TRENCH DRAW DOWN AND ABOVE GROUND BASINS TO BE ADOPTED BY WELSH WATER.
 SDS GEOLIGHT - 22x5.5x1.2(d), INVERT LEVEL = 171.25m AOD, TOP OF CRATE = 172.45 TO PROVIDE STORAGE FOR UP TO 1:10 yr STORM EVENTS
 LOWER BASIN - BASE LEVEL = 173.05, BENCH LEVEL = 173.55m
 UPPER BASIN - BASE LEVEL = 173.55, TOP OF BANK = 175.00m
 SEE DRAWING 190422-TWC-D-011 FOR DETAILS
