# Coed Darcy Crymlyn Tip Closure and Aftercare Management Plan

St. Modwen Developments Ltd

| Document title | Closure and Aftercare Management Plan |
| Document reference | 5041216-RAP-RPT-0001400 |

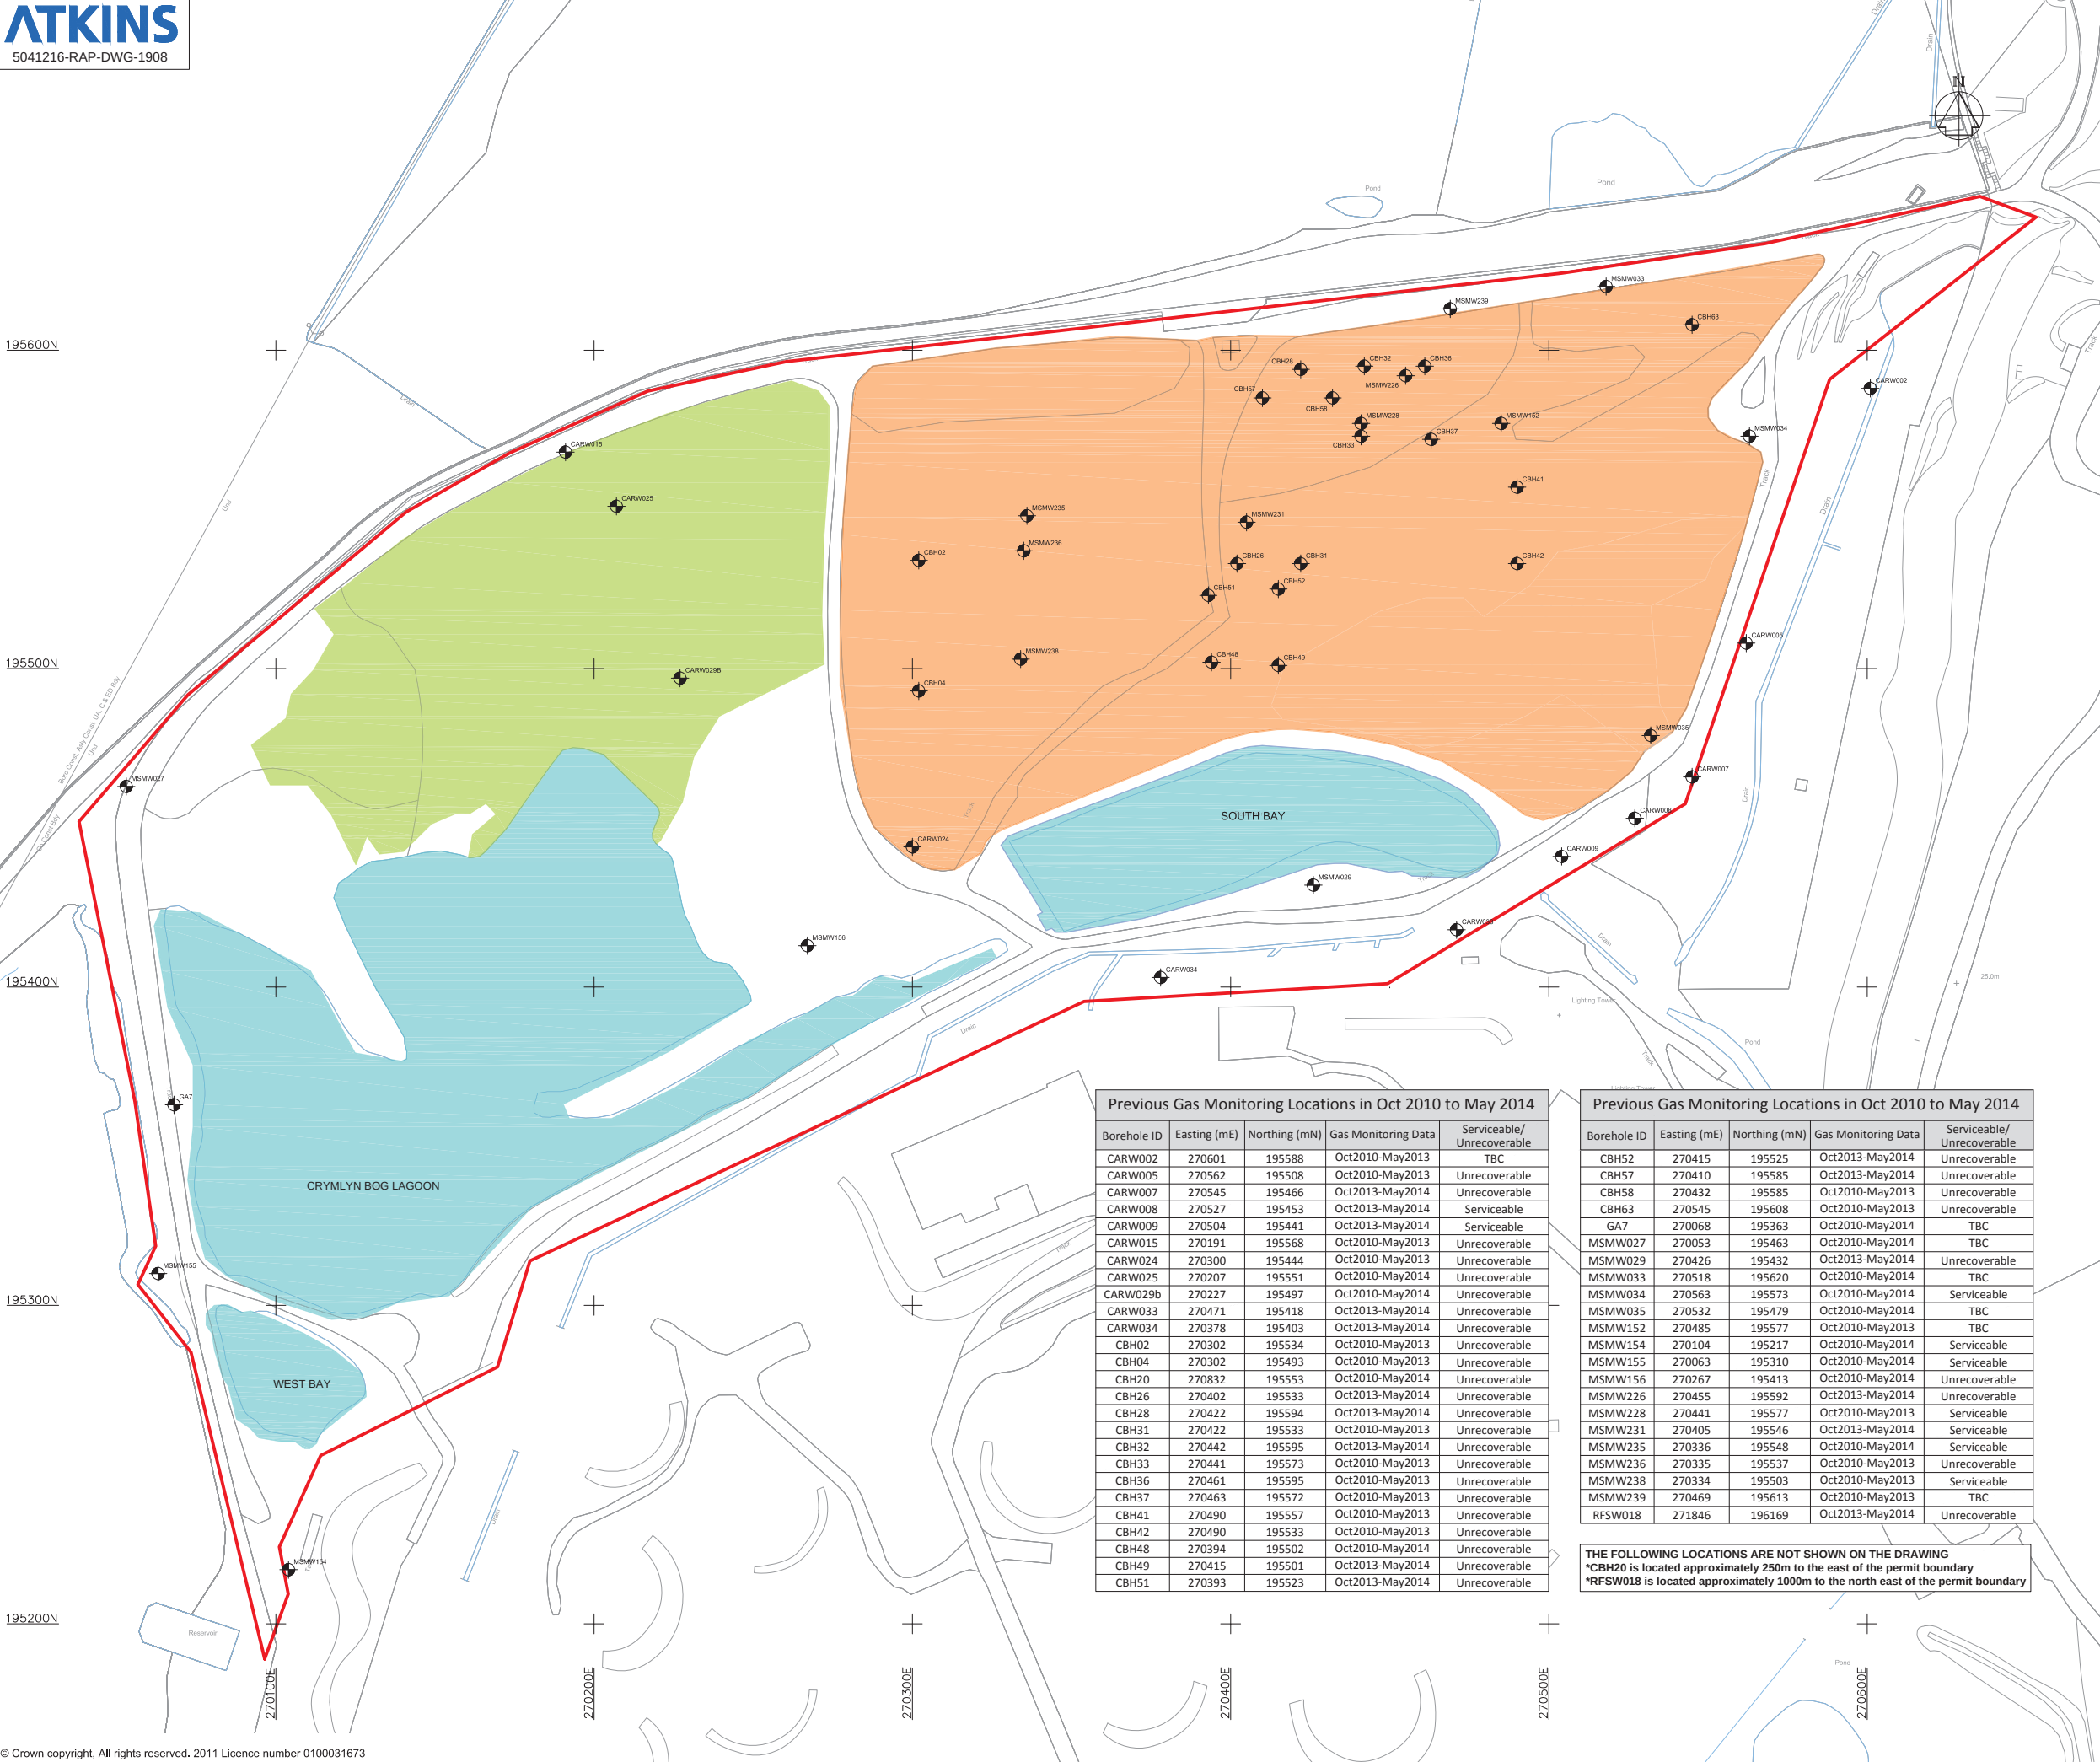
5041216-RAP-DWG-1908 - Previous Gas Monitoring Locations

- DO NOTE SCALE
- BOREHOLE LOCATIONS ARE INDICATIVE AND COORDINATES ARE APPROXIMATE ONLY.

The available information regarding the serviceability of the existing boreholes and their locations are shown on Drawings 5041216-RAP-DWG-0001908 and 1909. It should be noted that a number of the boreholes with existing monitoring data (undertaken in 2010 to 2014) are no longer serviceable. Within Site 1, all the previous boreholes have been destroyed due to the movement of earth materials.
