# Technical Note

| <b>Ref:</b> | 5041216-RAP-MEMO-0001399 | |
| <b>Subject:</b> | Coed Darcy Crymlyn Tip Gas Monitoring Audit | |

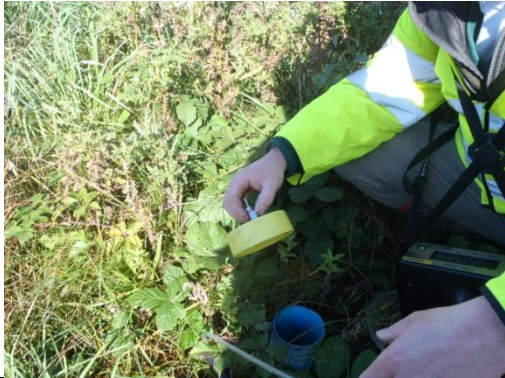
| Monitoring Point | Action required |
|---|---|
| GW37 | Plastic screw type end caps are not air tight and should be replaced.<br> |

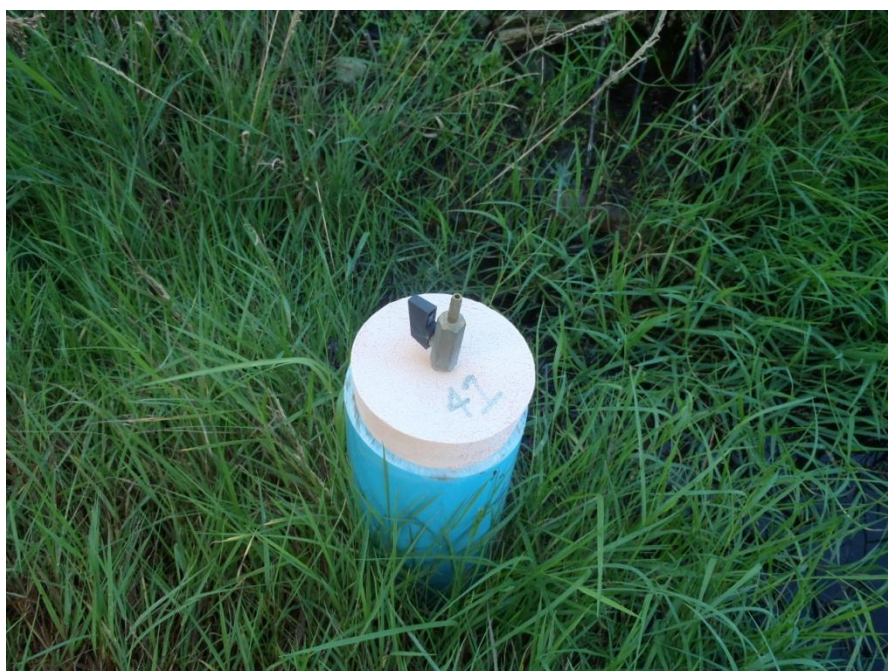
We also observed that the sampling tap had been left open at one well. At another well we found the gas tap/bung arrangement had been left on the floor. This is indicative of poor sampling practice. Monitoring boreholes must remain sealed at all times to avoid the dilution of landfill gas with air.

*Photograph showing monitoring point 41, with gas tap left open.*

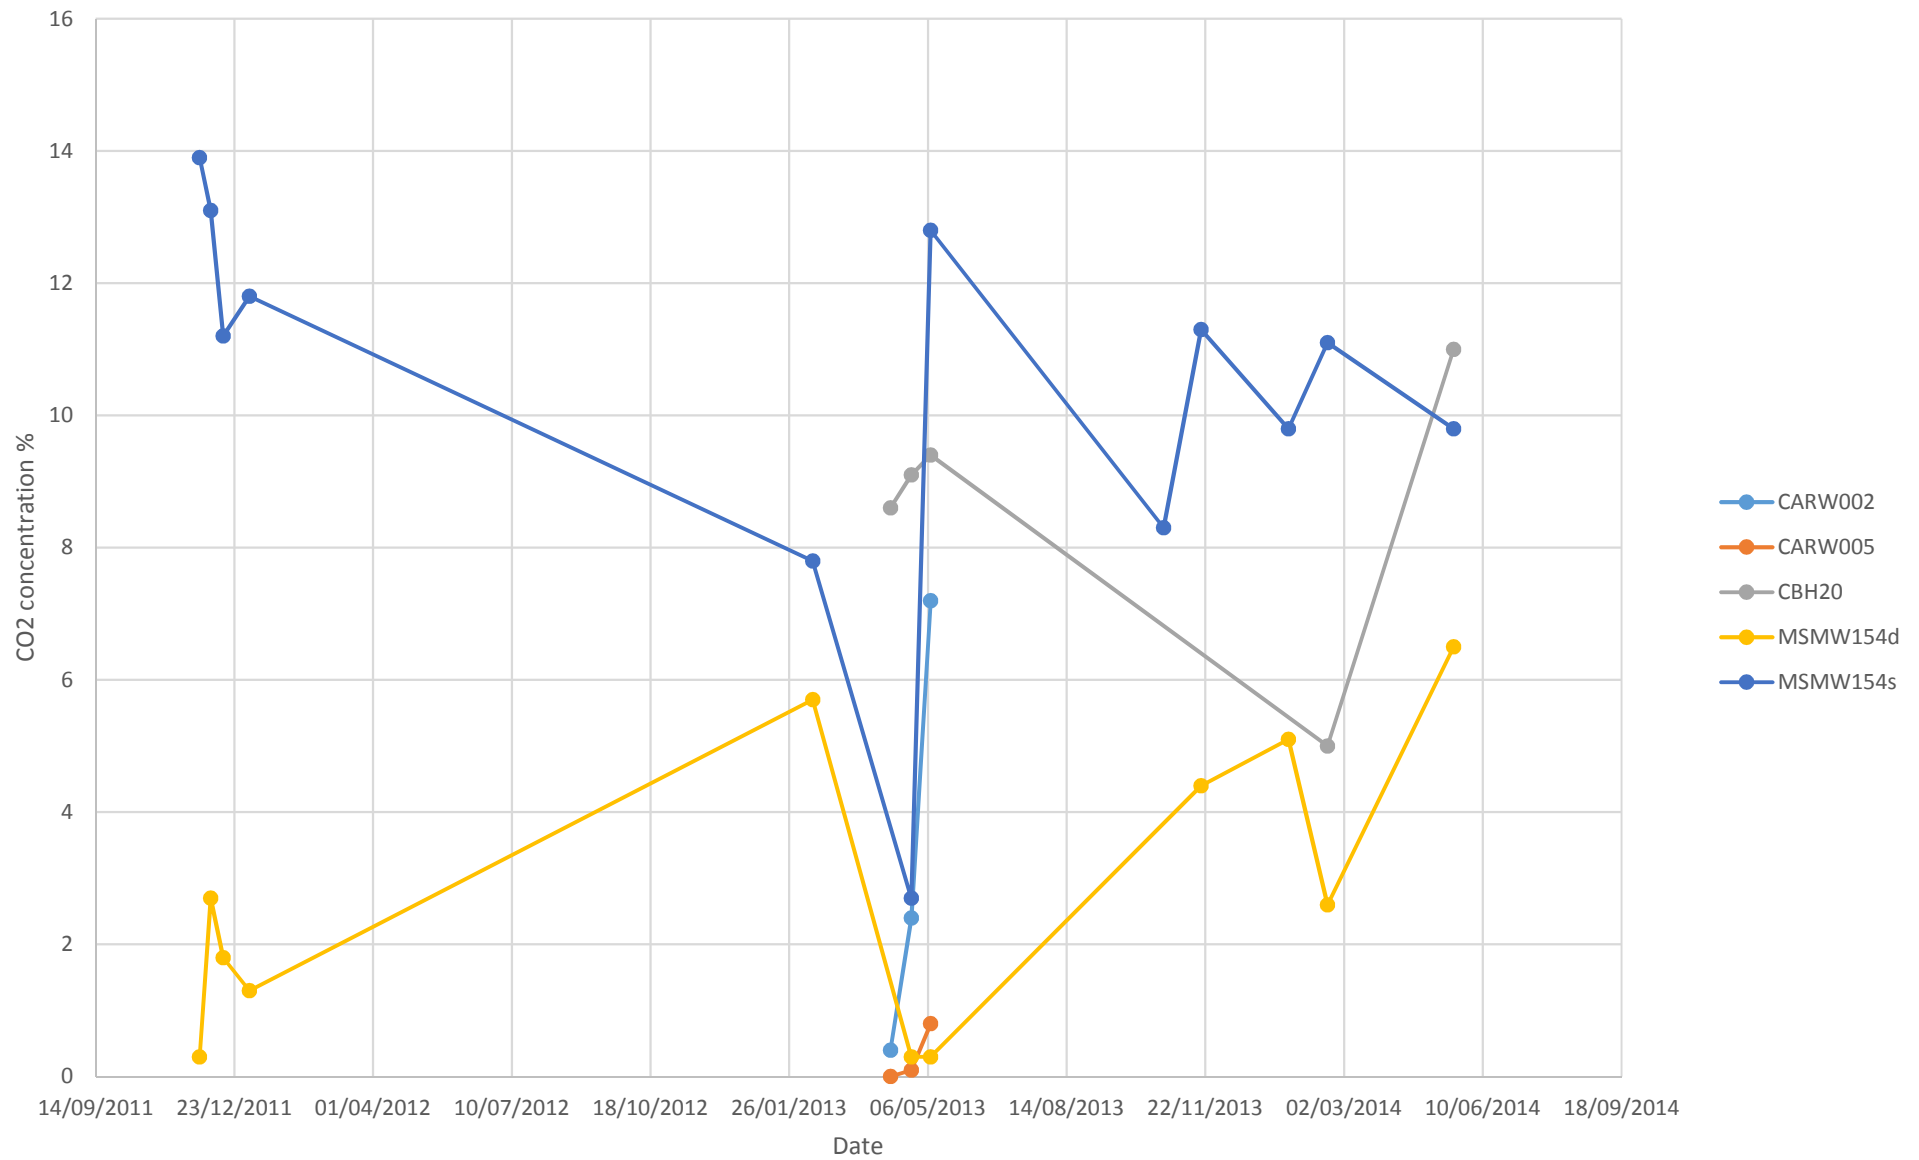
CO2 concentrations from boreholes located outside of the permit boundary
