Project Name:  
**SALMON FOR TOMORROW PHASE 2 HONDDU FORGE**

Drawing Title:  
**PROPOSED WEIR PLAN**

Suitability:	FOR CONSTRUCTION	Suitability Code:	A
Internal Project Number:	277161	Scale:	1:200
Rev.:		Rev.:	C01
Drawing Number:	277161-ARP-03-XX-DR-XX-0006

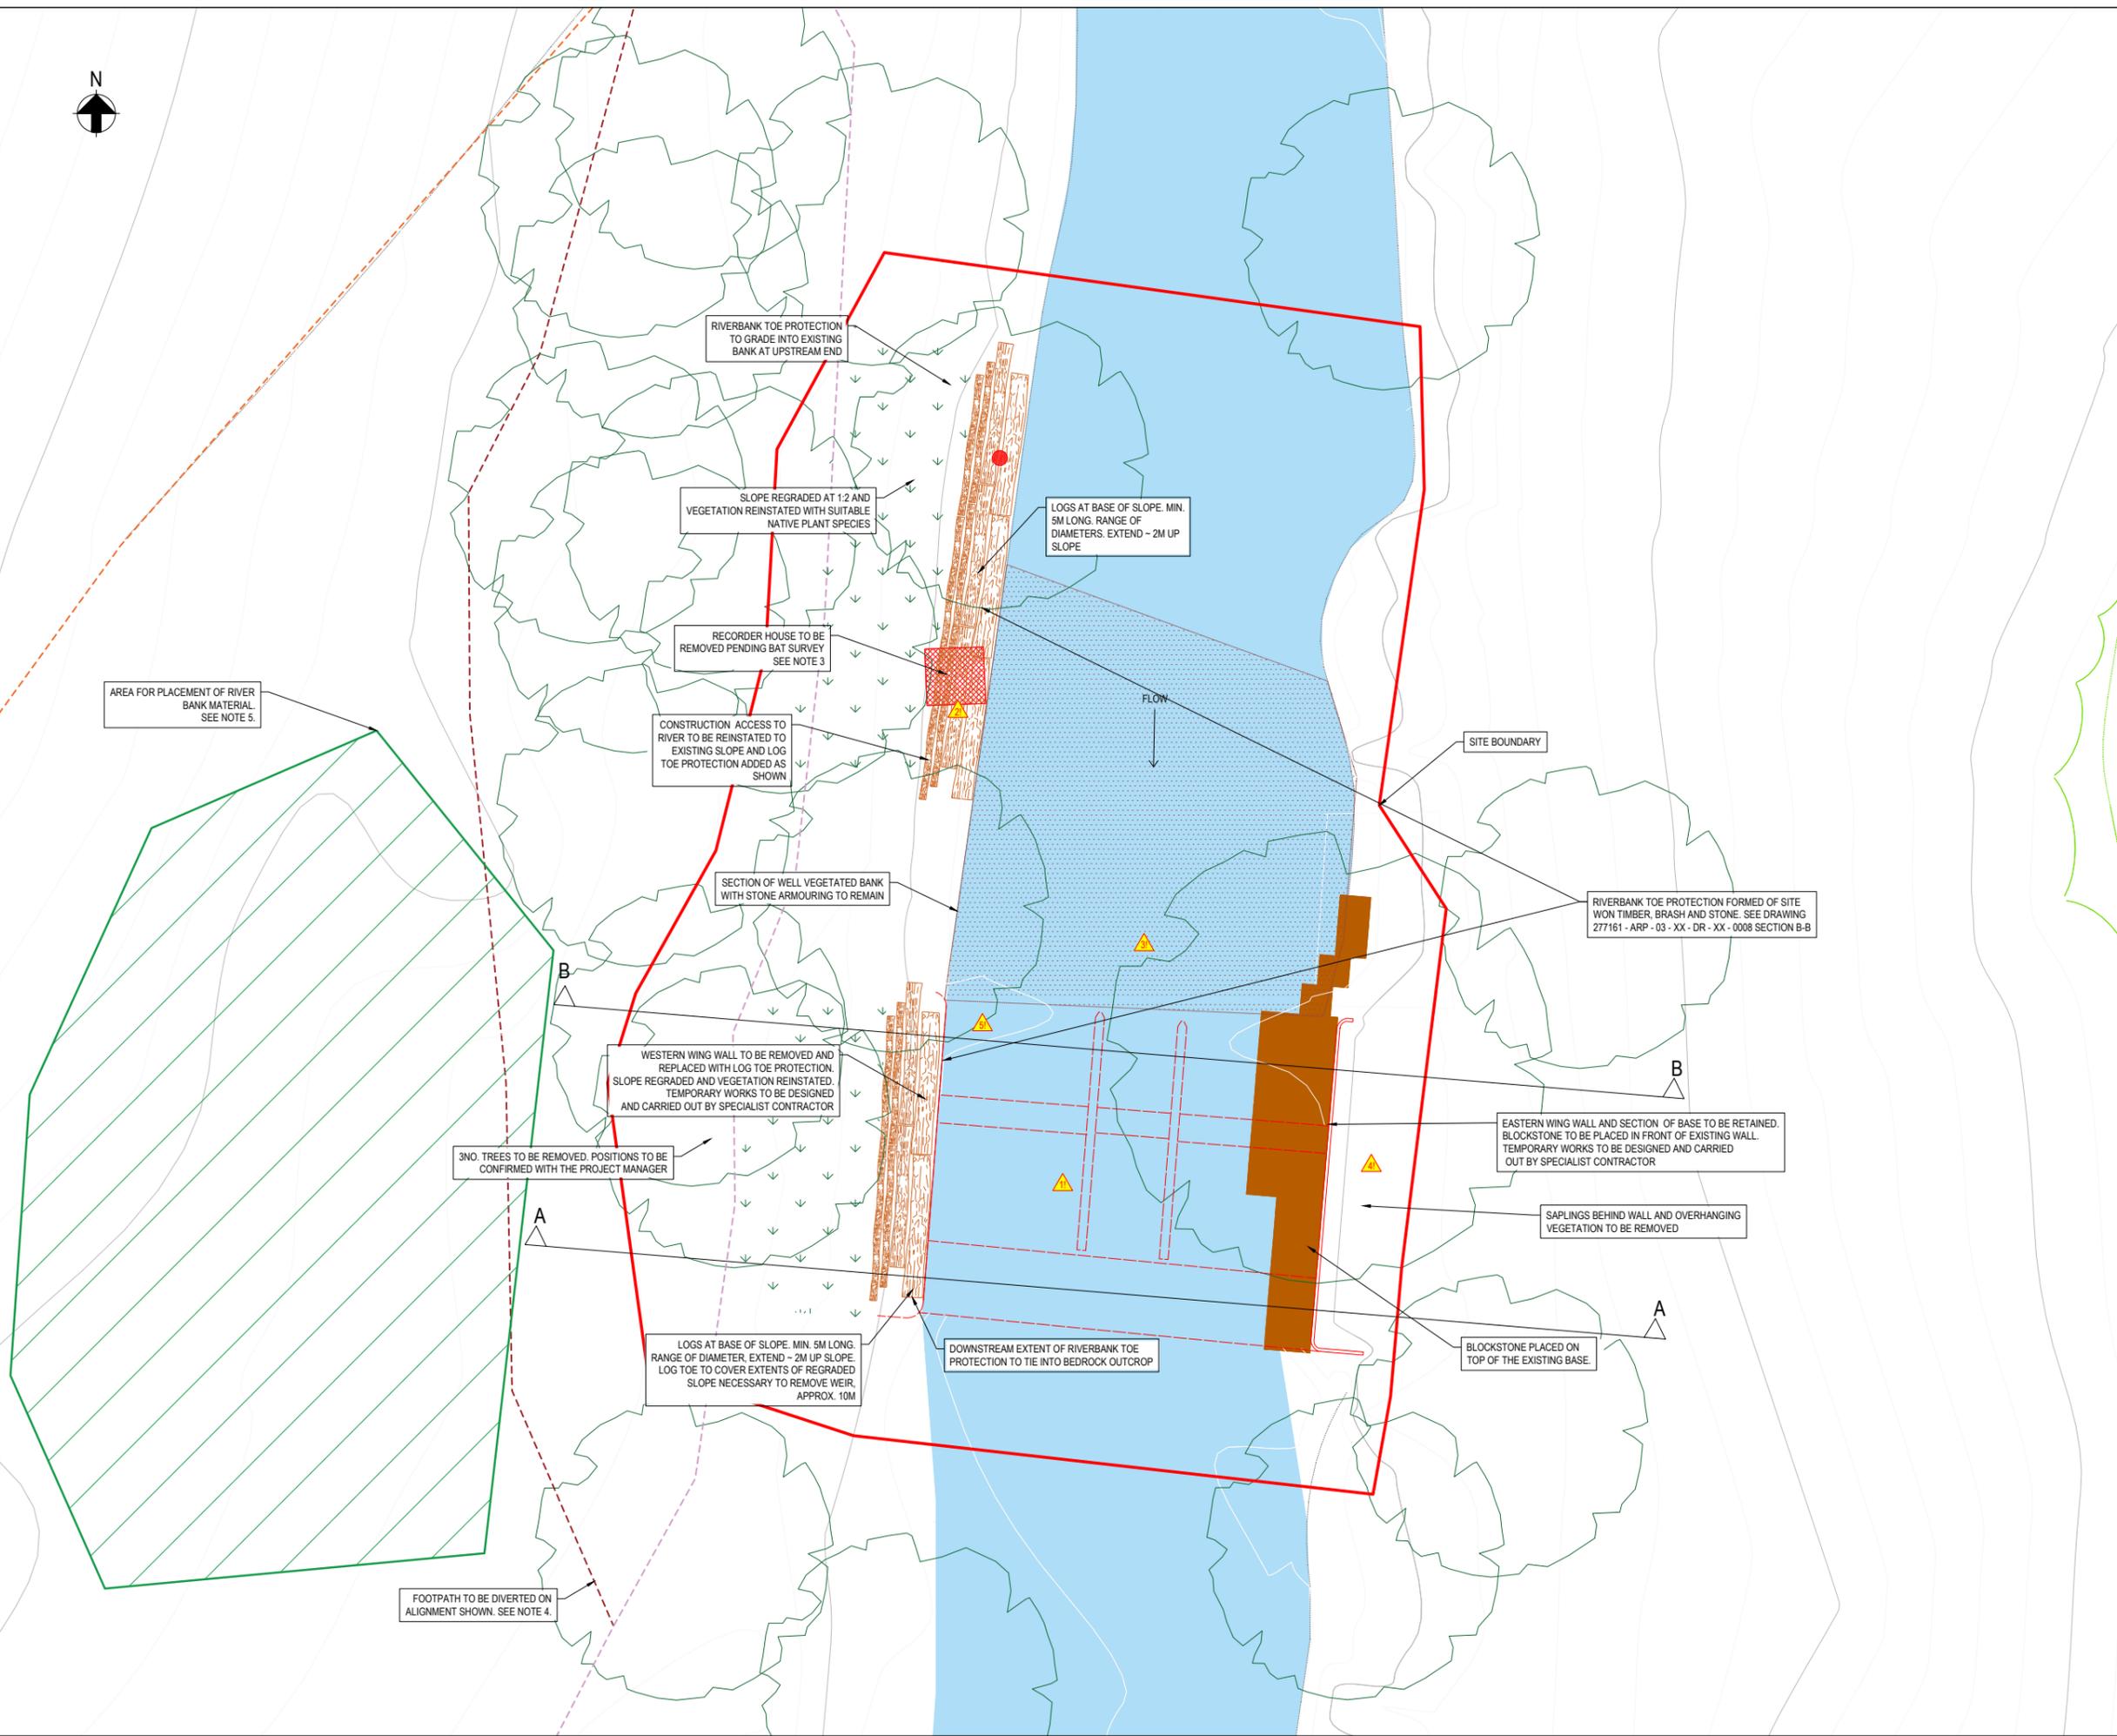
NO GROUND INVESTIGATION HAS BEEN CARRIED OUT. IT IS ASSUMED THAT THE RIVER BED IS FORMED OF GRANULAR MATERIAL ON THE BASIS OF VISUAL INSPECTION. BEDROCK IS VISIBLE IN THE CHANNEL IN THE PROXIMITY OF THE WORKS, AND IT IS POSSIBLE THAT ROCKHEAD MAY BE ENCOUNTERED DURING THE REGRADED WORKS. THE CONTRACTOR IS TO CONFIRM THIS PRIOR TO COMMENCING WORKS AND INFORM THE PROJECT MANAGER IF THIS IS NOT THE CASE.

FOOTPATH TO BE REINSTATED ON ROUTE SHOWN IN LINE WITH CRUSHED STONE SURFACE DETAIL ON DRAWING TD-L-004

AREA INDICATED ON DRAWING IS A DISUSED QUARRY TO BE USED FOR THE PLACEMENT OF MATERIAL TAKEN FROM THE WEST RIVER BANK FOLLOWING REGRADED. SUBJECT TO ECOLOGICAL SURVEYS.
